**The Buzzards Bay Stormwater Collaborative
Illicit Discharge Investigation Trailer**

Town of Acushnet Report

July 2021

Acushnet IDDE Report

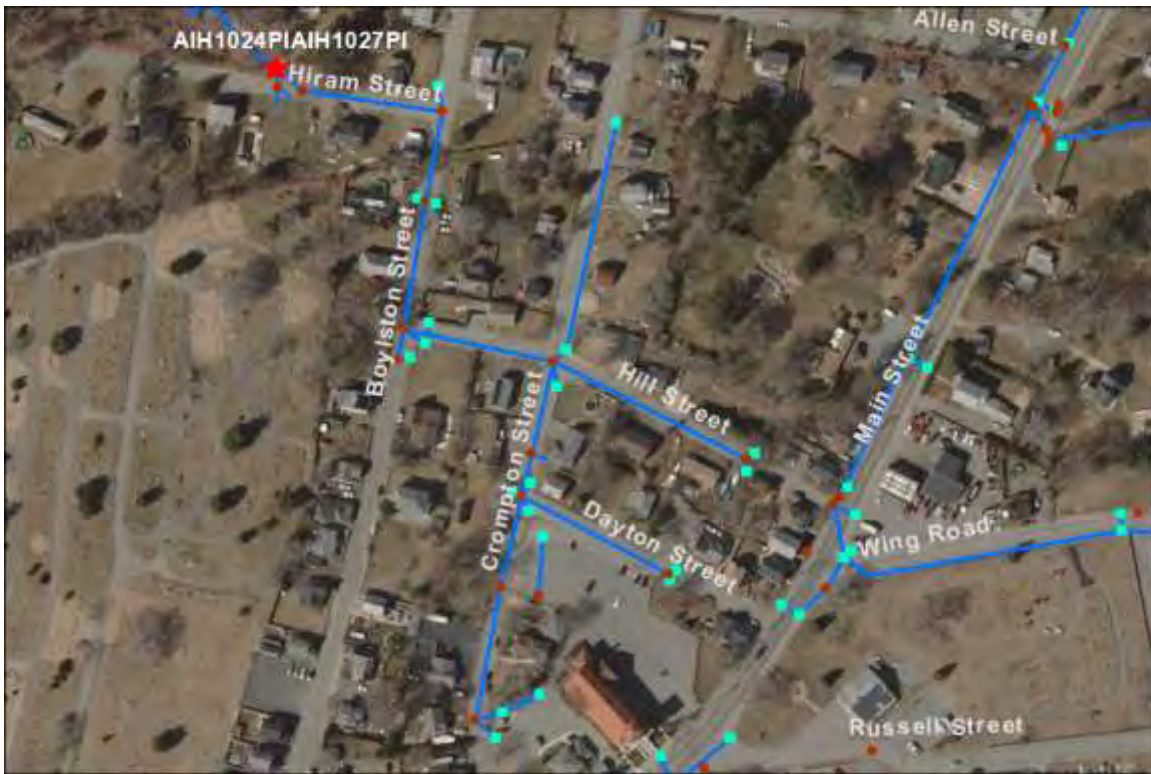
AIH1024PI and AIH1027PI – Hiram Street: no issues found; AIH1024PI has two storm pipes of undetermined origin; further investigation recommended; at the intersection of Boylston and Hill Streets, one broken catchbasin grate and one broken manhole frame were observed.

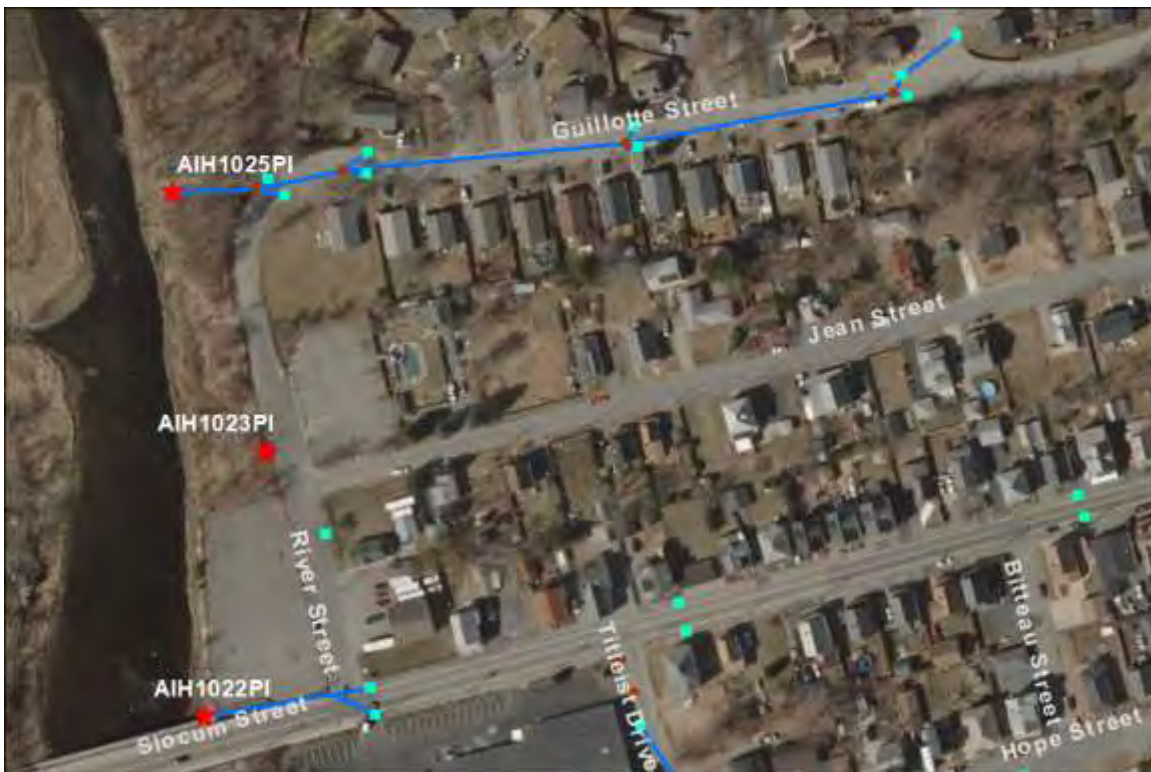
River Street: no issues found; AIH1025PI services Guillotte Street and drains through the park; AIH1023PI is a simple culvert; AIH1022PI appears to drain only two catchbasins on Slocum Street.

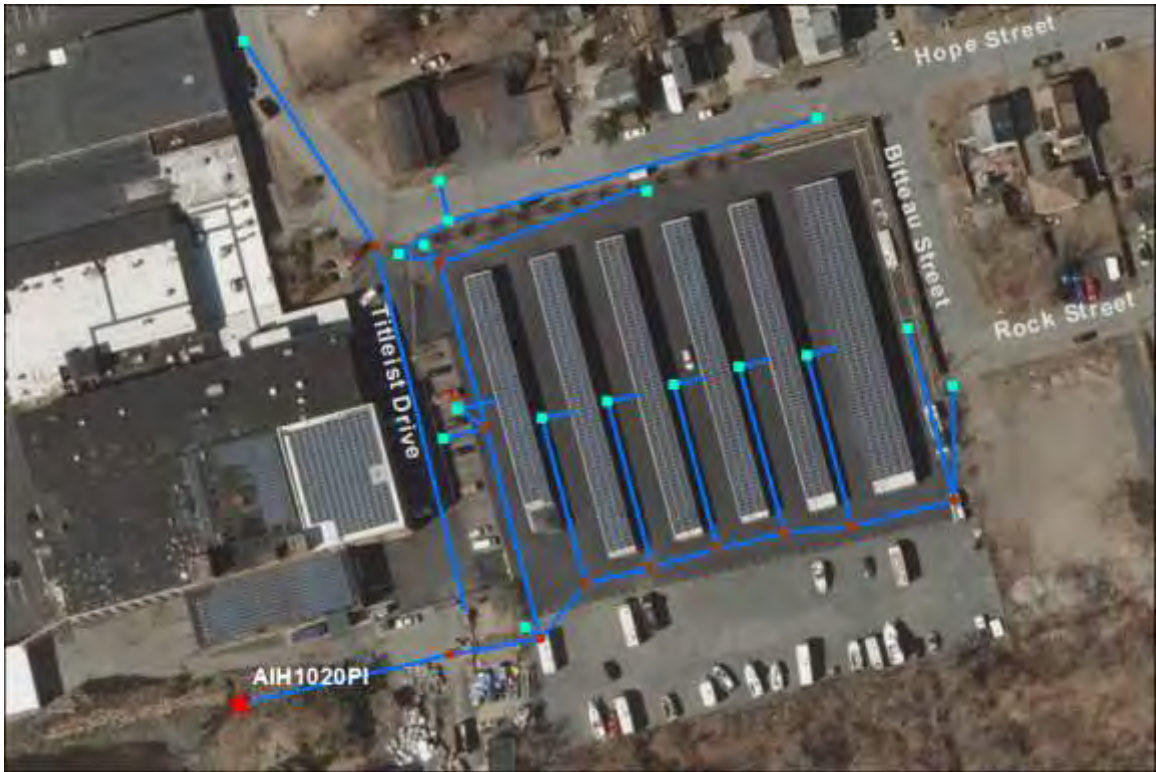
AIH1020PI – Titlelist Drive: no issues found; additional structures are shown on engineering drawings; follow-up field work recommended.

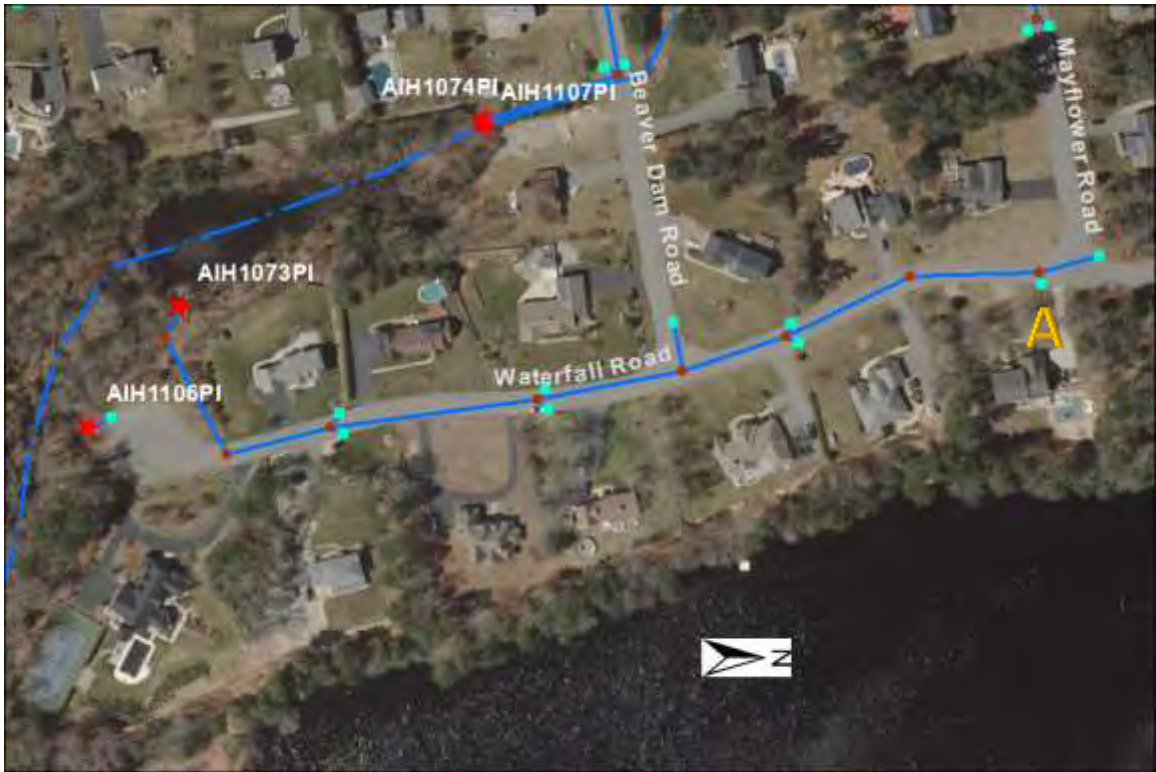
AIH1073PI and AIH1106PI – Waterfall Road: no issues found; the catchbasin at marked location A contained cloudy water; the sump water did not test positive for bacteria or detergent contamination; suspect suspended solids from local construction activity; no further action recommended.
