**The Buzzards Bay Stormwater Collaborative
Illicit Discharge Investigation Trailer**

Town of Bourne Report

November 2022

Bourne IDDE Report

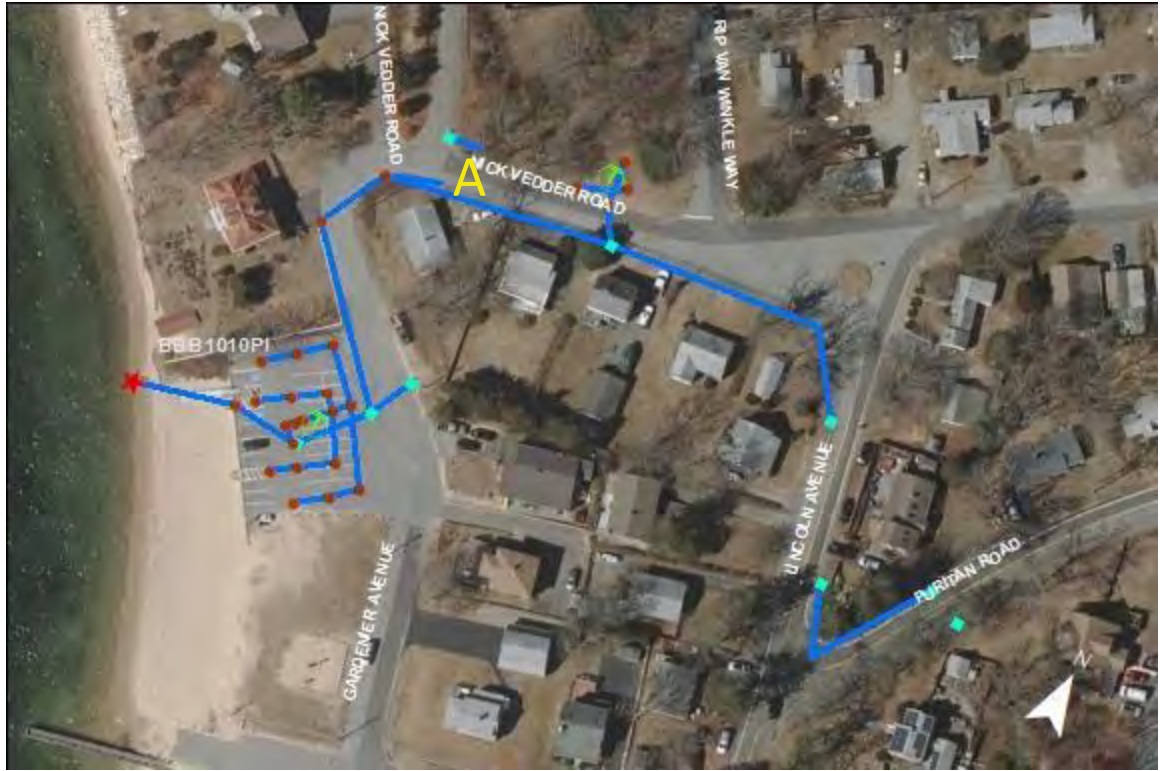
BBB1010PI- Gardenier Avenue: No issues found. This outfall is an overflow for an infiltration chamber under the parking area. The infiltration system appears to be clean and well maintained. There is a pipe entering the manhole at point A. Its origin is unknown. Further investigation is needed.

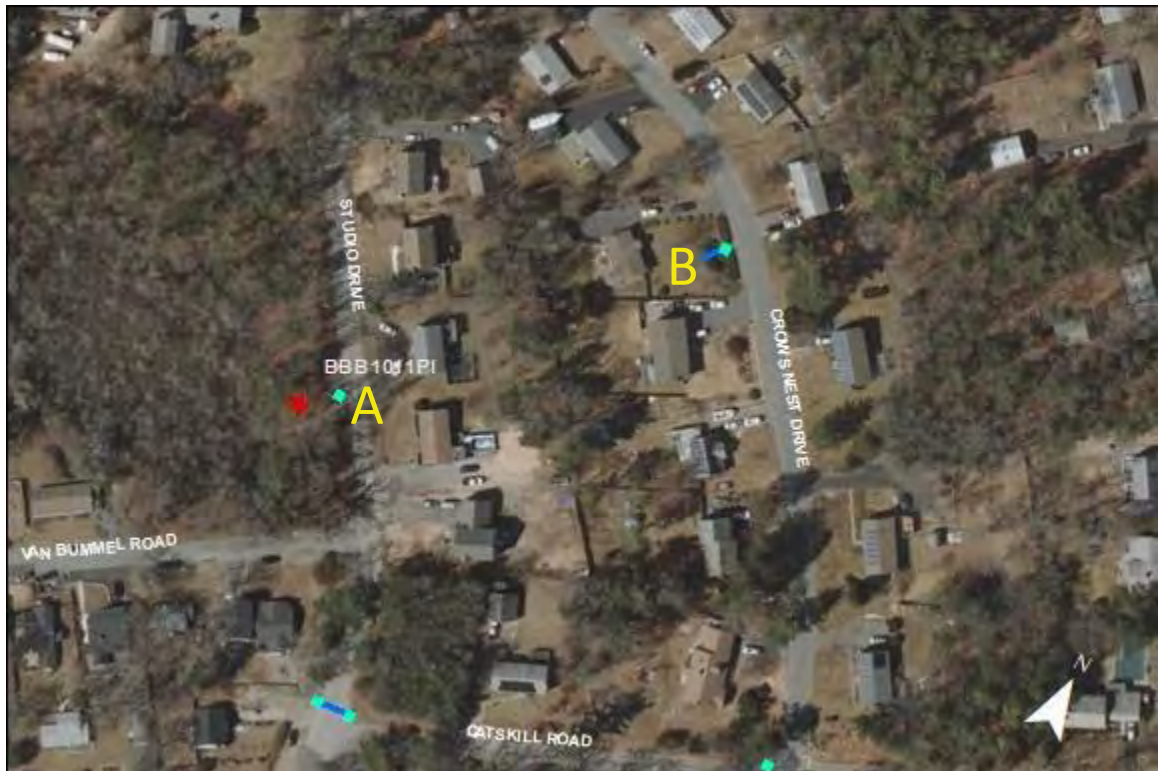
BBB1011PI- Studio Drive: At point A, the catchbasin is paved over by driveway. No longer functioning. Evidence of basin on other side of the street not working correctly also. Large ditch adjacent to catchbasin acting as a road cut. Further attention is recommended. At point B there is a pipe leaving the catchbasin its destination is unknown. Further investigation needed.

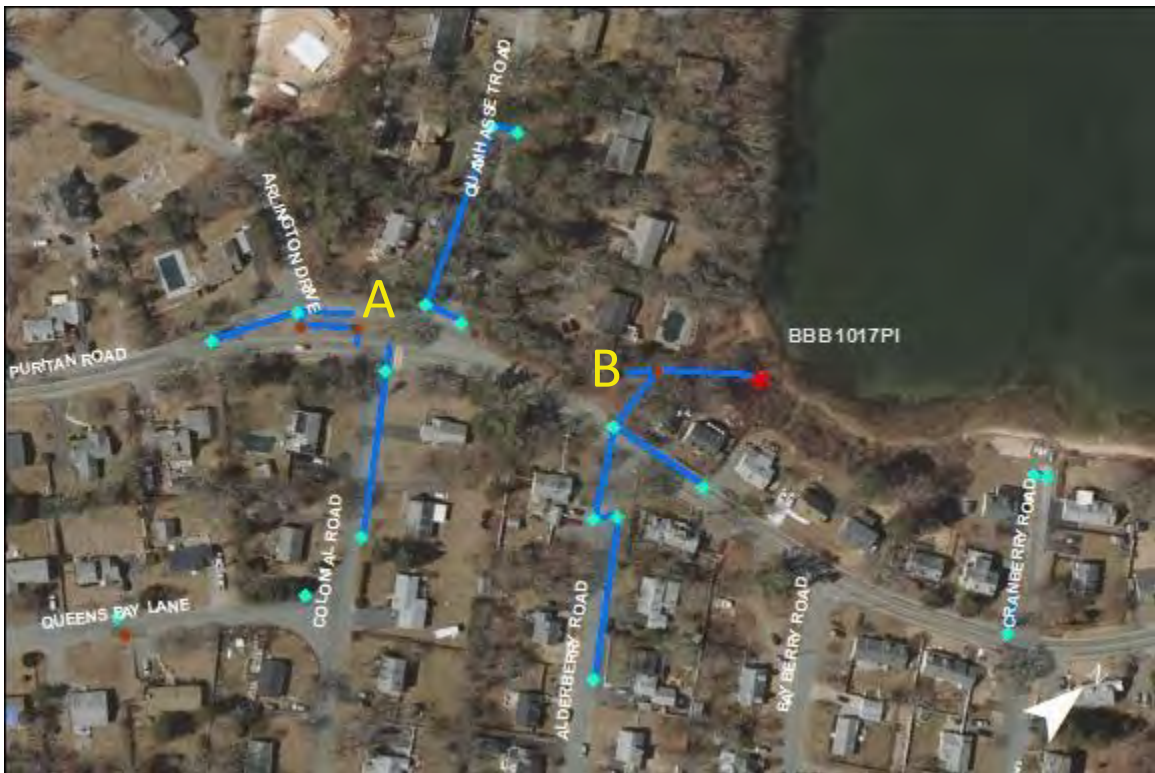
BBB1017PI- Puritan Road: No issues found. There is a pipe leaving the catchbasin at point A. Its destination is unknown. There is also a pipe entering the manhole at point B. Its origins are unknown. Further investigation is needed for both.

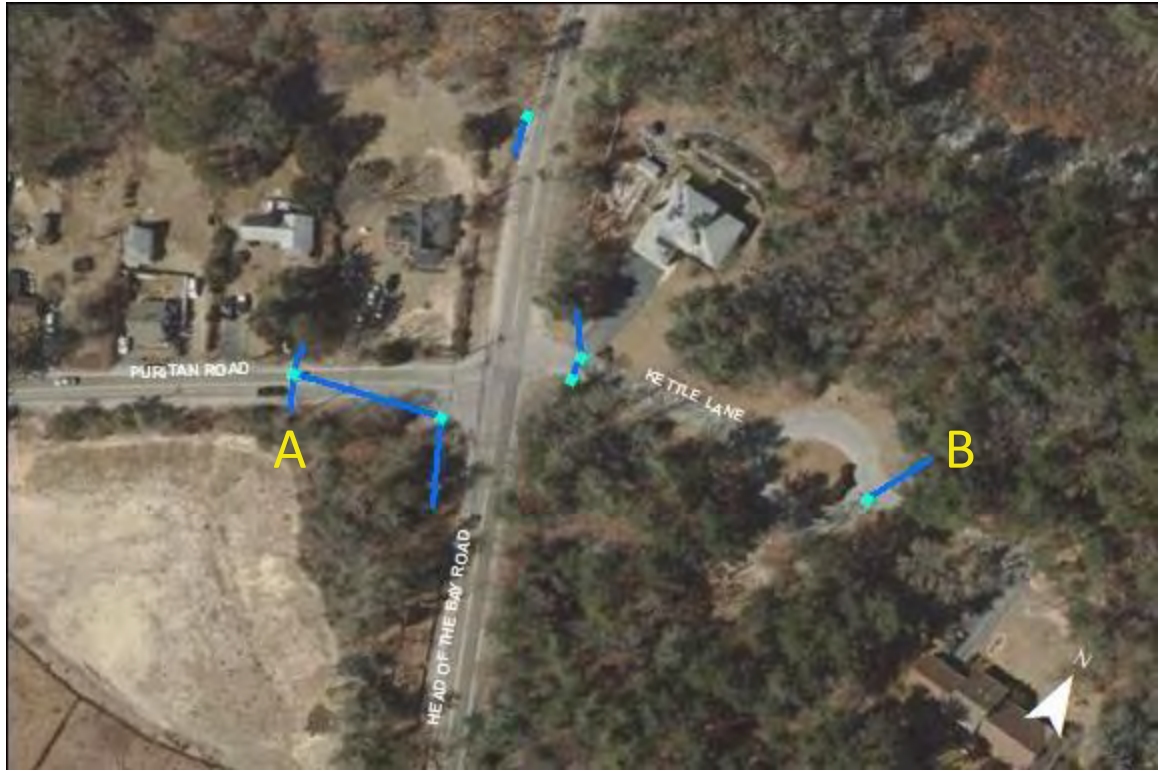
Puritan Road: At point A pipe exists the catchbasin in direction of the cranberry bogs. Kettle Lane: Pipe leaves catchbasin in direction of woods. Destination unknown. Pipe was clogged. Further investigation is needed. Police detail recommended for investigation of structures on Head of the Bay Road.

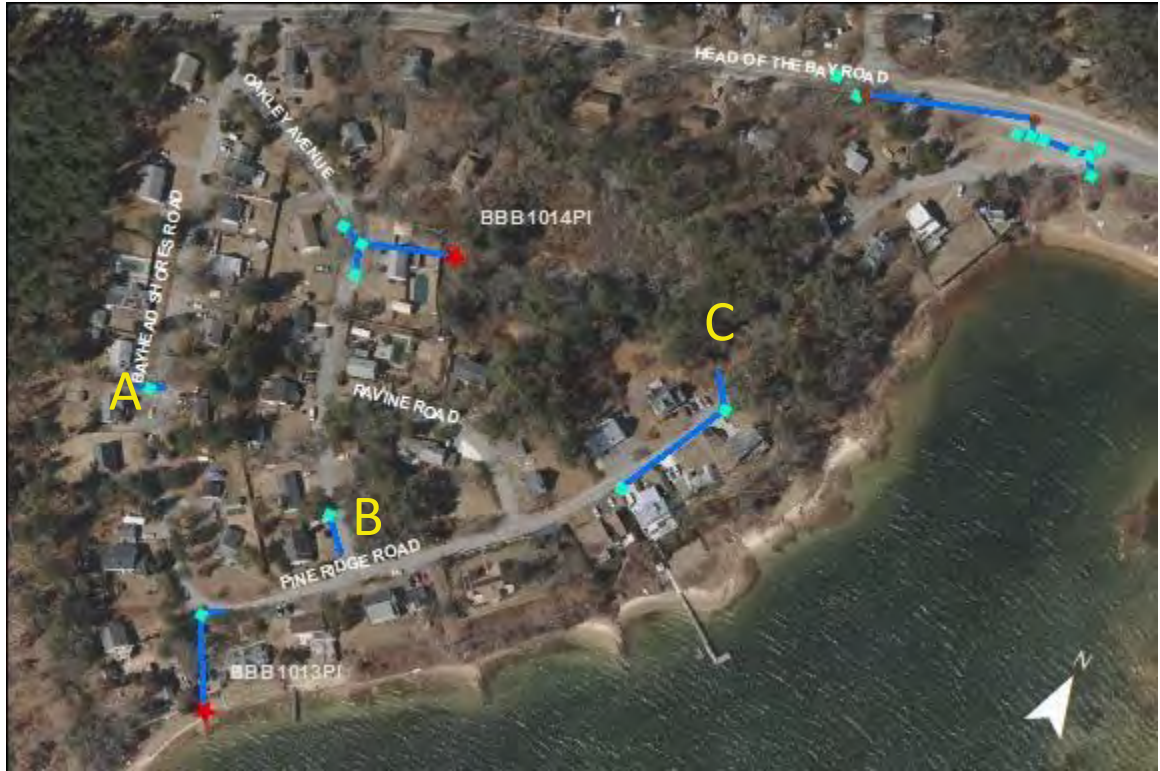
BBB1014PI- Oakley Avenue: No issues found. BBB1013PI- Pine Ridge Road: No issues found. At point A pipe enters catchbasin from direction of woods. Its orientation has not been identified. A pipe also exits the catchbasin, crossing over the street. It is suspected that there is a buried catchbasin there. Pipe was clogged. At point B pipe leaves catchbasin in direction of bay. It was never located. At point C pipe leaves catchbasin in direction of woods. A discharge is suspected. Further investigation is required.

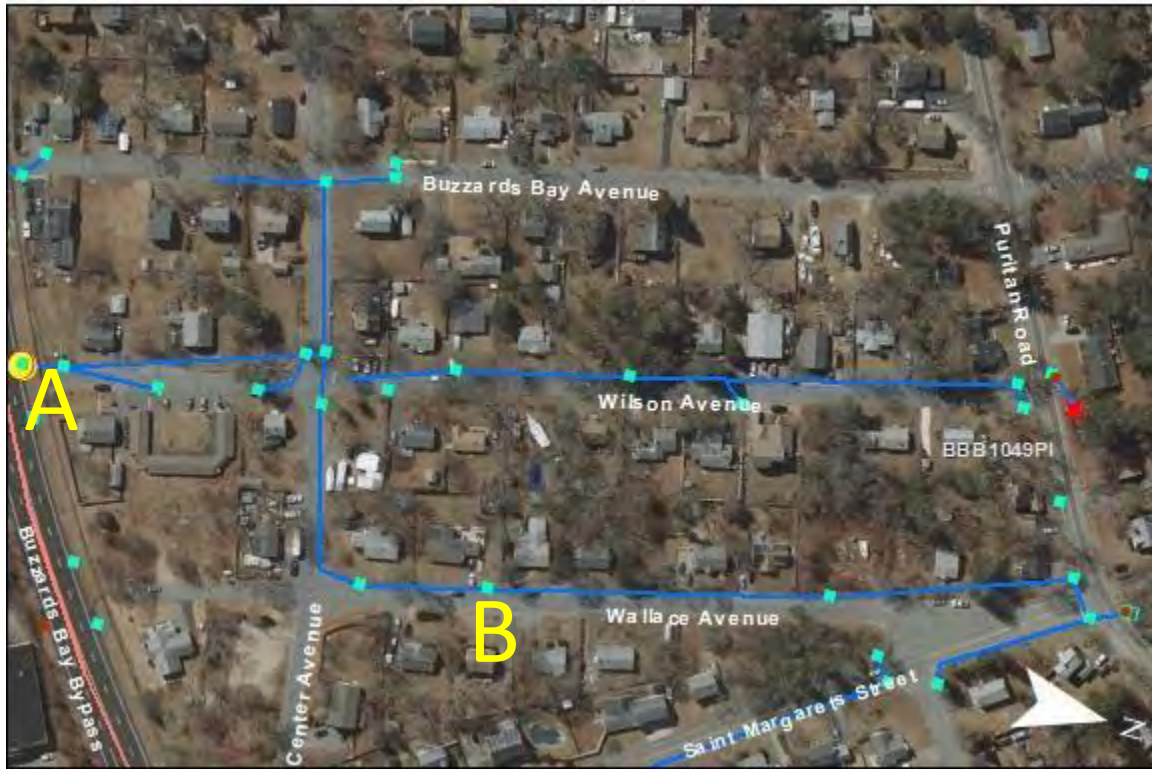
BBB1049PI- Puritan Road: No issues found. Buzzards Bay Avenue, Wilson Avenue, and Wallace Avenue: No issues found. At point A the Bourne's stormwater system connects to Massachusetts state's stormwater system. At point B the catchbasin is need of repair.

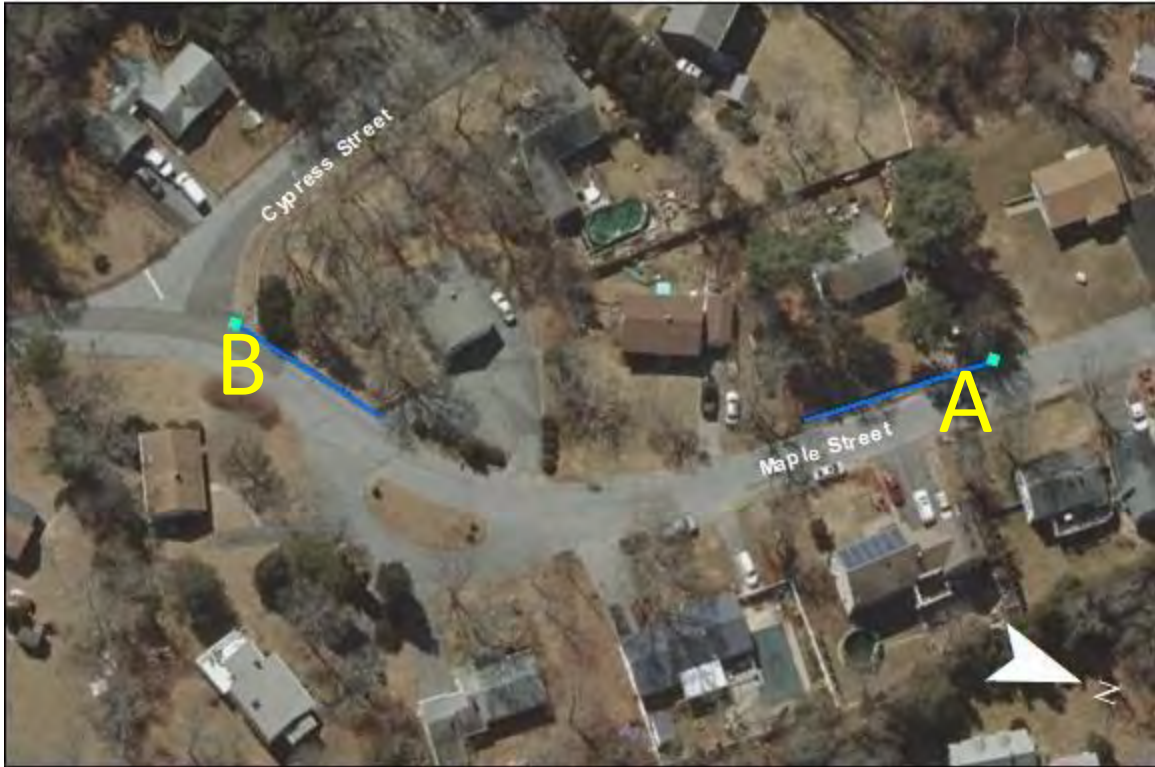
Maple Street: A pipe leaves catchbasin at point A. A pipe enters different catchbasin at point B. Further investigation is suggested to understand if and how these catchbasins connect.

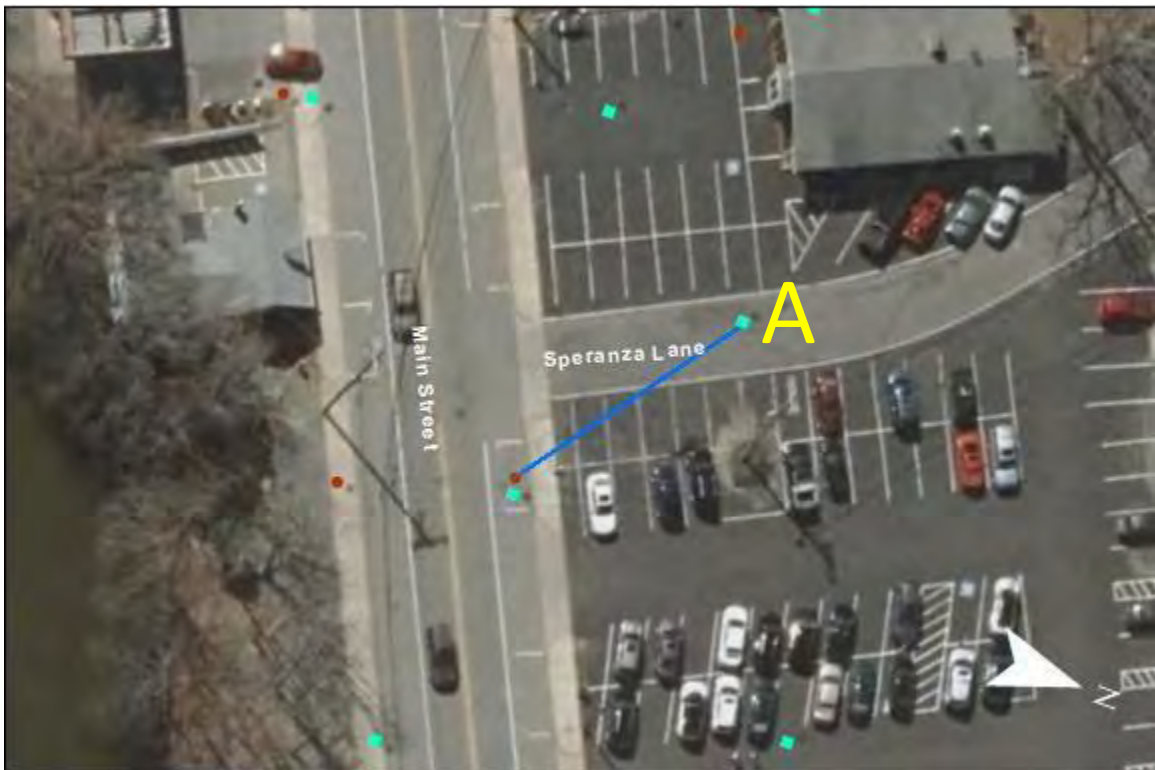
Speranza Lane: No significant issues found. Catchbasin at point A is slightly sunken and in need of repair. Street drainage connects to Main Street drainage. Police detail will be needed for all investigating done on Main Street.

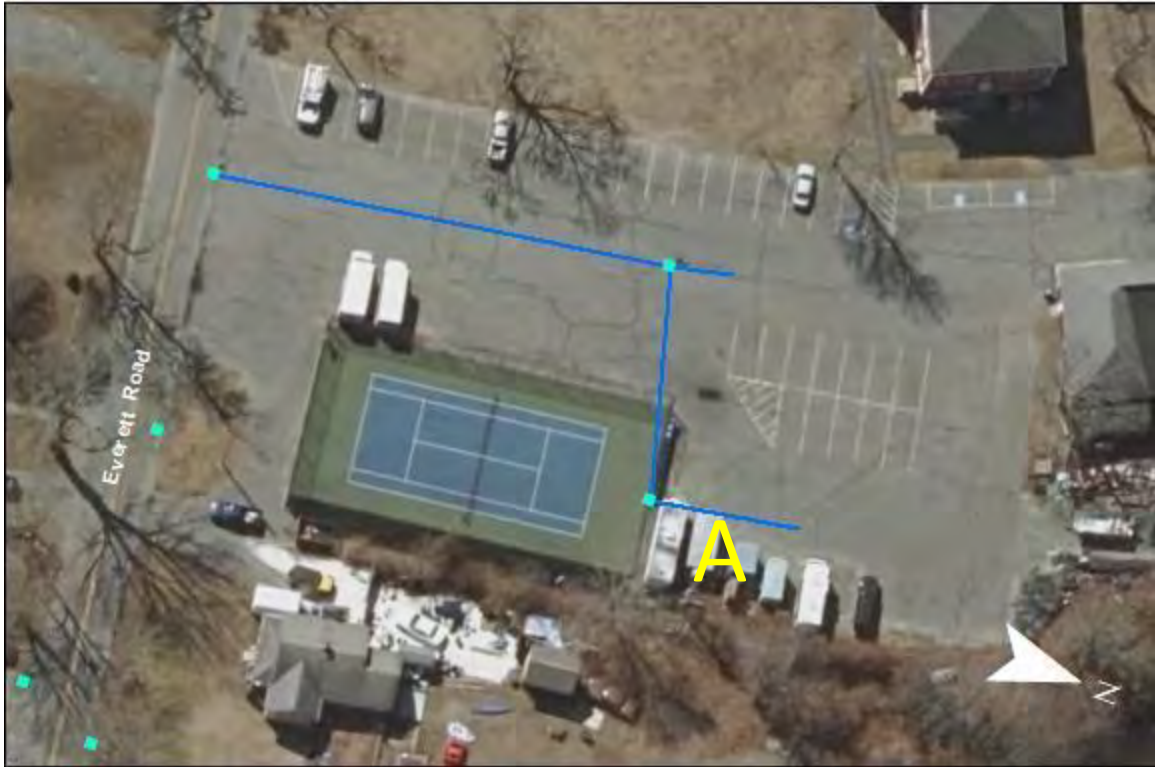
Town Hall parking lot: Pipe at point A is collapsed. An outfall for this catchment has not been able to be identified. Further investigation is suggested.

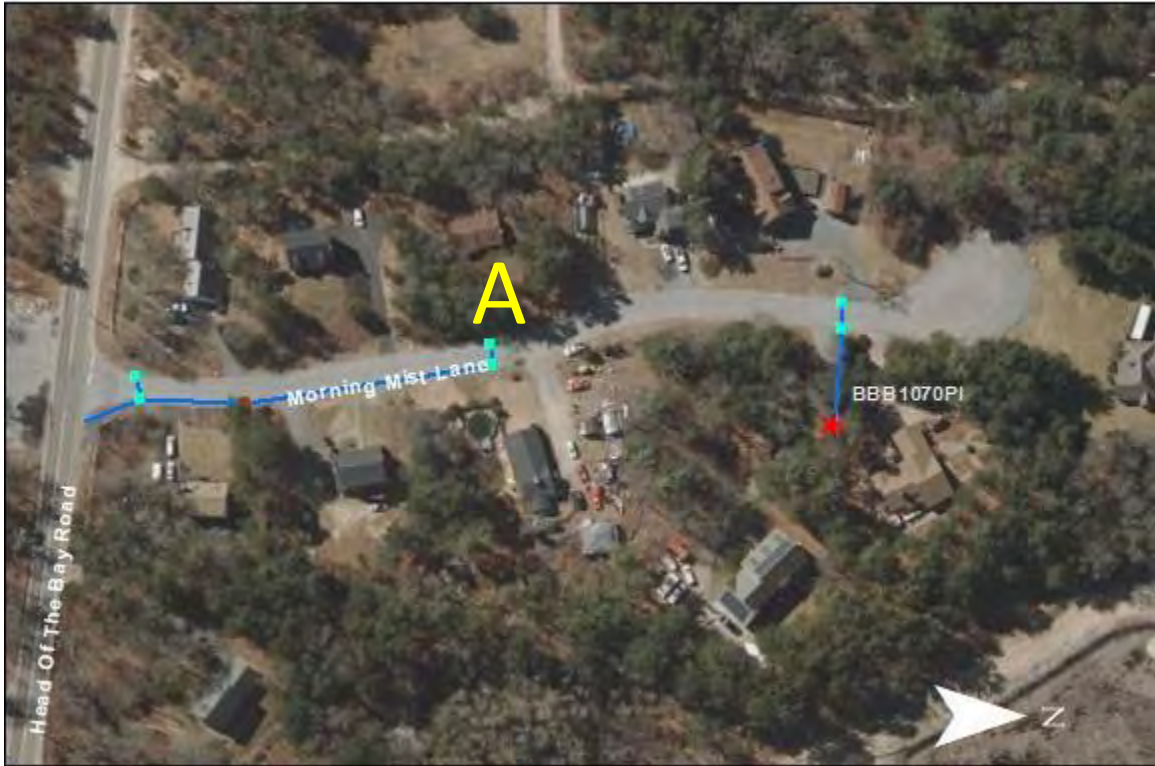
BBB1070PI- Morning Mist Lane: No significant issues found. The catchbasin at point A is slightly sunken and may need repair.

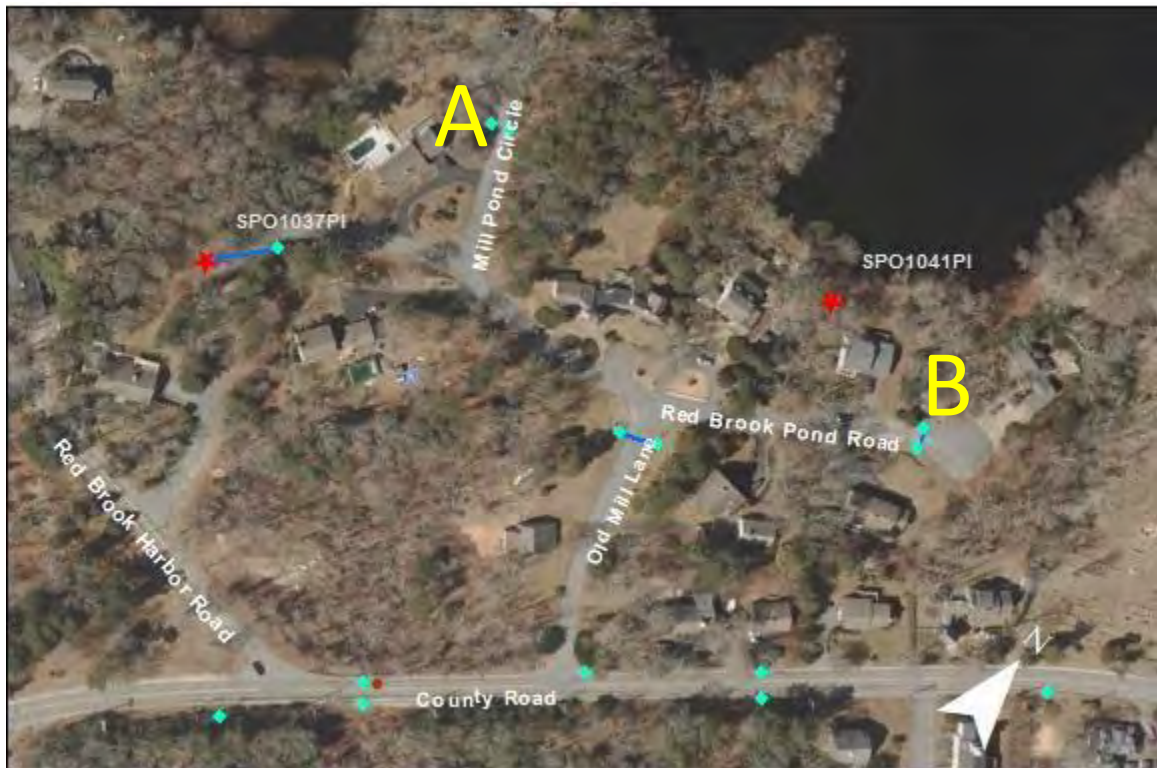
SPO1037PI and SPO1041PI- Red Brook Pond Road: No significant issues found. The catchbasins at point A and B are slightly sunken and may need repair. The catchbasins at point B are completely full of leaf debris. Unable to verify their connectivity to SPO1041PI. Further investigation is suggested.

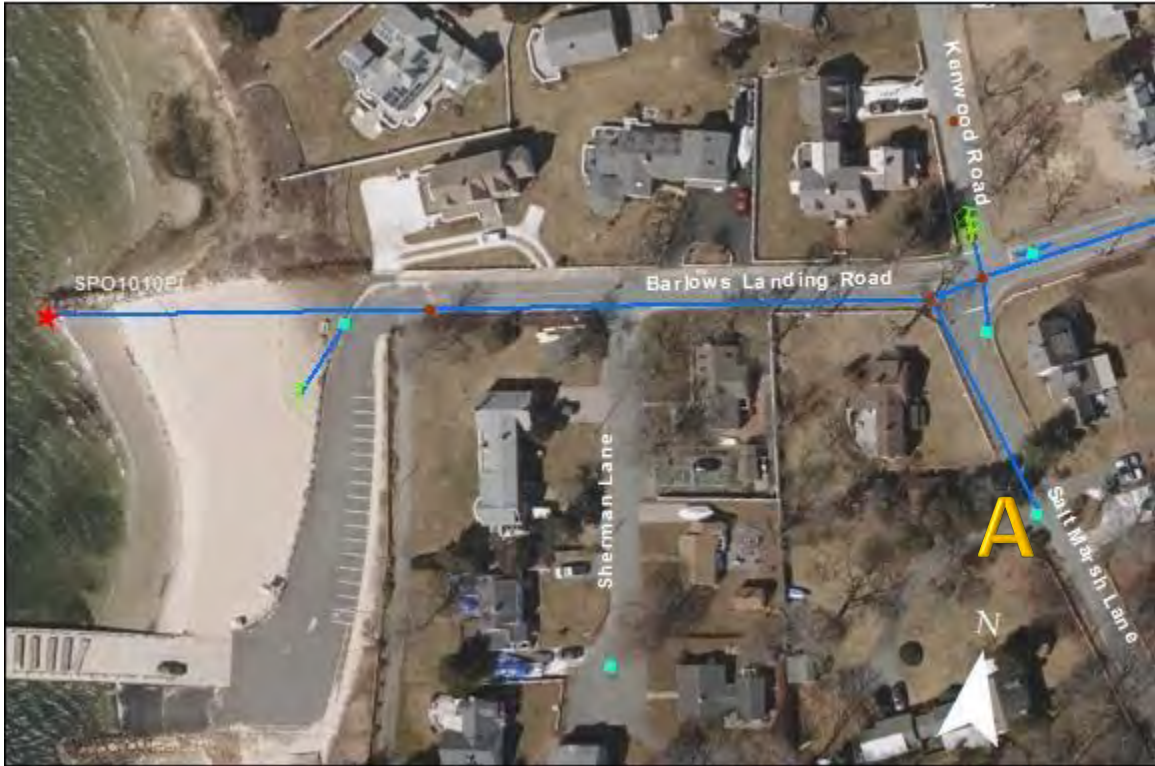
SPO1010PI- Barlows landing Road: No significant issues found. Catchbasin at point A has begun to sink. Preventative maintenance is suggested.

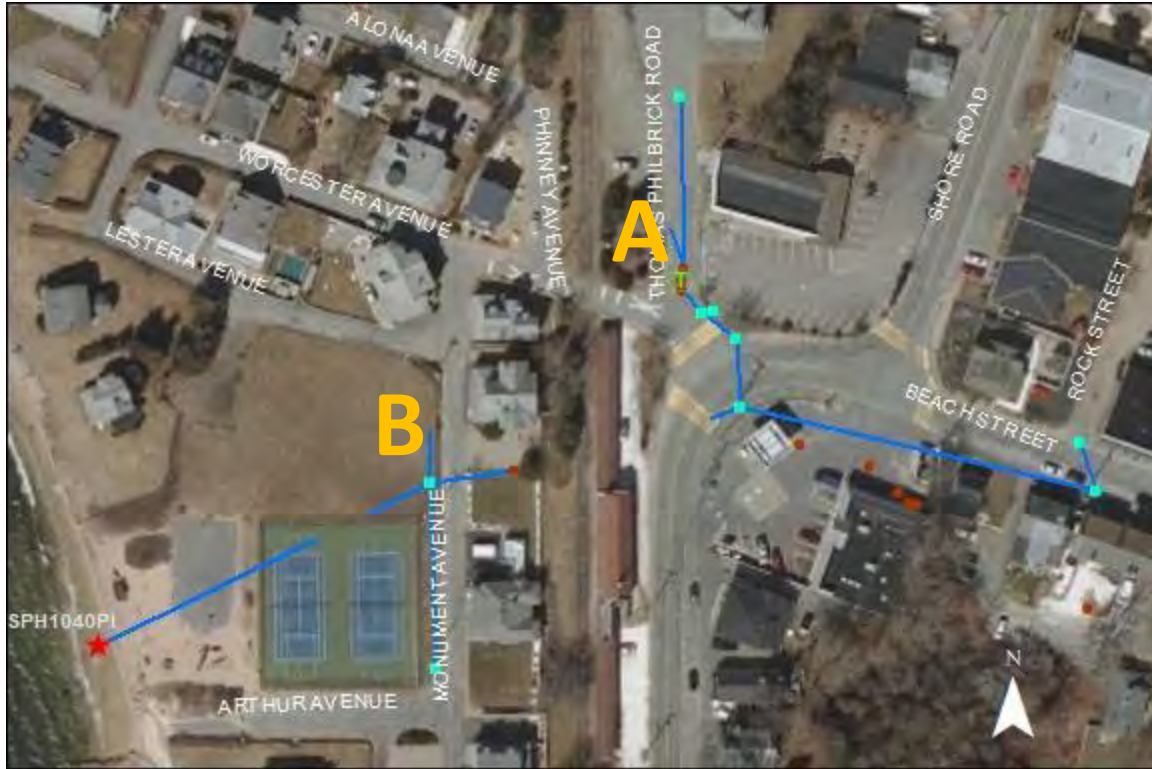
SPH1040PI- Shore Road, Beach Street, and Monument Avenue: No significant issues found. SPH1040PI is no longer in use. The outfall pipe was cemented off at the catchbasin. At point A and B, a 15" HDPE pipe enters the catchbasin/manhole. Their origins are unknown. Further investigation is recommended. Catchbasin at Rock Street and Beach Street is full of sand. Residents informed us that it is constantly flooding during rain events. Further maintenance is recommended.

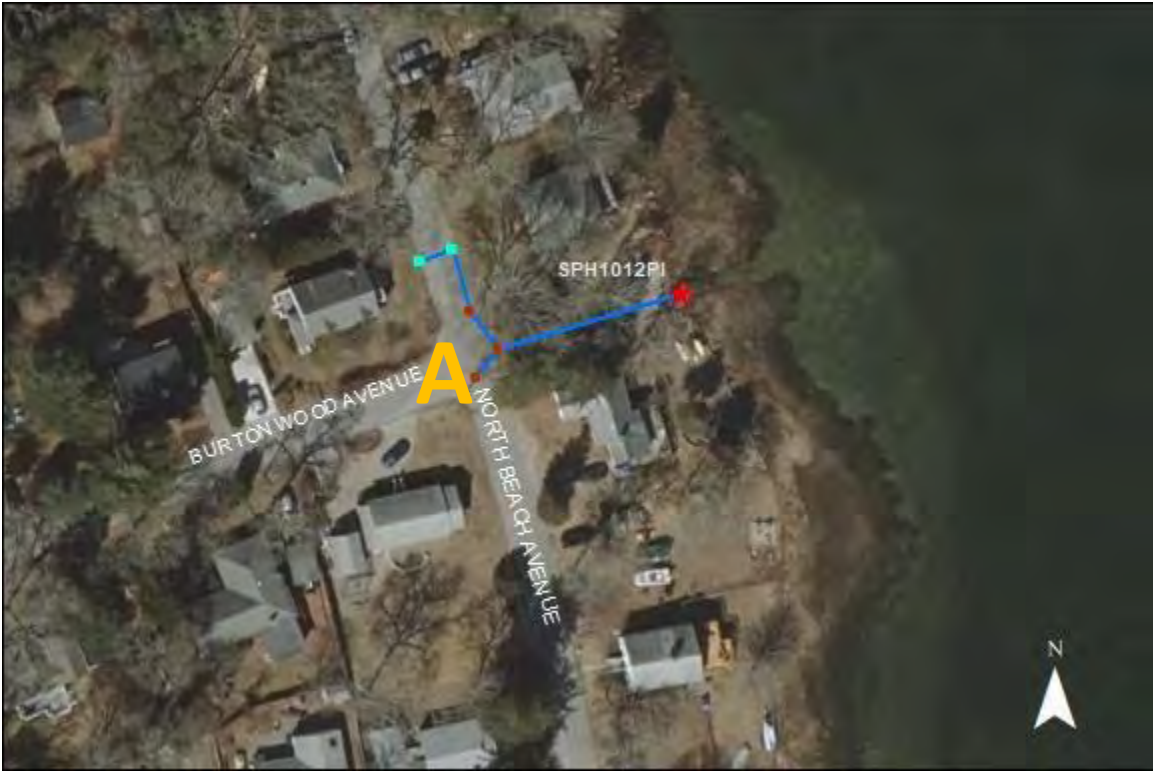
SPH1012PI- North Beach Avenue: At point A the manhole is in need of repair. Further maintenance is recommended.

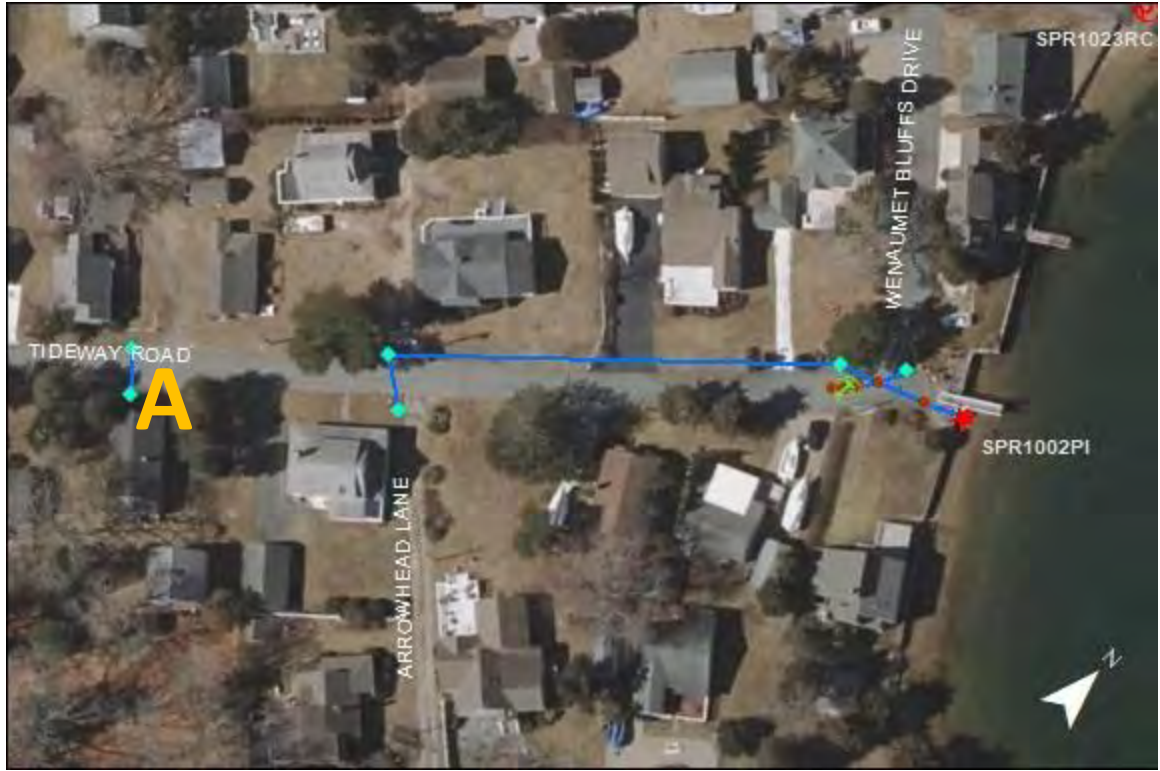
SPR1002PI- Tideway Road: At point A the catchbasin has begun to sink. Further maintenance is recommended.

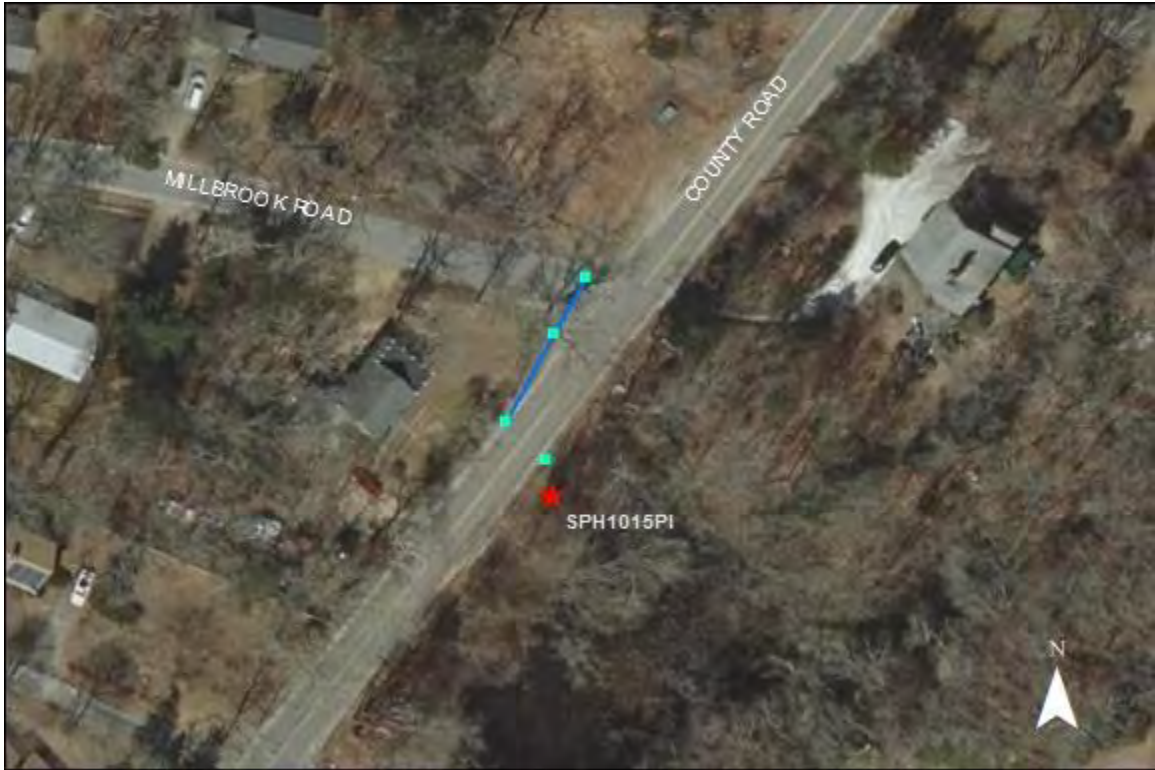
SPH1015PI- Millbrook Road: No significant issues found. Catchbasins were full of sand and need additional maintenance. In order to complete the catchment investigation a police detail is necessary for County Road.

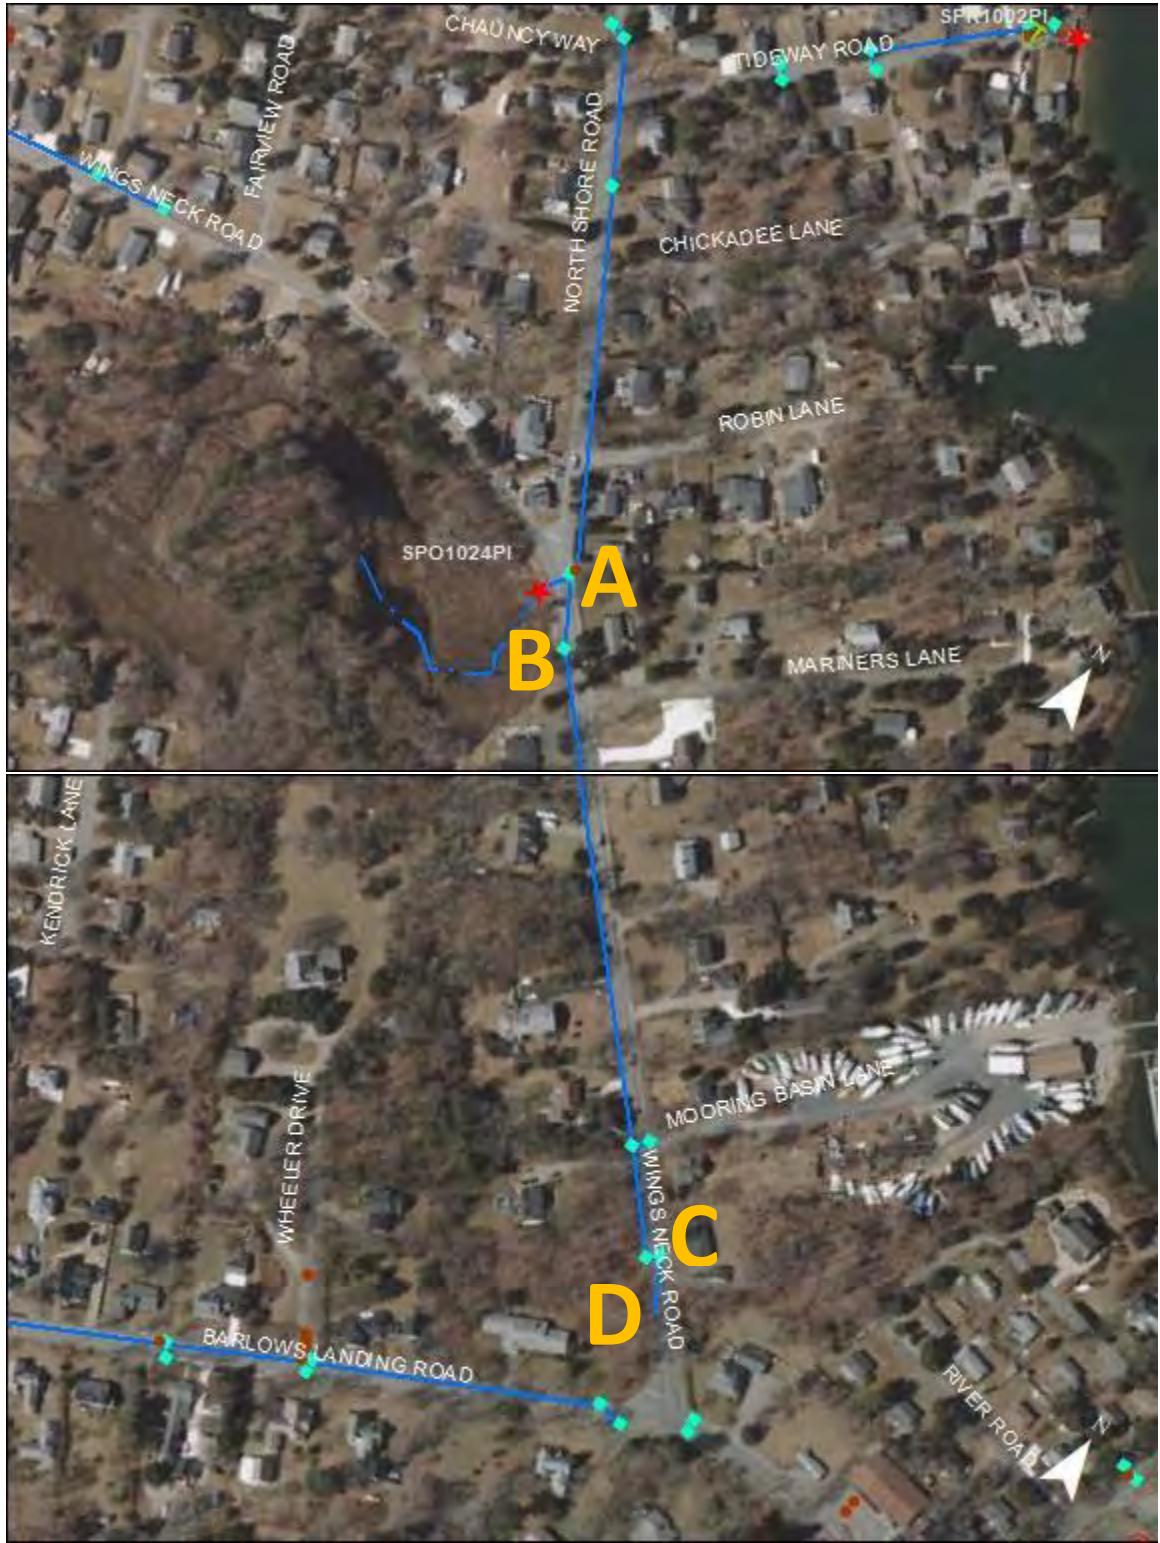
SPO1024PI- Wings Neck Road: Catchbasin at point A has sunken drastically. Maintenance to catchbasin is strongly recommended. Catchbasin at point B has a lot of sediment in it. During rain events it acts more like a roadcut. Maintenance to basin is recommended. Catchbasin at point C is also collapsing. Maintenance to catchbasin is strongly recommended. At point D a pipe enters the Catchbasin. Its origin is unknown. Further investigation is recommended.

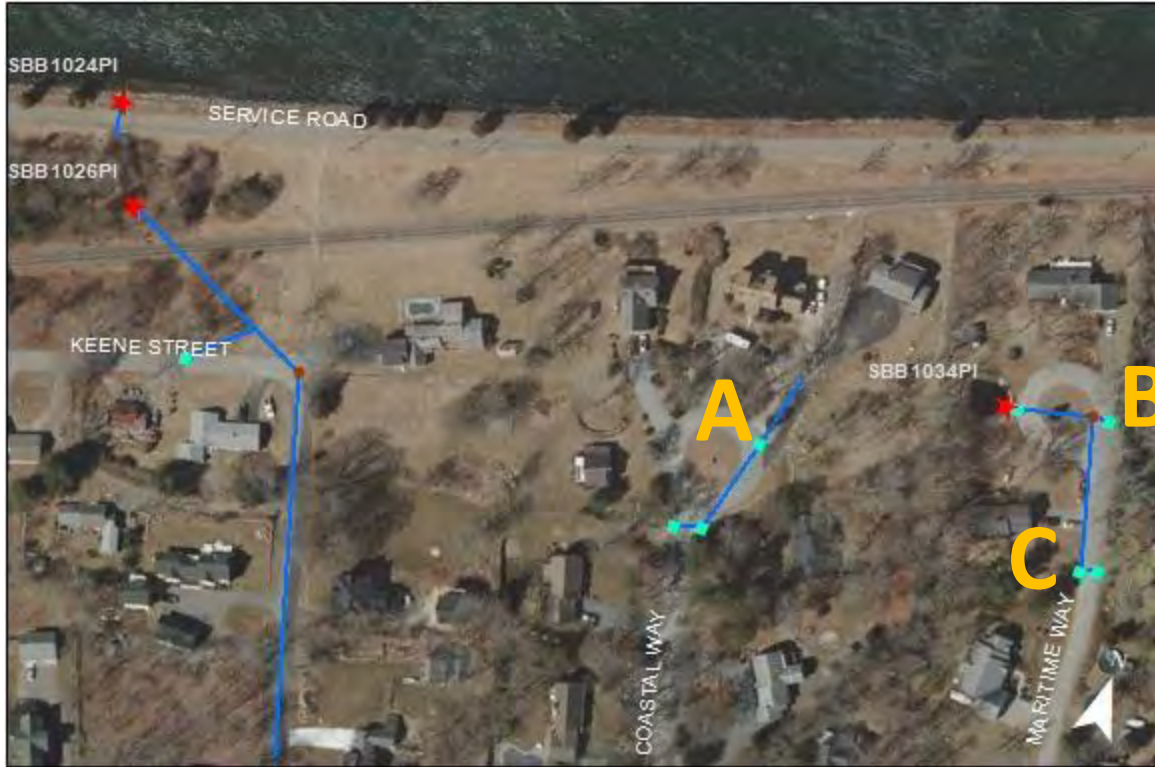
SBB1024PI, SBB1026PI, and SBB1034PI- Keene Street, Coastal Way, and Maritime Way: Catchbasins at points A, B, and C are sinking. Further maintenance is recommended.

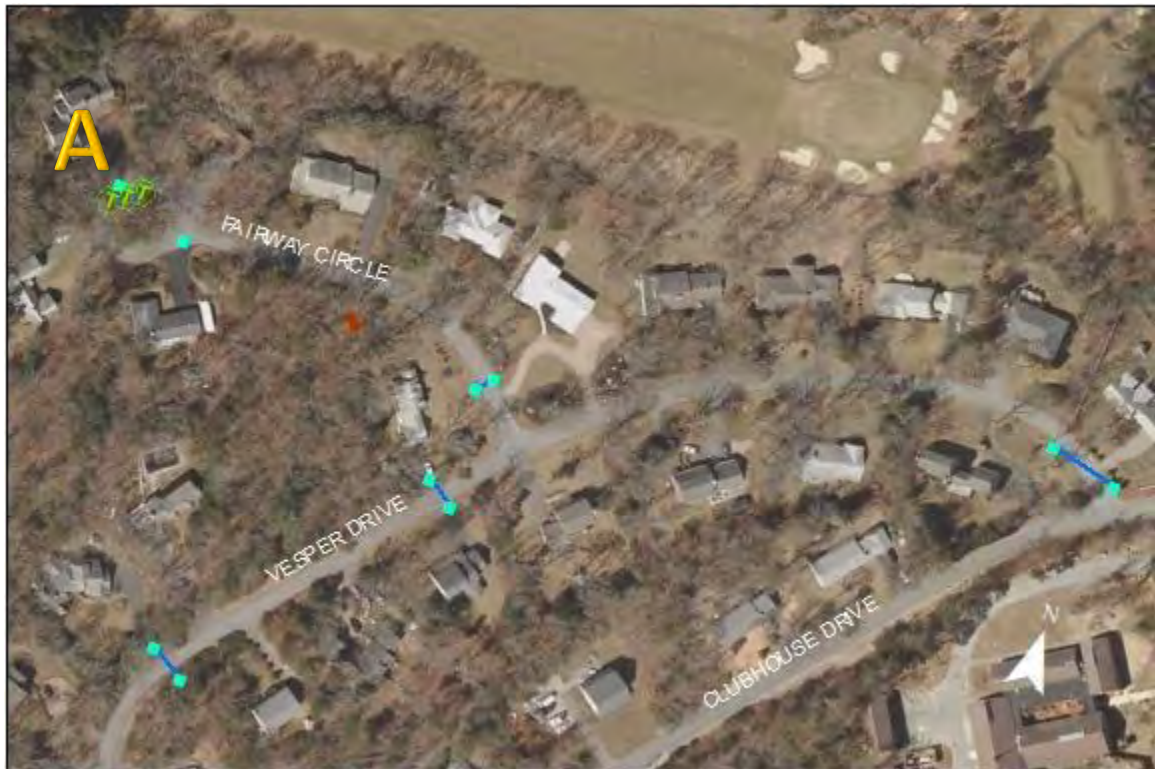
Vesper Drive and Fairway Circle: Catchbasin at point A is sinking. Further maintenance is recommended.

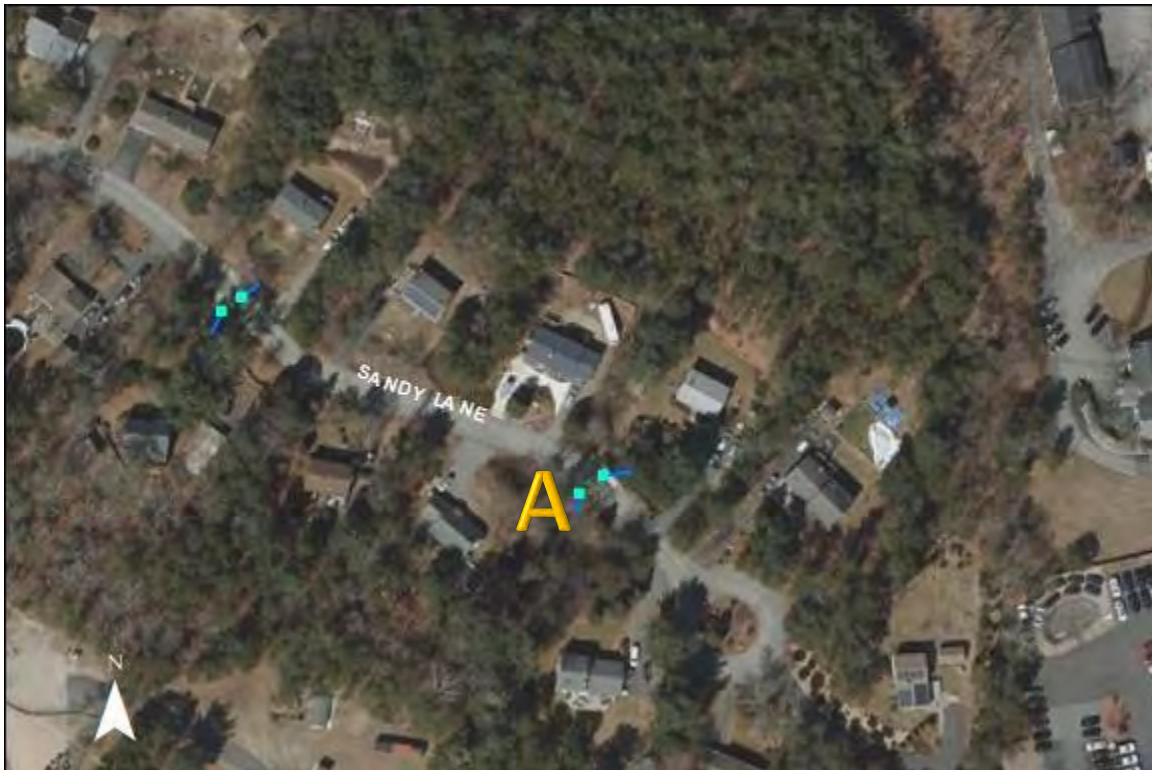
SPO1069PI- Sandy Lane: At point A three dead skunks were found in catchbasin. Removal is suggested. No further issues found.
