**The Buzzards Bay Stormwater Collaborative  
Illicit Discharge Investigation Trailer**

**Town of Dartmouth Report**

## Dartmouth IDDE Report

Illicit Discharge Detection and Elimination Field Work during May 3<sup>rd</sup> through May 7<sup>th</sup> of 2021 and May 23<sup>rd</sup> through May 25<sup>th</sup> of 2022.

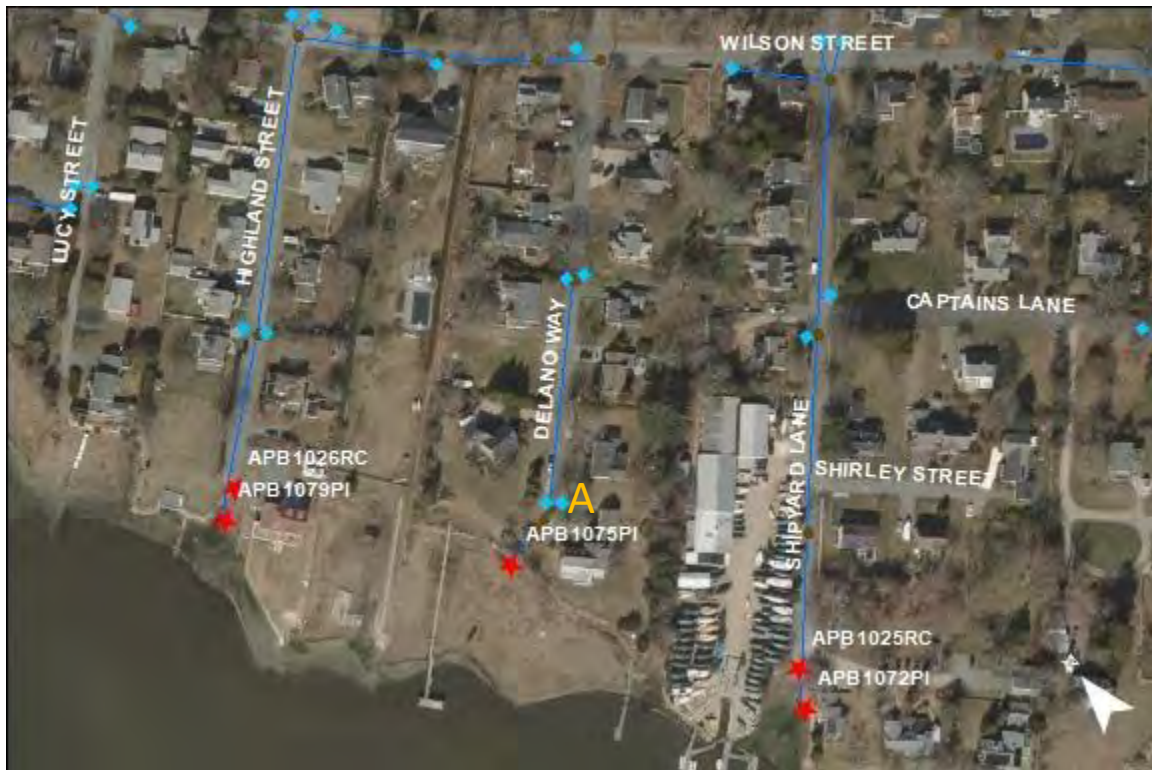
APB1079PI- Highland Street: No issues found; there is a buried manhole in front of 64 Wilson Street.  
APB1075PI- Delano Way: At point A there is a catchbasin slightly sunken; further inspection by DPW is recommended. APB1072PI- Shipyard Lane: No issues found.

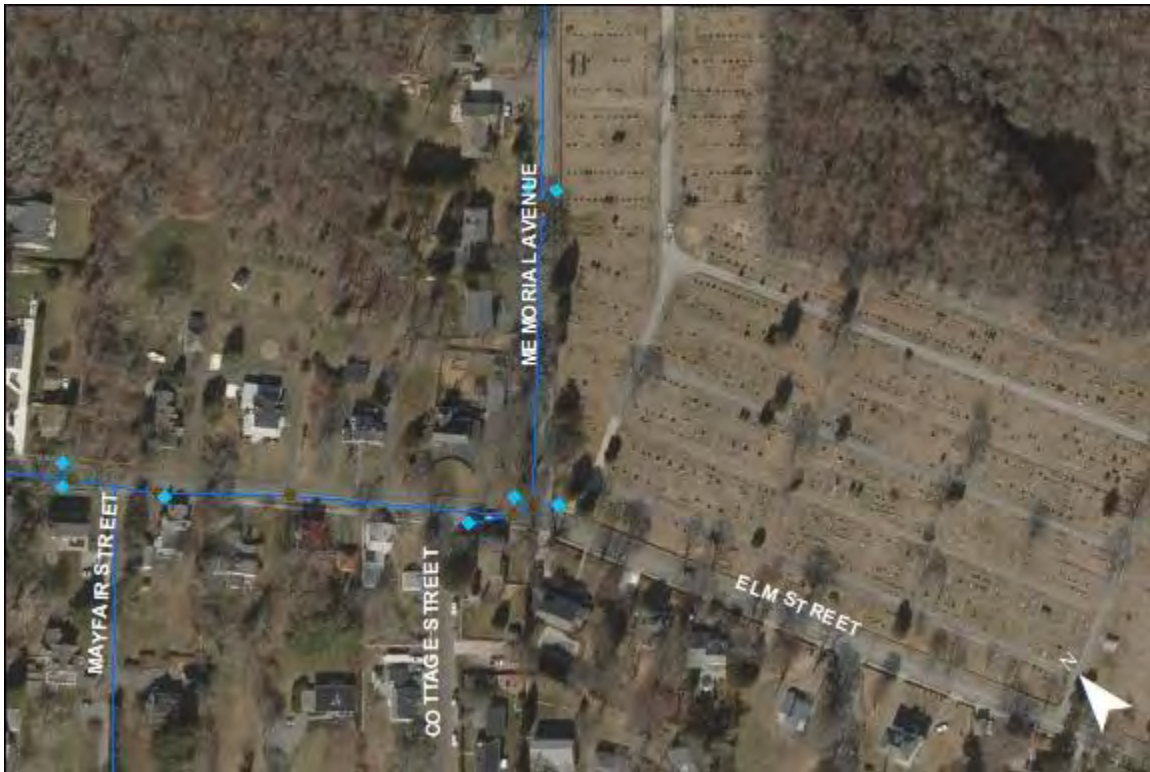
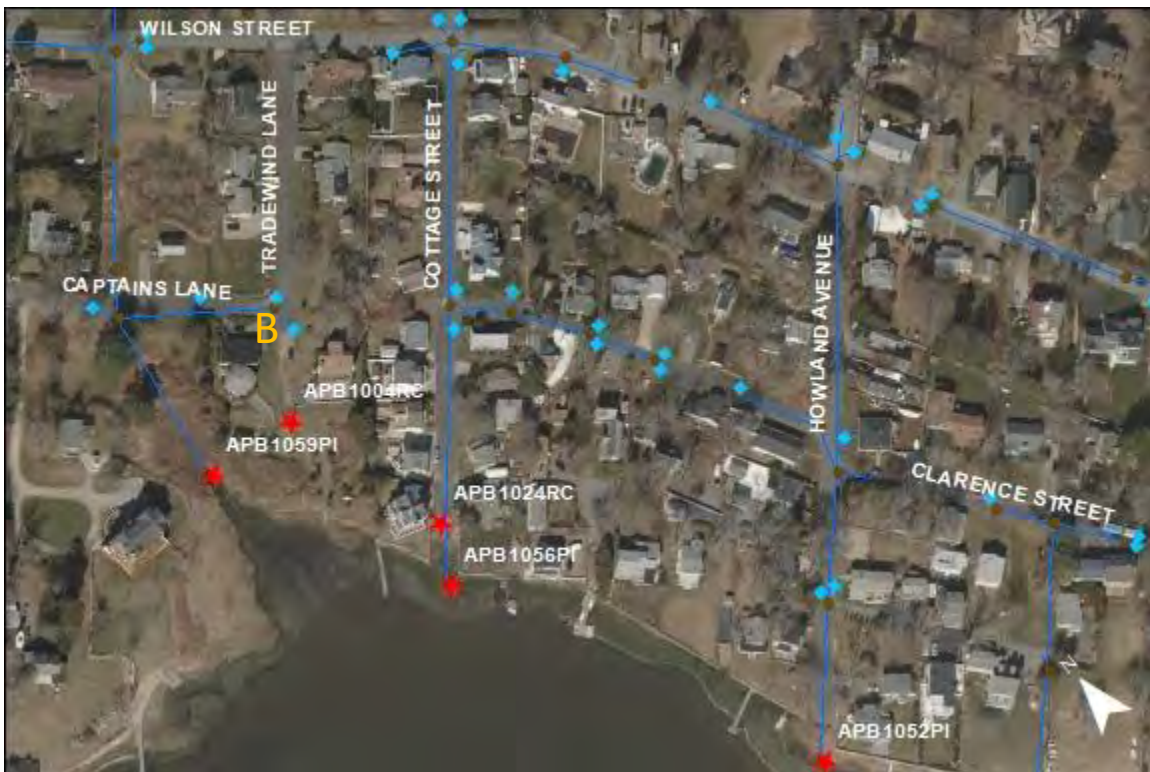
APB1059PI- Captains Lane: No significant issues found. There is a pipe connected to the catchbasin across from 21 Memorial Avenue, shown at point A. The pipe is coming in from the direction of the graveyard. Further investigation is needed to determine its origin. There is a buried manhole on Captains Lane, shown at point B. Please note the structures on Elm Street and Rockland Street could not be inspected due to high traffic. APB1056PI- Cottage Street: No issues found. APB1052PI- Howland Avenue: No issues found.

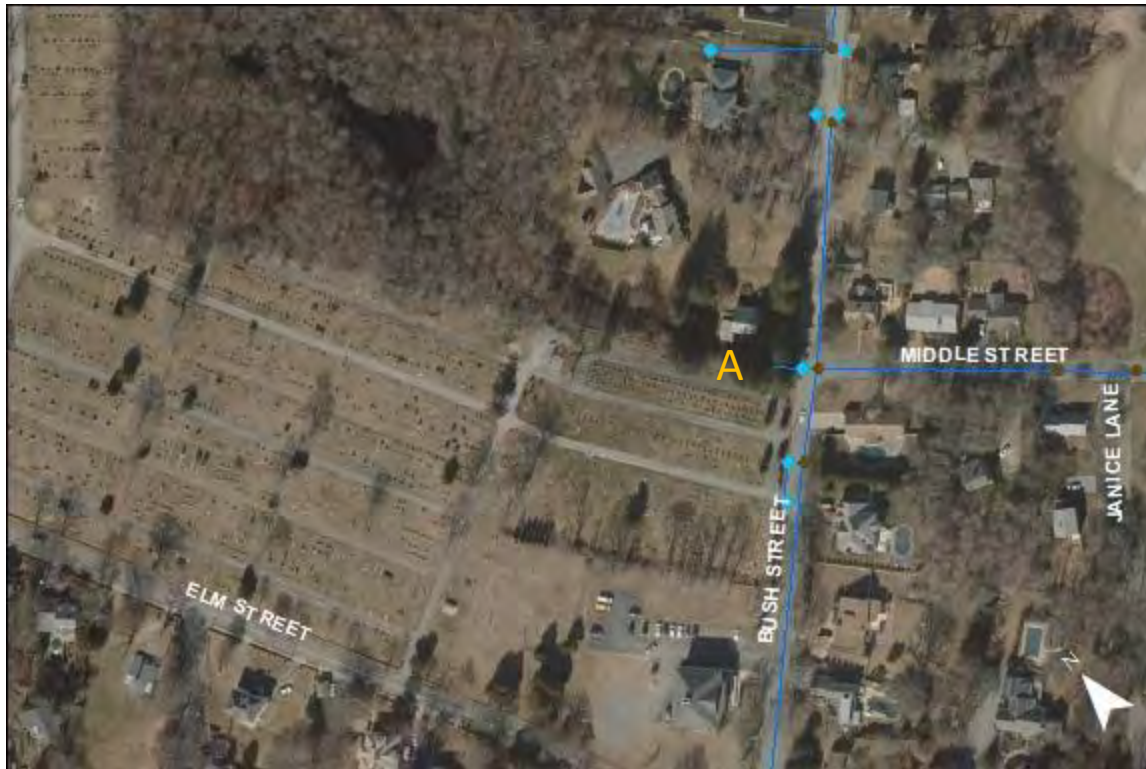
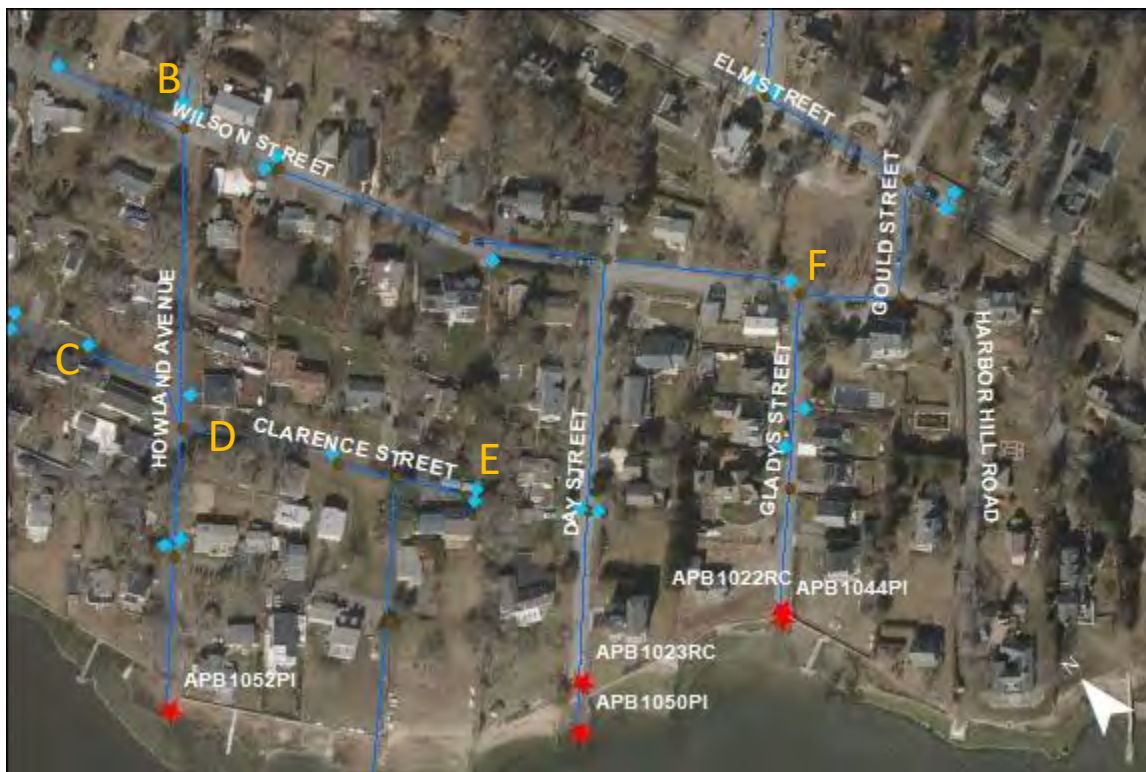
APB1022RC and APB1044PI- Gladys Street: No issues found. There is a pipe connecting to a catchbasin at the intersection of Bush Street and Middle Street, shown at point A. Further investigation needed.

APB1052PI- Howland Ave: No significant issues found. There is a buried manhole at the North side of Clarence Street connecting to the manhole on Howland Avenue, shown at point C on the South side of Clarence Street there is a pipe entering the manhole at point D. It is suspected that it is no longer in use.

APB1050PI- Day Street: No issues found. There is a pipe entering the manhole at the intersection of Wilson Street and Gladys Street, shown at point F. Further investigation needed. The catchbasins at point B and E are sinking. Further inspection by DPW is recommended.

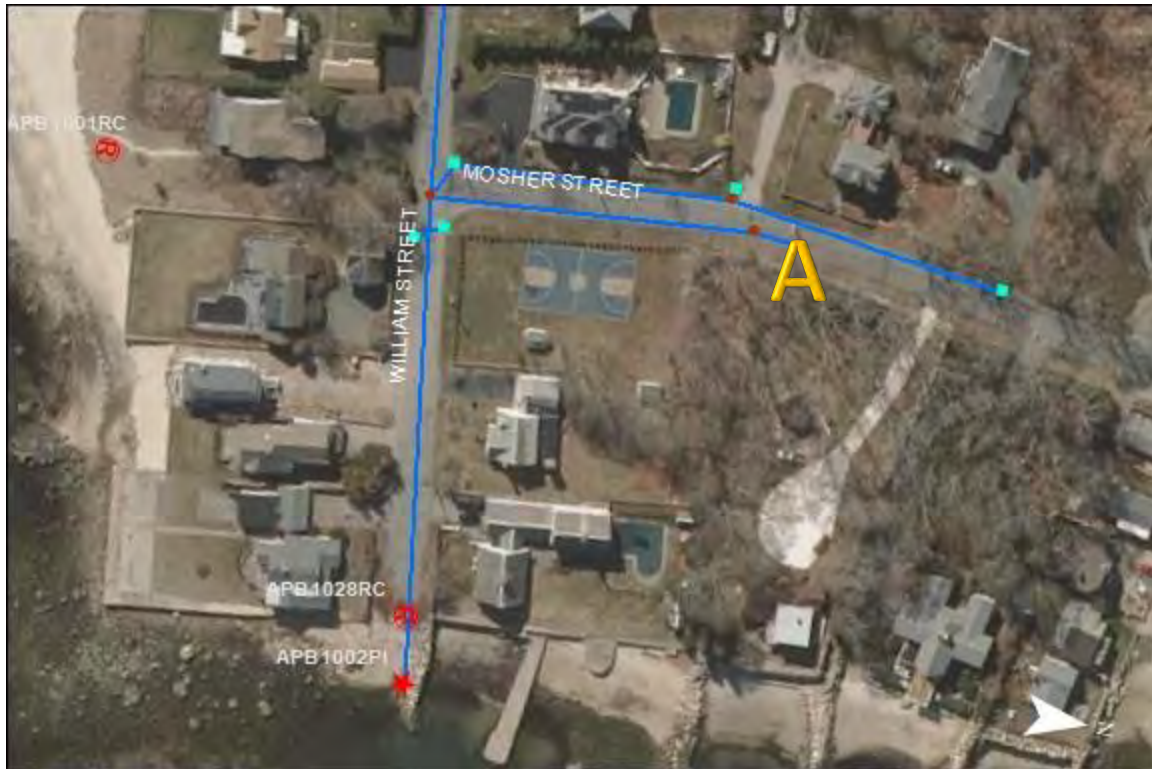
APB1002PI- William Street: At points A, B, and C pipes enter the structures. Their origins are unknown. Further investigation is suggested. The catchbasin at point D has begun to sink. Preventative measures are recommended.

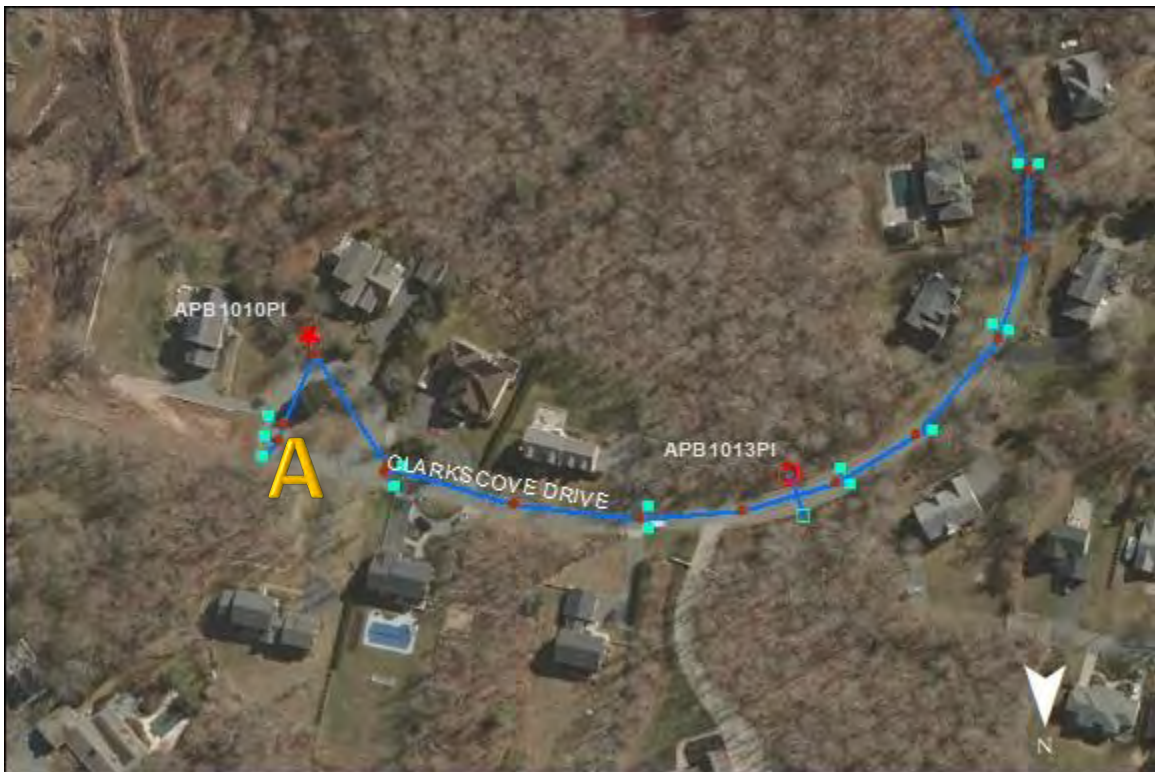
APB1010PI- Clarks Cove: No significant issues found. The manhole at point A is paved over.

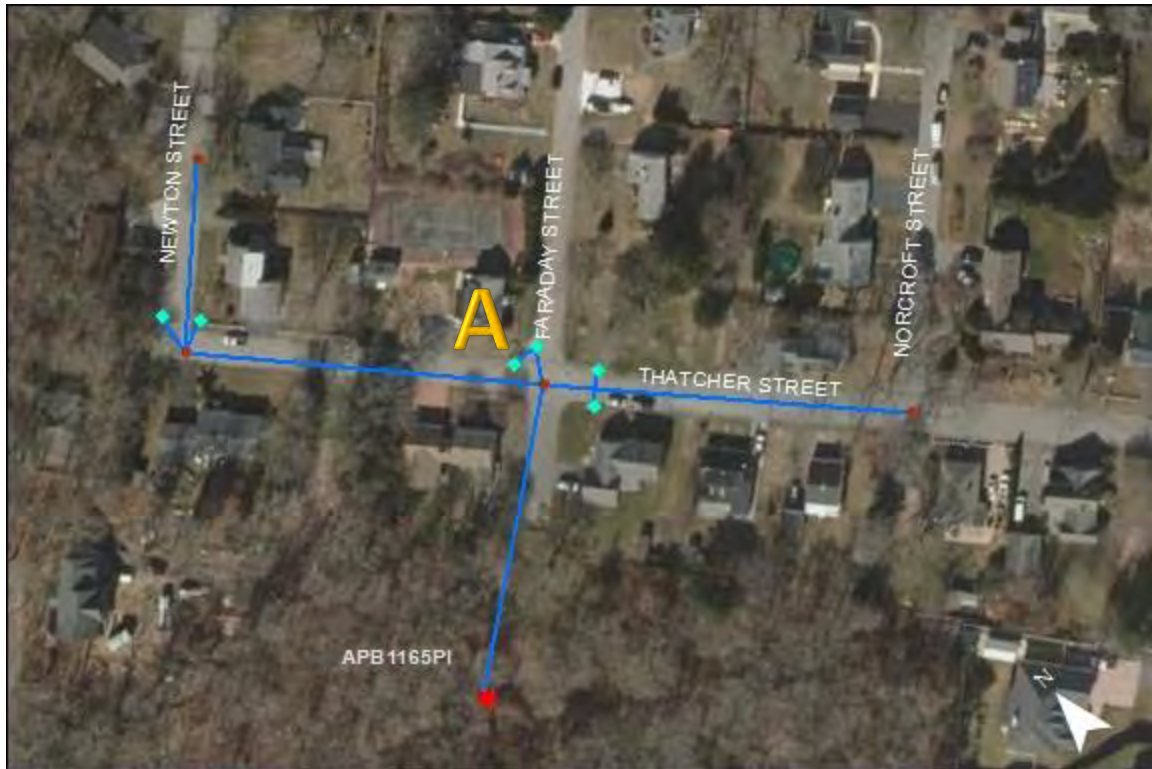
APB1165PI- Thatcher Street: At point A the catchbasin had grey water in it. There was a sump pump present. The catchbasin should be revisited and its sump water tested.

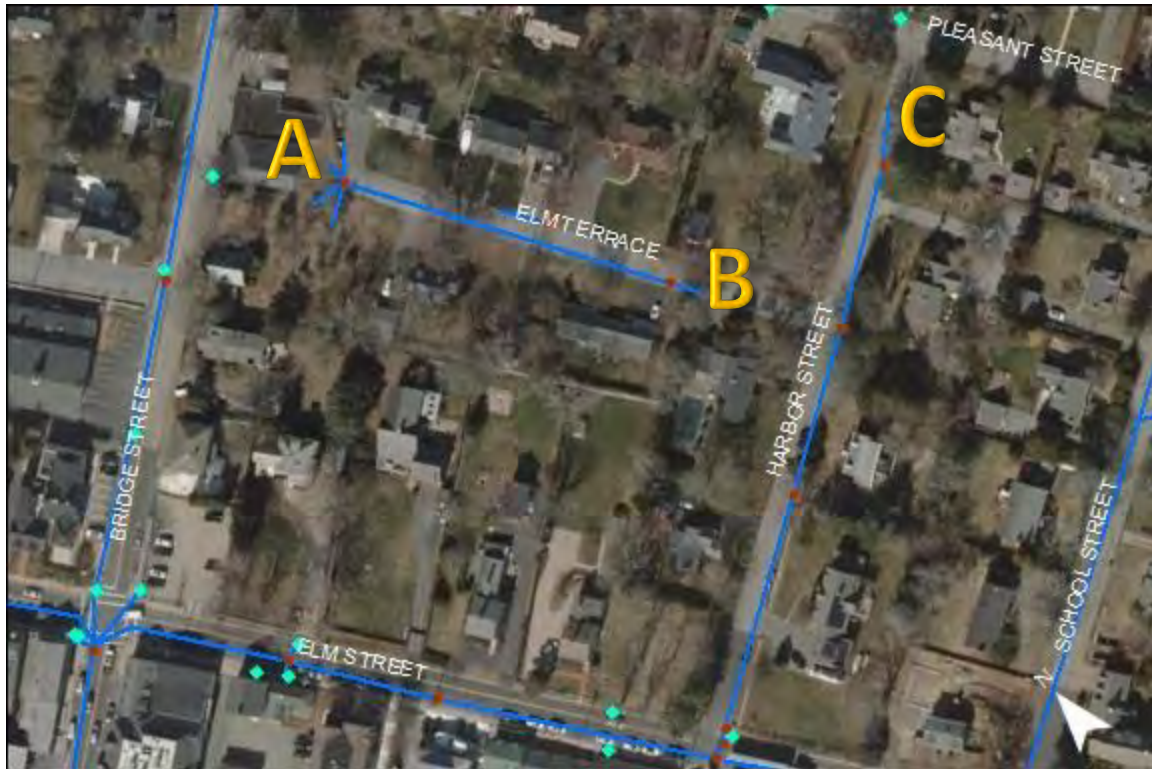
APB1033PI (1/7)-Elm Terrace and Harbor Street: At point A There are multiple pipes entering the manhole. Their origin and destination are unknown. Further investigation is recommended. At point B and C there are additional pipes with no known origin. Further investigation is recommended.

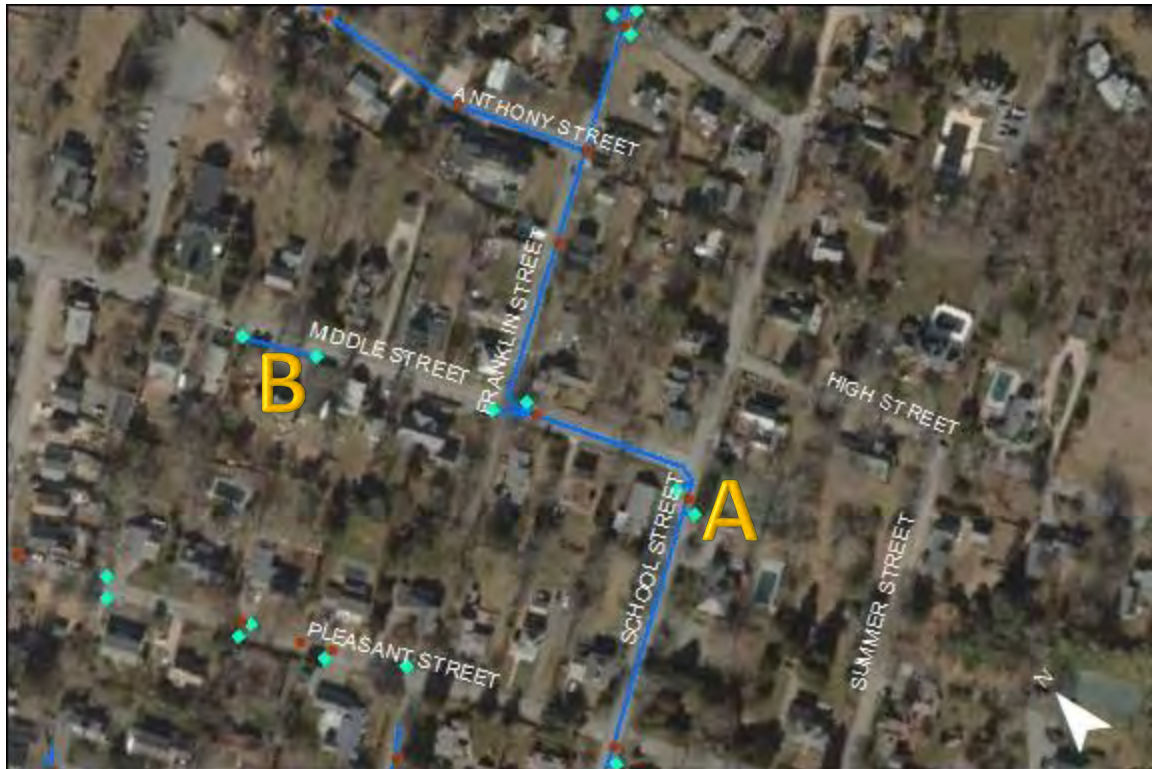
APB1033PI (3/7)- School Street, Franklin Street, and Anthony Street: The catchbasin and manhole at point A are showing signs of erosion. Further maintenance is recommended. At point B the pipe connecting the two catchbasins is clogged. Further maintenance is recommended.

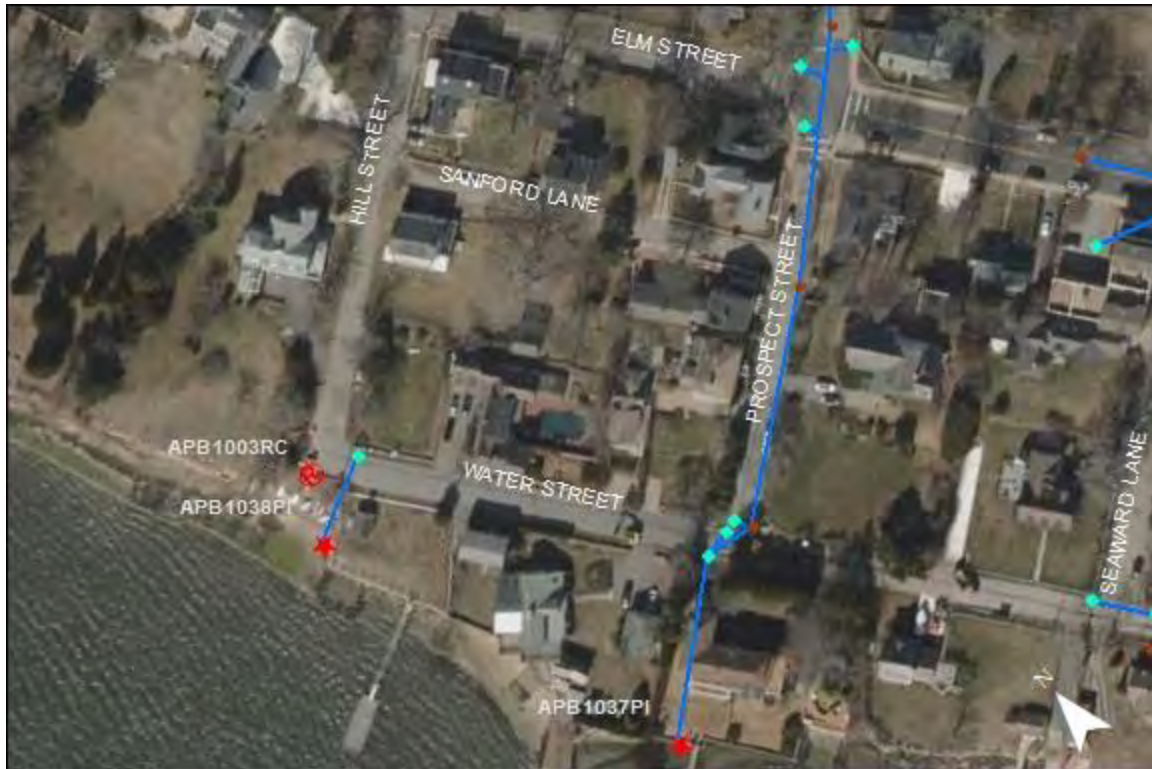
APB1037PI (1/3)- Prospect Street: No issues found. Catchbasin at point A is beginning to sink. Preventative measures are recommended. At point B a pipe enters the catchbasin its origin is unknown. Further investigation is suggested.
