**The Buzzards Bay Stormwater Collaborative  
Illicit Discharge Investigation Trailer**

**Town of Fairhaven Report**

**November 2022**

### **Fairhaven IDDE Report**

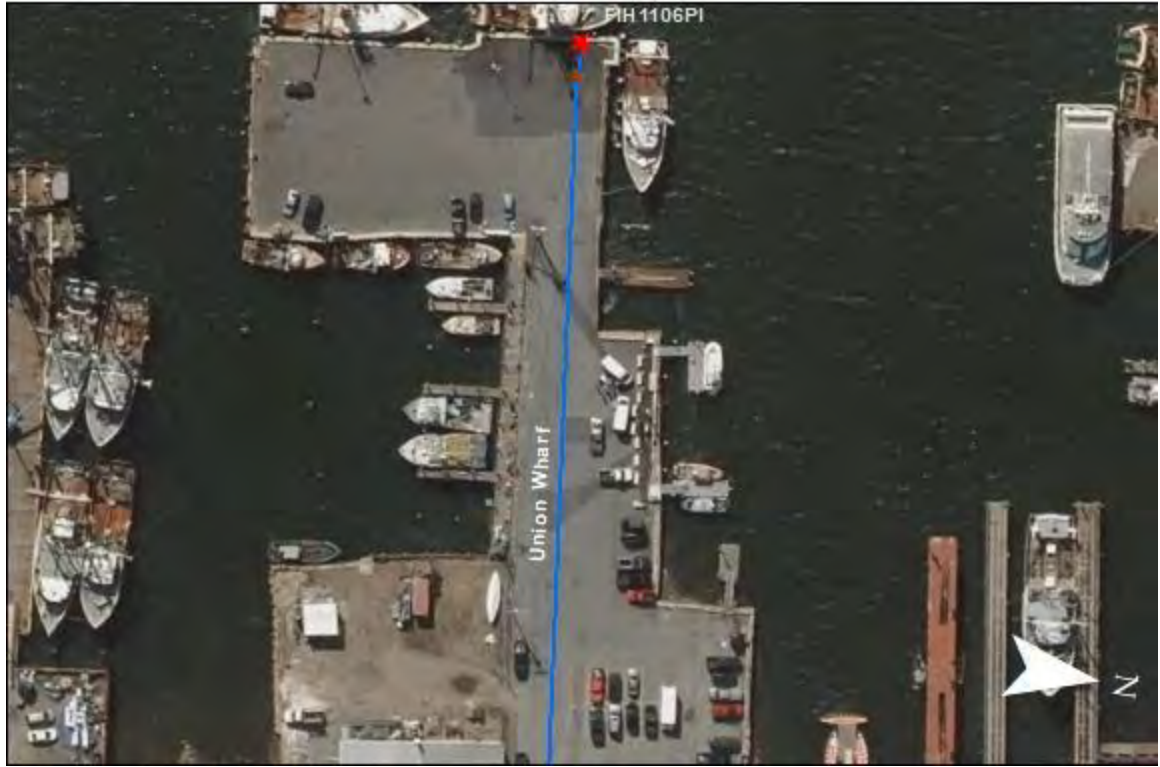
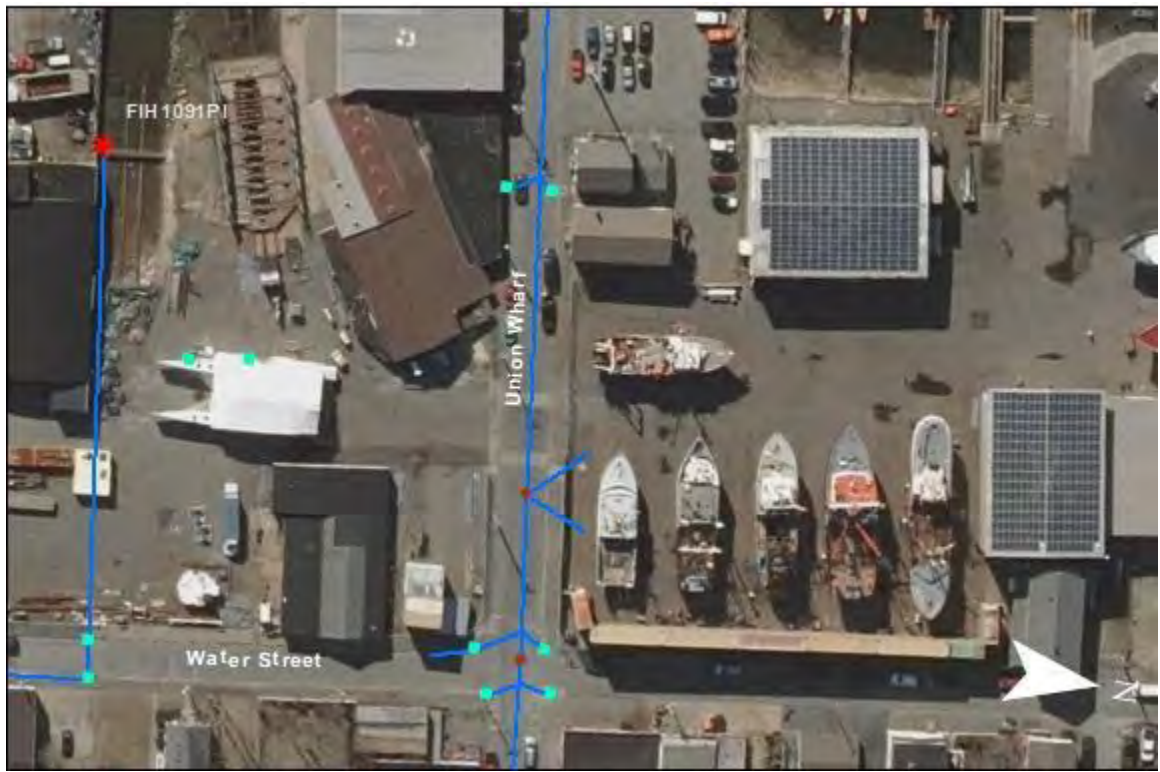
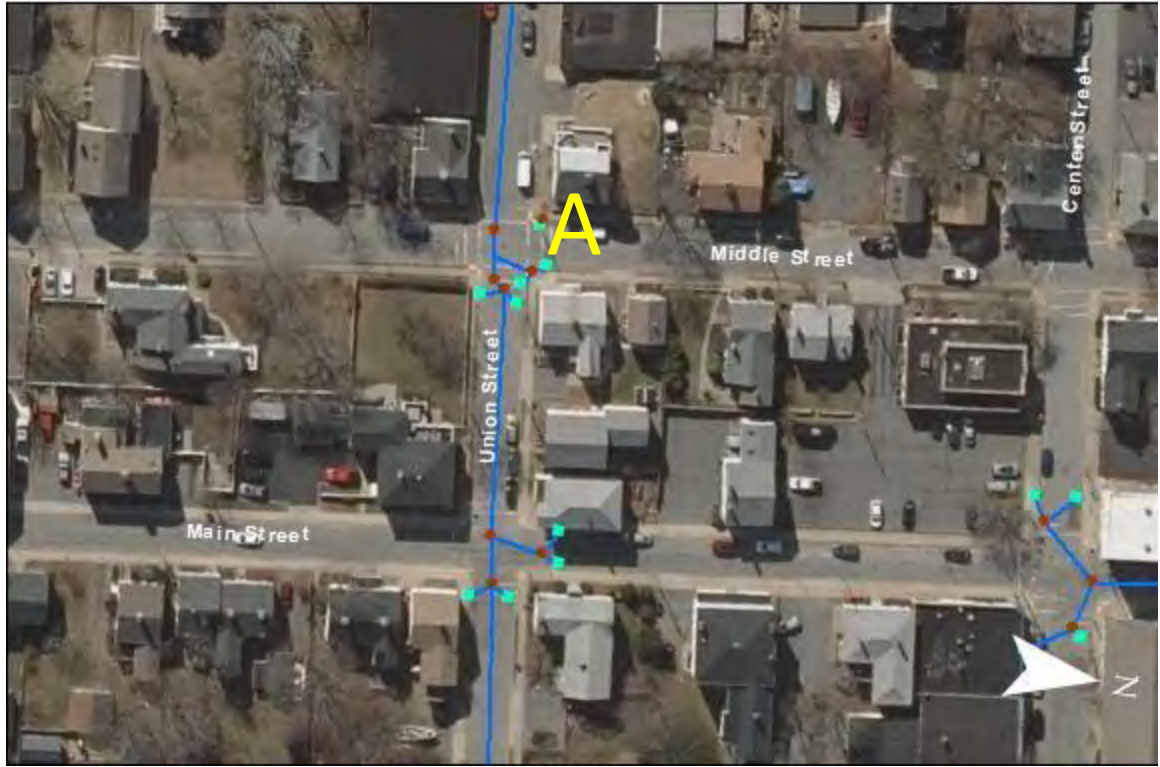
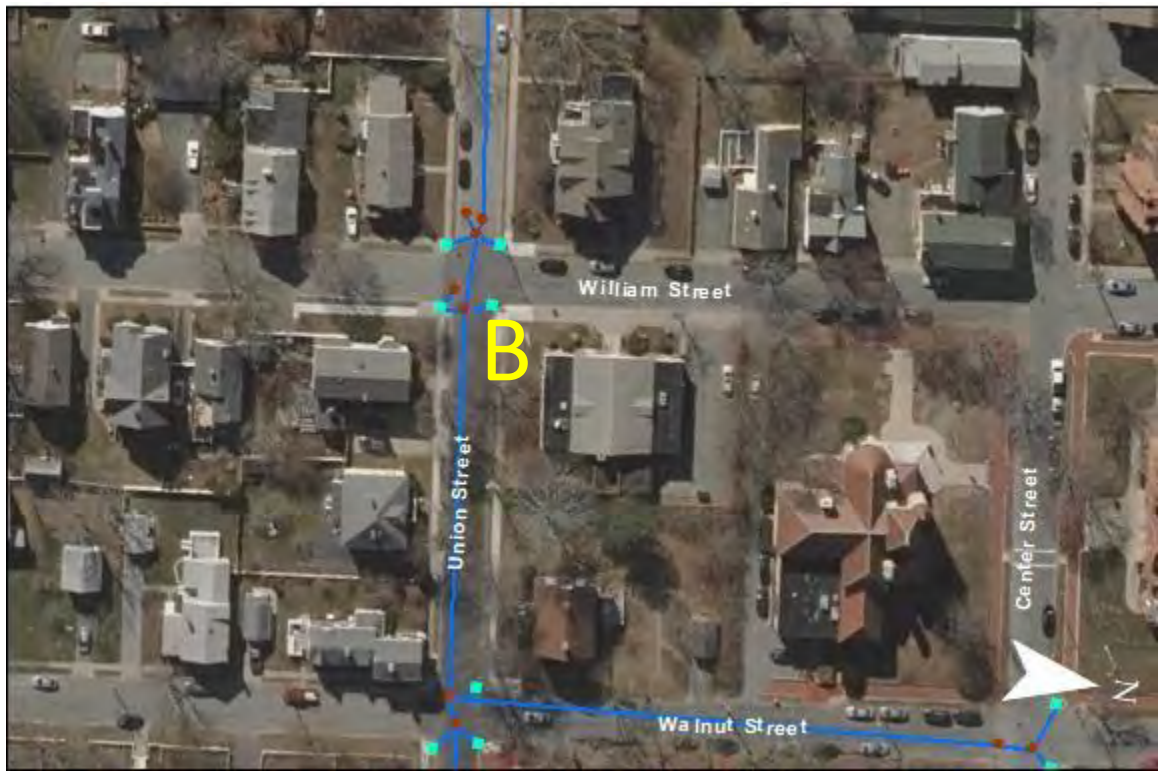
FIH1053PI- Phoenix Street, Cedar Street, and Pleasant Street: No issues found. At point A there is a very old manhole with a pipe entering and exiting. The origin and destination of these pipes is unknown.

FIH1106PI- Union Street: At point A, a pipe enters the catchbasin. The origin of the pipe is unknown. At the corner of William Street and Union Street, at point B, there is a connection between the stormwater system and the sewer system. This needs immediate attention. Since the first version of this report the connection has been blocked. Is now in good order.

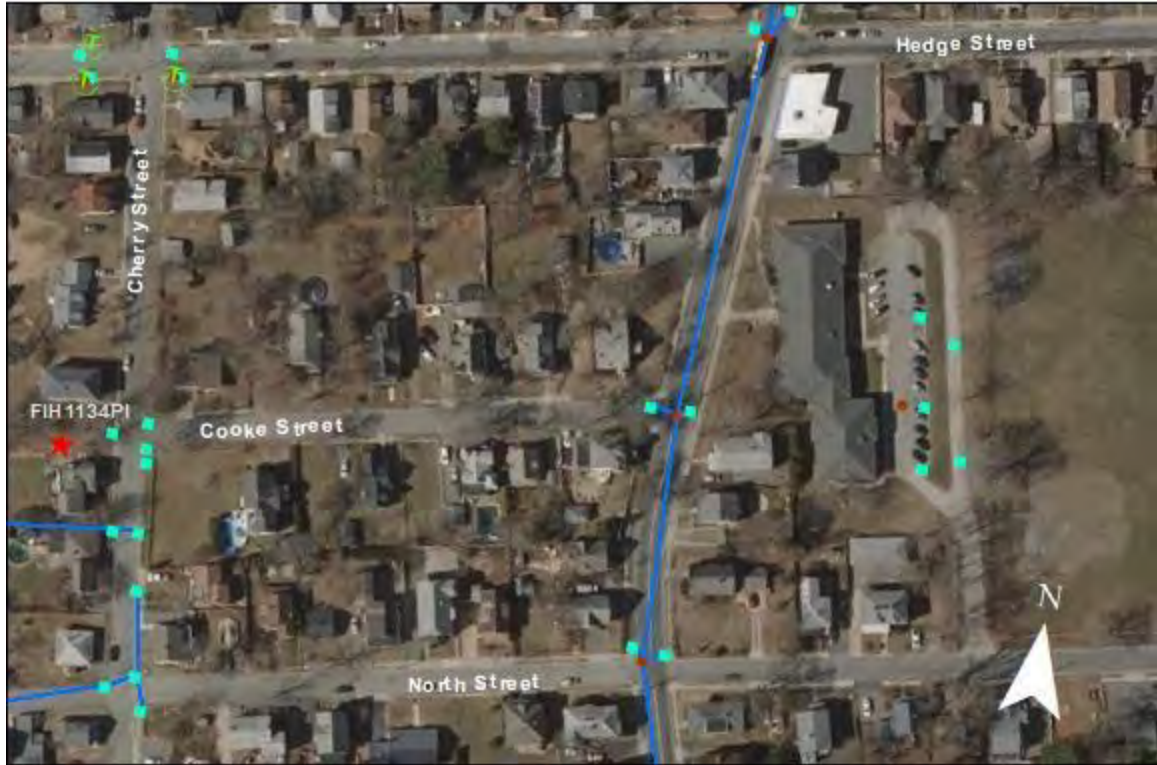
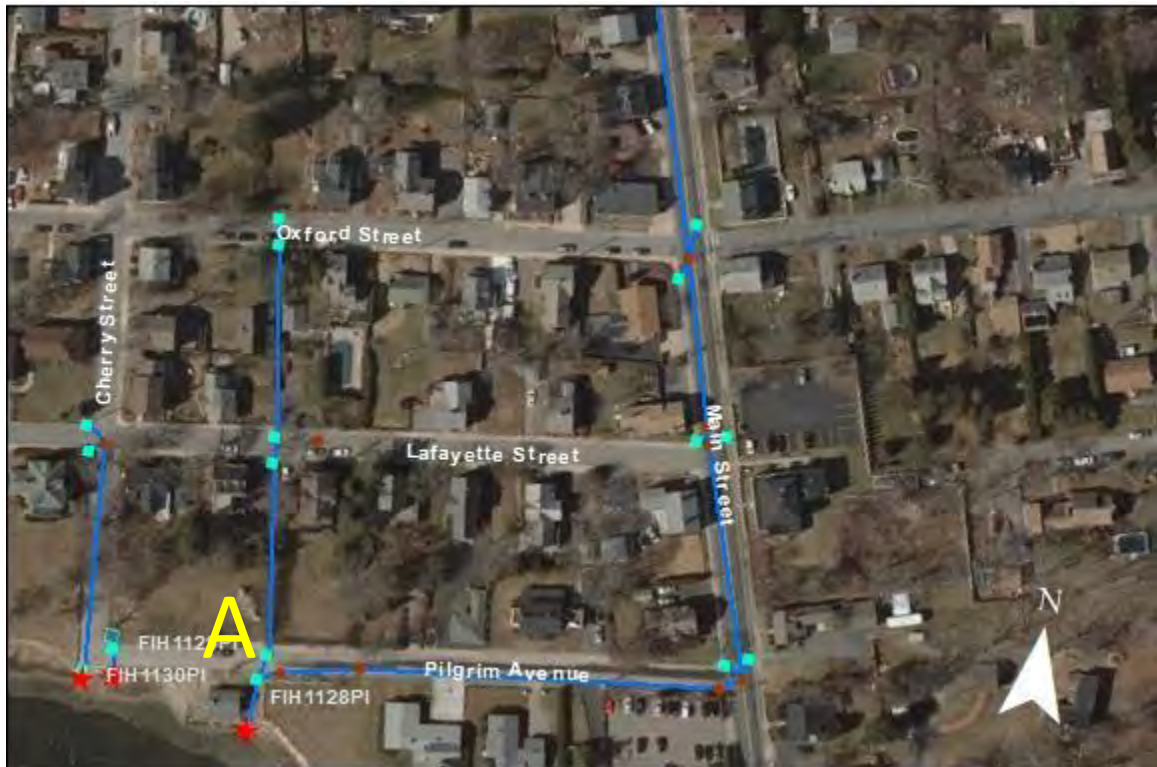
FIH1130PI, FIH1129PI, and FIH1128PI- Pilgrim Avenue, Cherry Street, and Main Street: No issues found. The catchbasin at point A has a silt screen on it. Removal of the silt screen is recommended.

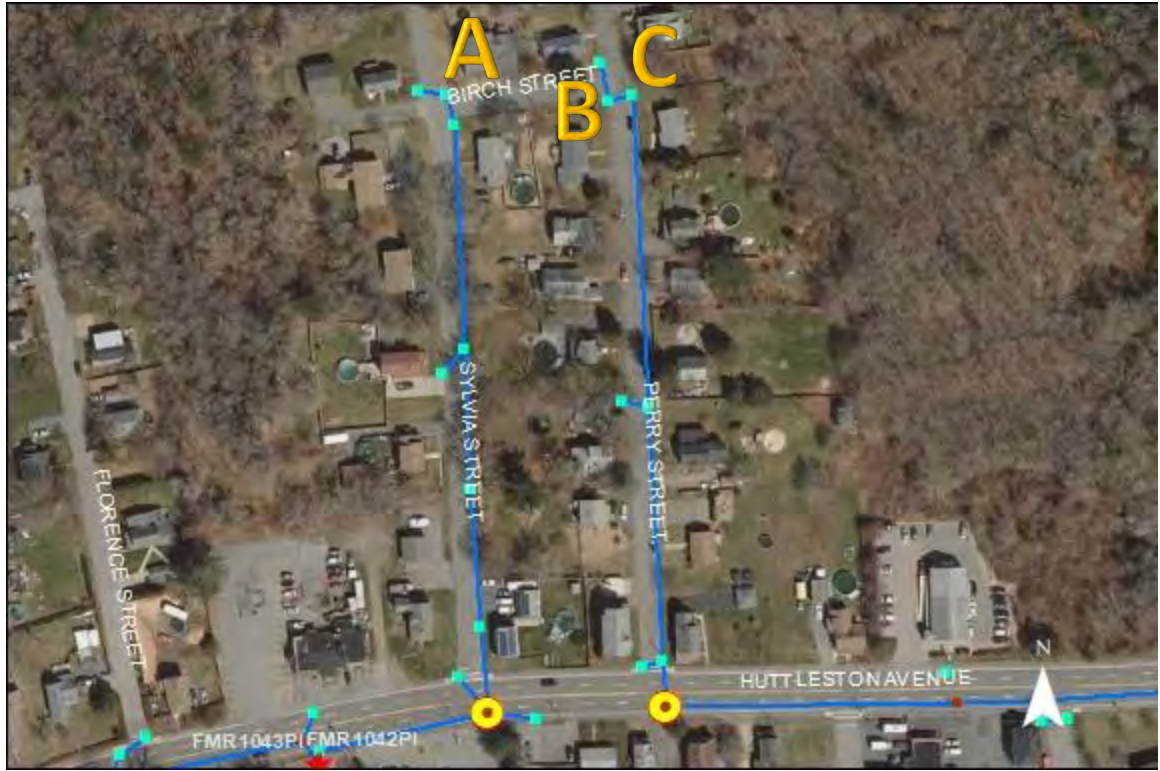
Sylvia Street and Perry Street: At point A and B the catchbasins are sinking. The brick on the inside of the structures is crumbling. Further maintenance is strongly recommended. At point C a pipe exits the catchbasin towards the woods. This pipe is no longer in use. Both catchments drain onto Huttleston Avenue and interconnect to the state's stormwater system as shown by the yellow circles above.

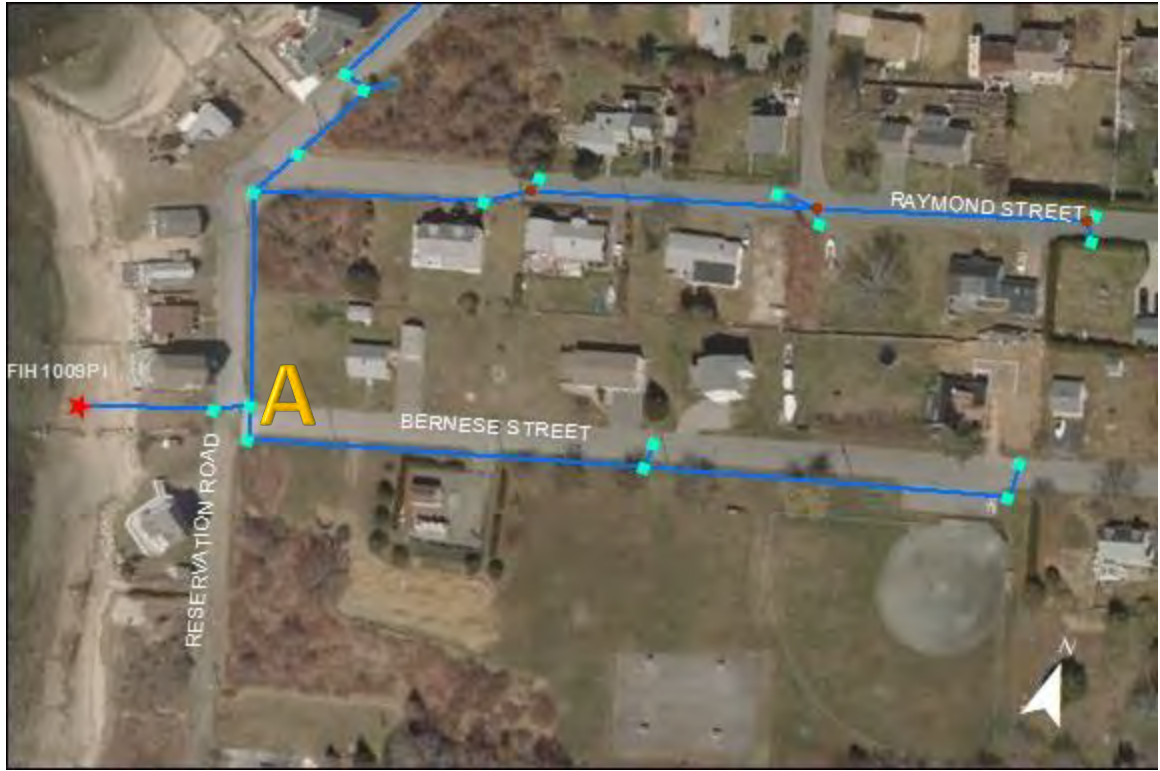
FIH1009PI- Bernese Street, Raymond Street, and Reservation Road: At point A the catchbasin is in need of repair.

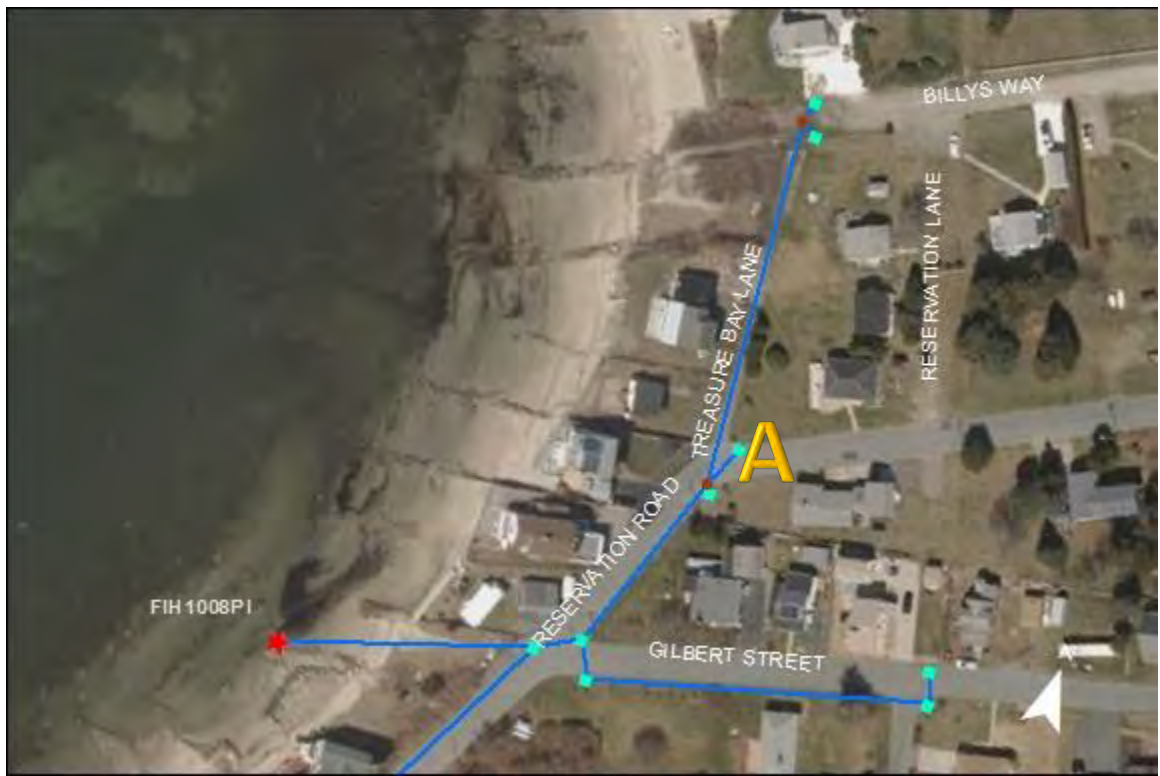
FIH1008PI- Reservation Road, Treasure Bay Lane, and Gilbert Street: At point A the catchbasin is in need of repair.

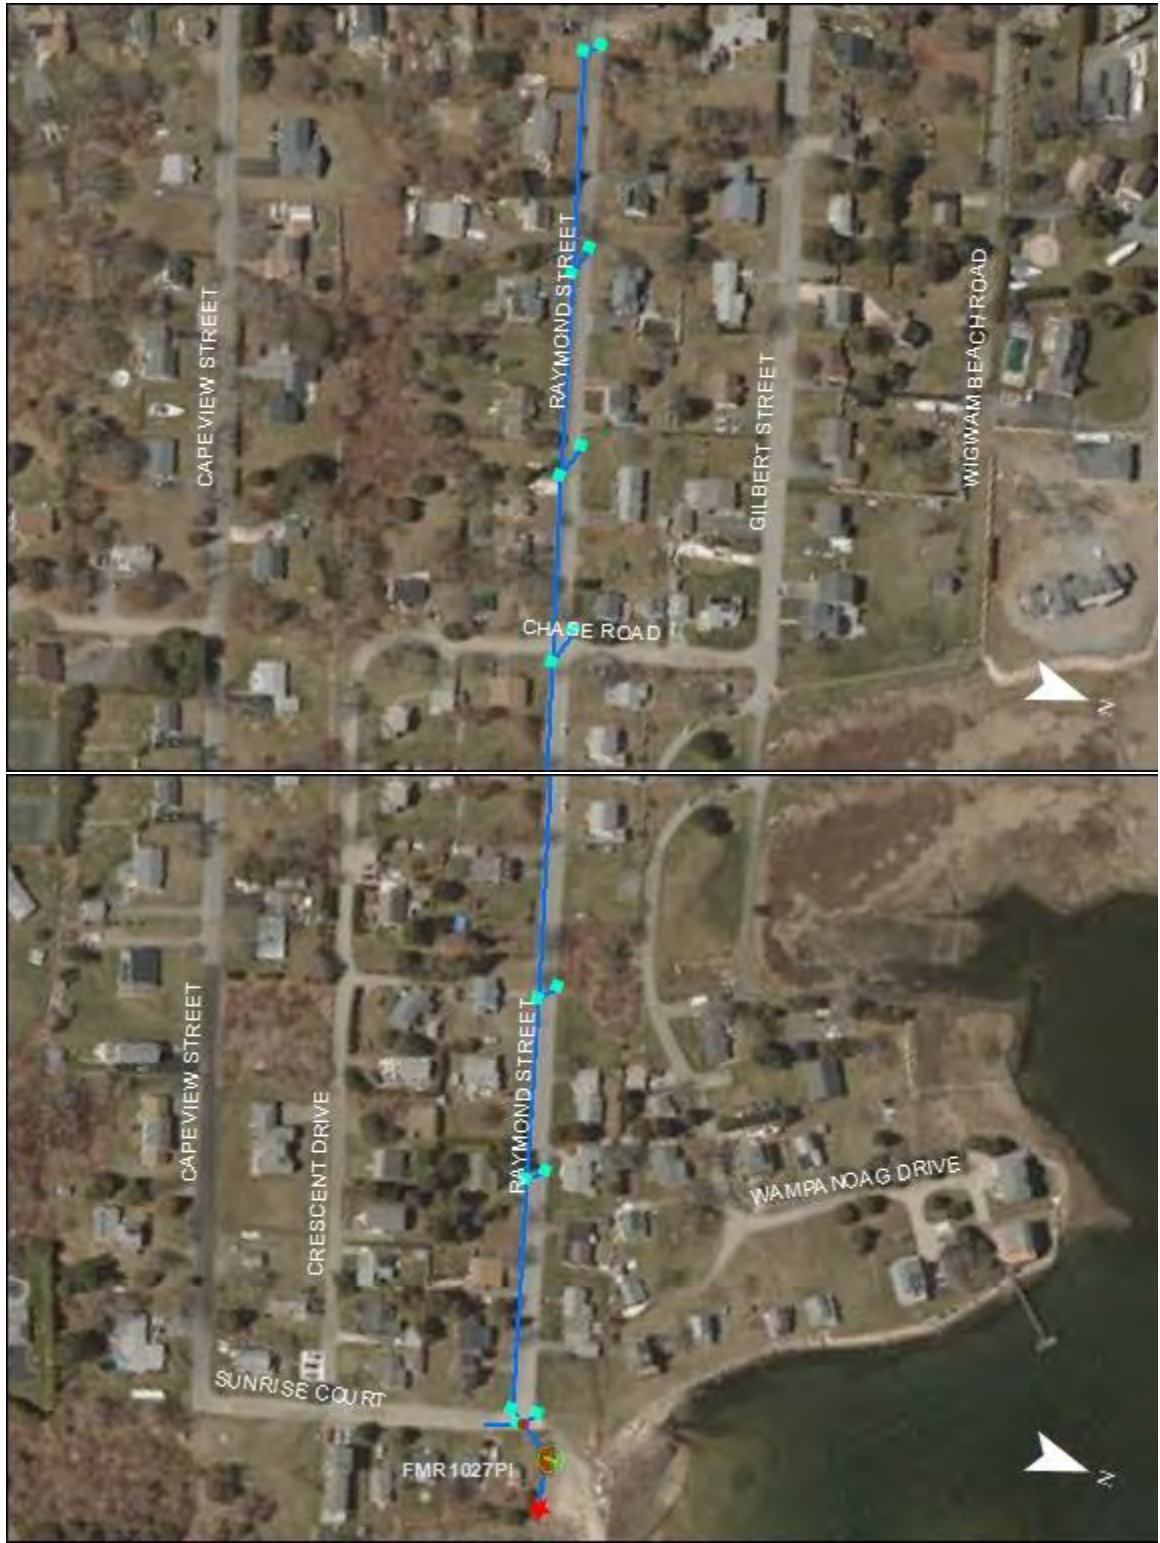
FMR1027PI- Raymond Street: No significant issues found. At point A, a 12" concrete pipe enters the manhole. Its origin is unknown. Further investigation is recommended.

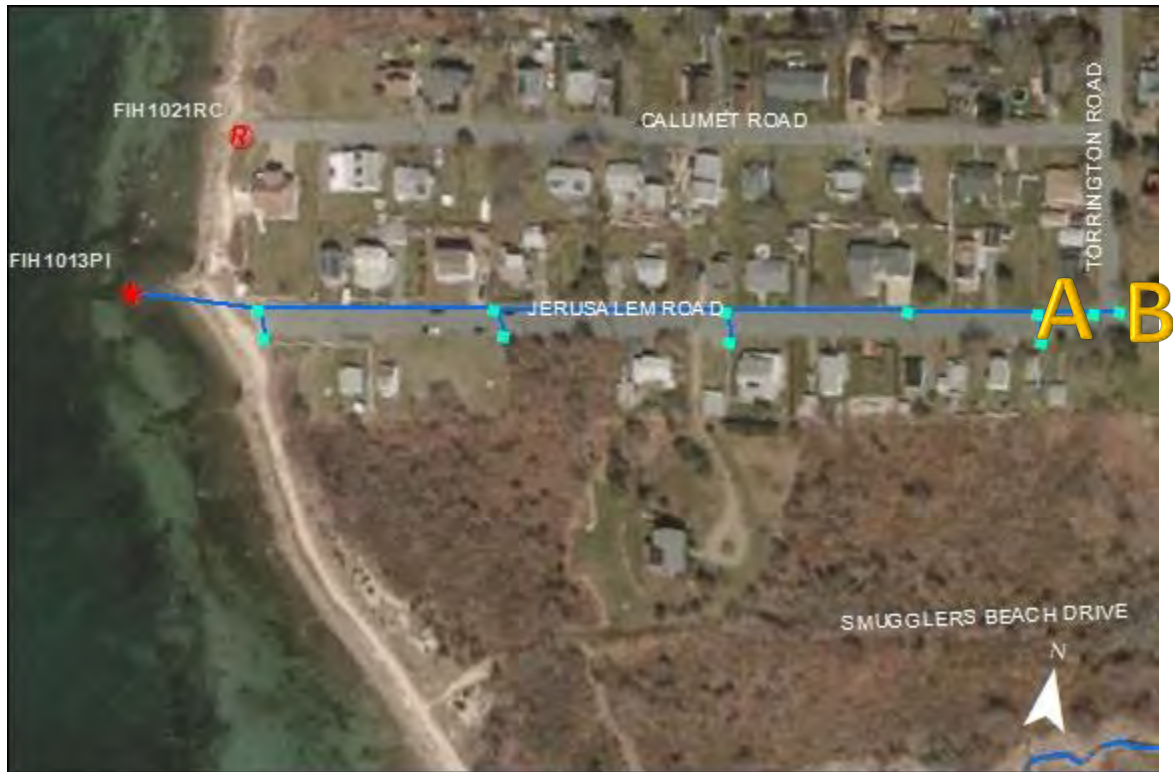
FIH1013PI, FIH1021RC- Jerusalem Road and Calumet Road: Unnatural color observed at points A and B. Further investigation is recommended.

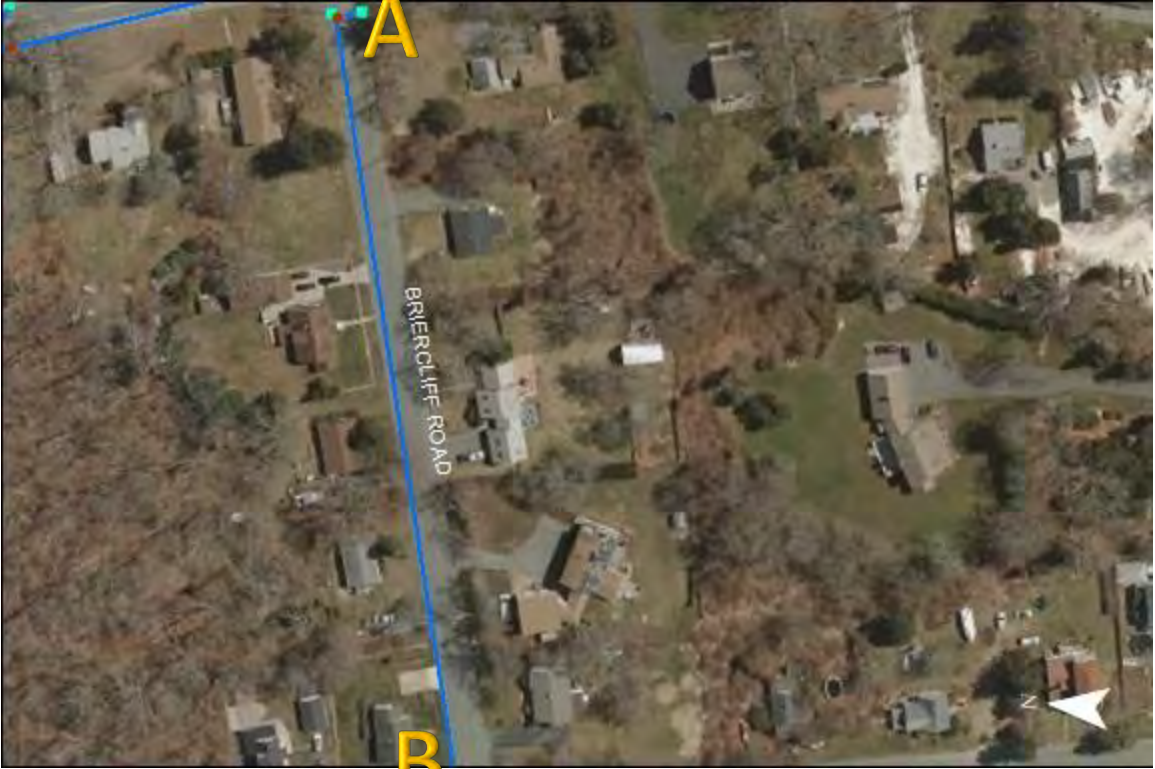
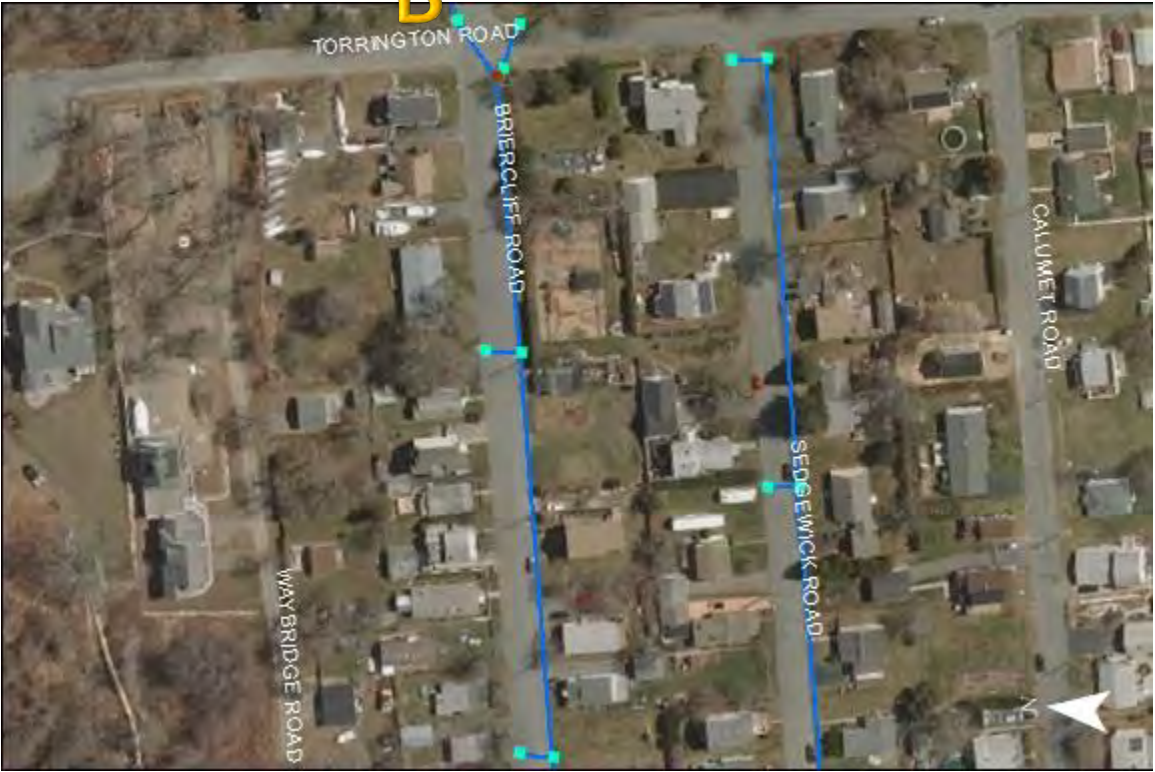
FIH1010PI and FIH1011PI- Briercliff Road and Sedgewood Road: At point A the bricks on the inside of the catchbasin are missing or starting to crumble. Preventative maintenance is recommended. The catchbasin had suds in the water of the sump of the basin. There was a sump pump coming from house #42. Could not confirm if the soap was from the pipe or from recent car washing. Further investigation is recommended. No issues found on Sedgewick Road.

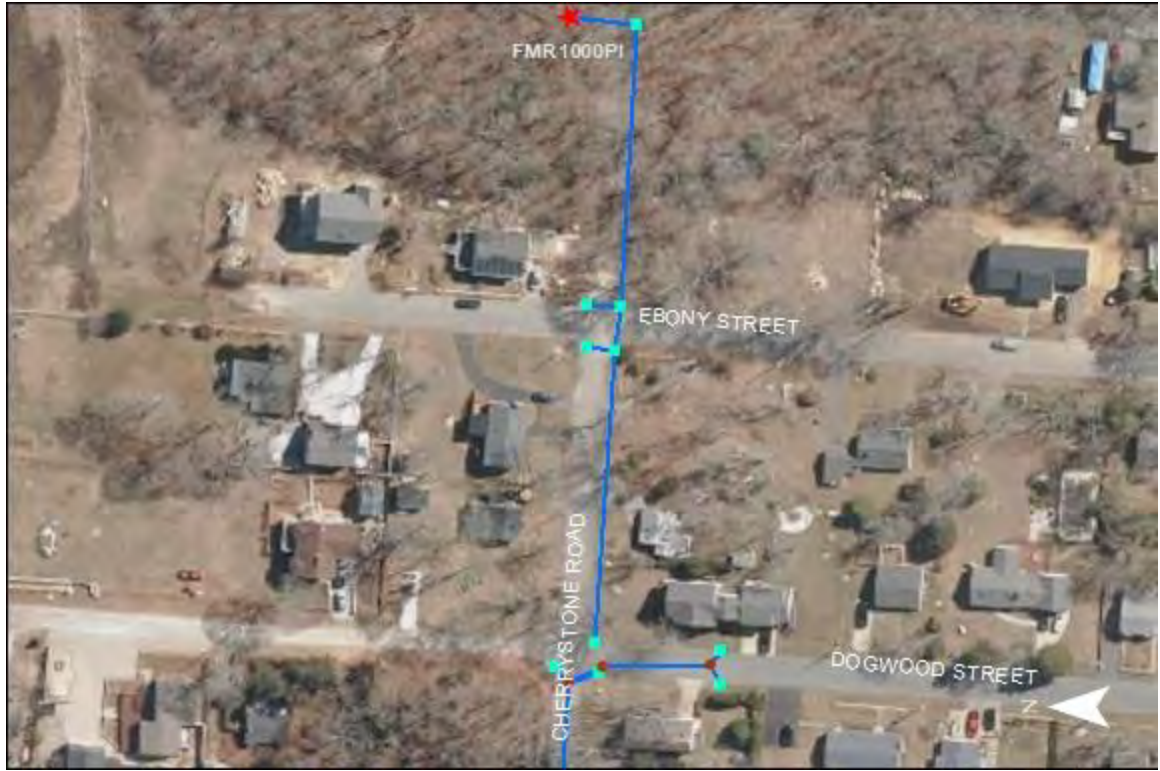
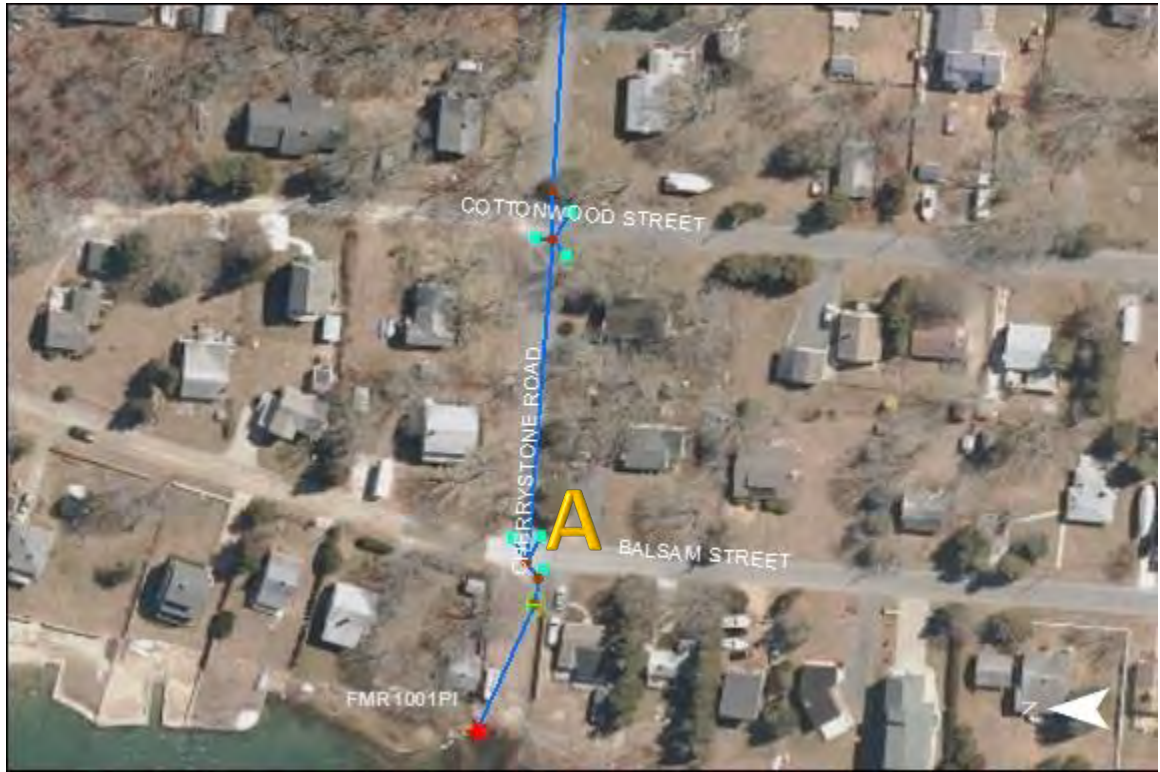
FMR100PI and FMR1001PI- Cherry Stone Road: At point A the catchbasin is sinking. Further maintenance is recommended. Lots of fox excrement was observed in numerous basins and manholes.

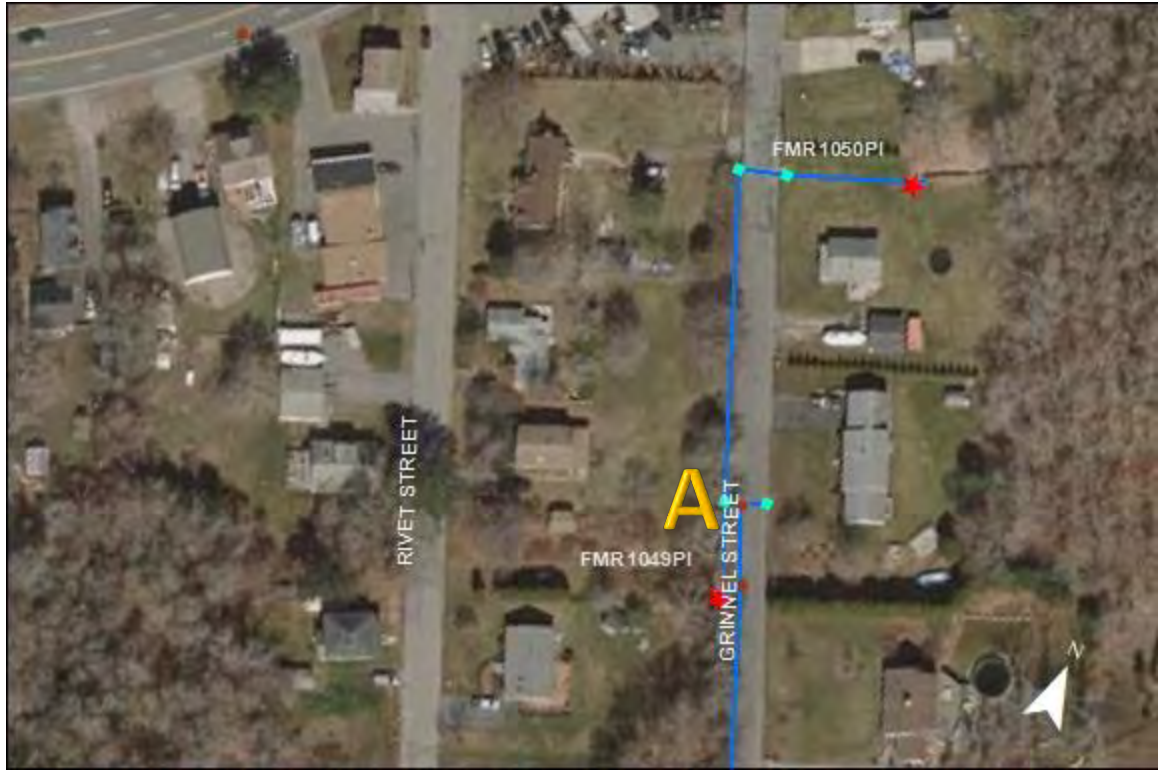
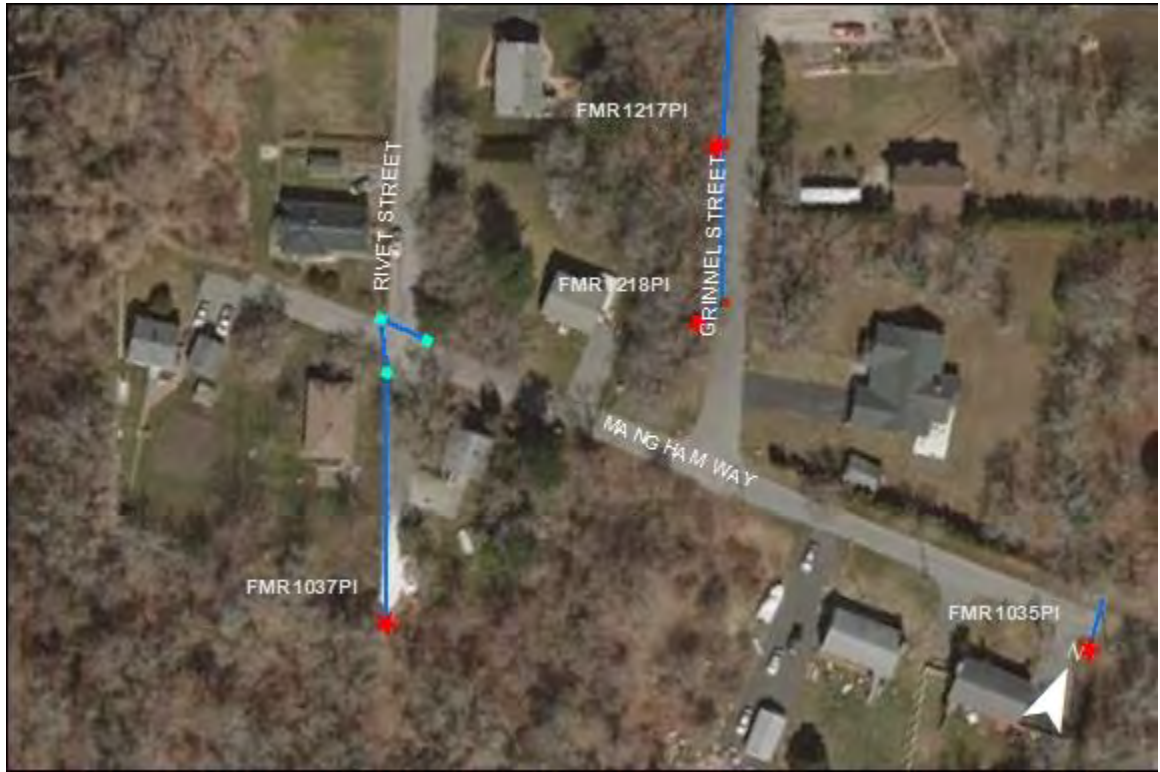
FMR1050PI, FMR1049PI, FMR1217PI, FMR1218PI, FMR1037PI, and FMR1035PI- Mangham Way and Grinnel Street: No significant issues found. At point A, a pipe enters the catchbasin. Its origin is unknown. Further investigation is recommended.

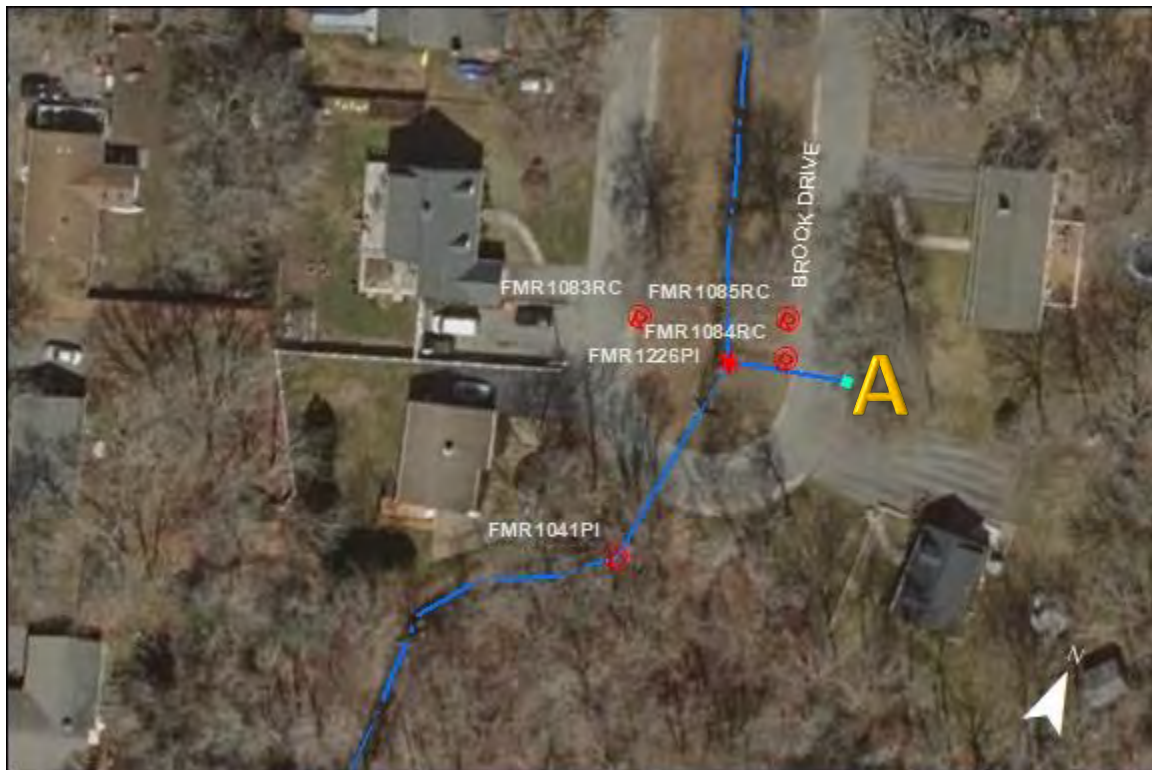
FMR1083RC, FMR1085RC, FMR1084RC, FMR1226PI, and FMR1041PI- Brook Drive: At point A the catchbasin is inking. Further maintenance is recommended.

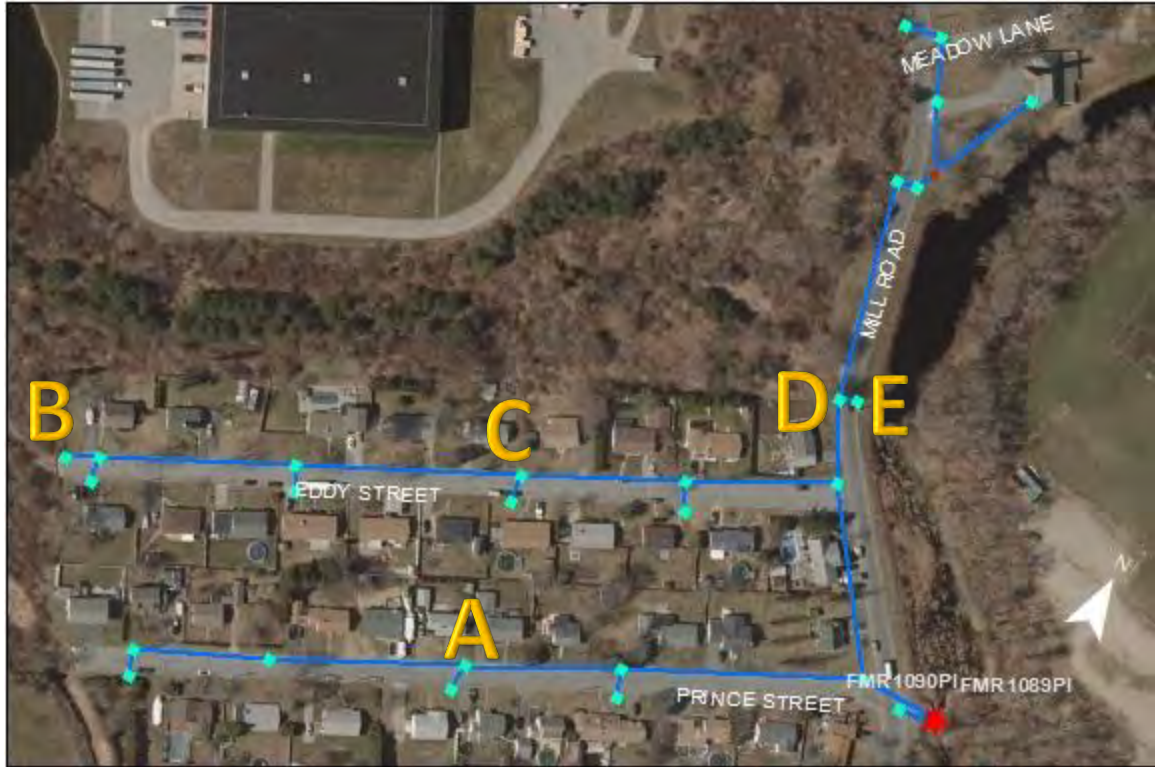
FMR1090PI and FMR1089PI- Mill Road, Eddy Street, and Prince Street: The catchbasins at A, B, C, D, and E are sinking. Further maintenance is recommended.

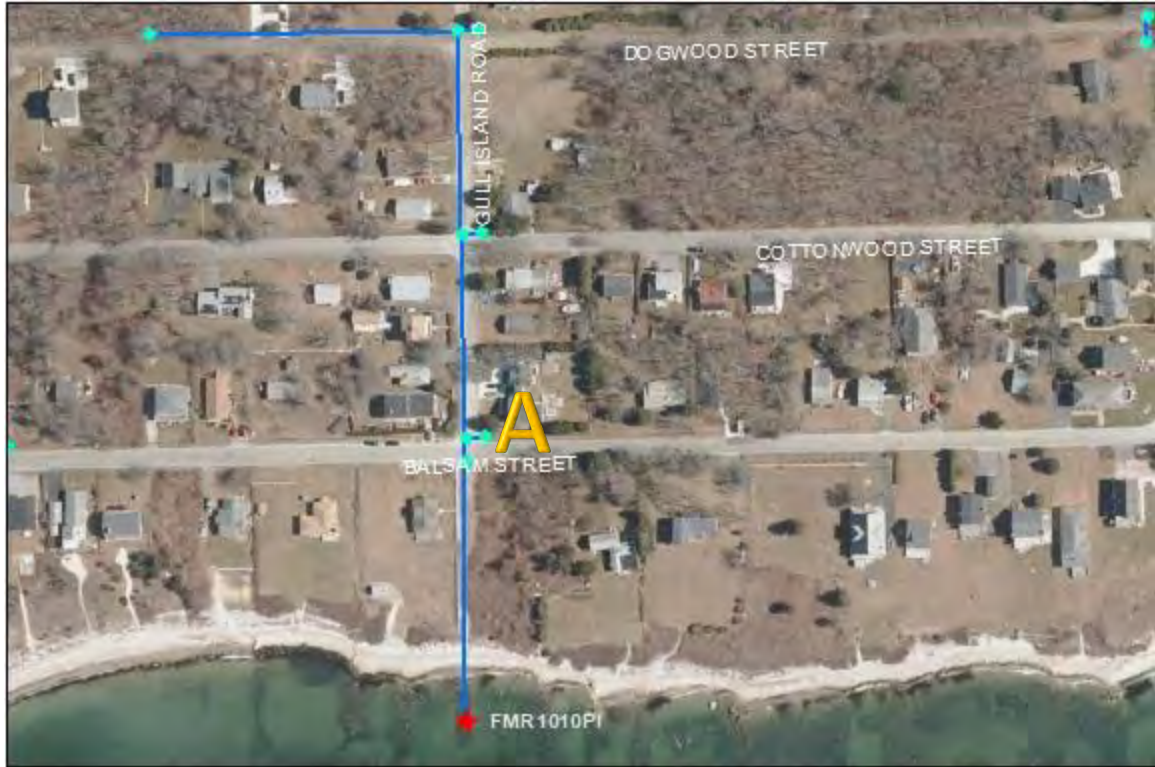
FMR1010PI- Gull Island Road: Catchbasin at point A is sinking. Further maintenance is recommended.

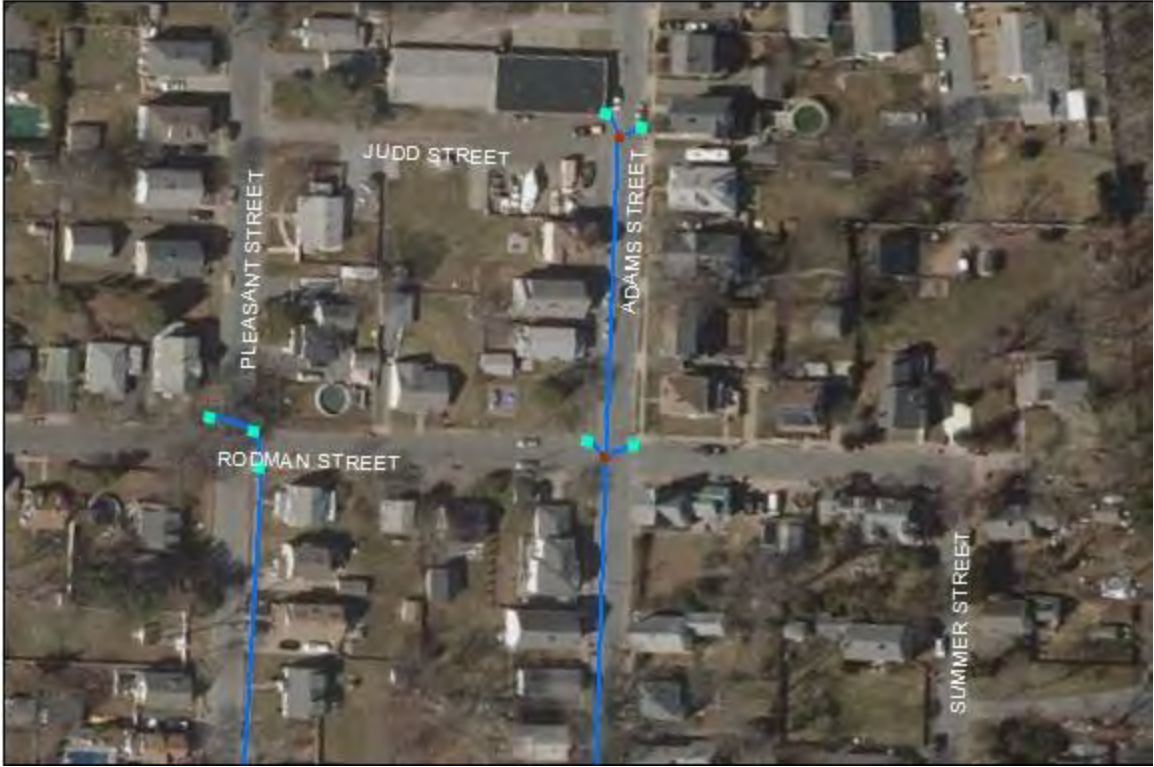
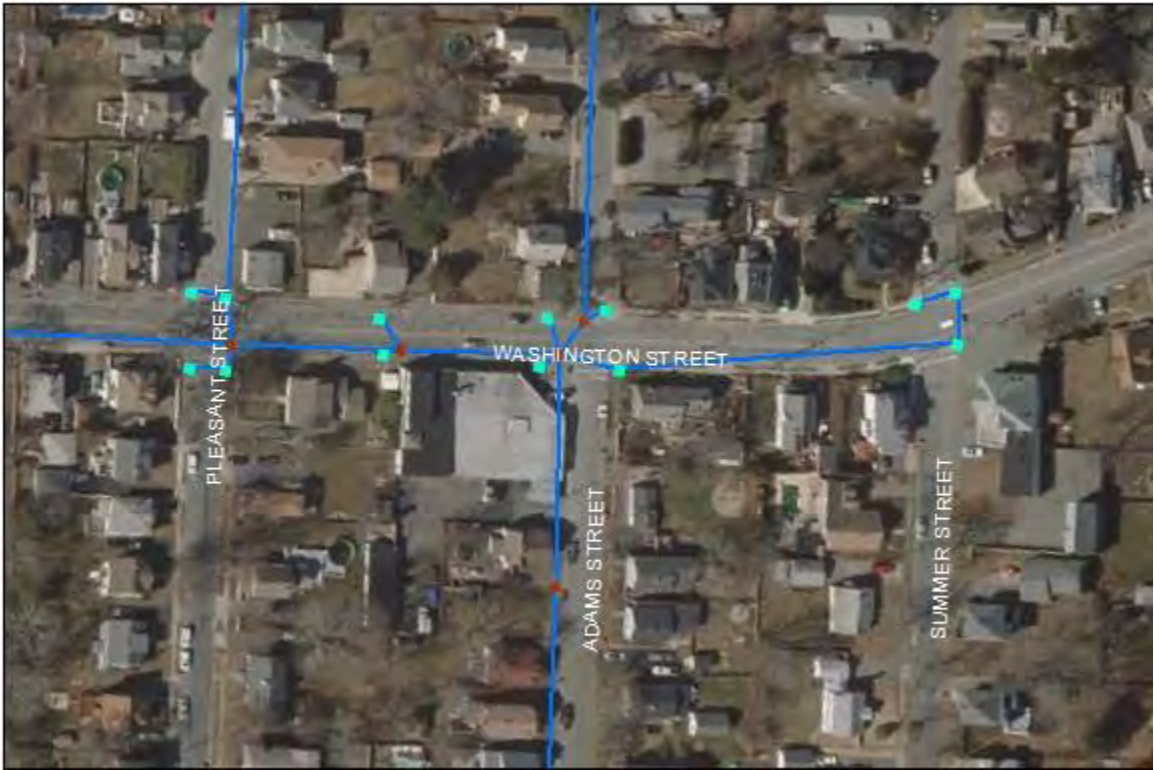
(1/2) FIH1051PI- Adams Street: At point A and B the structures were full of water. Likely that there is a blockage in each one. Friendly Street floods during rain events. Further maintenance is highly suggested.

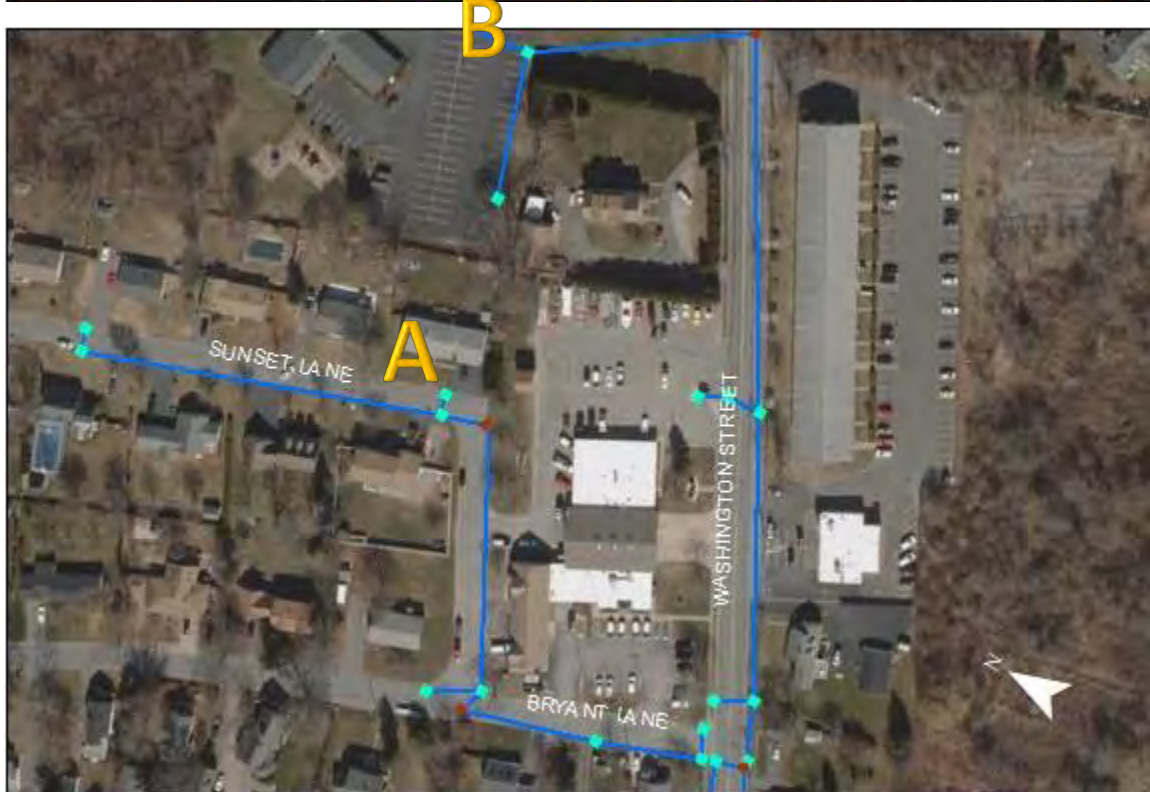
(2/2) FIH1048PI- Washington Street, Sunset Lane, and Temple Place: Catchbasins at point A, B, and C have begun to sink. Further maintenance is suggested.
