**The Buzzards Bay Stormwater Collaborative
Illicit Discharge Investigation Trailer**

Town of Marion Report

August 2022

Marion IDDE Report

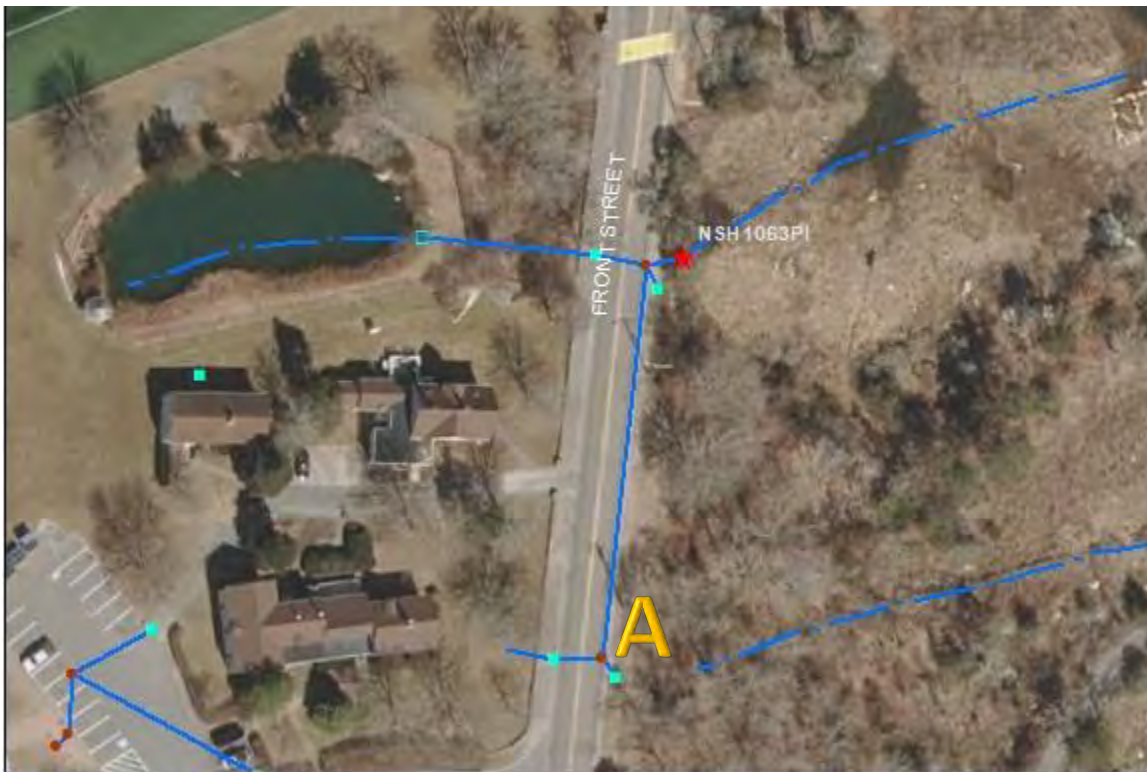
NSH1063PI- Front Street: No significant issues found. The manhole at point A was packed with dirt and had significant root growth. The Town cleaned it out and the connection between manholes was confirmed. It has previously flooded in this area. Further maintenance within the pipes may still be needed to avoid this.

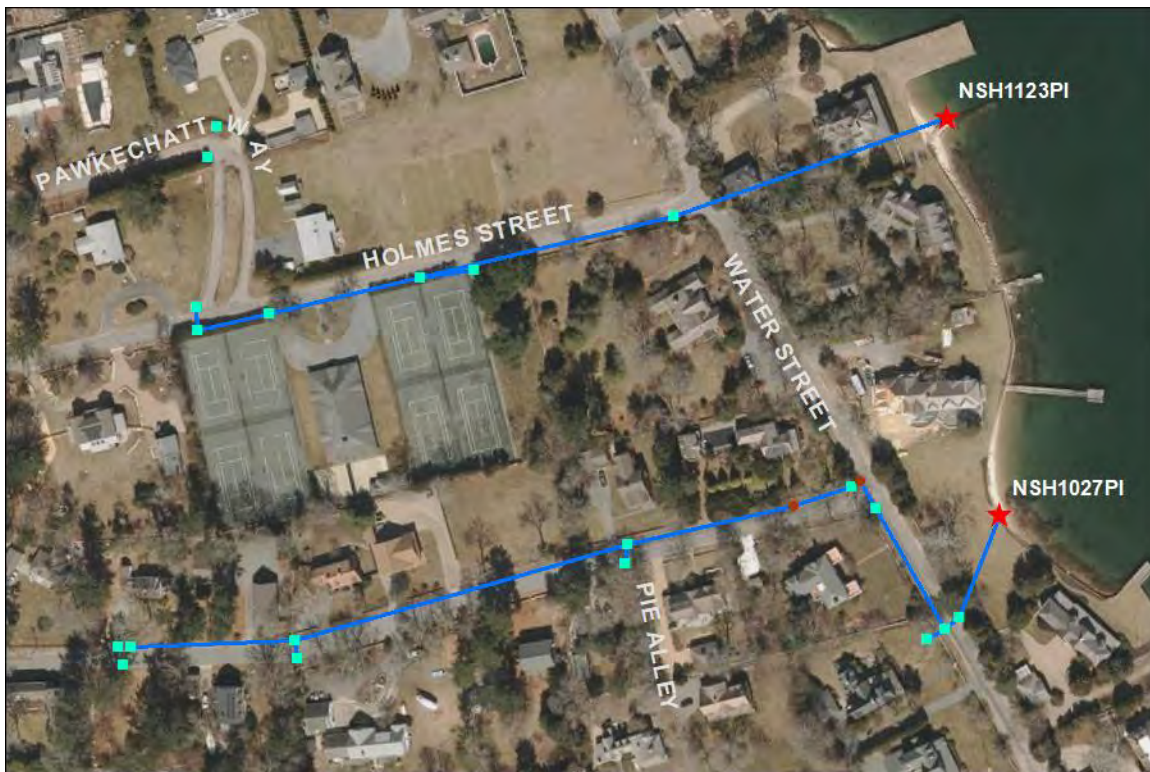
NSH1123PI – Holmes Street: No significant issues found; newly documented outfall; this is a very old network with various structures poorly added; excessive pet waste in area. Community outreach is recommended.

NSH1027PI – Allen Street: No significant issues found; this is also an old network with excessive pet waste in area. Community outreach is suggested.

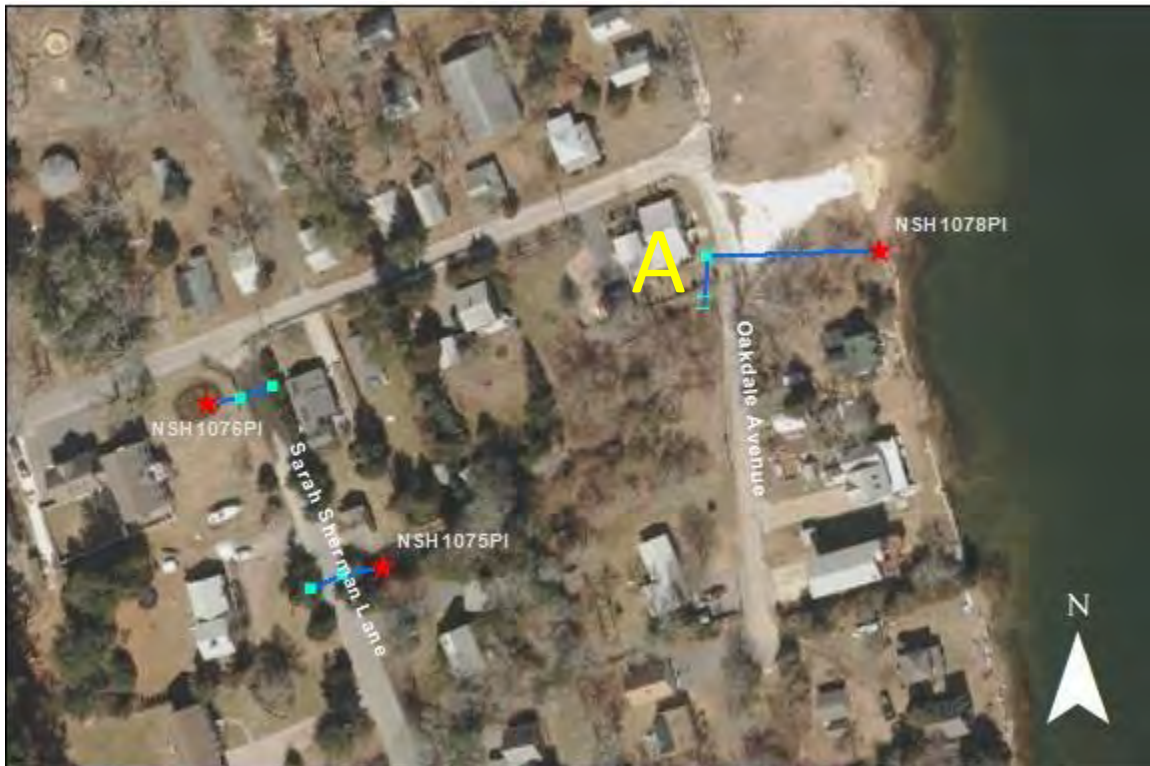
NSH1076PI and NSH1075PI- Sarah Sherman Lane: No issues found.
NSH1078PI- Oakdale Avenue: Pipe may be collapsed or buried. Unable to locate outfall. At point A, a clay pipe enters the catchbasin. Evidence pipe is broken in yard just South of basin.

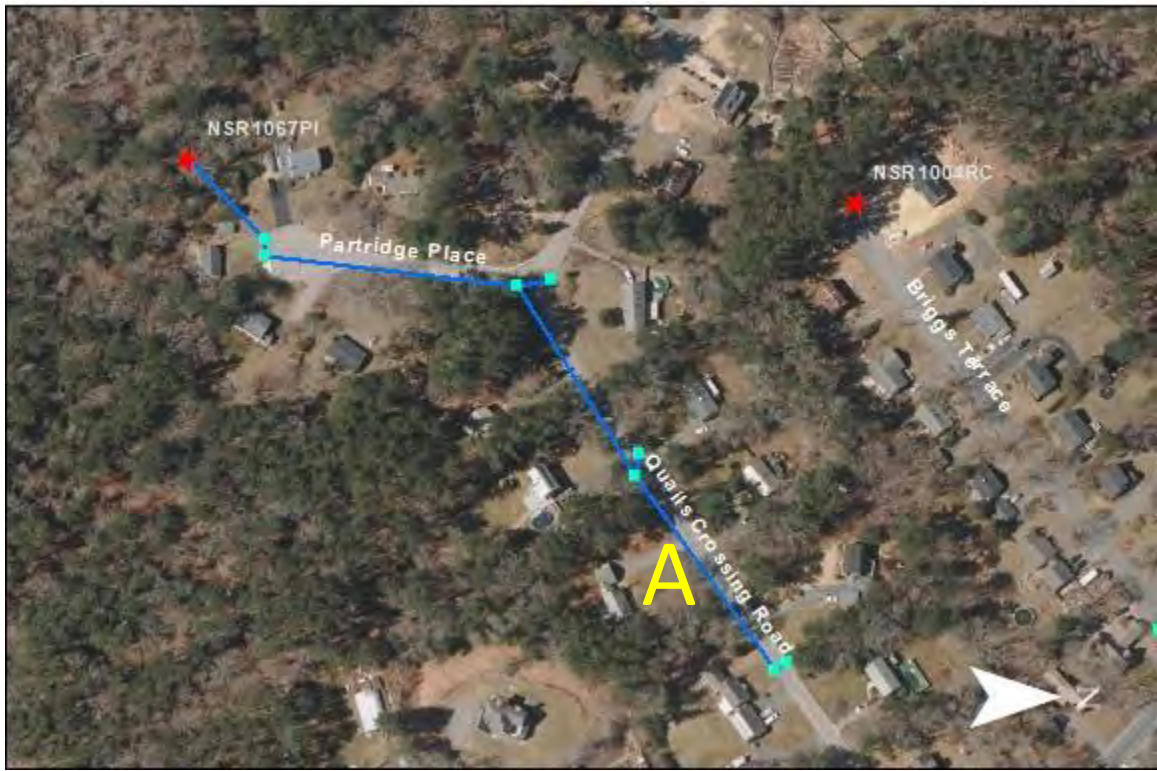
NSR1067PI- Partridge Place: No issues found. At point A groundwater is penetrating catchment at pipe seam.

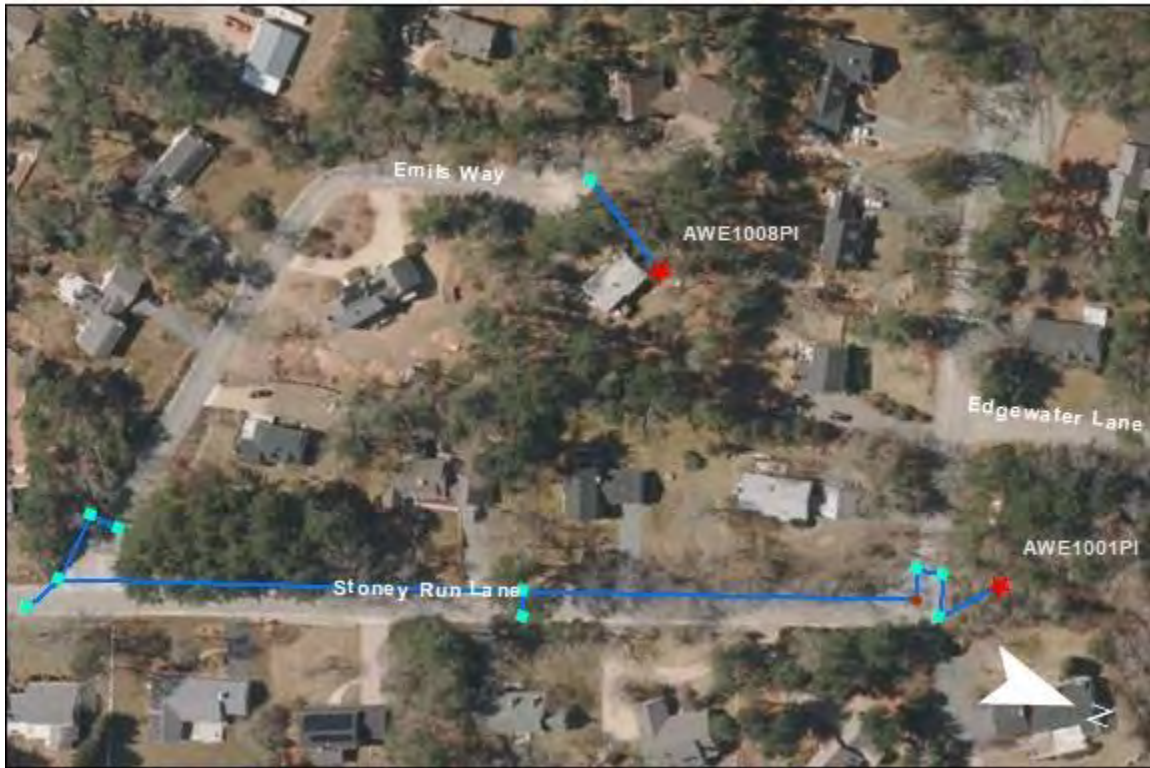
AWE1001PI- Stoney Run Lane: Structures near outfall are completely full of sand. Difficult to inspect due to debris. Further maintenance is suggested.

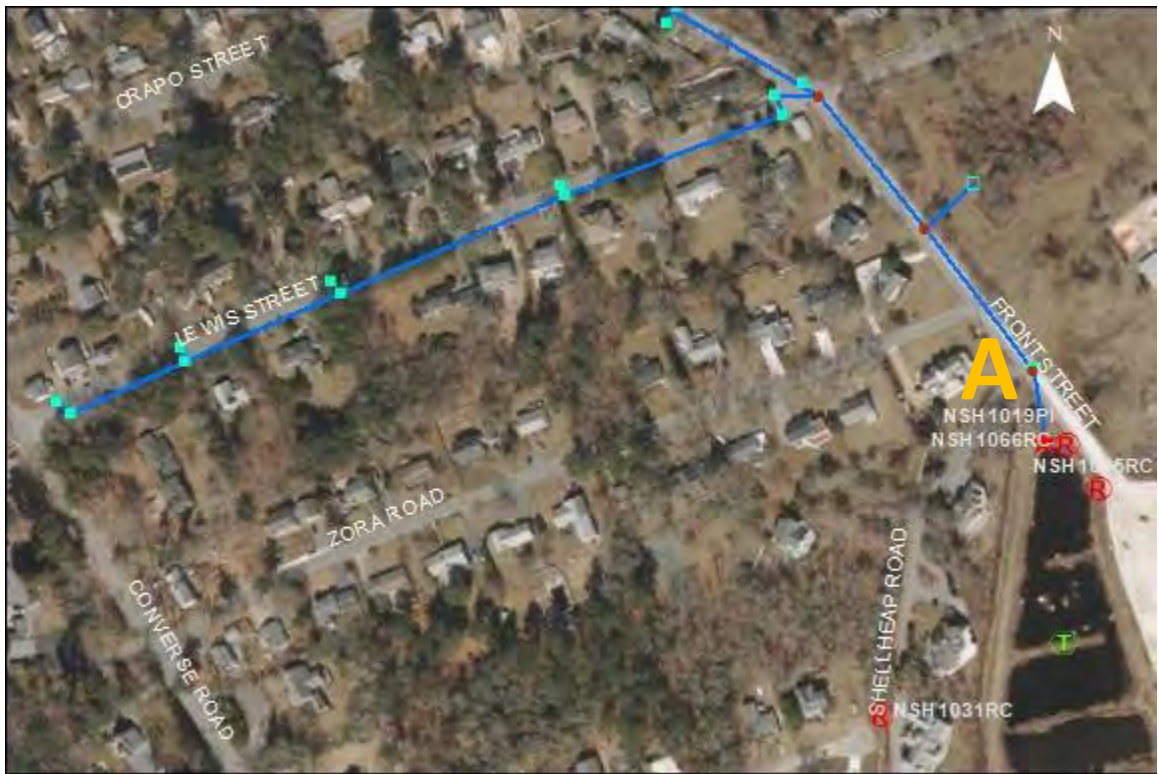
NSH1019PI (1/3)- Front Street and Lewis Street: No significant issues found. Two 12-inch concrete pipes enter the manhole at point A. Their origins are unknown. Several basins on Lewis Street had large amount of sand and leaf debris. Further maintenance is suggested.

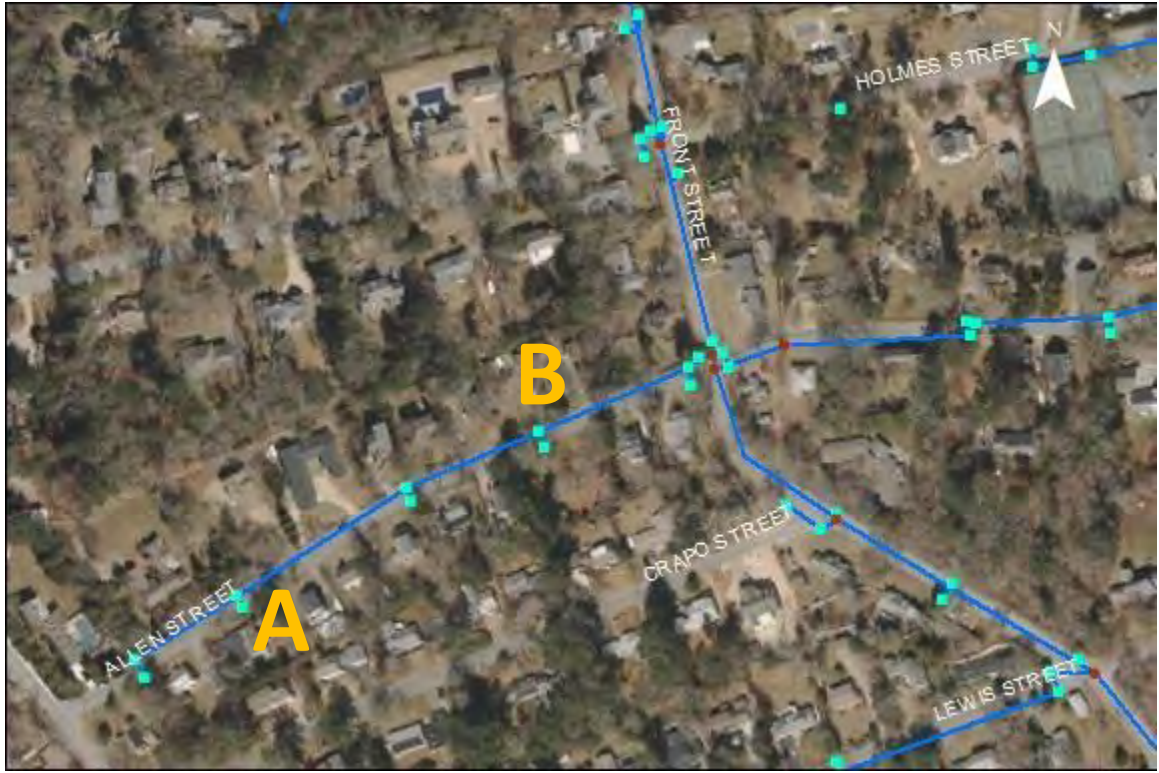
NSH1019PI (2/3)- Front Street: At point A and B the catchbasins have begun to sink. Both are in need of repair. Preventative maintenance is recommended.

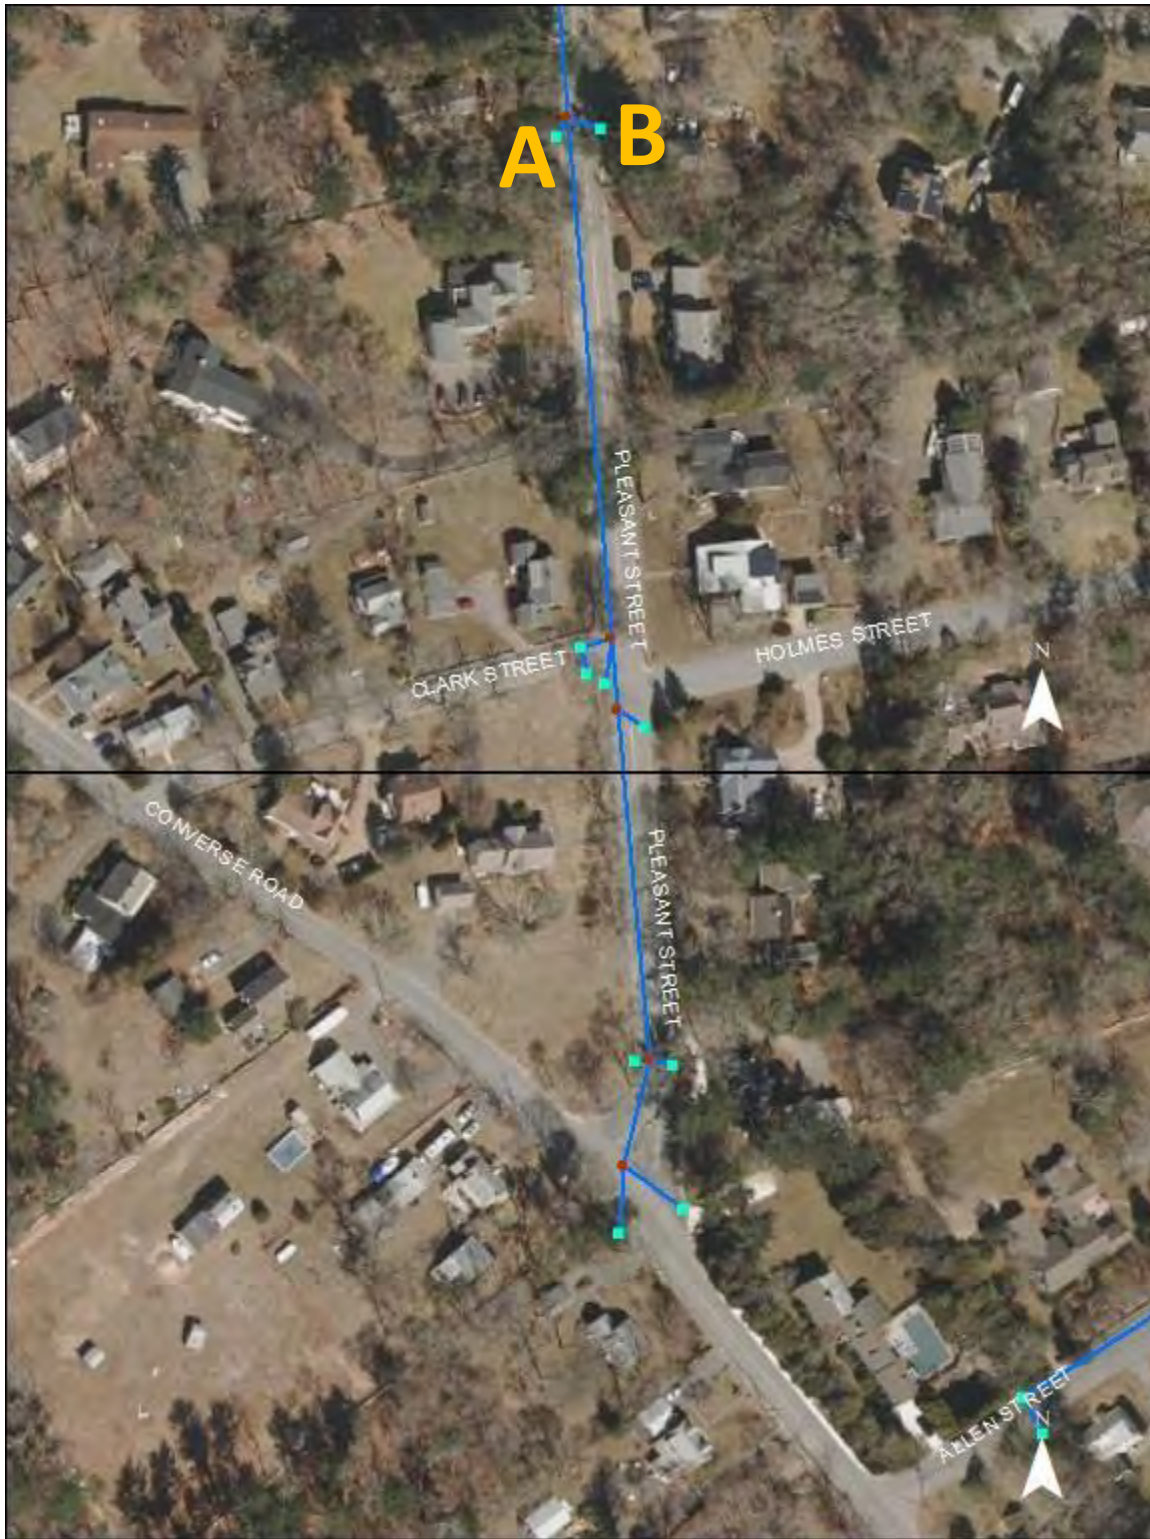
NSH1046PI (2/2) - Pleasant Street: At point A the bricks on the inside of the catchbasin are beginning to crumble. Catchbasin is in need of repair. At point B the catchbasin is full of dirt and not draining properly. The structure is in need of cleaning.

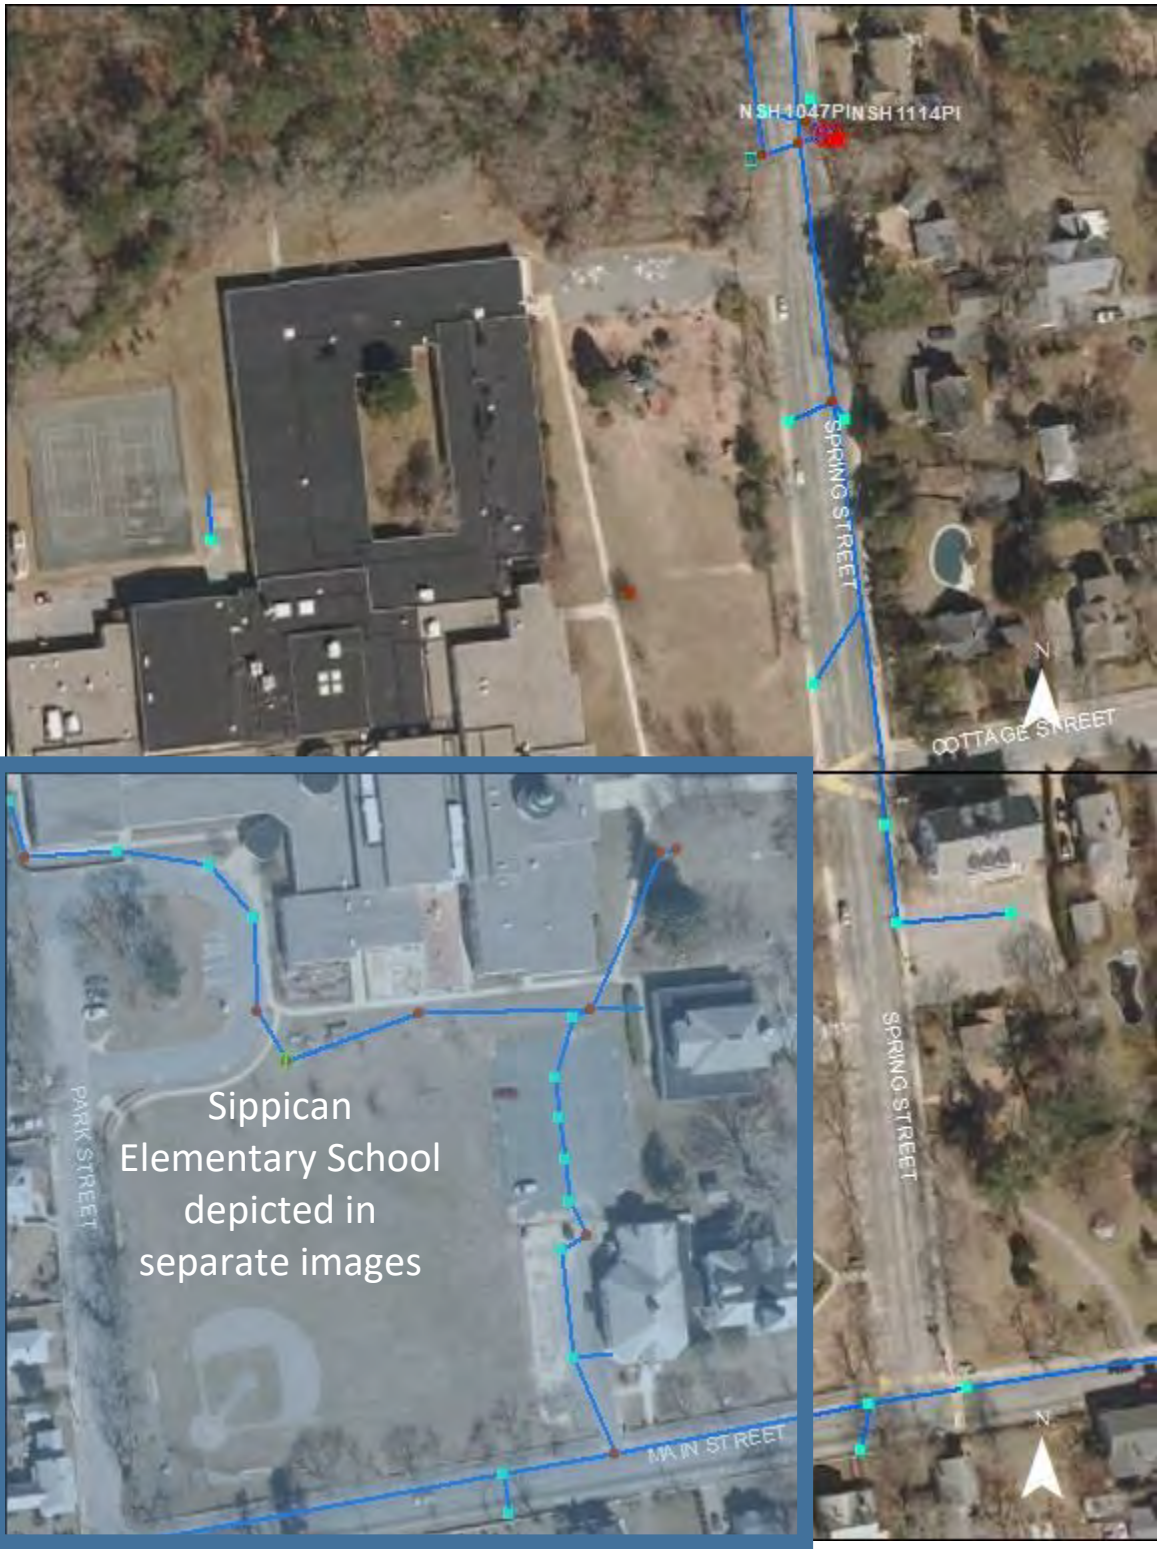
NSH1114PI and NSH1047PI- School Street: At point A there is a large construction sandbag inside the catchbasin. Its removal is recommended.

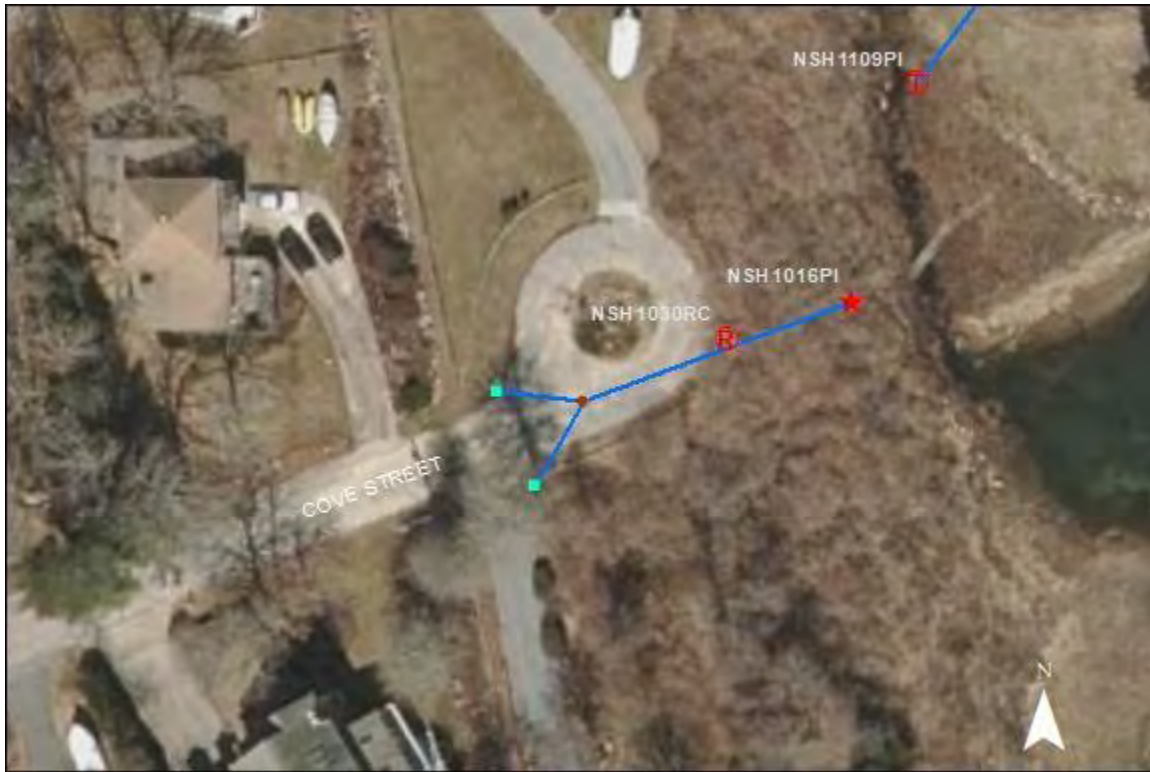
NSH1030RC and NSH1016PI- Cove Street: Catchbasins and the manhole on Cove Street are full of sand. Further maintenance is recommended.

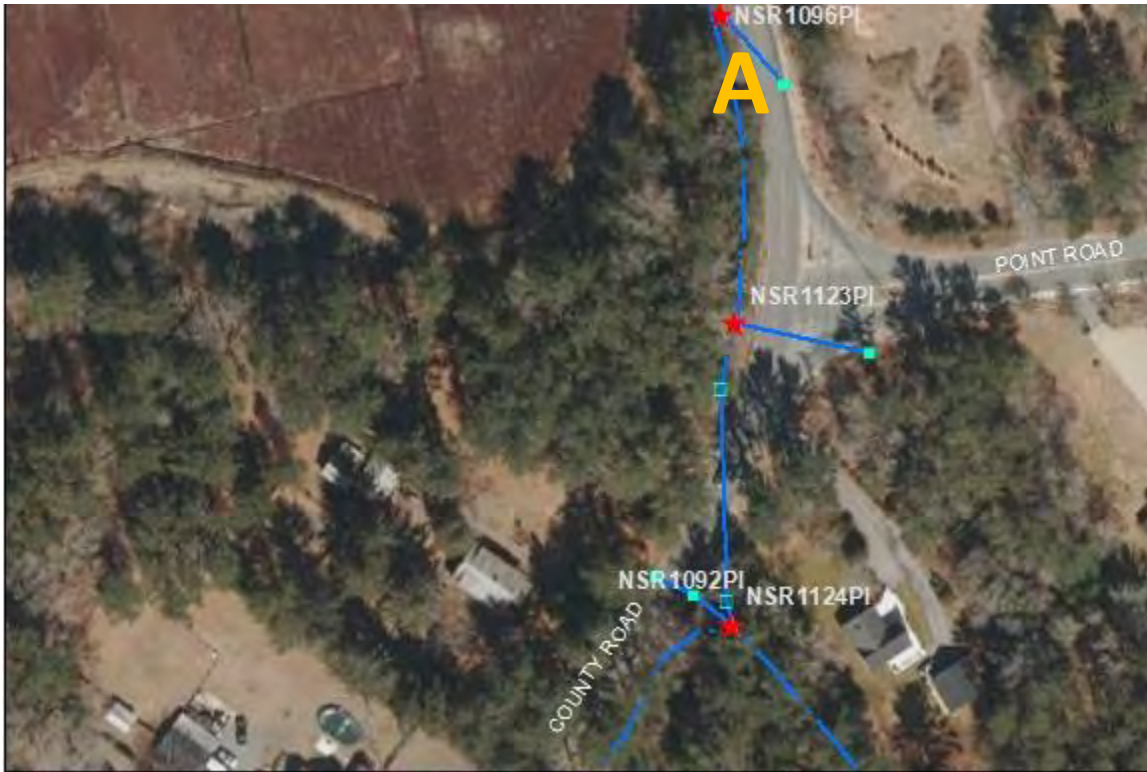
NSR1096PI, NSR1123PI, NSR1092PI, and NSR1124PI- County Road at Point Road: No significant issues. Pipe at point A is clogged. Further maintenance is recommended.

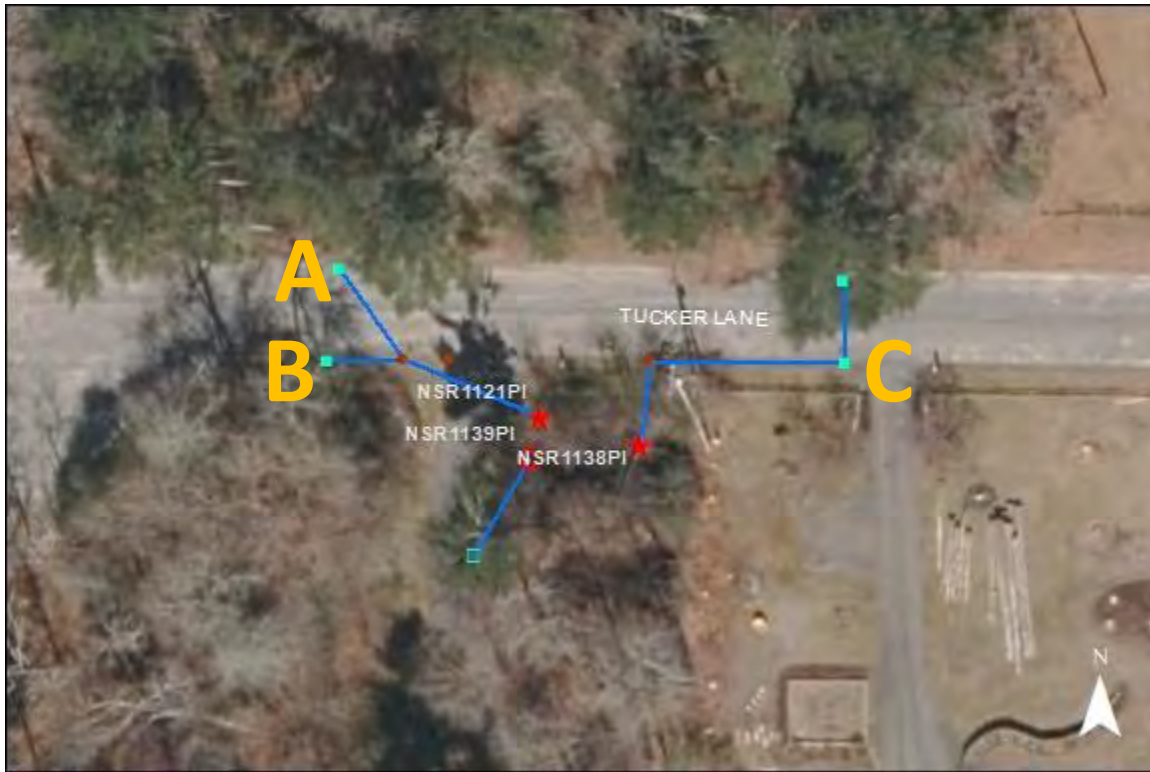
NSR1121PI, NSR1139PI, and NSR1138PI- Tucker Lane: Catchbasins at A, B, and C have all begun to sink. Preventative maintenance is recommended.

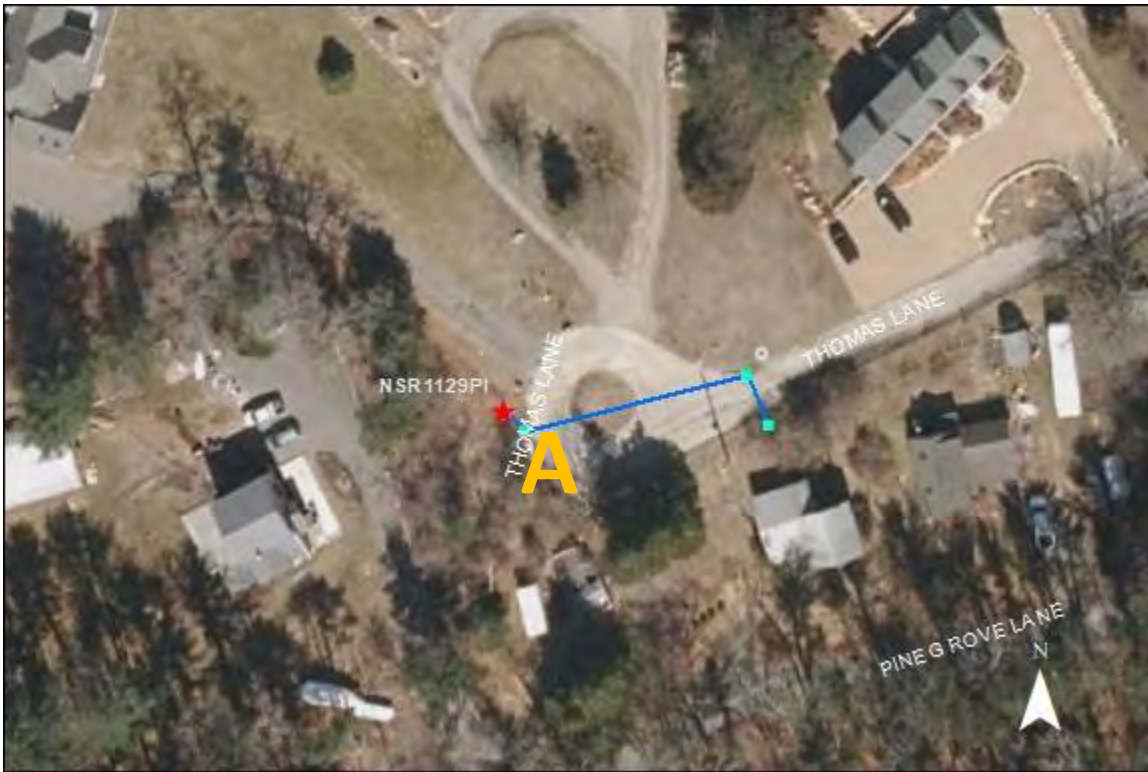
NSR1129PI- Thomas Lane: The catchbasin at point A had a lot of lumber dumped into it. Catchbasin should be cleared of debris.

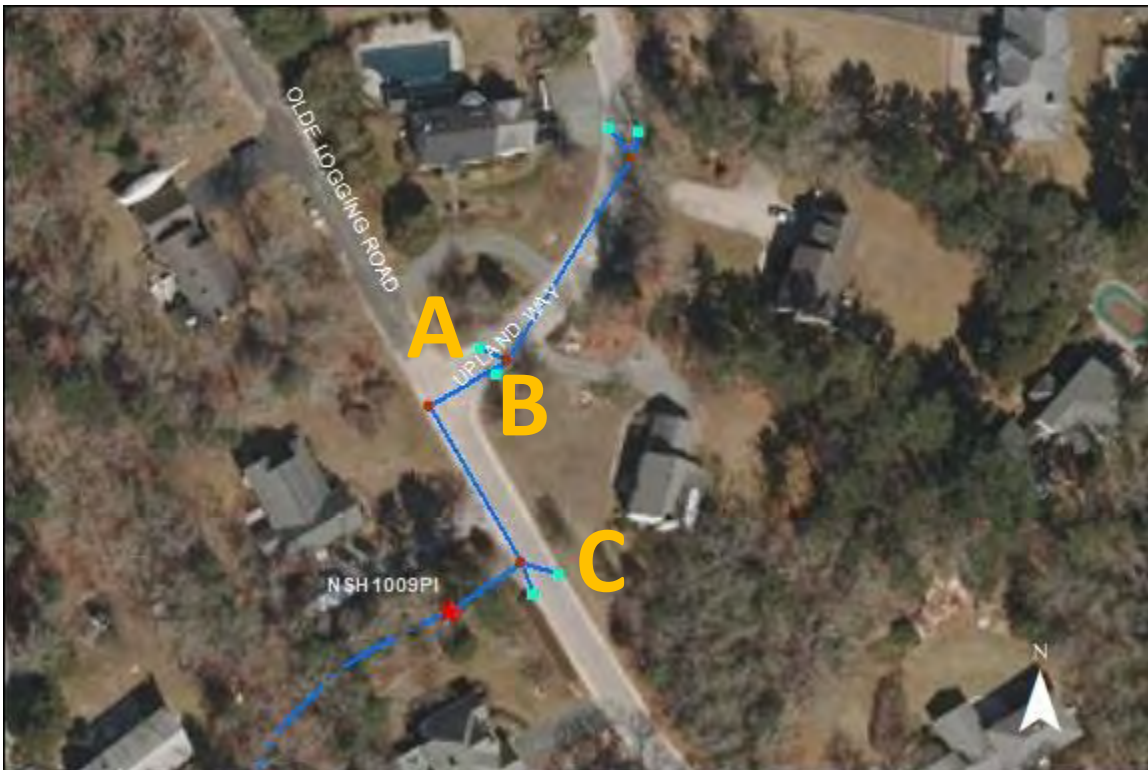
NSH1009PI- Upland Way and Olde Logging Road: At point A, B, and C, the catchbasins are beginning to sink and the frames are beginning to chip. Preventative maintenance is recommended.

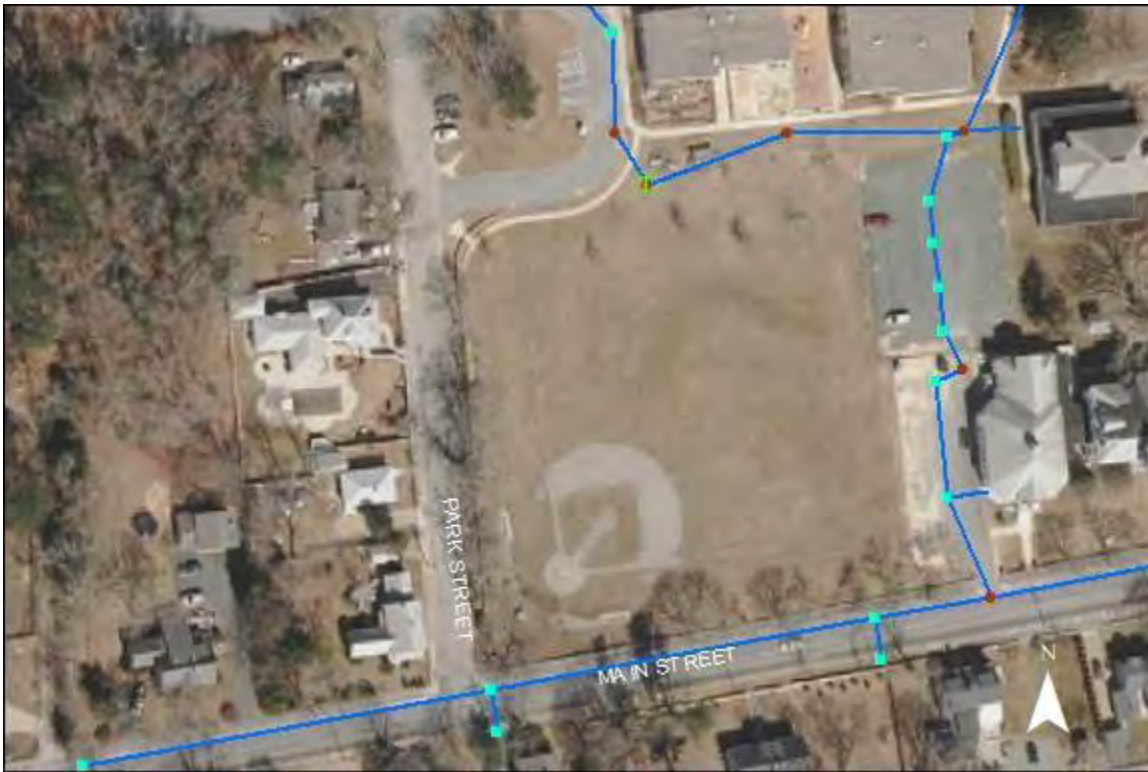
Sippican Elementary School- No issues observed. At point A there is a 12" cement pipe running through the structure. It is damaged. Unsure of what that piper carries. Further attention is strongly recommended.

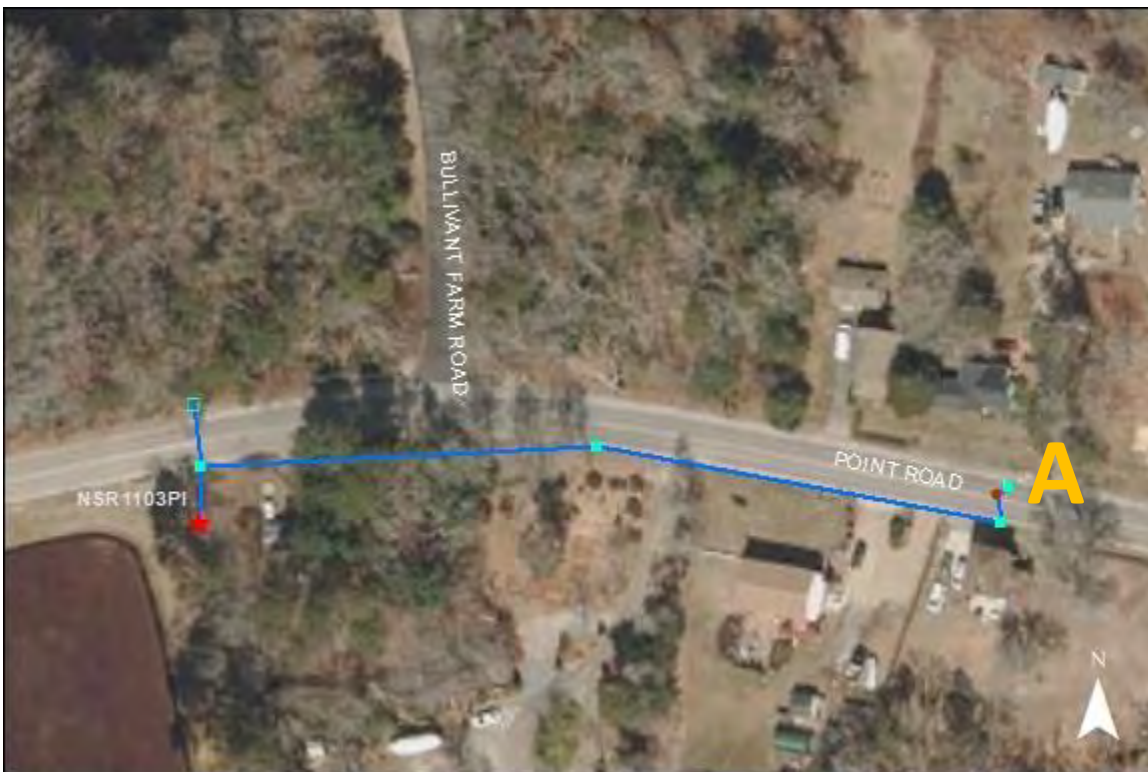
NSR1103PI- Point Road: At Point A, both the manhole and catchbasin are full of dirt. Further maintenance is recommended.

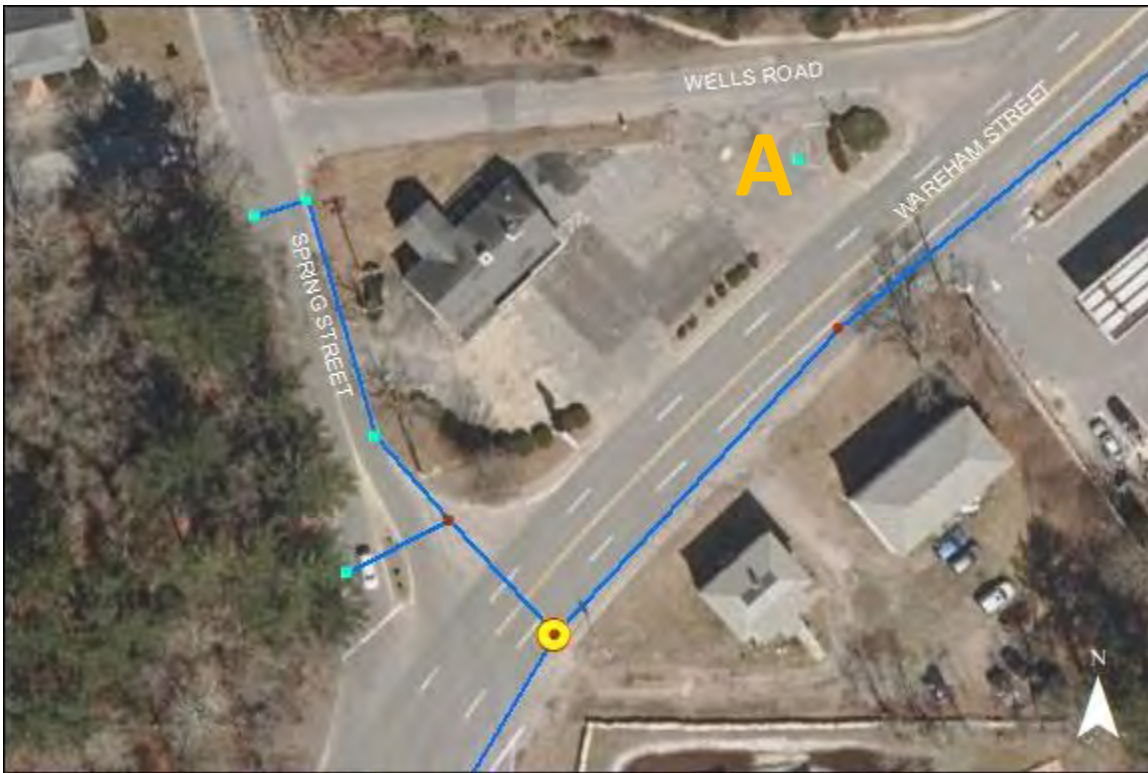
Spring Street: No issues found. Spring Street drains into a state road as shown at the yellow circle above. The catchbasin shown at point A is sinking. Further maintenance is suggested.

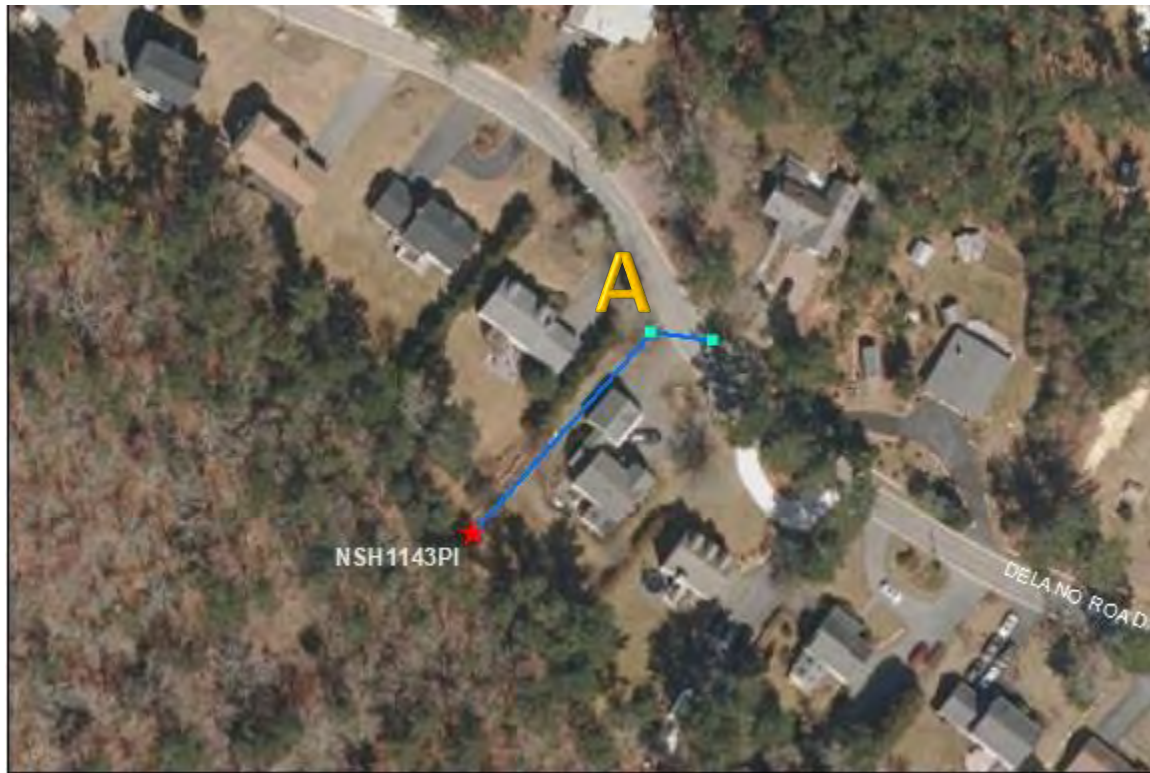
NSH1143PI- Delano Road: No significant issues found. At point A the road floods during rain events. There is a small 4" HDPE pipe located above ground to help relieve this issue. However, it does not extend far enough to drain the water retention in front of house #529. Further remediation is recommended.
