**The Buzzards Bay Stormwater Collaborative
Illicit Discharge Investigation Trailer**

Town of Mattapoisett Report

June 2023

Mattapoisett IDDE Report

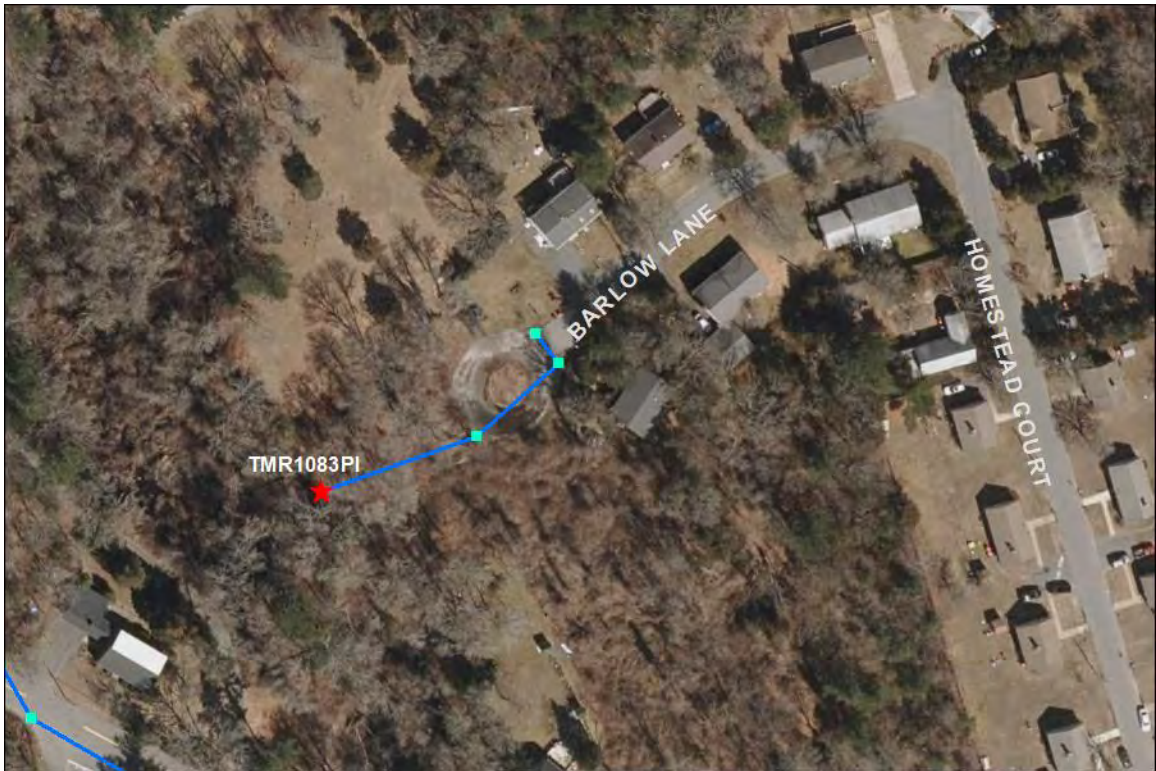
TMR1083PI – Barlow Lane: Private road; outfall pipe could not be found; structures are in poor condition; recommend that the owner be compelled to repair structures.

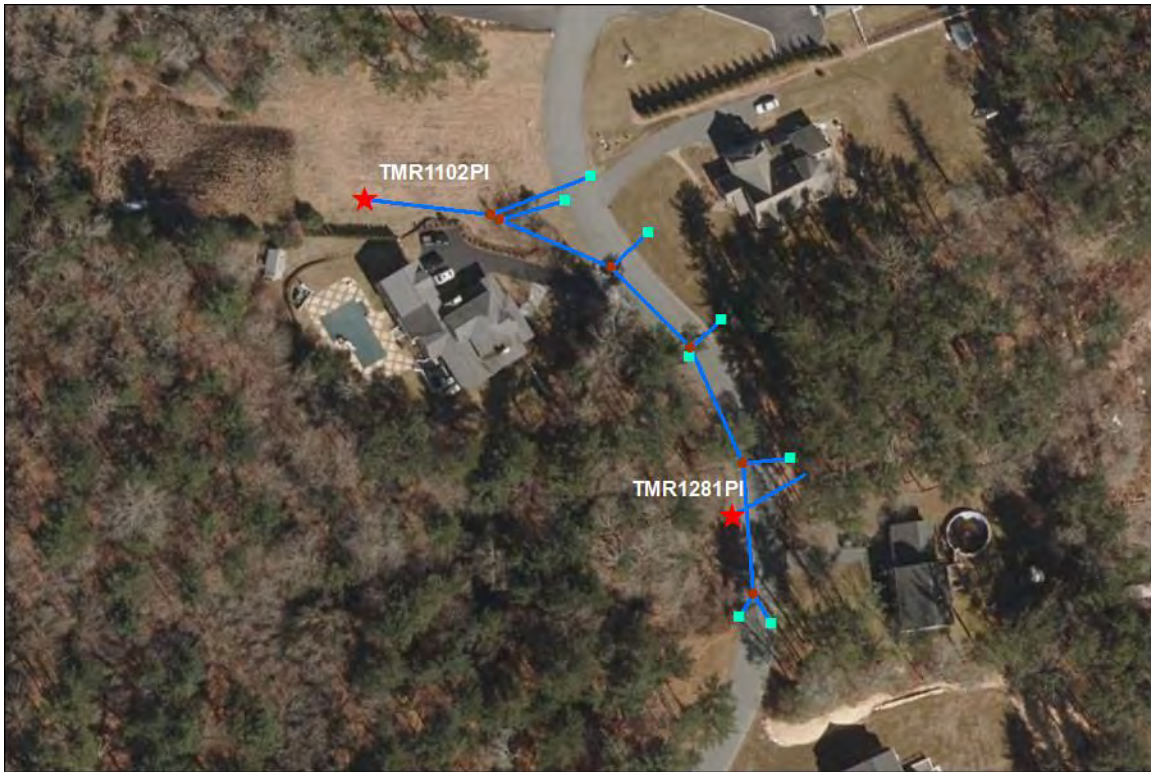
TMR1102PI and TMR1281PI – Park Place: No issues found; the system includes structures to retain high flows; the outfall was recently moved to accommodate the construction of another home; some catchbasins in this area require cleaning.

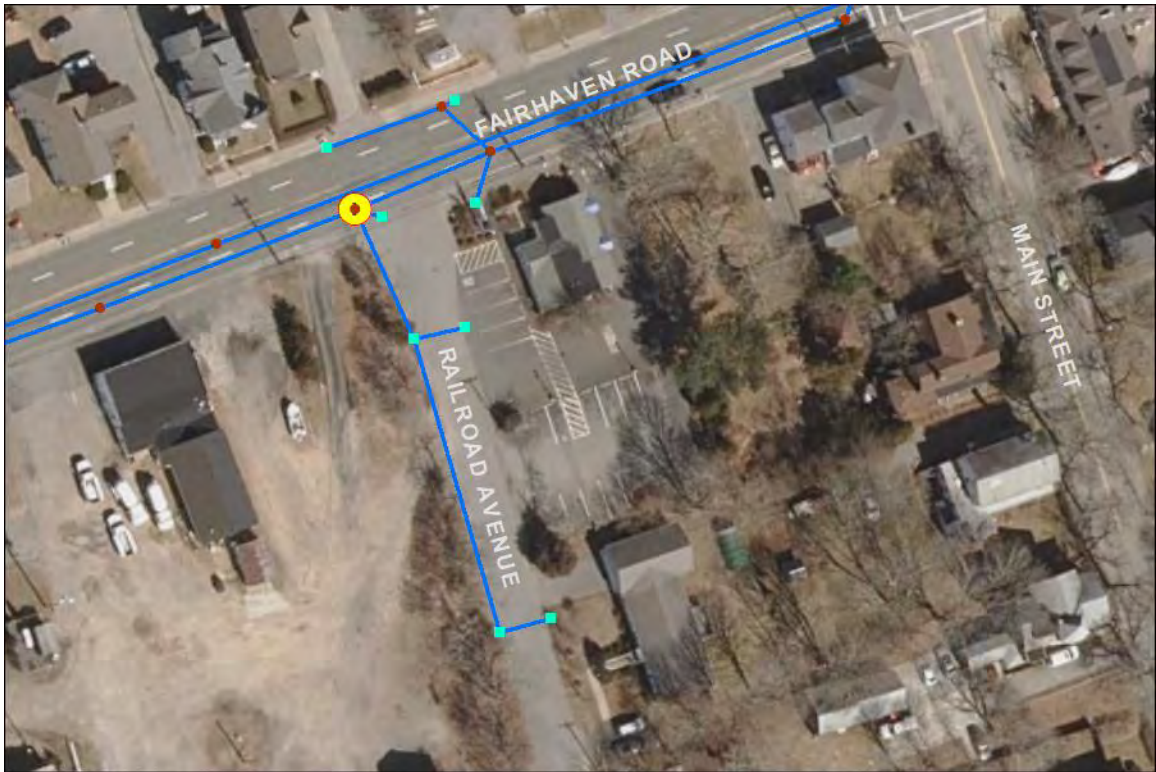
Railroad Avenue: No issues found; the activities to the West could be industrial and impact these catchbasins; recommend testing sumps for evidence of oil; these structures drain to an interconnection on Route 6.

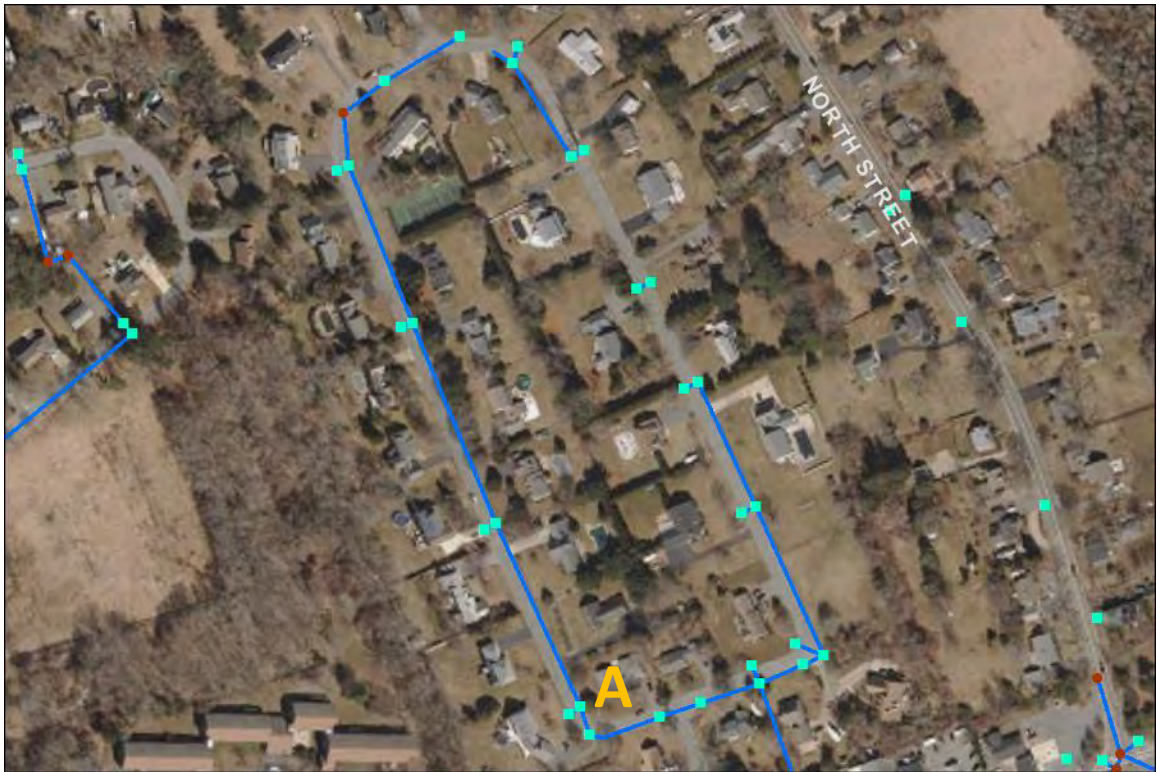
Upland Way and Hitching Post Road: No issues found; blocked pipes were reported and an attempt to jet the obstruction was made; the source of the problem is a poorly installed bend in the pipe at the location marked A; this storm drain network continues South across Route 6 and then to the Bay; there may be a state interconnection at Route 6; this investigation stopped at Hitching Post Road.

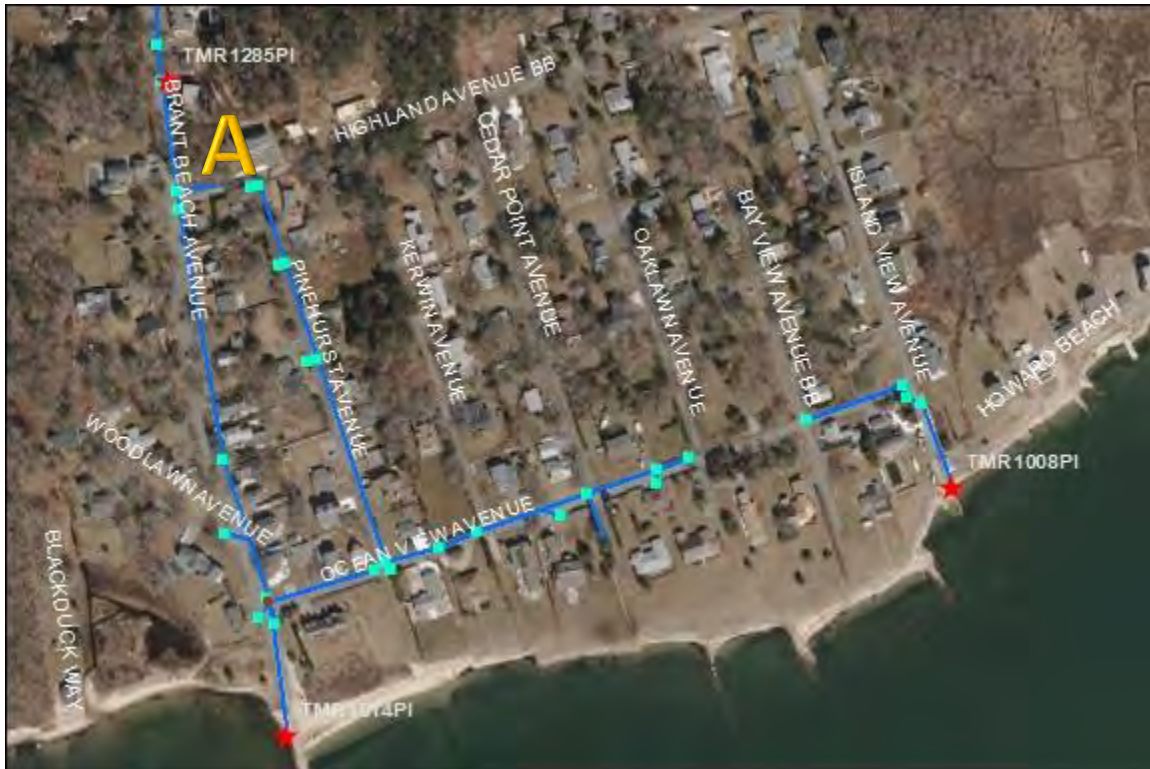
TMR1285PI, TMR1014PI, and TMR1008PI- Brant Beach Avenue and Ocean View Avenue: No issues found. At point A there is an 8" PVC pipe that enters the catchbasin. Its origin is unknown. Further investigation is recommended.

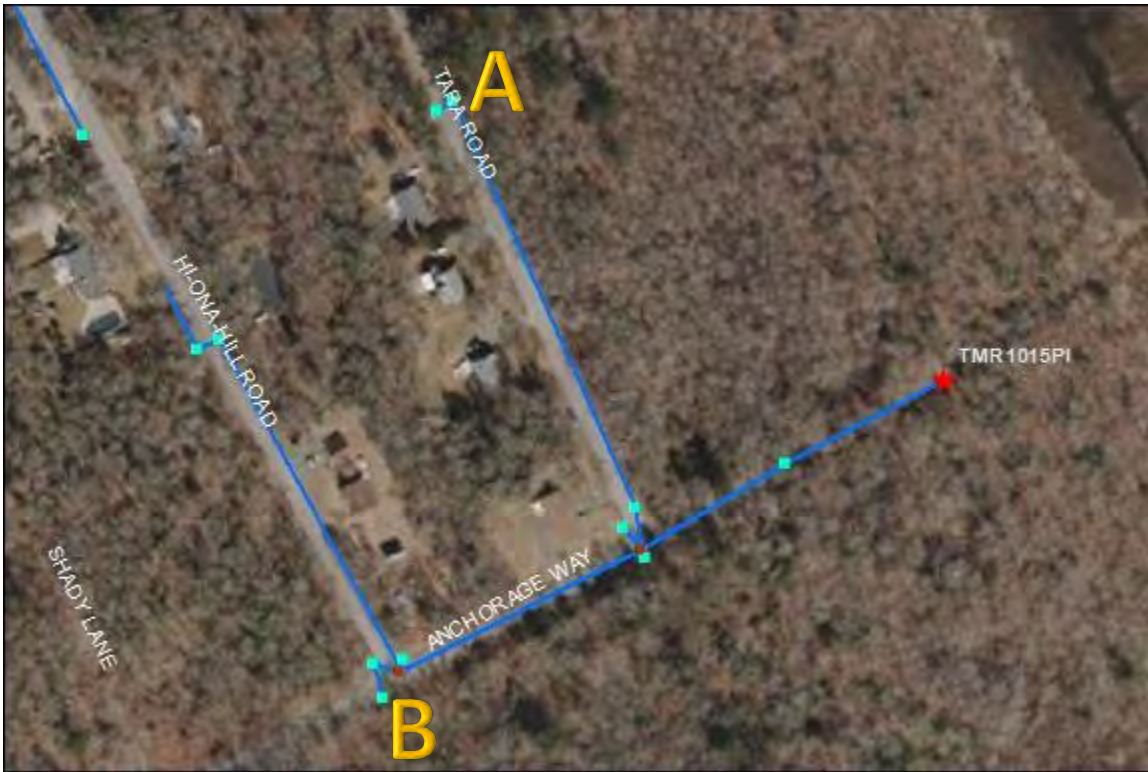
TMR1015PI- Tara Road, Hi-Ona-Hill Road, and Anchorage Way: No significant issues found. At point A and B, the catchbasins are both beginning to sink. Preventative measures are recommended.

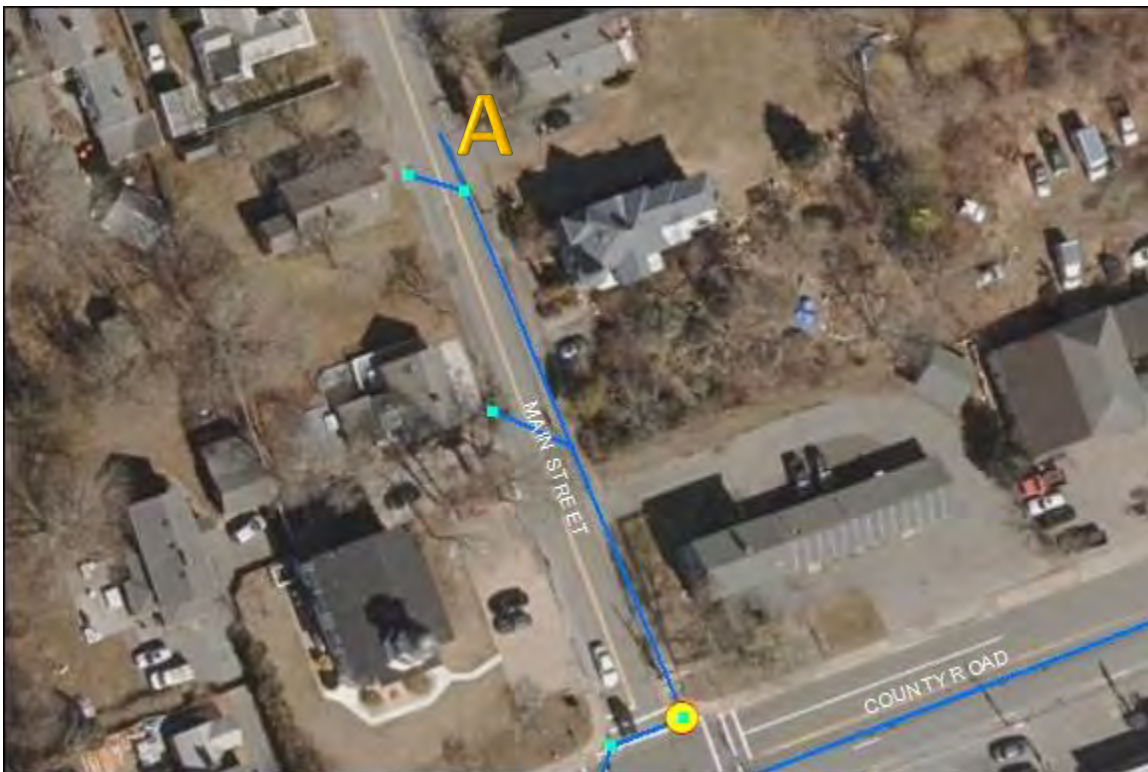
Main Street N of County Road: No issues found. Interconnection between Mattapoisett's stormwater system and the state's stormwater system. At point A, a 12" metal pipe enters the catchbasin. Its origin is unknown. Further investigation is recommended.

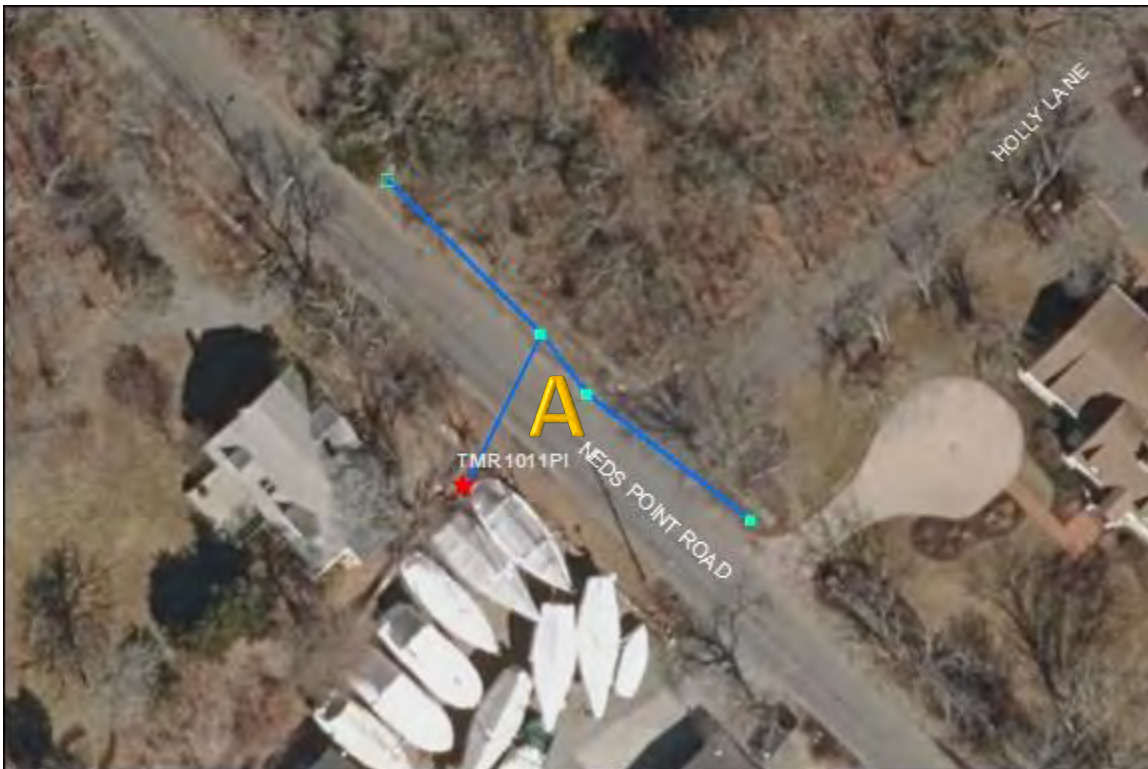
TMR1011PI- Neds Point Road: No issues found. At point A two 12" metal pipes exit the catchbasin. Their destinations are unknown. Further investigation is suggested.

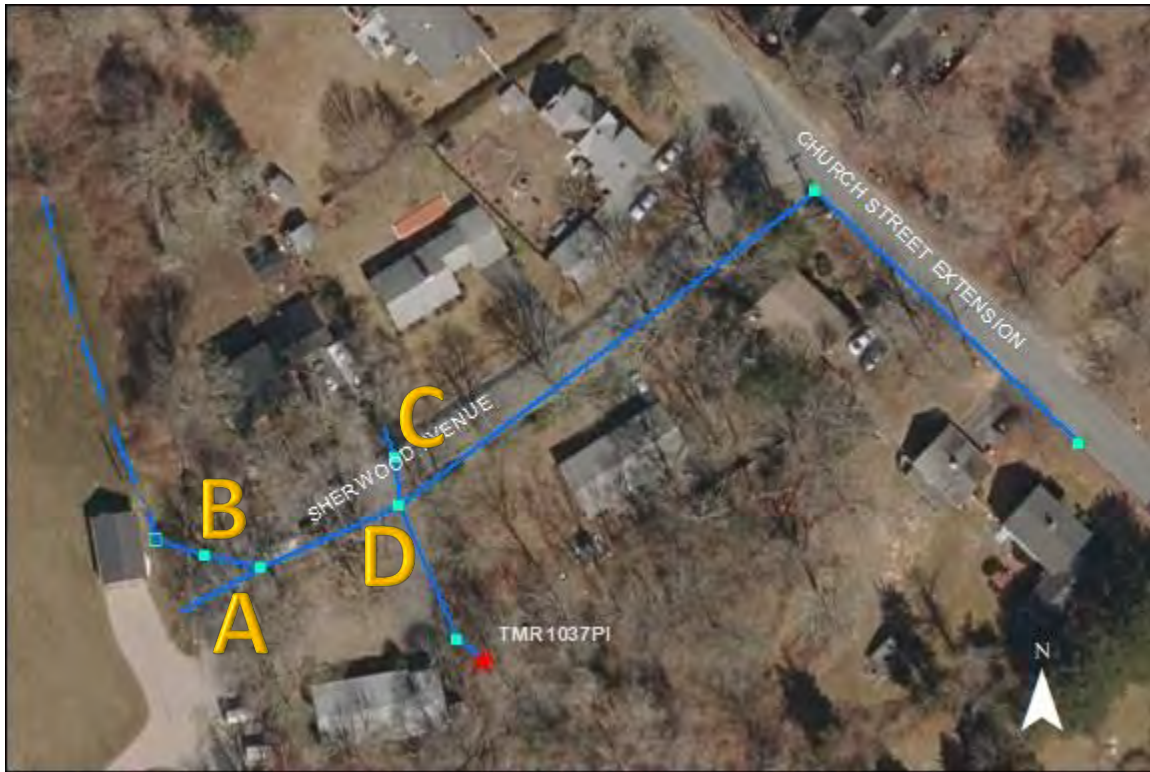
TMR1037PI- Sherwood Avenue: At point A, a 12" PVC pipe enters the catchbasin. Its origin is unknown. Further investigation is suggested. At points B, C, and D the catchbasins have begun to sink. Preventative measures are strongly recommended.

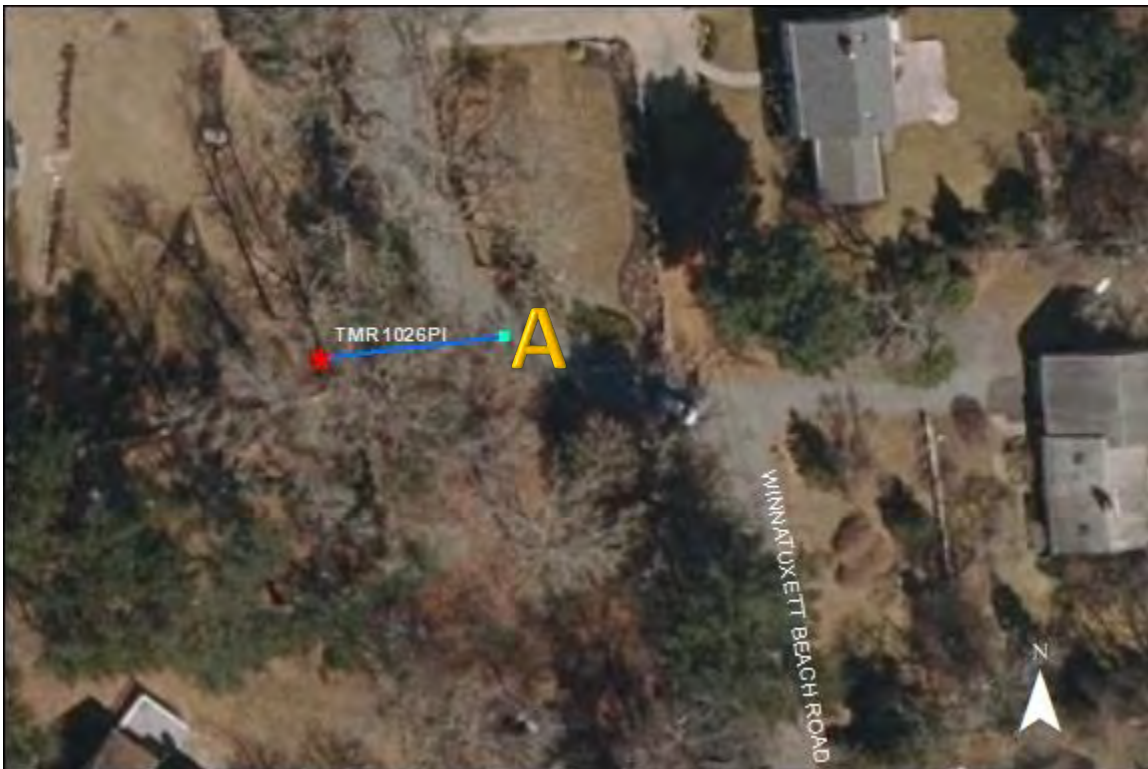
TMR1026PI- Winnatuxett Beach Road: At point A the catchbasin is sinking. Further attention is needed.

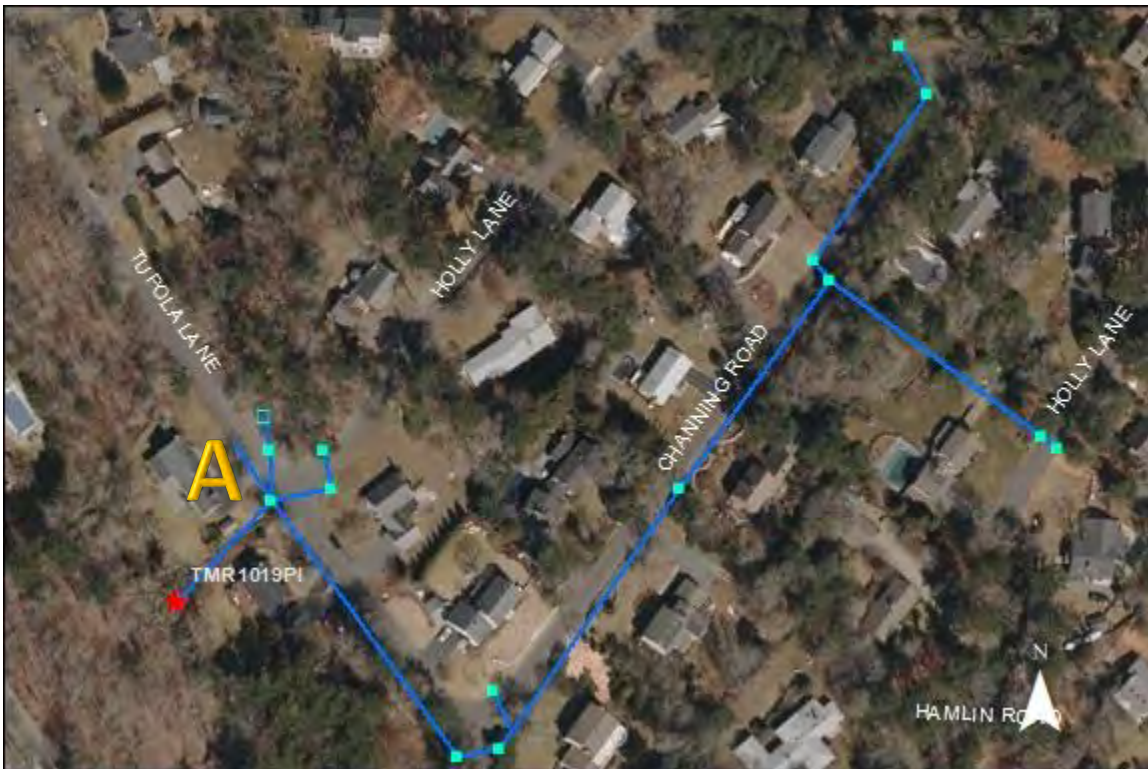
TMR1019PI- Tupola Lane and Channing Road: No issues found. At point A an 8" metal pipe enters the catchbasin. Its origin is unknown. Further investigation is suggested.

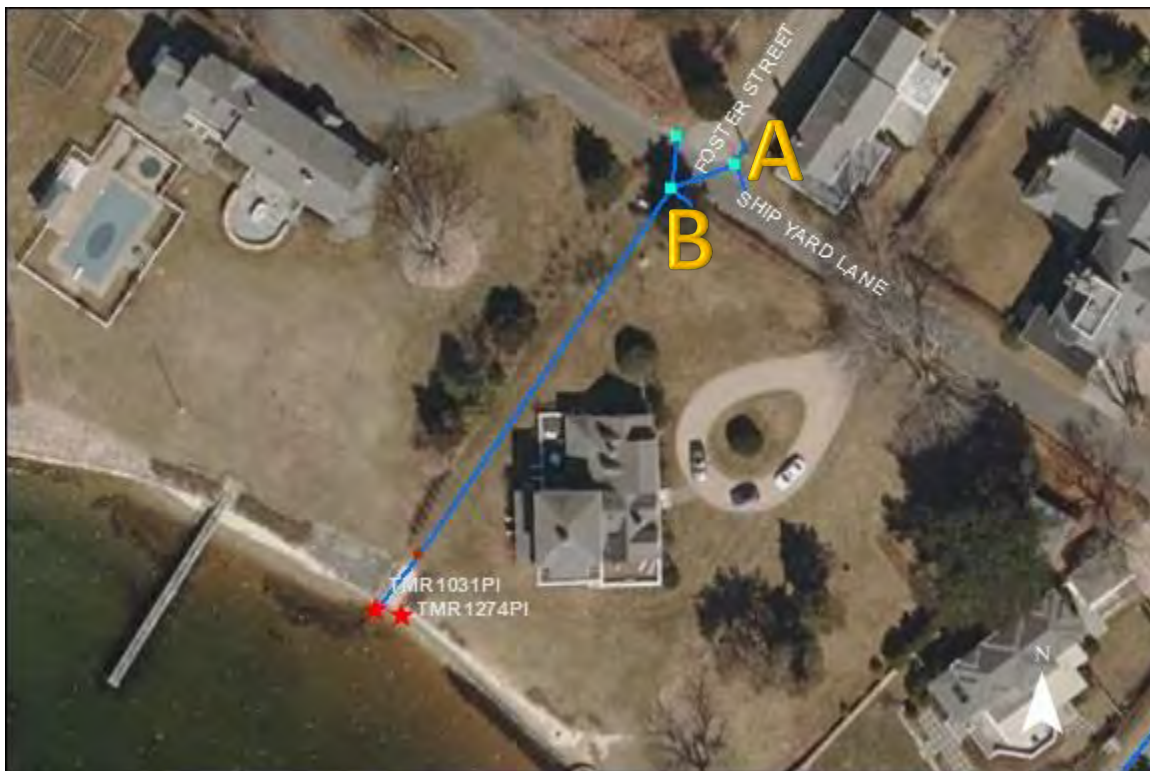
TMR1031PI and TMR1274PI- Ship Yard Lane: No issues found. Multiple pipes shown at point A and B enter the catchbasins. Their origins are unknown. Further investigation is suggested.

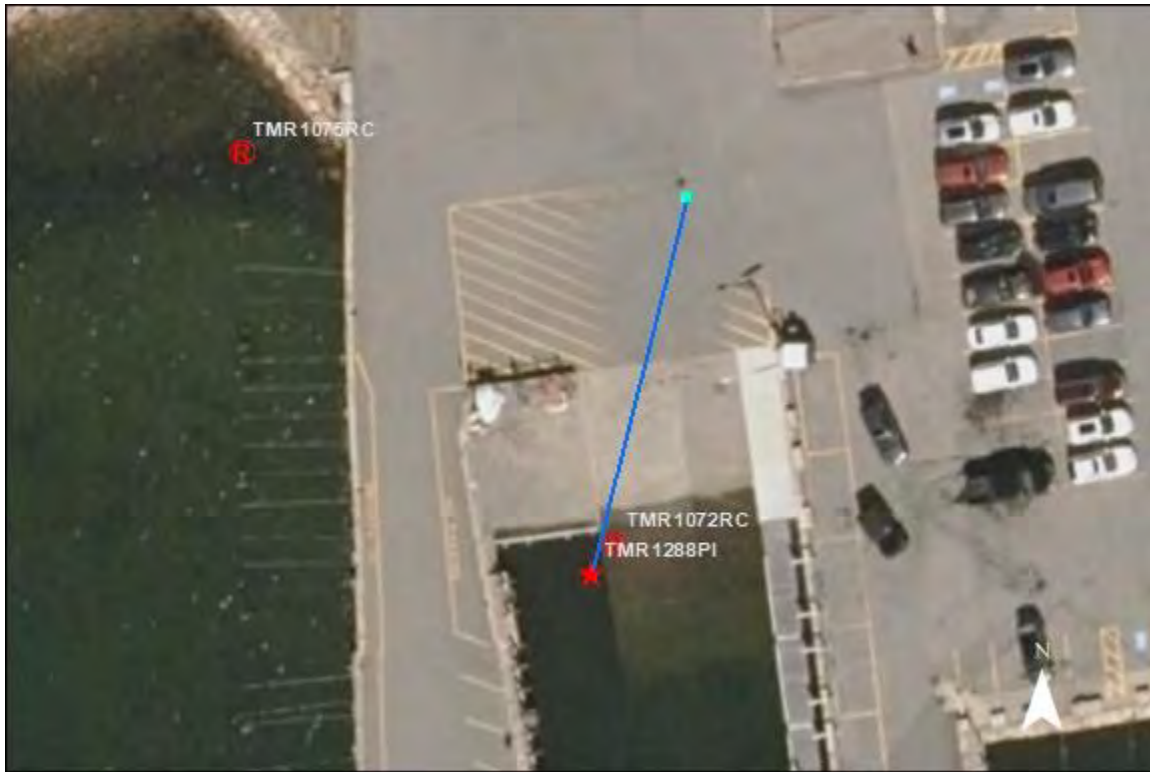
TMR1072RC and TMR1288PI- Marina parking lot: No significant issues found. Suds were observed in the catchbasin. Given that no pipes enter this structure it is likely these suds came from people washing off their boats after pulling them from the water. Educational outreach is recommended.

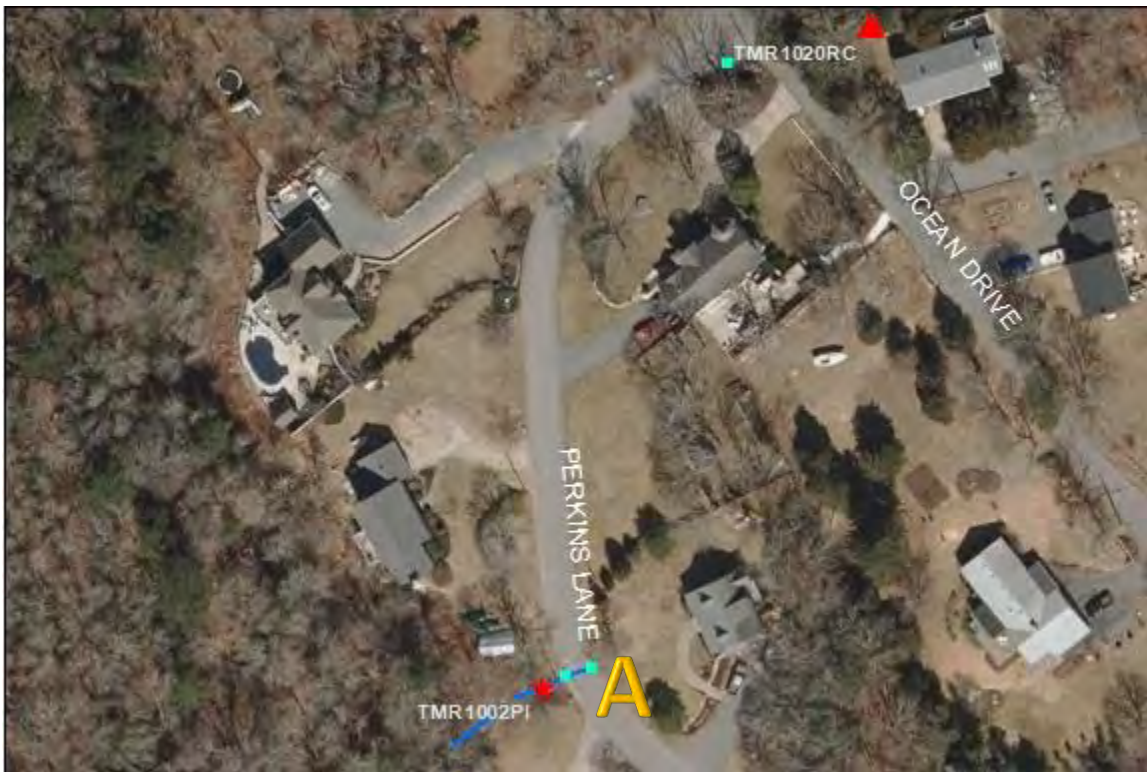
TMR1002PI- Perkins Lane: Both catchbasins are starting to sink. Sink holes adjacent to structures. Further attention is recommended.

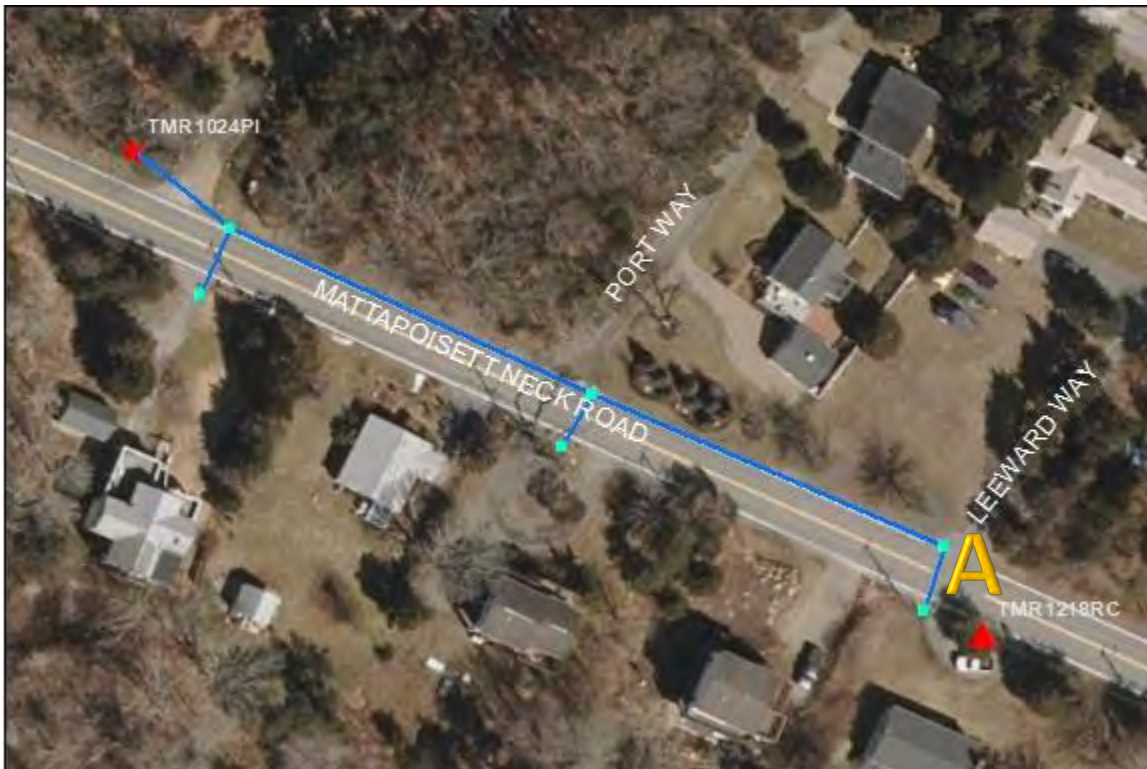
TMR1024PI and TMR1218RC- Mattapoissett Neck Road: Catchbasins at point A are full of water. Very likely there is a blockage in pipes. Further maintenance is suggested.

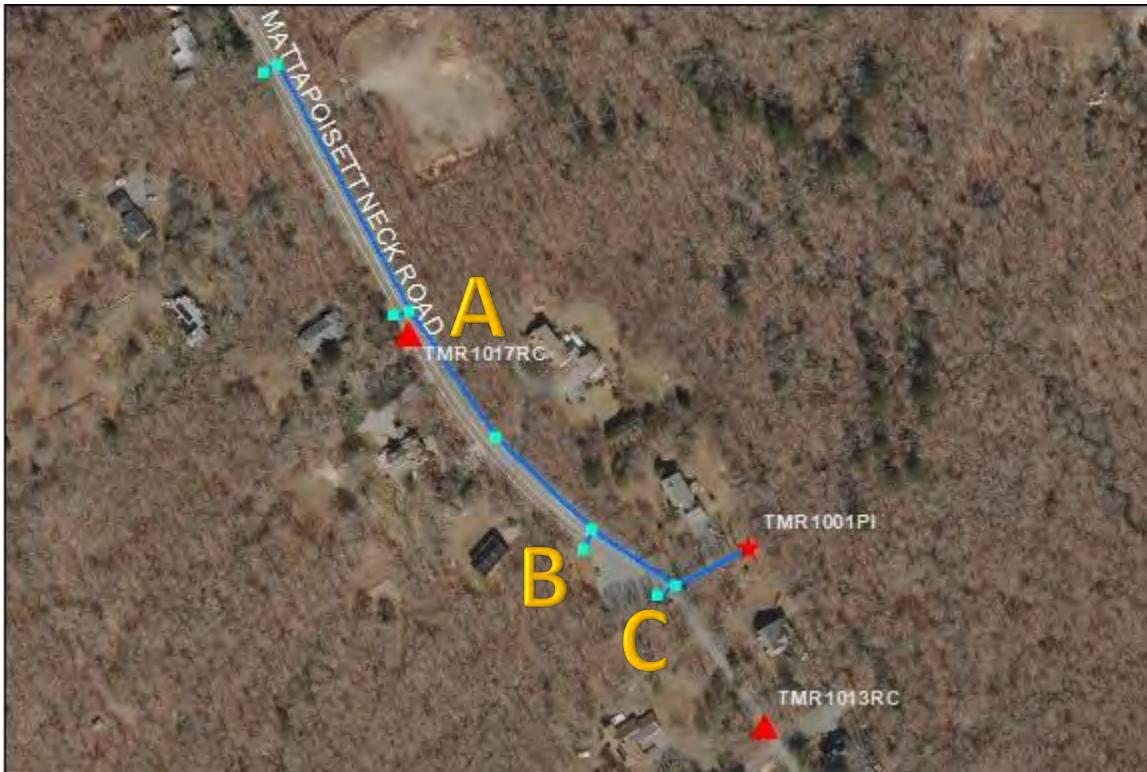
TMR1001PI, TMR1017RC, and TMR1013RC- Mattapoissett Neck Road: No significant issues found. Catchbasins at point A, B, and C have begun to sink. Preventative maintenance is suggested.

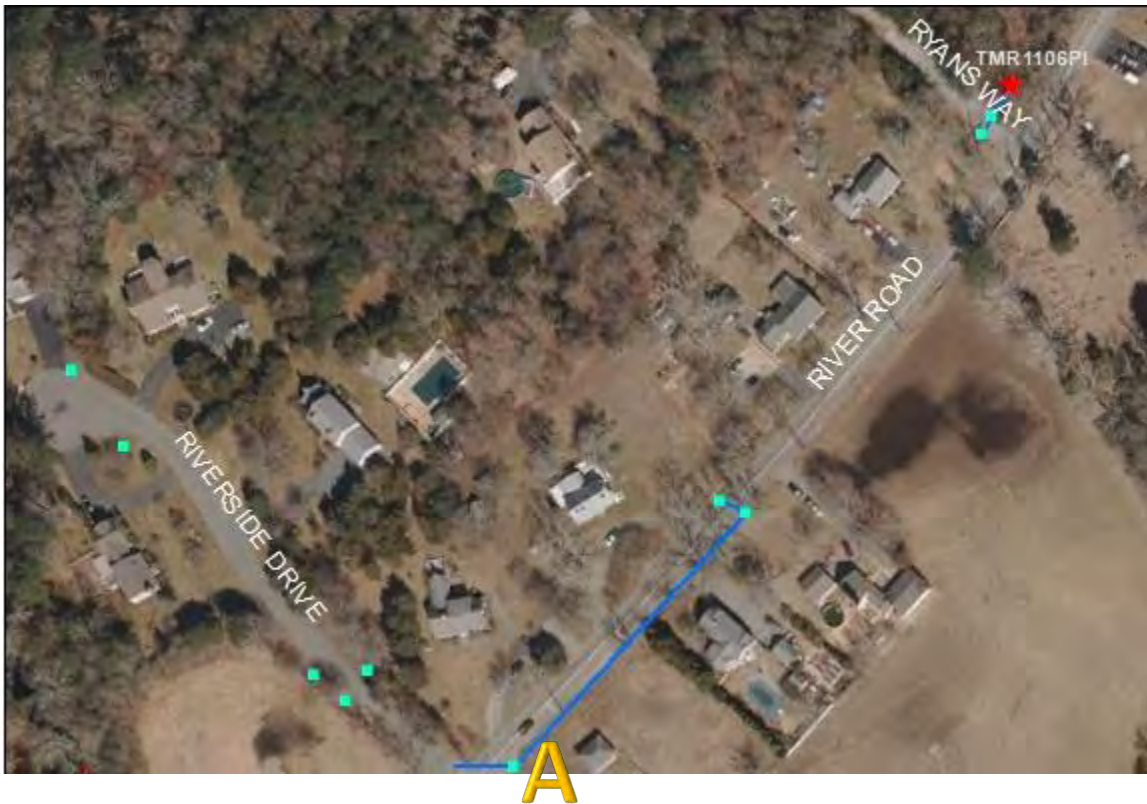
TMR1106PI- Ryans Way: No issues found. Riverside Drive: Catchbasins are infiltration basins. No issues found. River Road: Catchbasin at point A has a blocked pipe exiting it. Drainage outfall could not be determined due to this. Maintenance and reinspection are recommended.

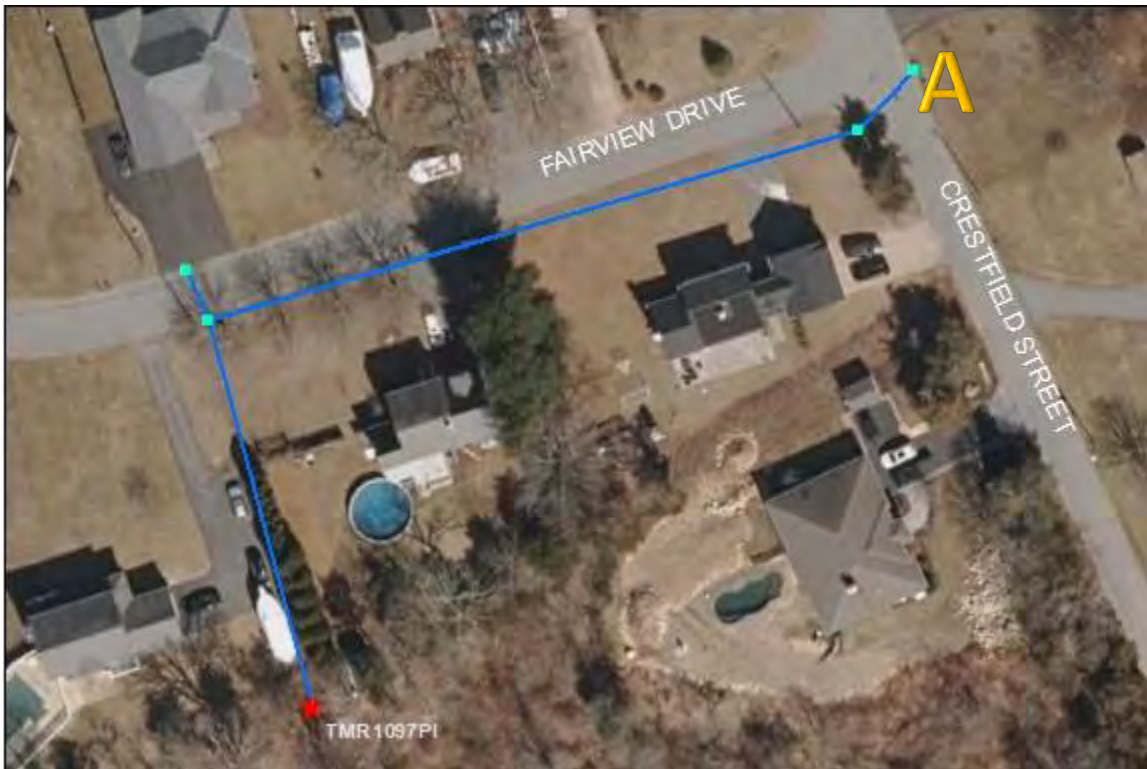
Another important problem to be addressed is the catchbasin at the end of the driveway to house #5 on Crestfield Street. There is 50+ dog waste bags. Although this basin and the catchment it is apart of is outside the urbanized area this problem should be addressed with community outreach. The basin should be cleaned out as soon as possible.

TMR1097PI- Fairview Drive and Crestfield Street: At point A there is an incredible amount of dog waste bags, roughly 50. Cleaning of the catchbasin and community outreach is strongly recommended.

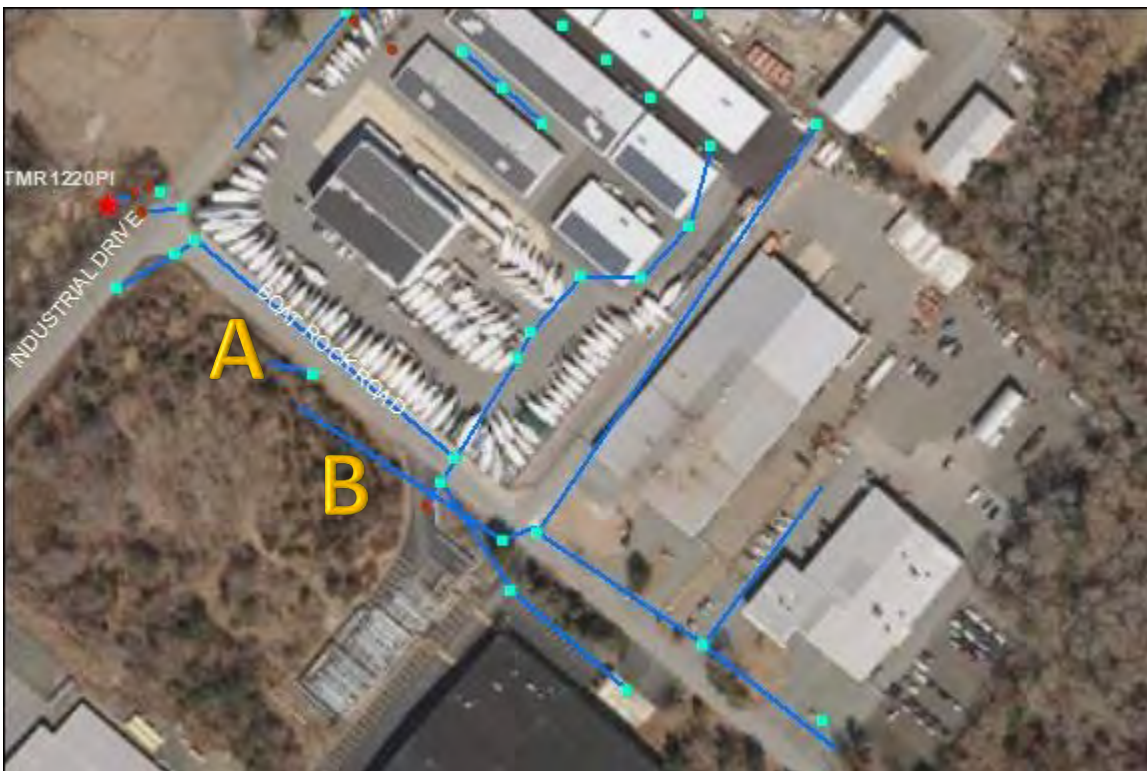
TMR1220PI- Industrial Drive: The structures on Boat Rock Road did not appear to connect to outfall TMR1220PI. At point A the catchbasin is in need of cleaning. The entire structure is full of roots. Further maintenance and reinspection are recommended. At point B, a pipe left the catchbasin. Its destination is unknown. There was a steady flow of water through this pipe. Further inspection is suggested.

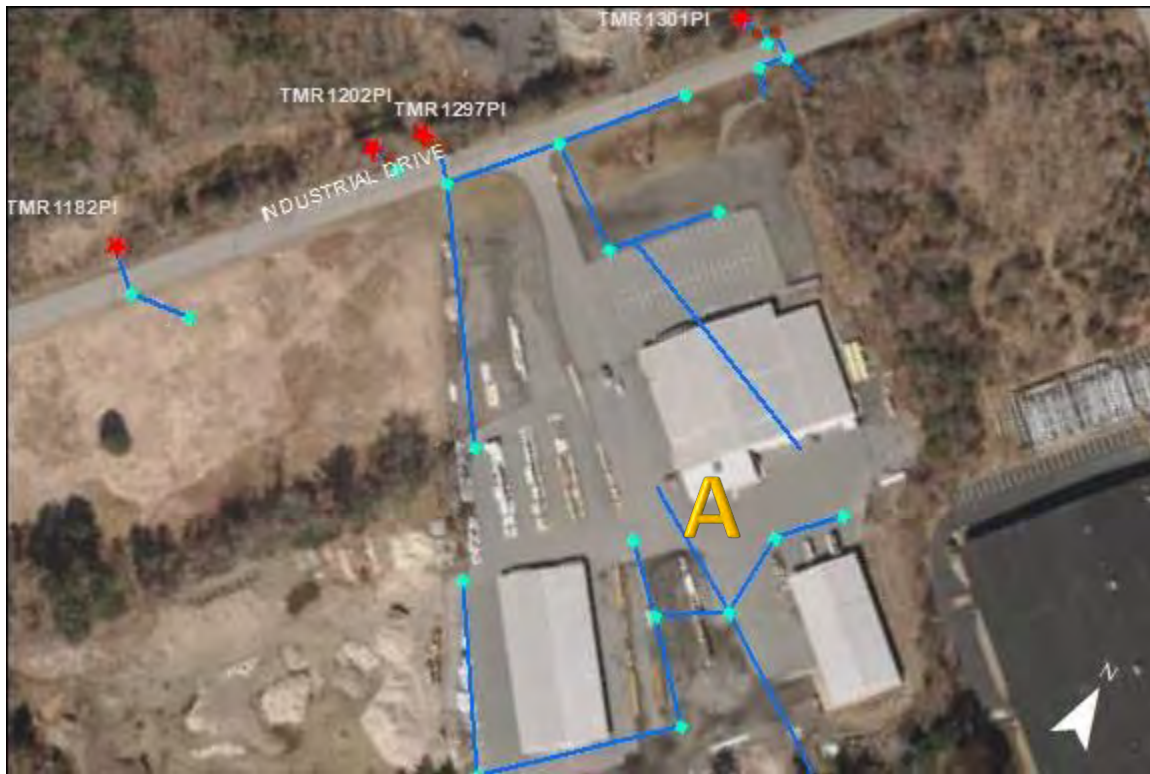
TMR1182PI TMR1202PI, TMR1297PI, and TMR1301PI- Industrial Drive: No issues found. At point A there is a steady flow of water flowing through the pipe. Its destination is unknown. It did not connect to stormwater infrastructure on Industrial Drive. Further investigation is suggested.

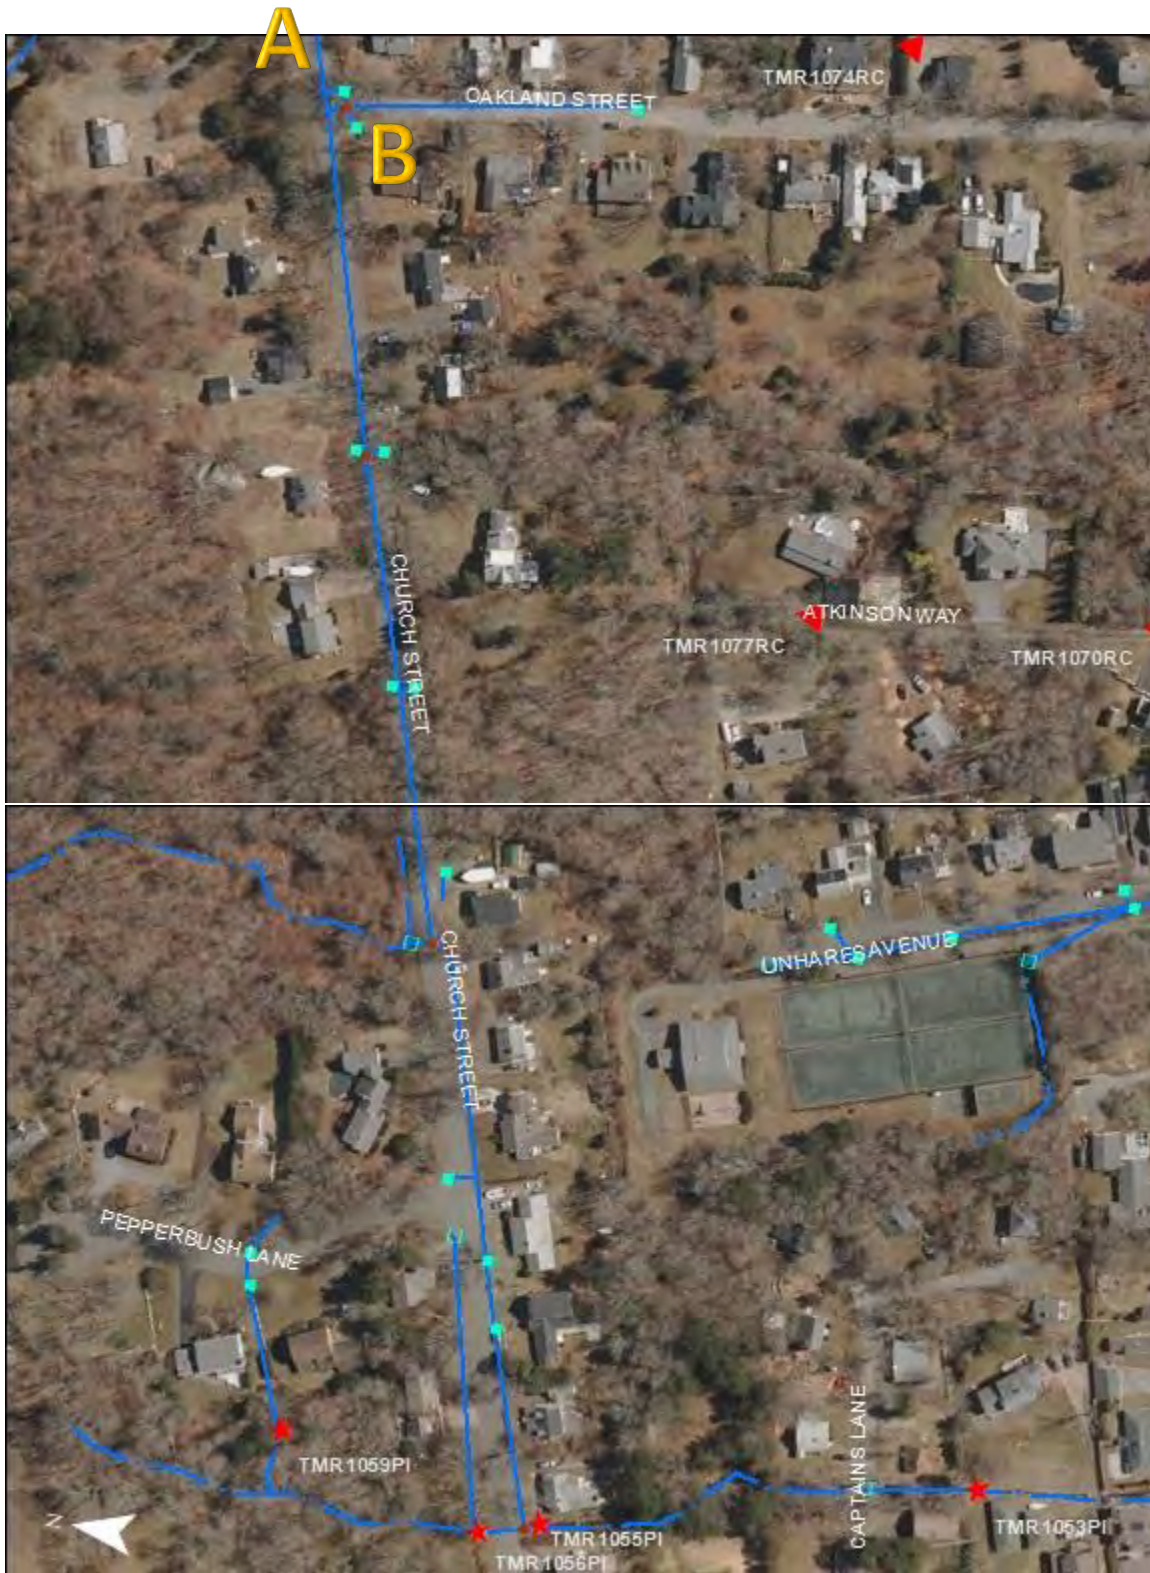
TMR1055PI and TMR1056PI- Church Street: No significant issues found. At point A the stormwater structures begin to connect to the trunk line going West down Church Street. The origin of the trunk line has not been determined. There is an inlet slightly East of point A. Connection between the two still needs to be confirmed. Further investigation is recommended. At point B the catchbasin has begun to sink. Preventative maintenance is suggested.
