**The Buzzards Bay Stormwater Collaborative
Illicit Discharge Investigation Trailer**

Town of Wareham Report

November 2nd, 2022

Wareham IDDE Report

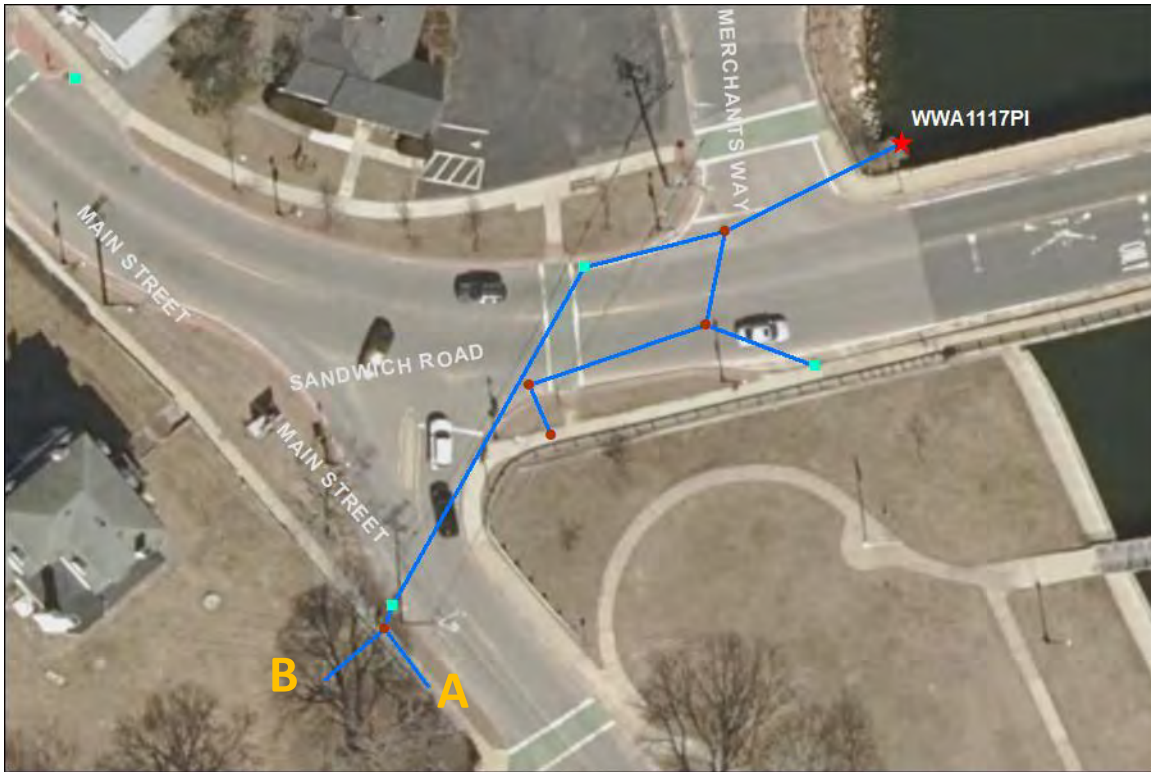
WWA1117PI – Main Street: No issues found; pipe at location A was connected to structures now removed with hospital construction; pipe at location B comes from hospital property under new parking area.

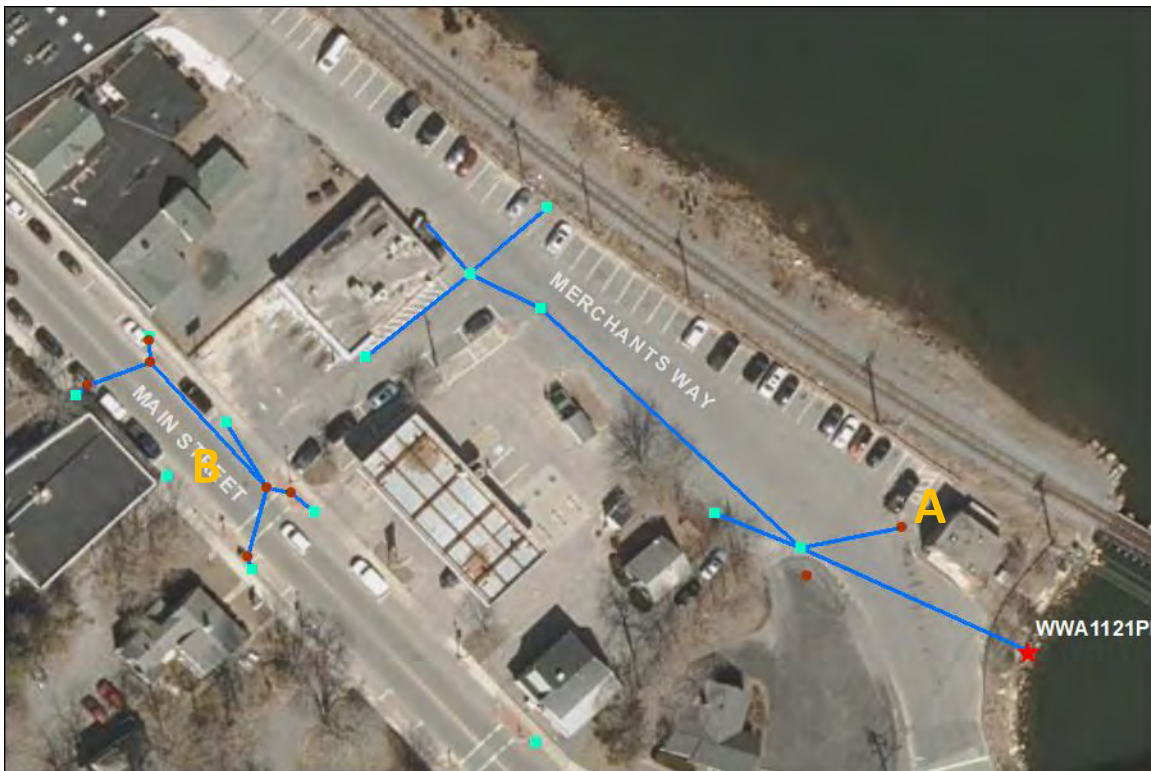
WWA1121PI – Merchants Way: No issues found; manhole at location A appears to be an unused interface with the sewage pump station; area at location B connectivity to network not determined; requires follow-up.

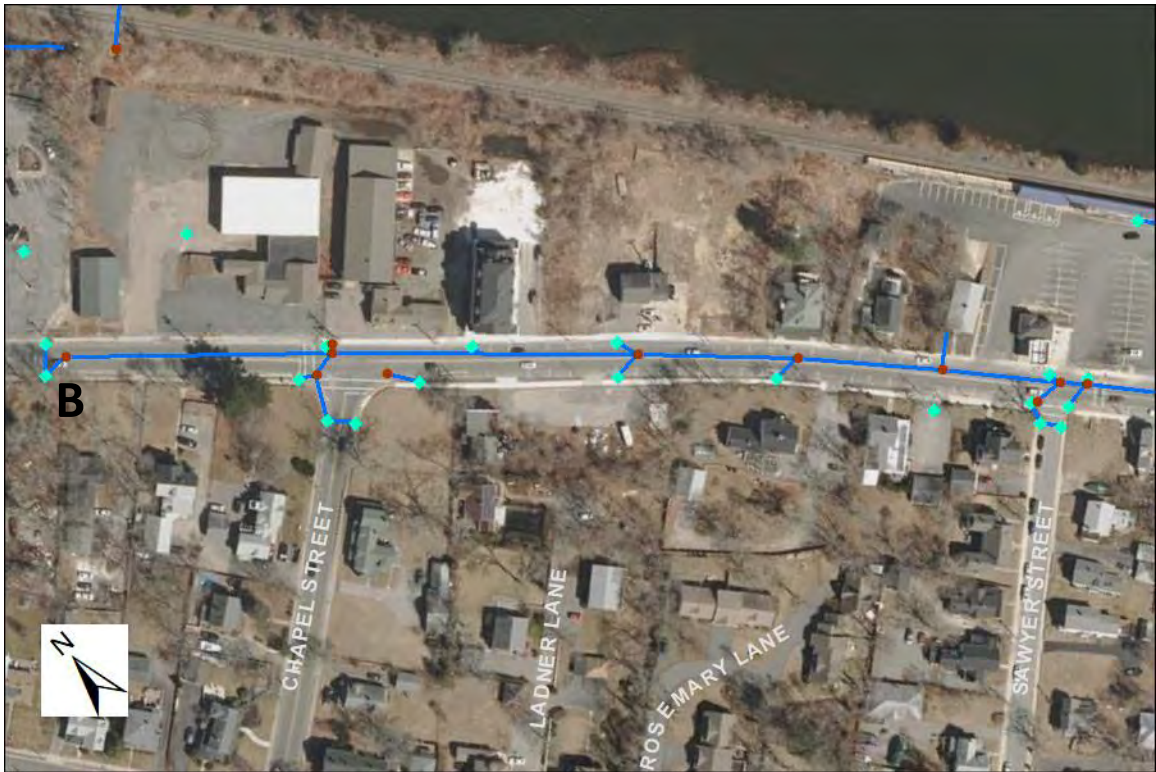
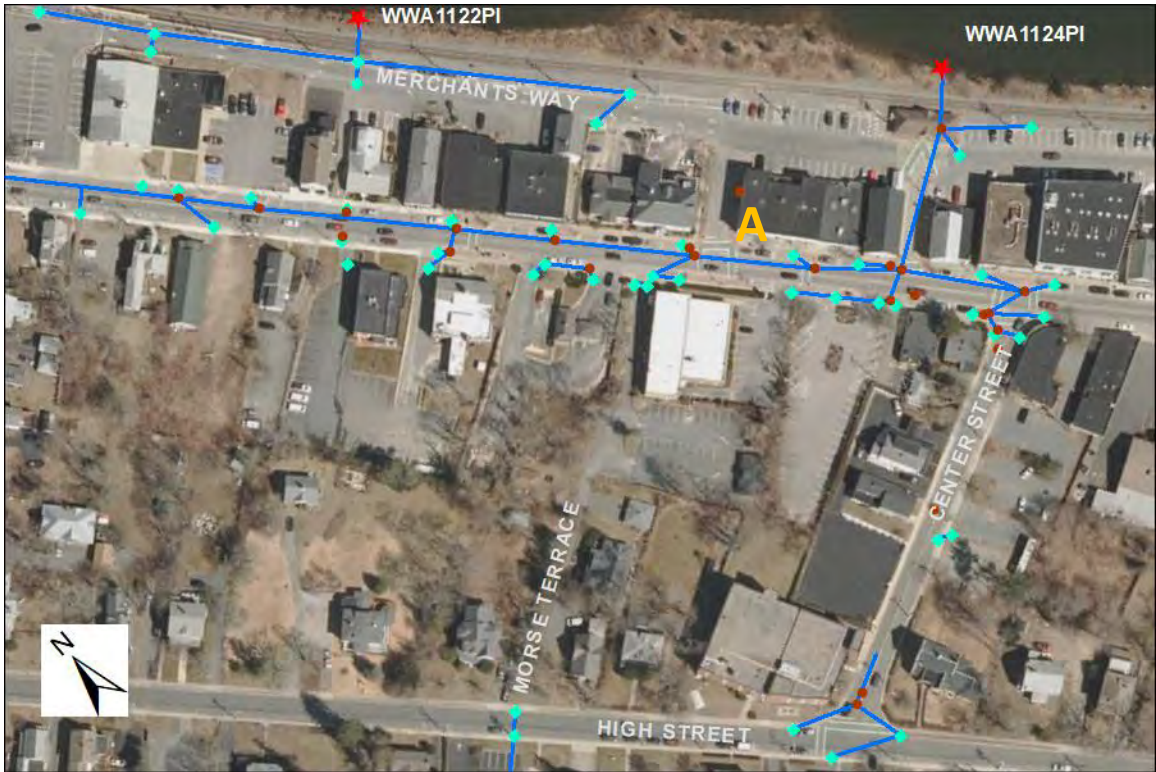
WWA1124PI and WWA1122PI – Merchants Way: No issues found; excessive trash in many of the catchbasins; pipe at location A in front of the Jugg Shop may have a connection or a crack with groundwater flowing; recommend sampling at manhole to the East; Center Street requires further investigation; manhole at location B could not be easily opened; recommend follow-up inspection; most catchbasins on Merchants Way are rusted to the frames causing the frames to come up with the grate. Further maintenance is strongly recommended.

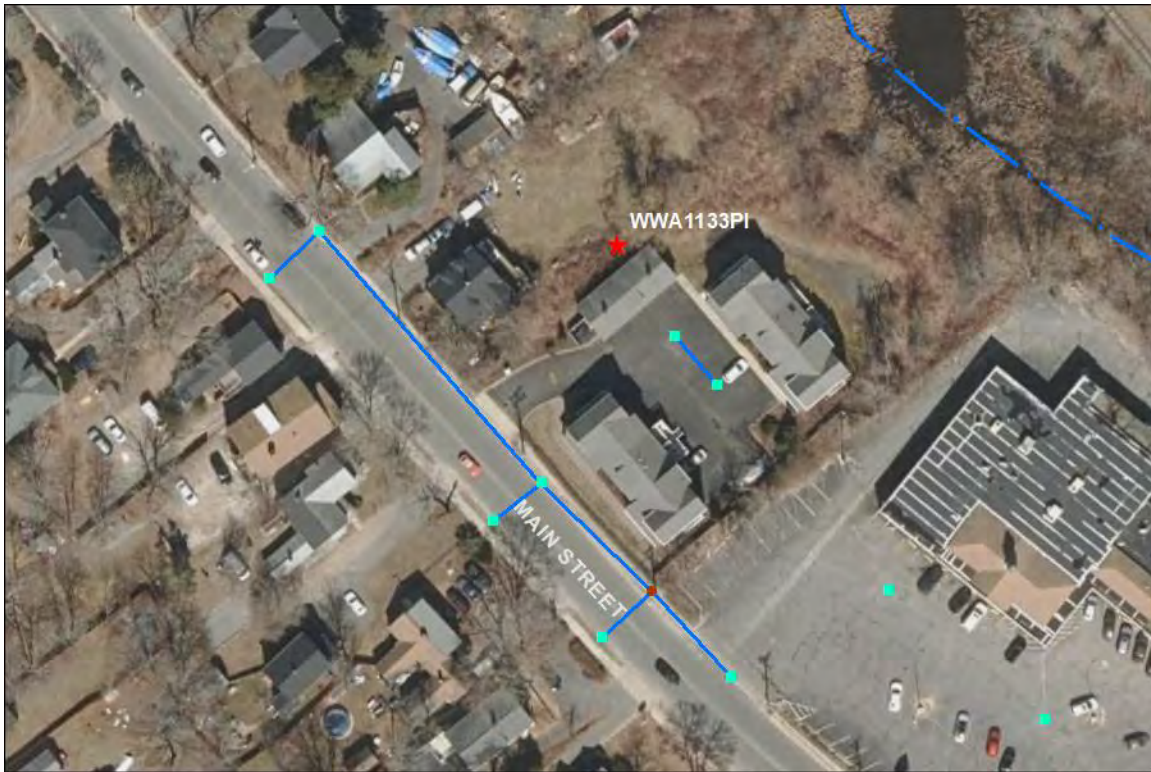
WWA1133PI – Main Street: No issues found but most structures too full to inspect; unresolved connectivity; recommend follow-up. Further maintenance is strongly recommended.

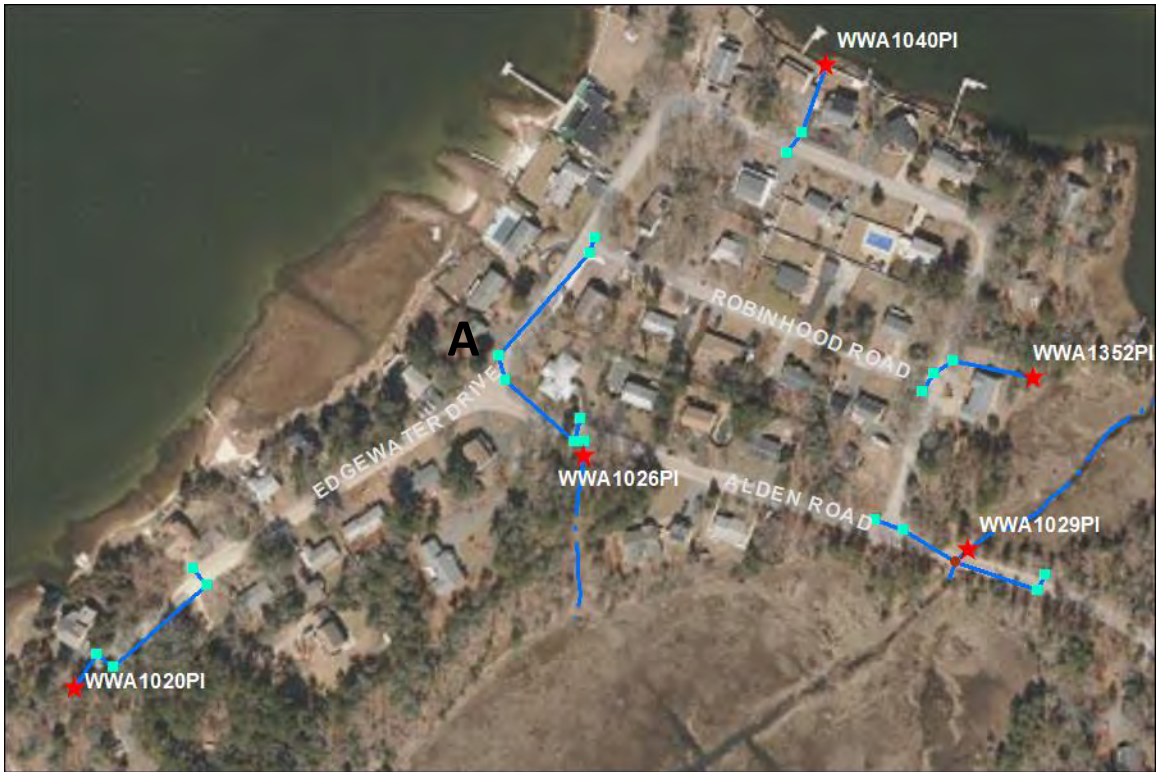
WWA1020PI, WWA1026PI, WWA1040PI, WWA1352PI, and WWA1029PI – Edgewater Drive and Alden Road: No issues found; at location A homeowner stacked bricks on catch basin preventing access.

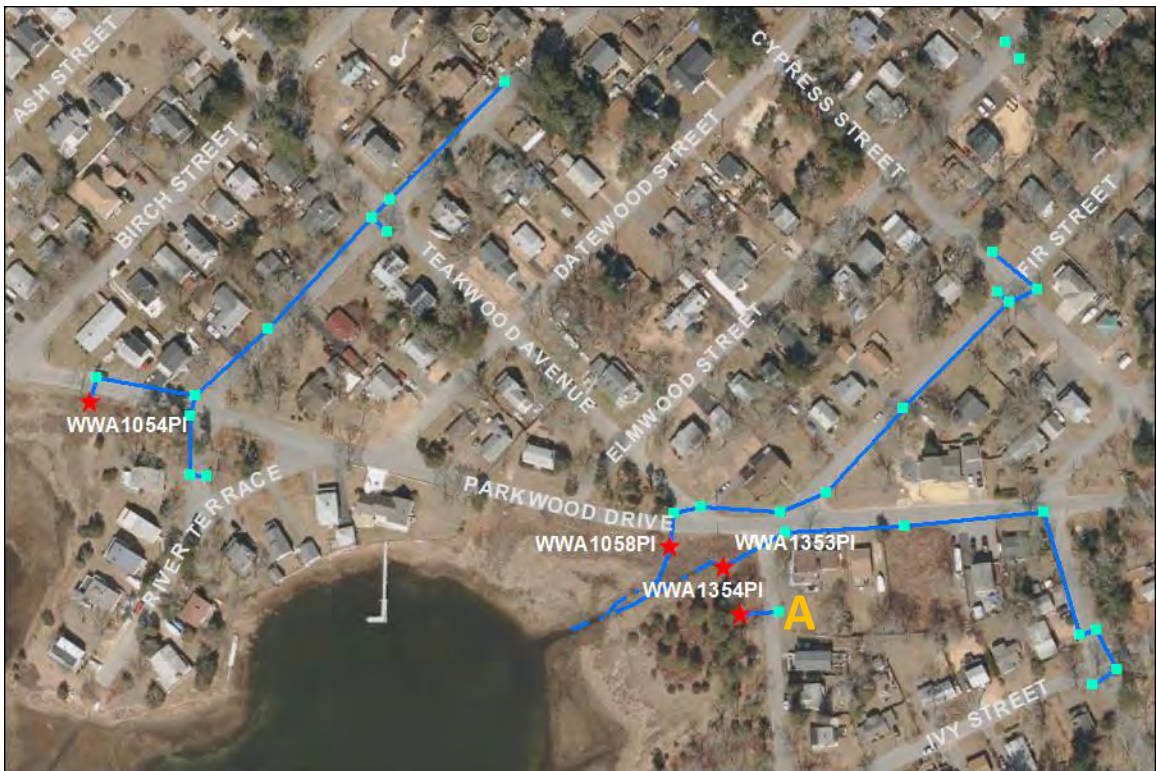
WWA1054PI, WWA1058PI, WWA1354PI, and WWA1353PI – Parkwood Drive: Minor issue found; at location A an odor was detected; recommend sampling outfall pipe during rain.

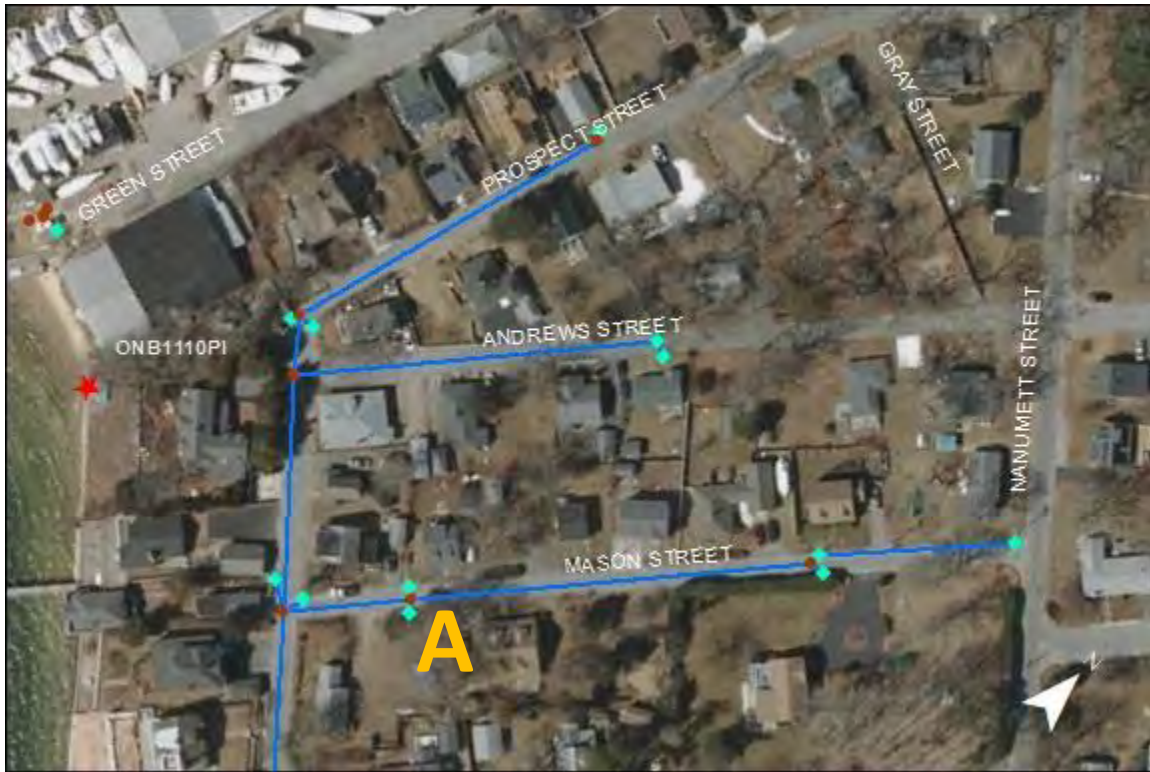
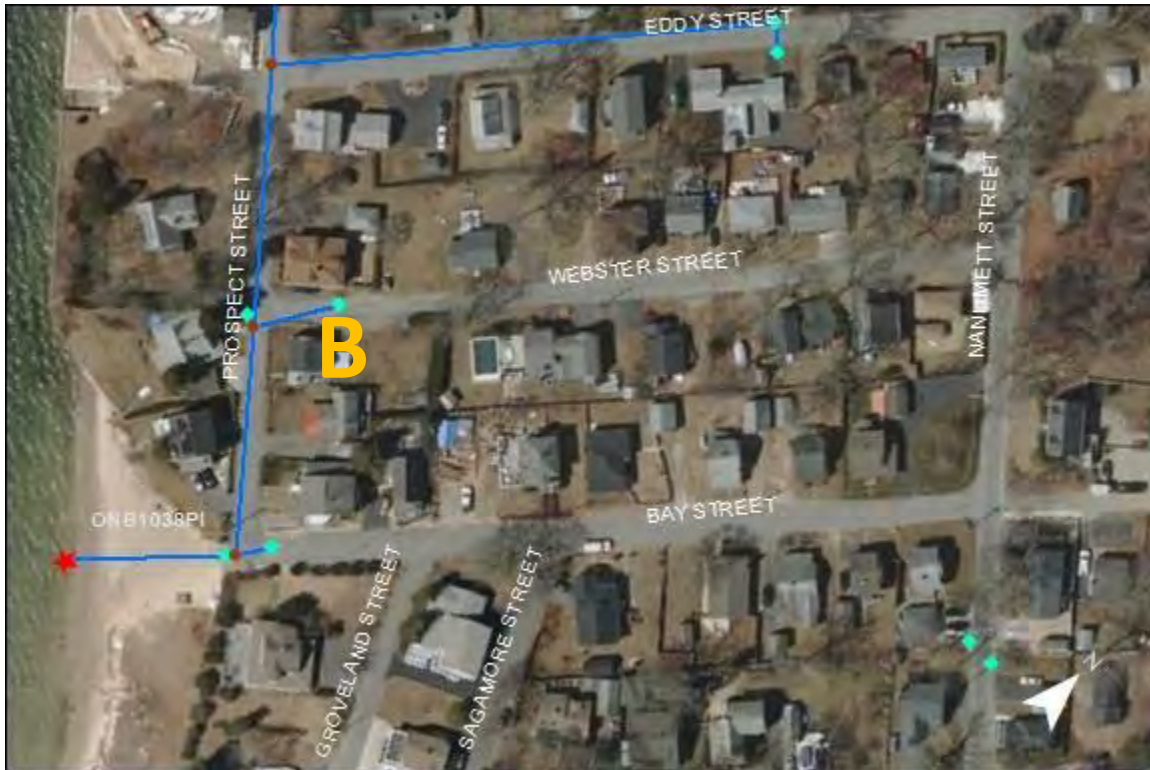
ONB1038PI- Prospect Street, Bay Street, Webster Street, Eddy Street, Mason Street, and Andrews Street: The catch basins at point A and B have begun to sink. Structures need to be repaired.

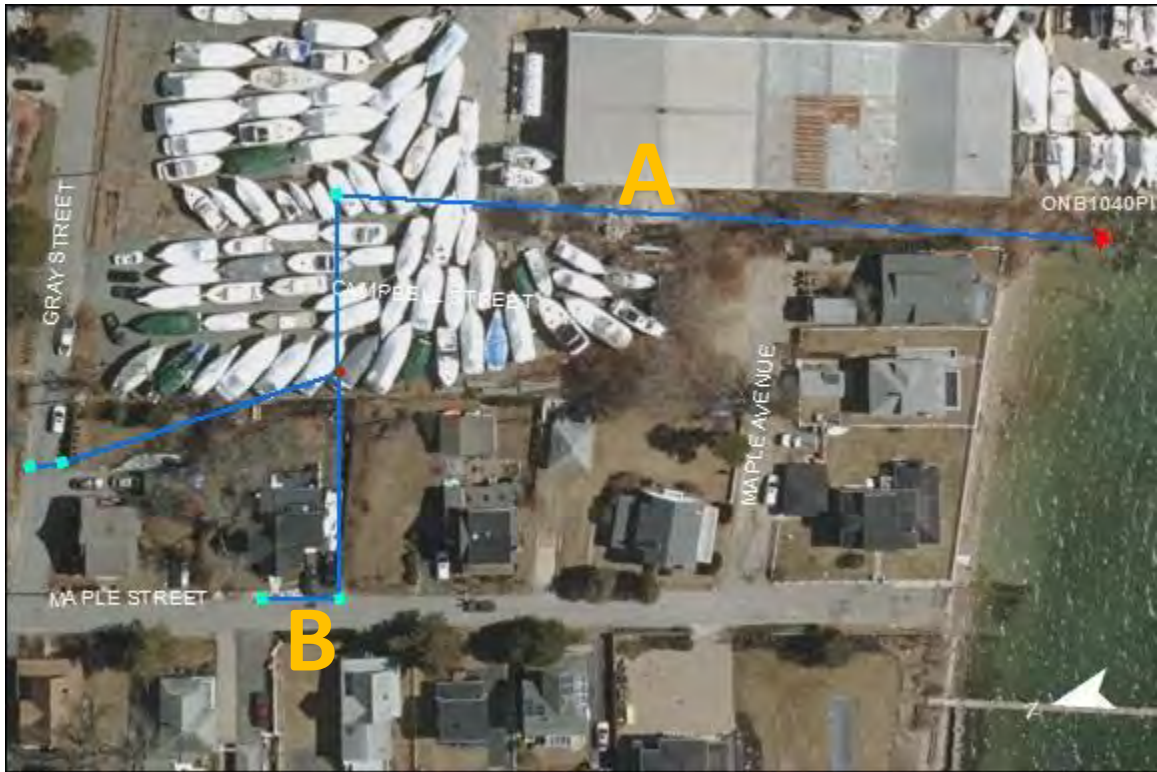
ONB1040PI- Gray Street and Maple Street: Pipe shown at point A is extremely blocked, most likely collapsed. Flooding occurs in the boat yard and at the Northwest catch basins shown at point B. Blockage of pipe needs to be repaired.

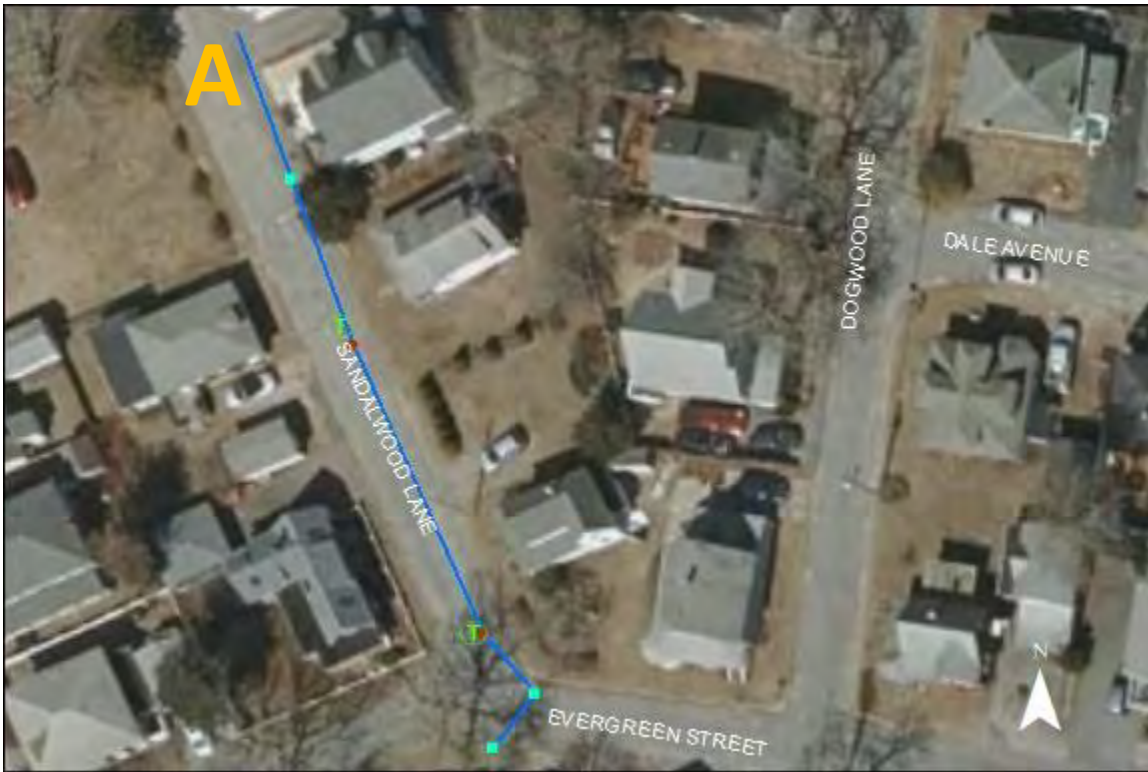
Sandalwood Lane: No issues found. Catchment drains into underground treatment structures. At point A there is an incoming pipe. Its origin is unknown. Further investigation is suggested.

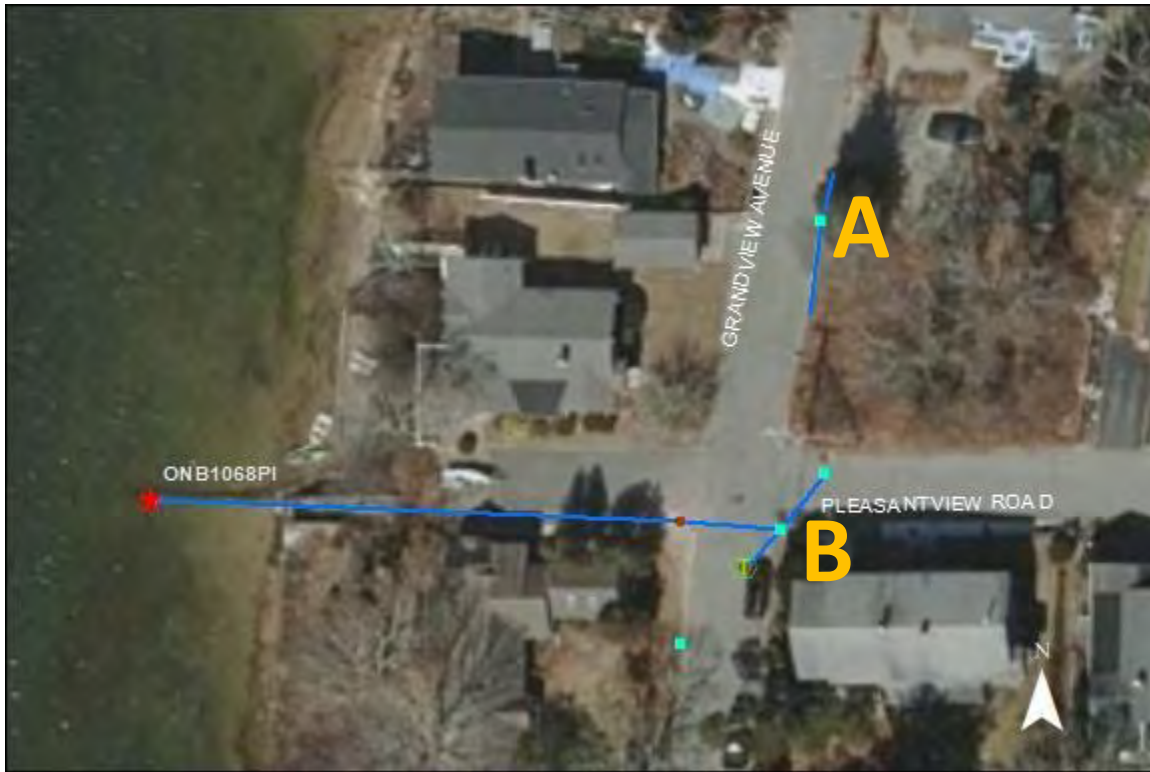
ONB1068PI- Grandview Avenue at Pleasantview Road: Catch Basins were full of sand. They need to be cleaned out and reinspected. At point A, a pipe enters and exits the catch basin. The origin and destination of these pipes are unknown. At point B the catch basin has begun to sink. Preventative measures are suggested. Further maintenance and investigation is strongly encouraged.

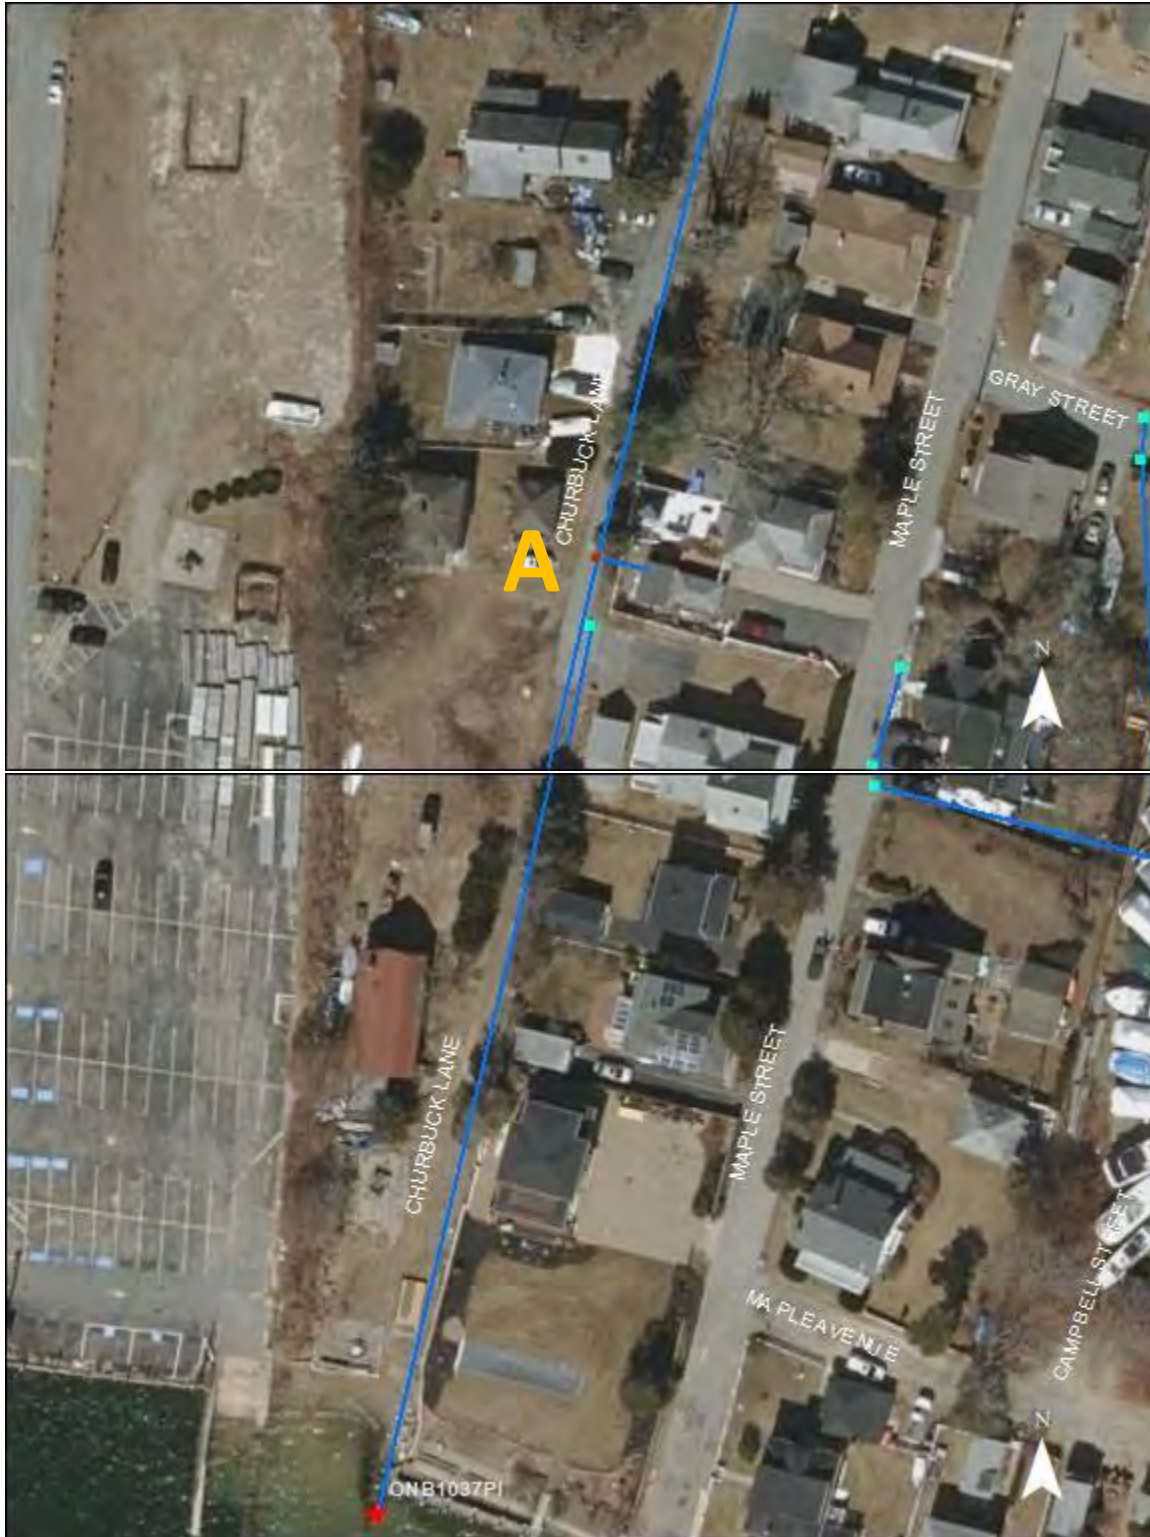
ONB1037PI- Churbeck Lane: No significant issues found. At point A, a pipe enters the manhole. Its origin is unknown. Further investigation is suggested. The catchment continues onto Onset Avenue. A police detail is needed to complete the investigation of the entire catchment.

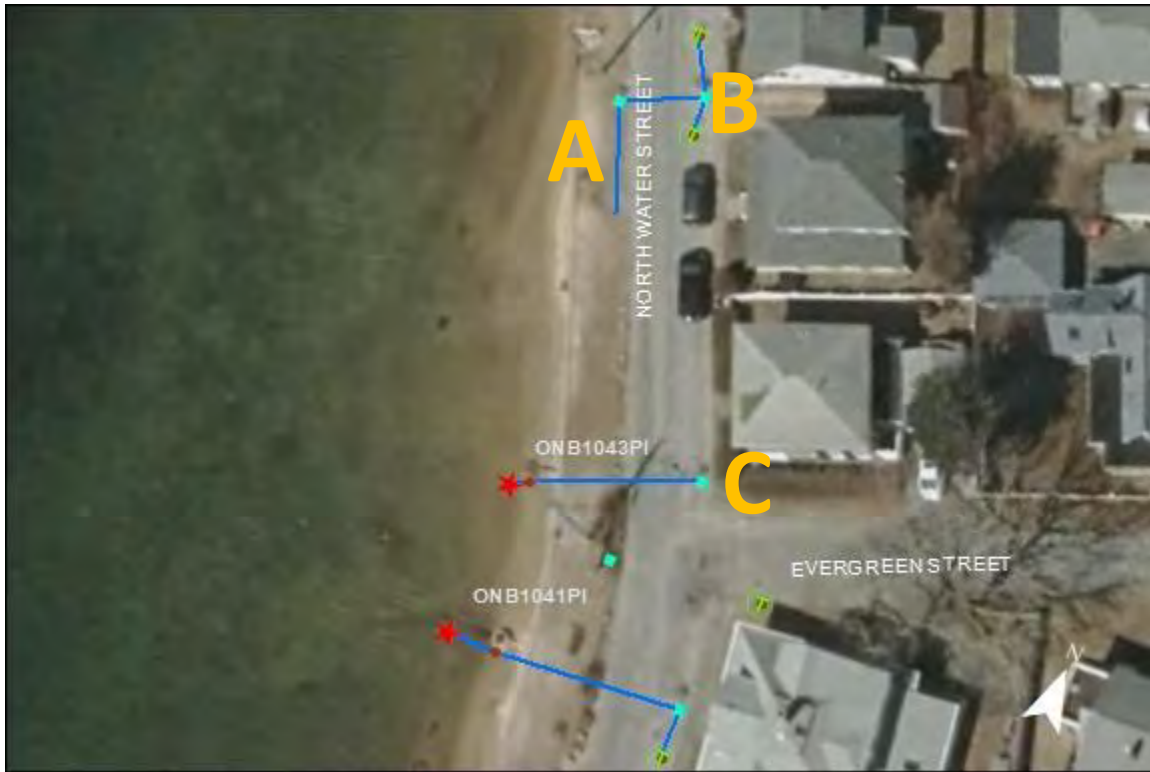
ONB1043PI and ONB1041PI- North Water Street: Manholes just before both outfalls are extremely debilitated and pose a risk to unsuspected persons. Immediate attention is recommended. At point A, a pipe enters the catchbasin. Its origin is unknown. Further investigation is recommended. At point B and C, the catchbasins have begun to sink. Preventative measures are recommended.

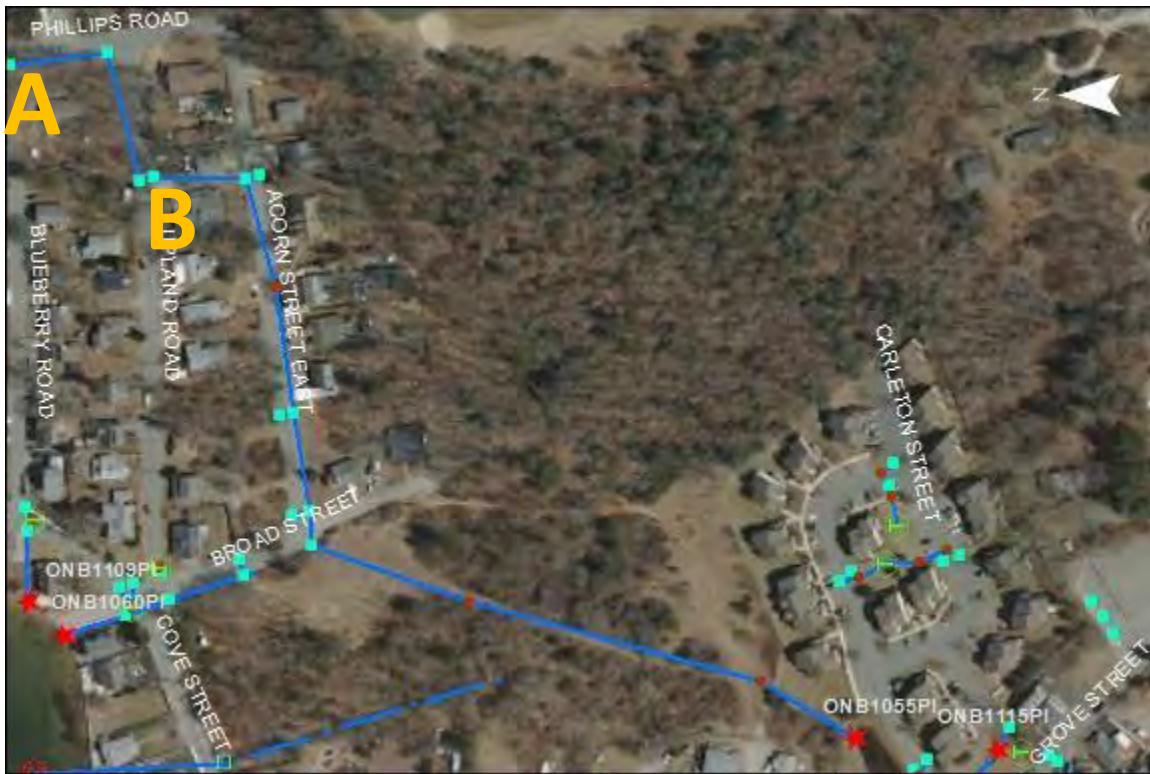
ONB1055PI- Acorn Street East, Upland Road, and Phillips Road: At point A the catch basin is extremely clogged and in need of cleaning. At point B the catch basin is in need of repair. Further attention is recommended.

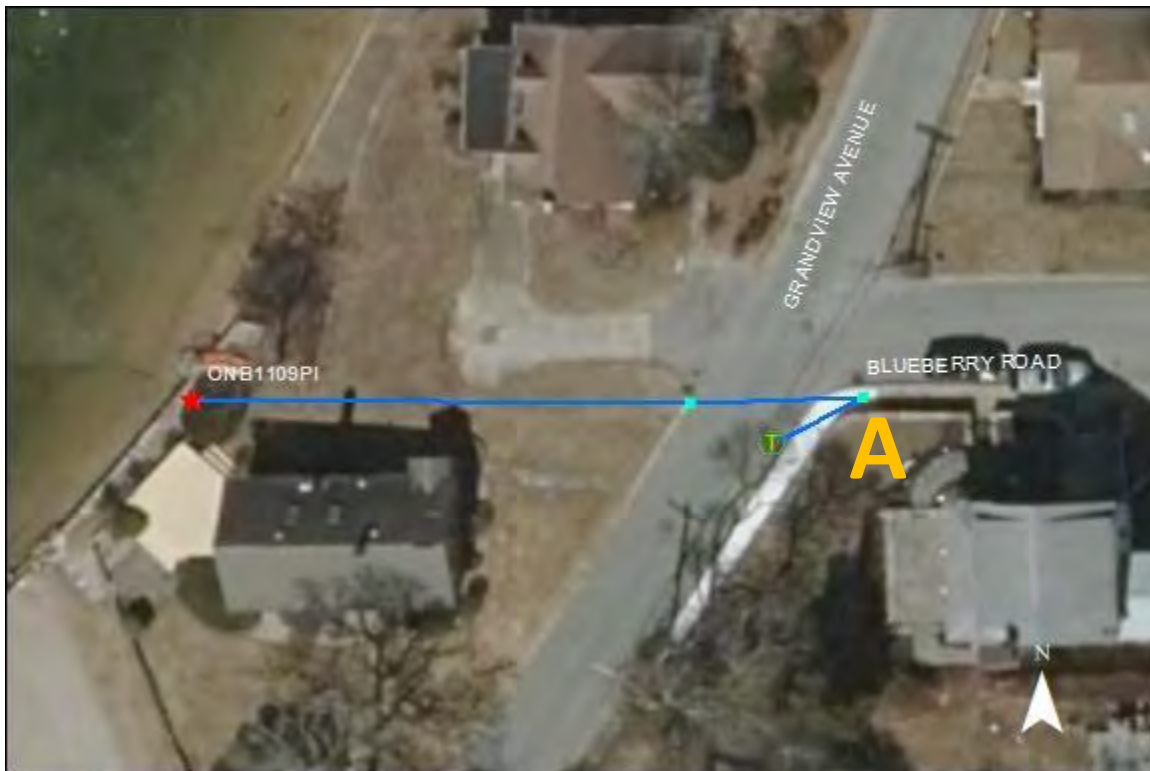
ONB1109PI- Grandview Avenue at Blueberry Road: Manhole at point A is full of sand. Catchment is in need of cleaning and reinspection. Further action is recommended.

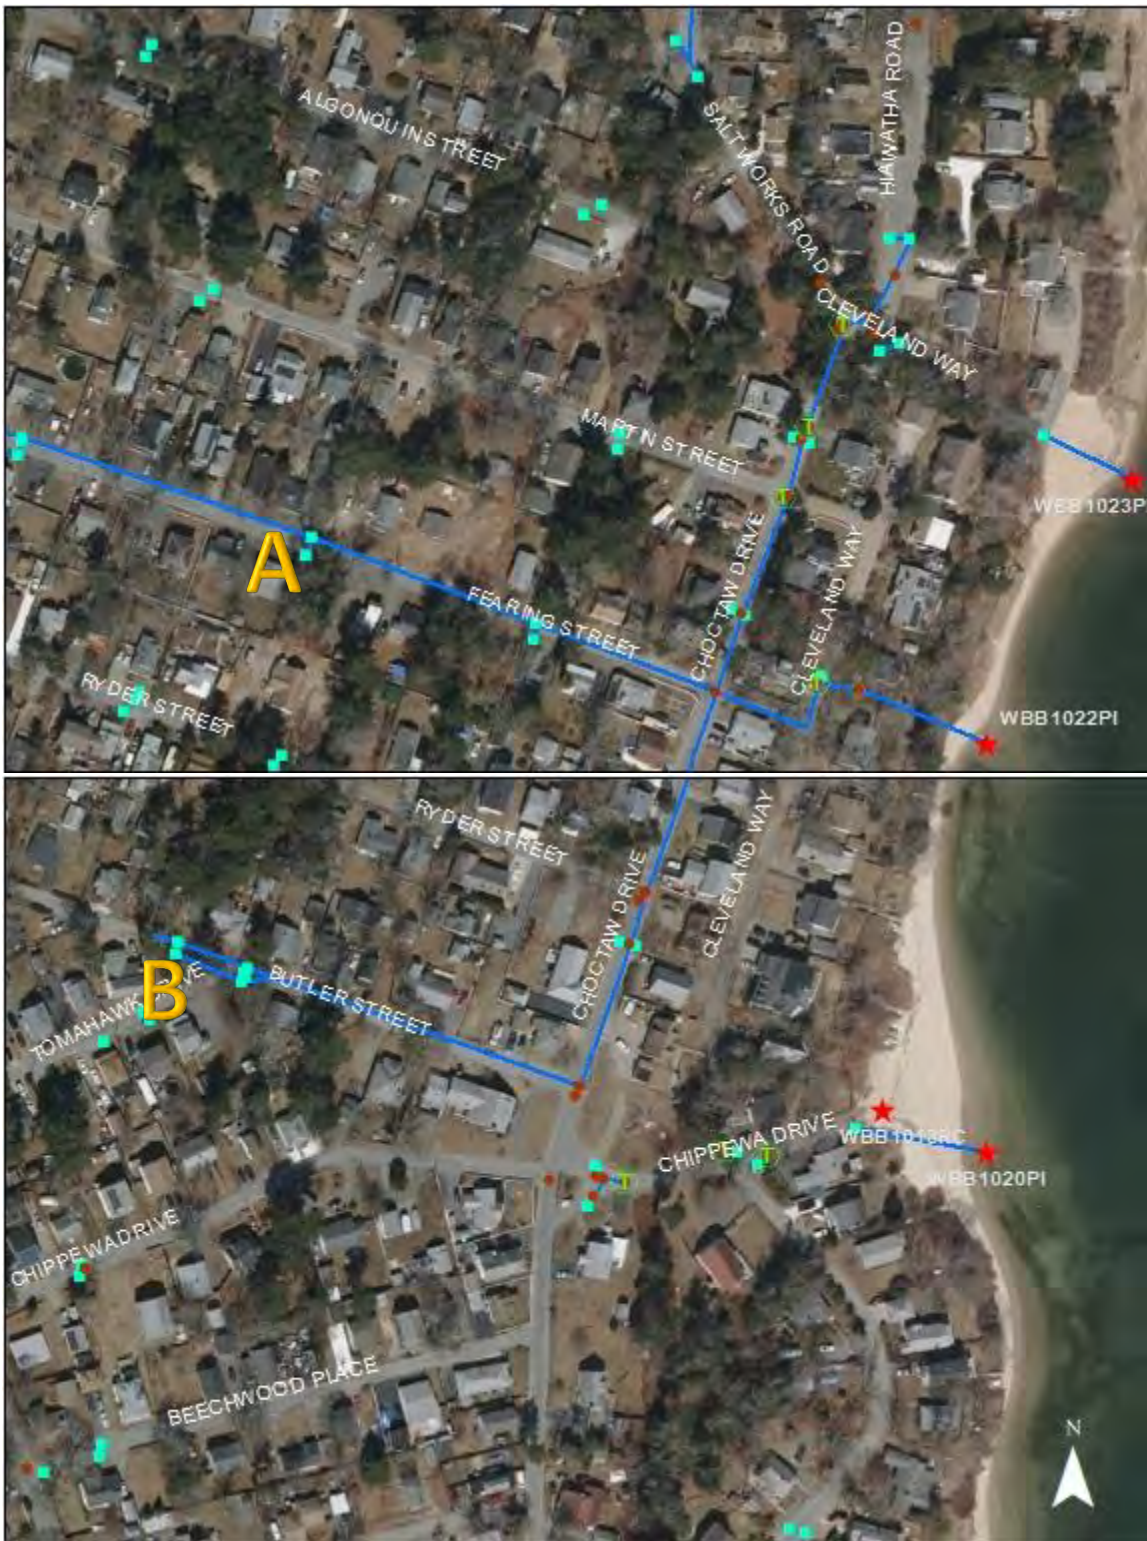
WBB1023PI, WBB1022PI, WBB1013RC, and WBB1020PI- Cleveland Way, Choctaw Drive, Butler Street, and Chippewa Drive: At point A the basin is completely full of water. All other surrounding basins were dry. Extremely likely there is a clogged pipe. Maintenance is recommended. At point B on Butler Street the catchbasin is collapsing. Further maintenance is recommended.

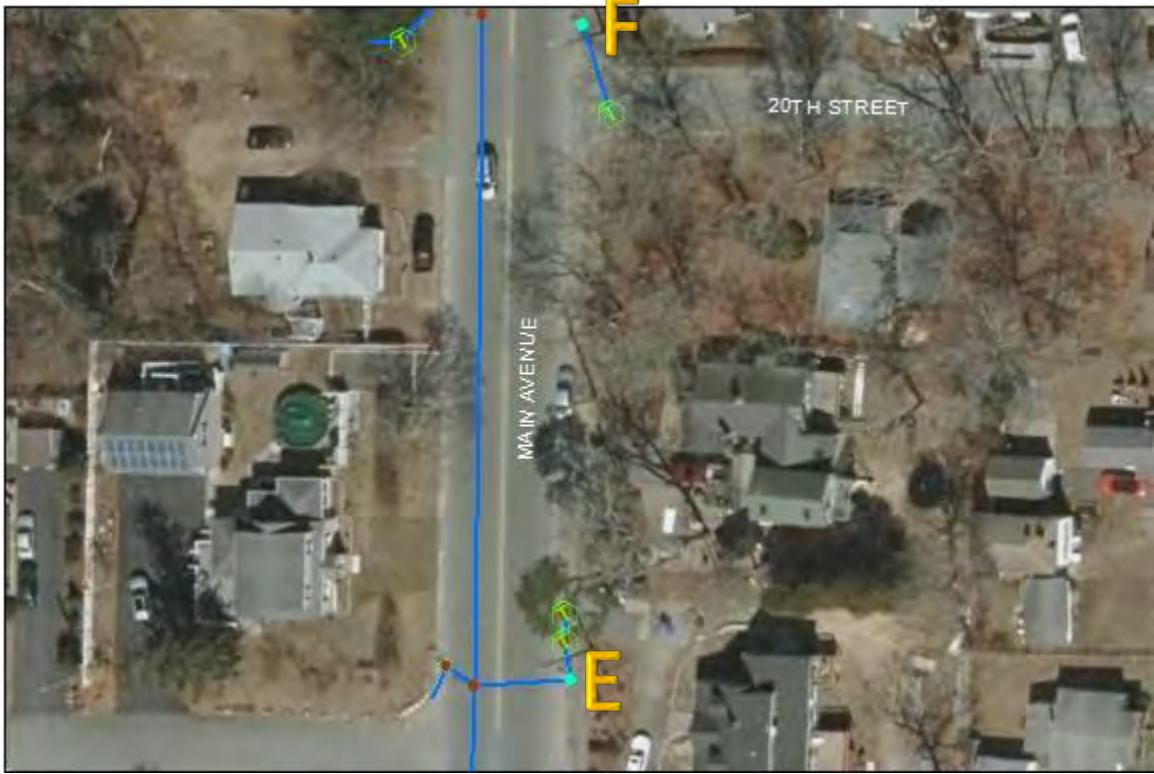
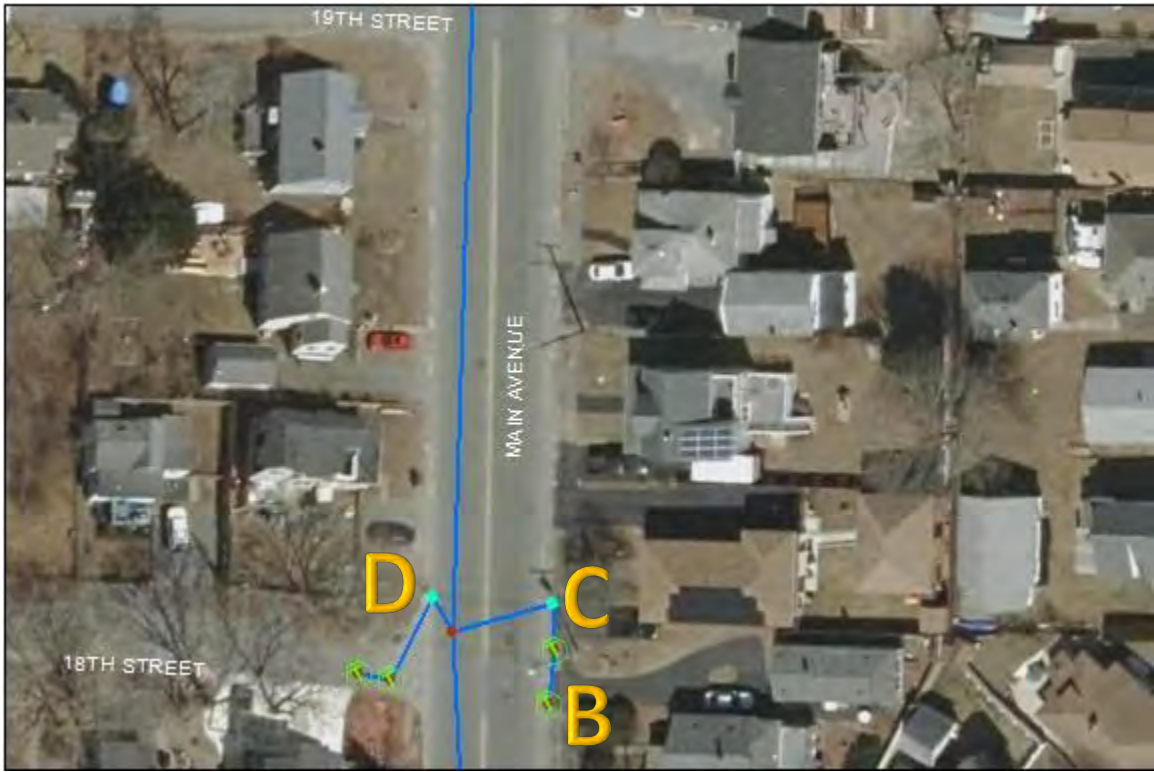
ONB1057PI- Main Avenue: Catchbasins and manholes at points A, B, C, D, E, and F are all sinking. Most of them are missing bricks inside. At point F there is a sinkhole between the catchbasin and the sidewalk and poses risk to pedestrians. Point F needs immediate attention. Additional maintenance to all other points is recommended.

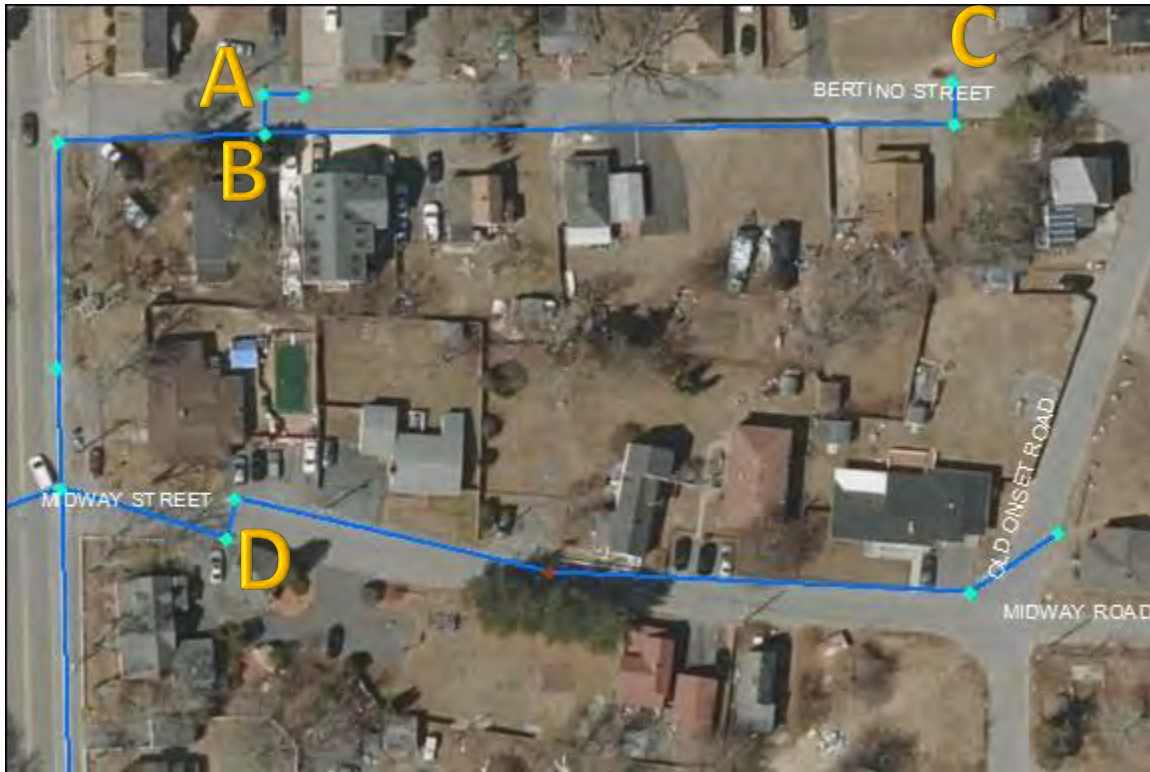
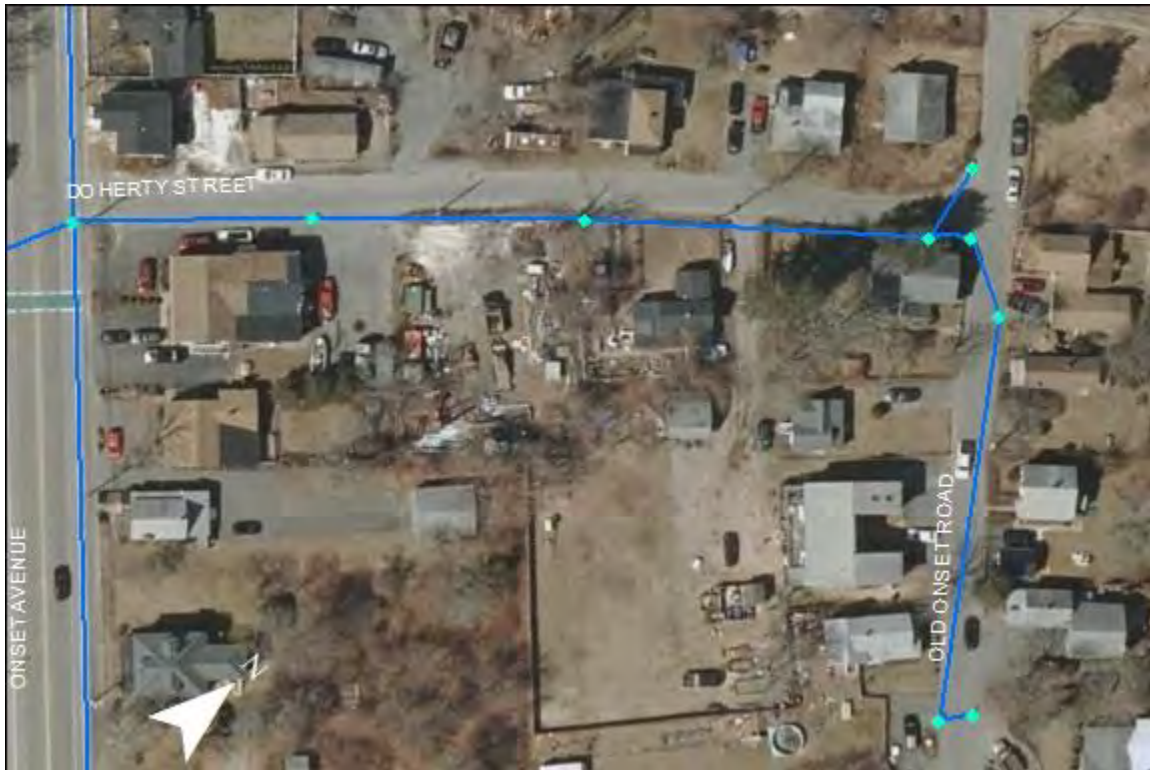
ONB1022PI- Bertino Street, Midway Street, Doherty Street, and Old Onset Road: At point A there is a large sink hole. It is covered with a traffic barrel. Maintenance is strongly recommended. At points B and A the catchbasin covers appear to be the wrong size for their frames, thickness wise. At point D there appeared to be cooking grease dumped down the drain. Thanksgiving fell on the week prior to the inspection. Community outreach and education is suggested for matters like this. This catchment connects to Onset Avenue and continues. Police detail needed for further investigation.

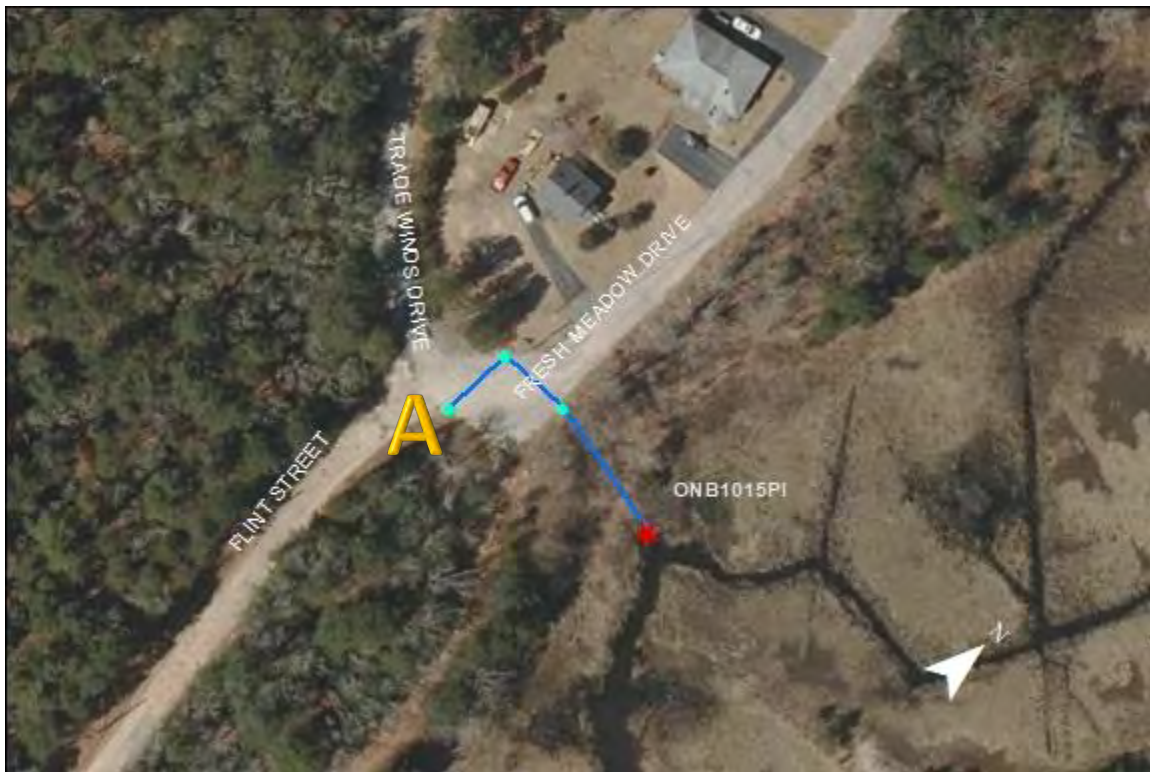
ONB1015PI- Fresh Meadow Drive: No significant issues. At point A the catchbasin is full of dirt. Further maintenance is suggested.
