**The Buzzards Bay Stormwater Collaborative
Illicit Discharge Investigation Trailer**

Town of Wareham Report

November 2nd, 2022

Wareham IDDE Report

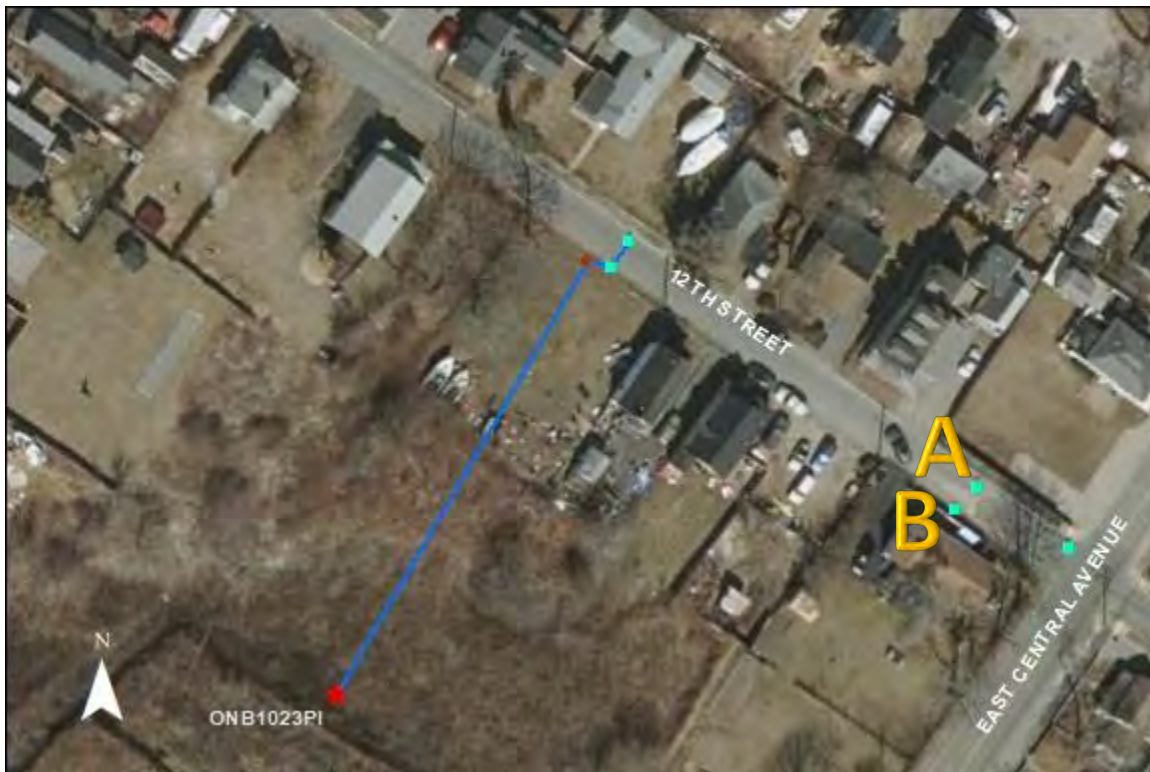
ONB1023PI- 12th Street: The catchbasins at point A and B are completely packed with dirt and have begun growing vegetation. Further maintenance is strongly recommended.

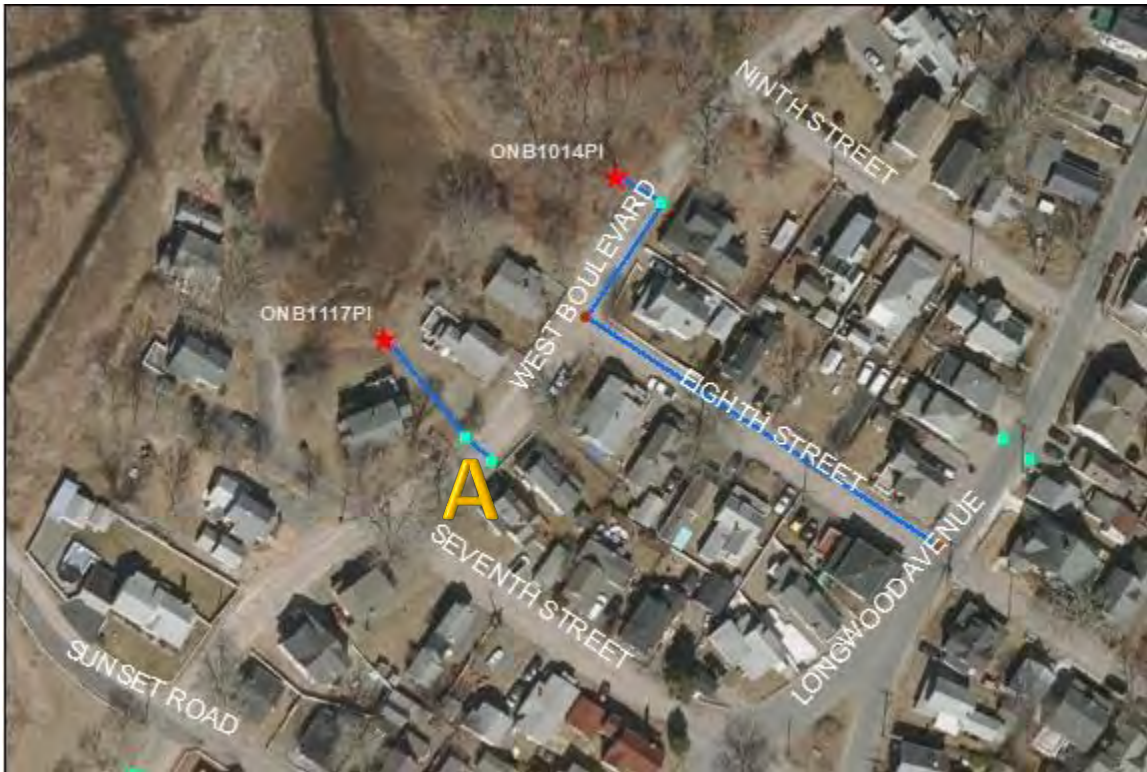
ONB1117PI and ONB1014PI- West Boulevard: No significant issues found. At point A the catchbasins flood. There appears to be a lot of blockages in the pipes at that location. Further maintenance is suggested.

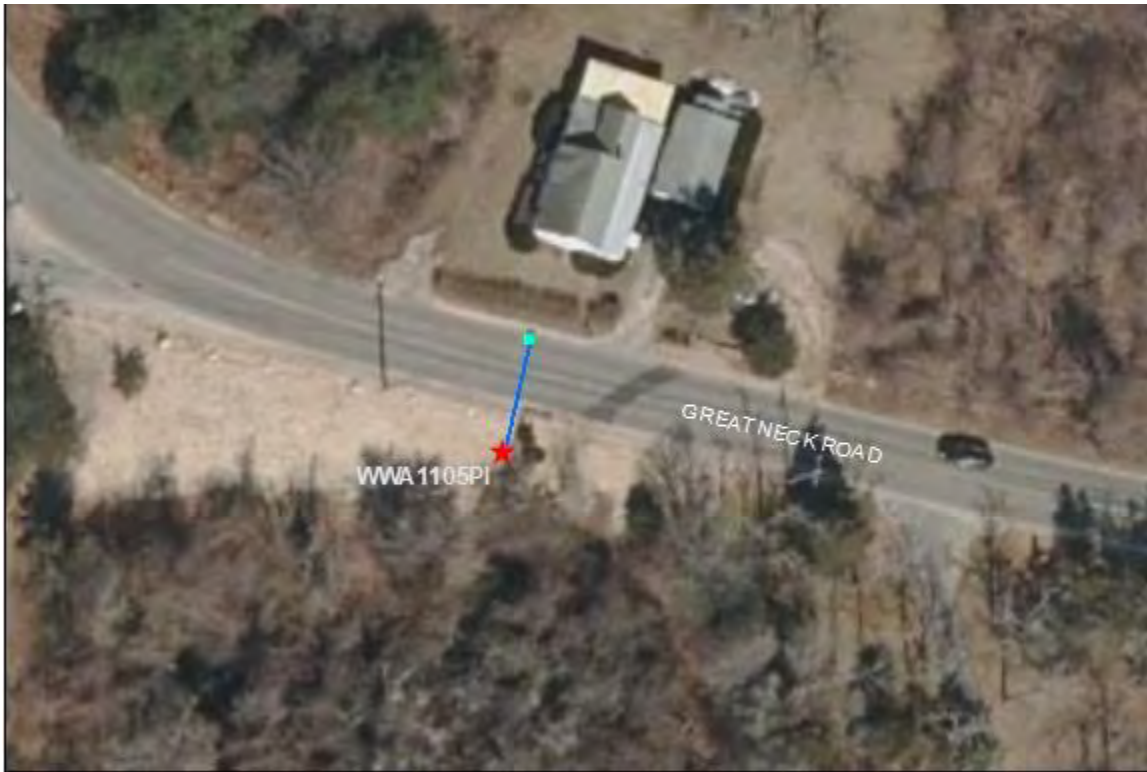
WWA1105PI- Great Neck Road: The catchbasin frame has begun to rot. Preventative maintenance is suggested.

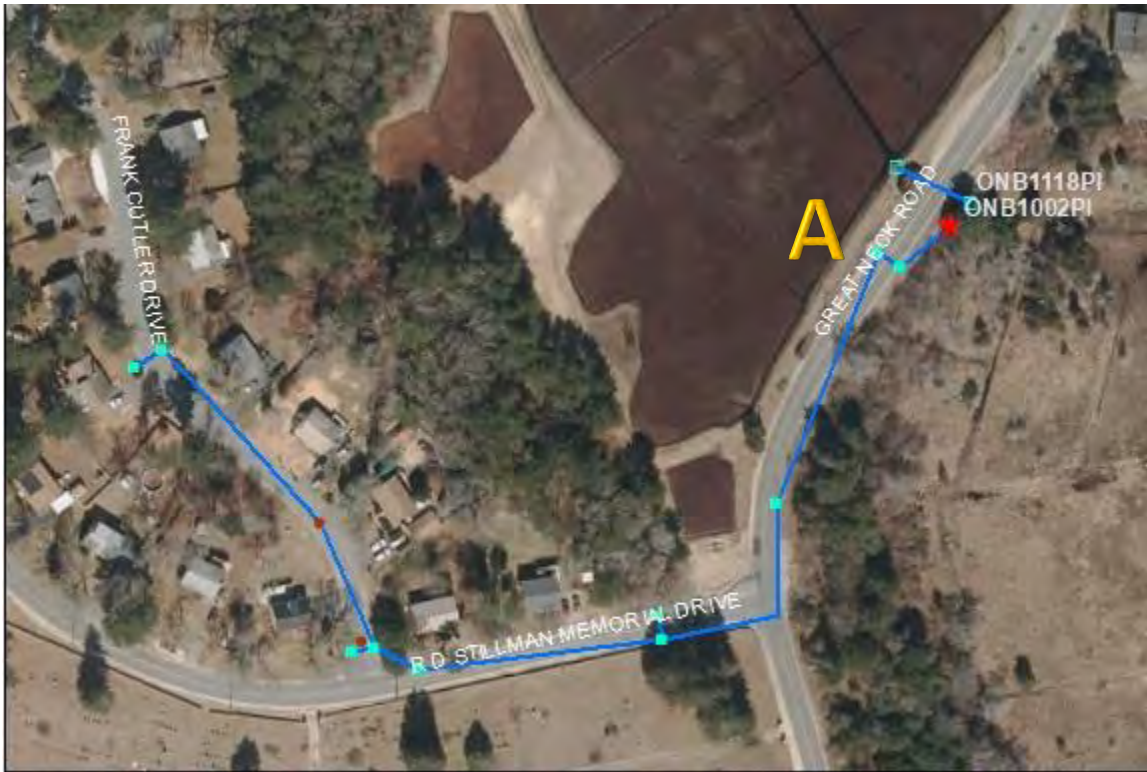
ONB1118PI and ONB1002PI- Great Neck Road: No significant issues found. At point A the catchbasin frame began to sink. Preventative maintenance is suggested.

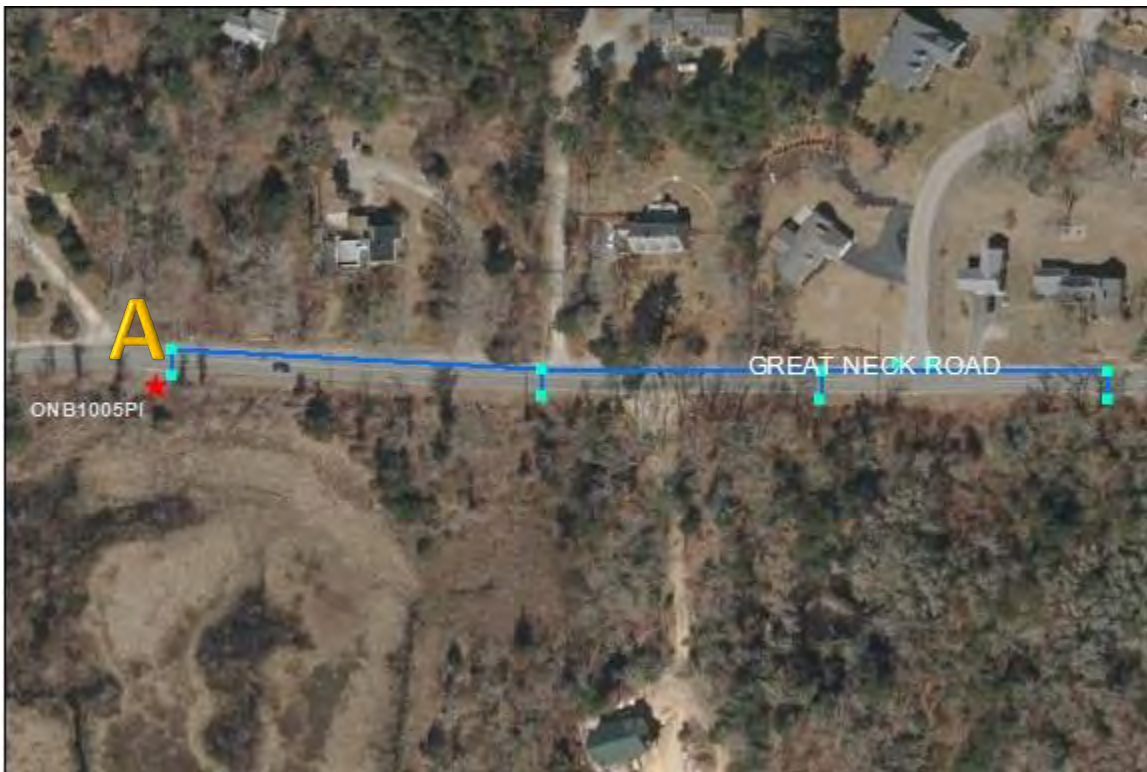
ONB1005PI- Great Neck Road: At point A the catchbasin began to sink. Preventative maintenance is suggested.

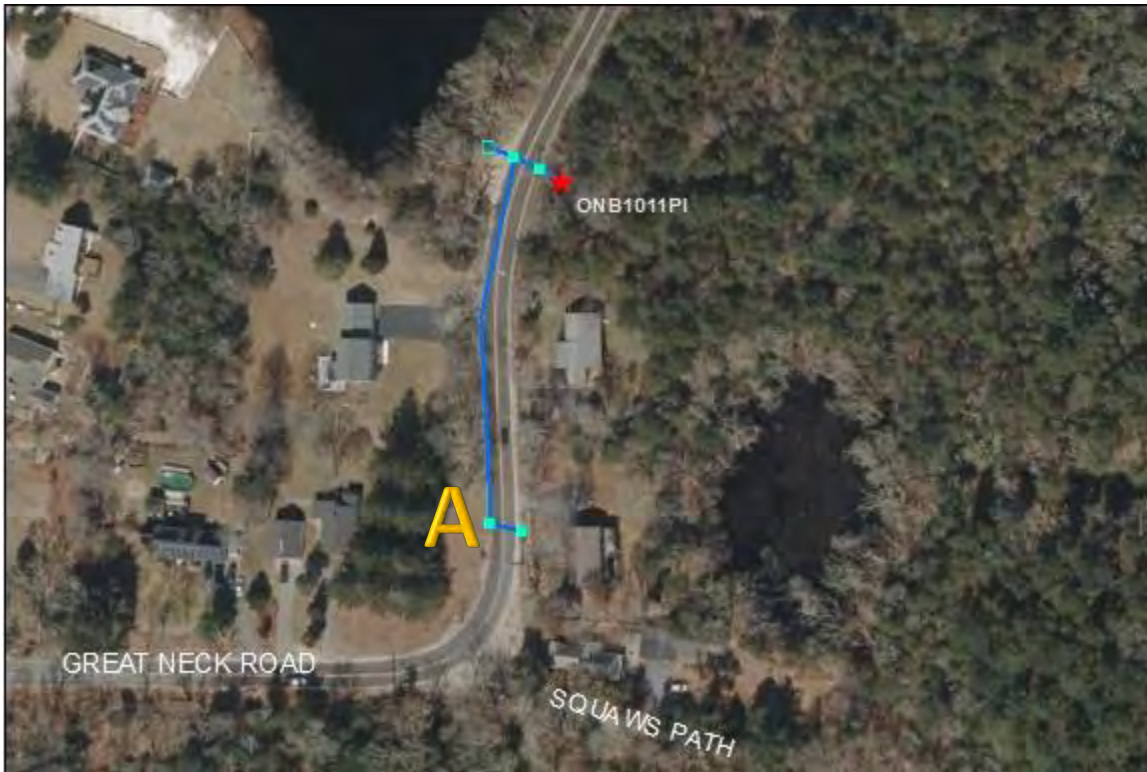
ONB1011PI- Great Neck Road: No significant issues found. At point A the catchbasin cover is broken. Further attention is recommended.

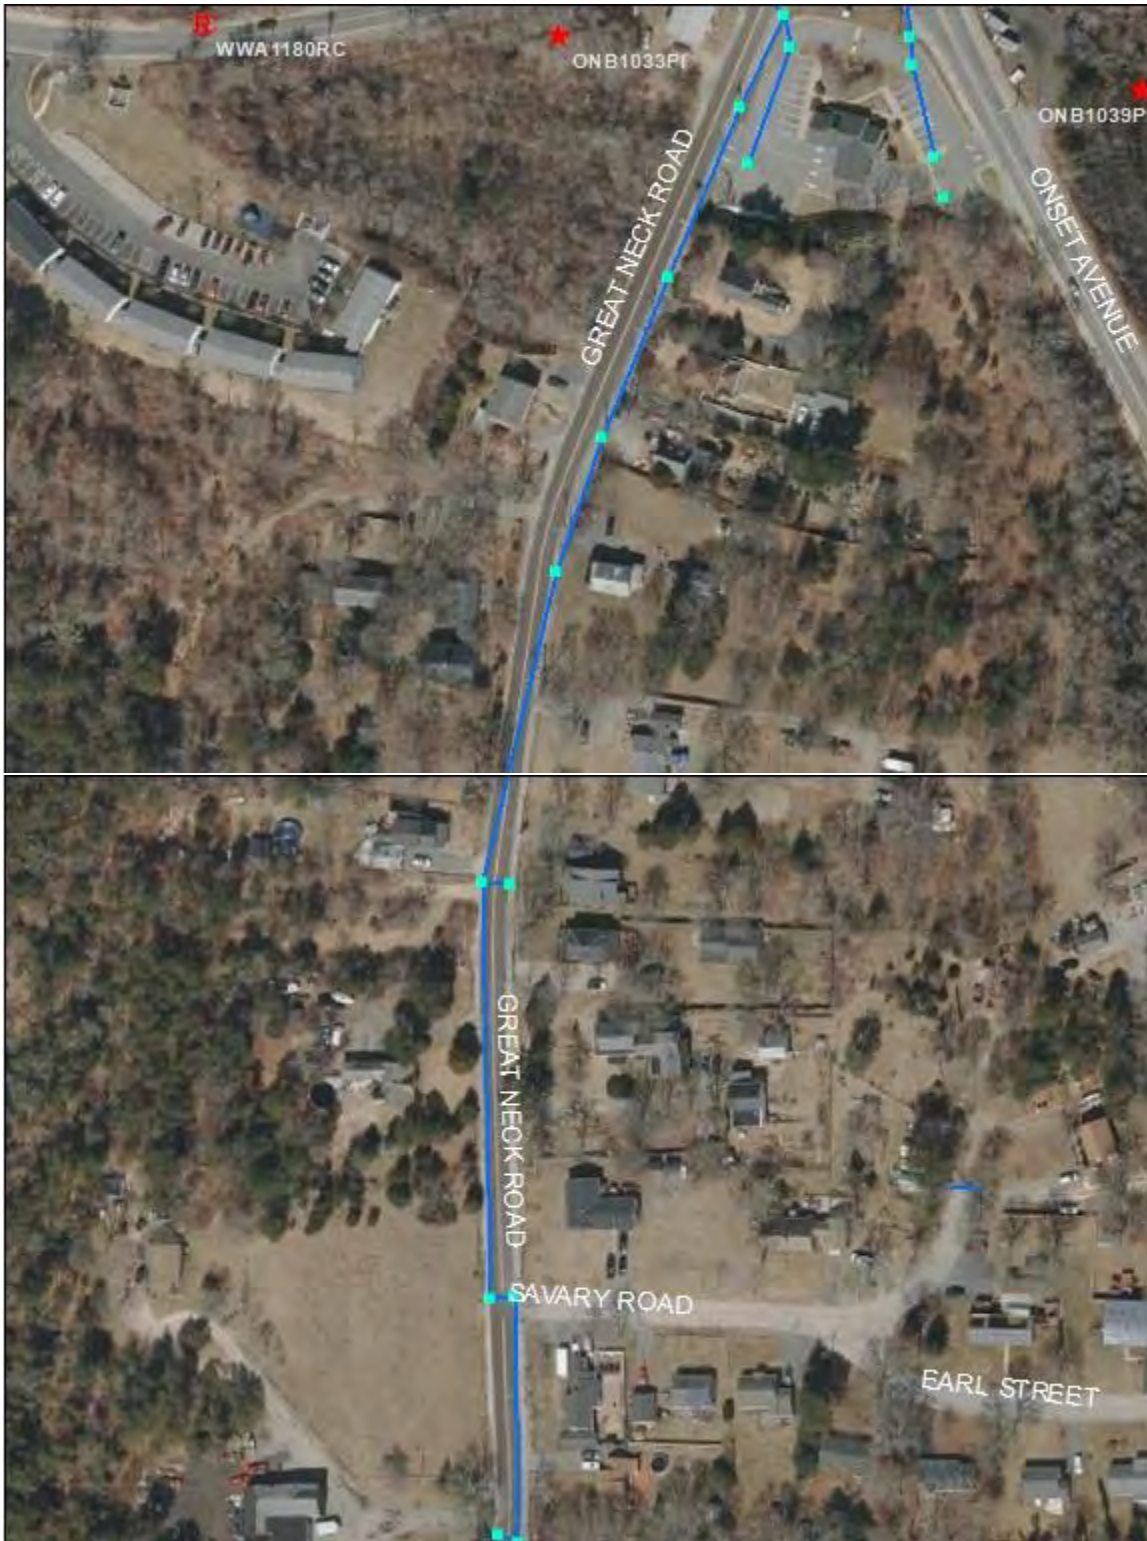
Great Neck Road: Catchbasins along this part of Great Neck Road are in need of repair. Basin frames are rusted or broken, brick work on the inside of certain structures is crumbling, and certain basins have begun to sink. Evaluation and remediation are strongly recommended. For further investigation of catchment a police detail is needed. The intersection of Onset Ave and Great Neck Road can have heavy traffic.

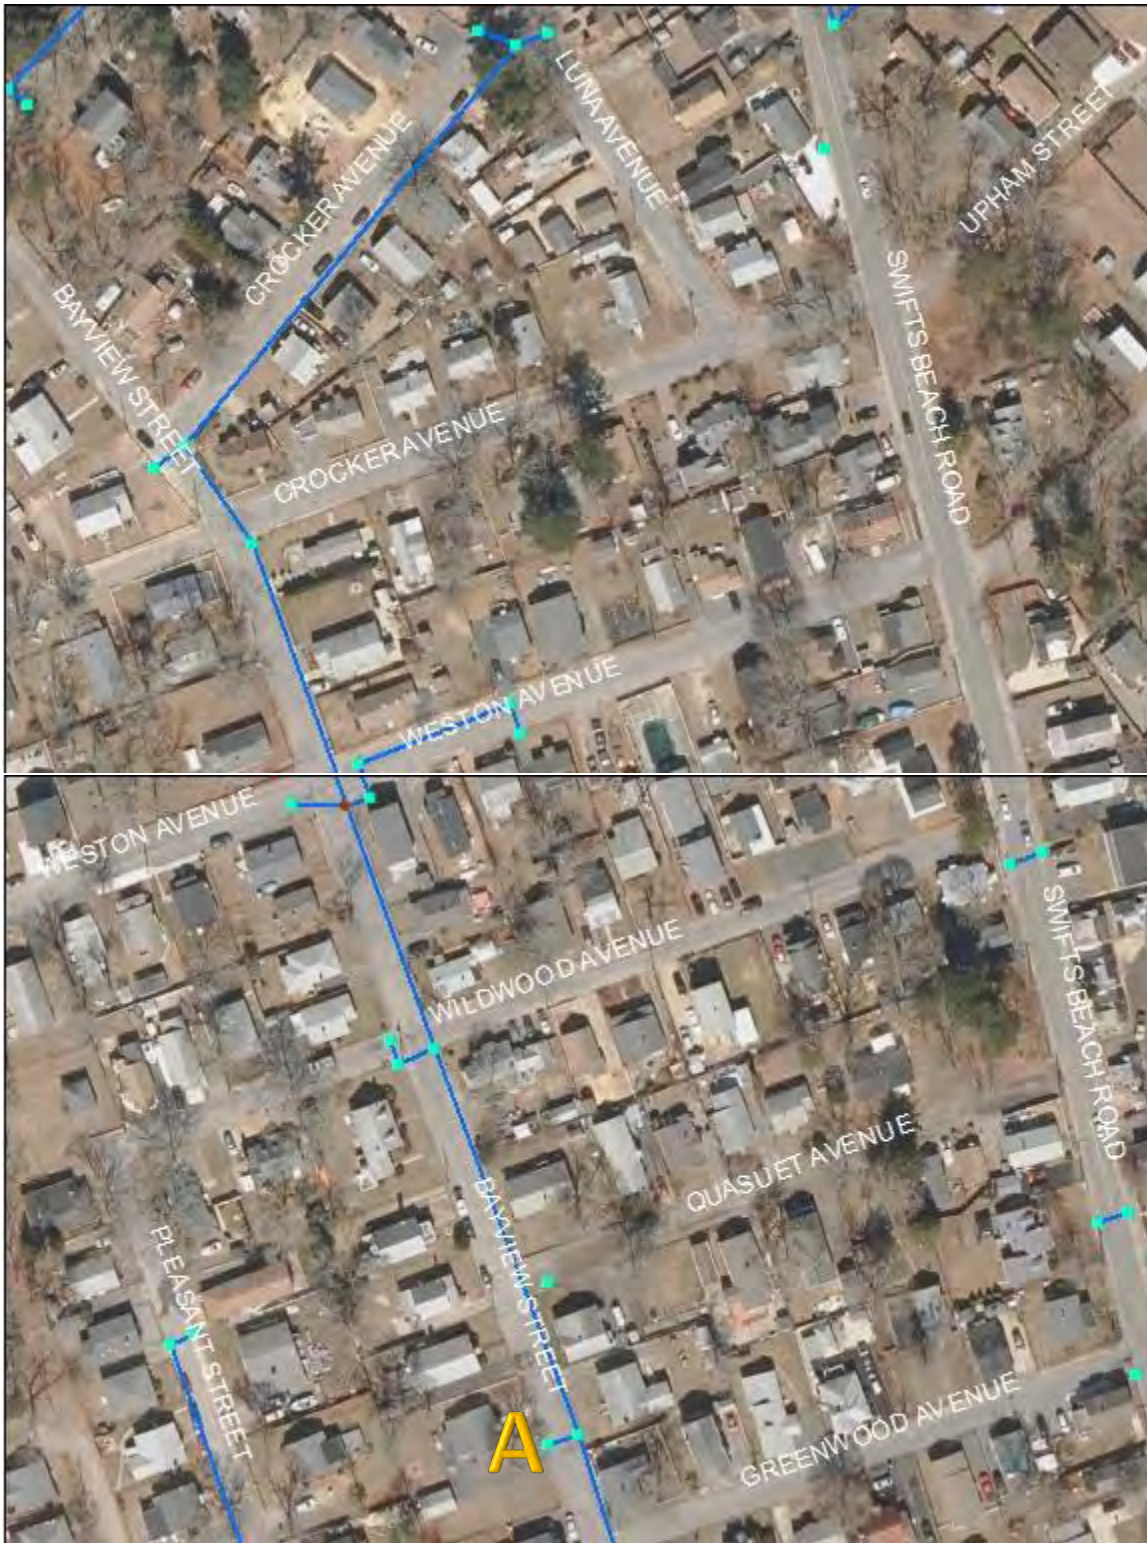
Bayview Street: No significant issues found. At point A the catchbasin has begun to sink. Preventative maintenance is suggested.

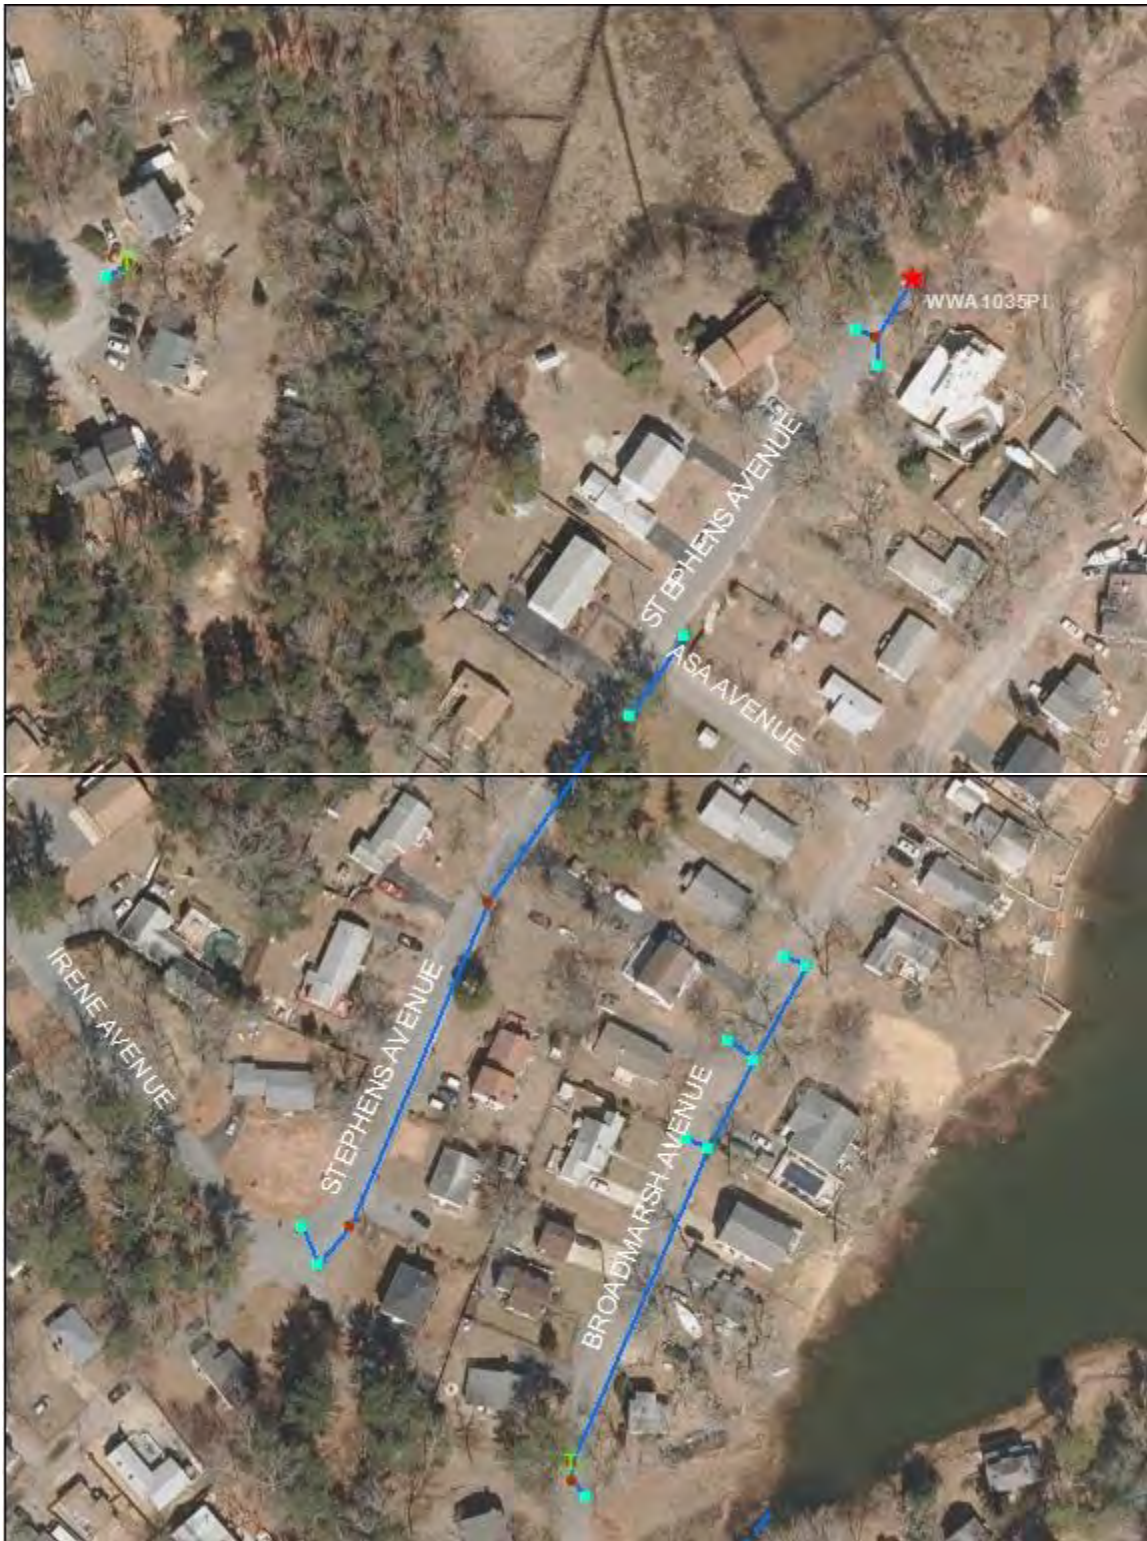
WWA1035pi- Stephens Avenue and Broadmarsh Avenue: No significant issues found. All catchbasins on Broadmarsh Avenue have 12" metal pipes that are clogged. Residents informed that it floods in this area often. Further maintenance is strongly suggested.

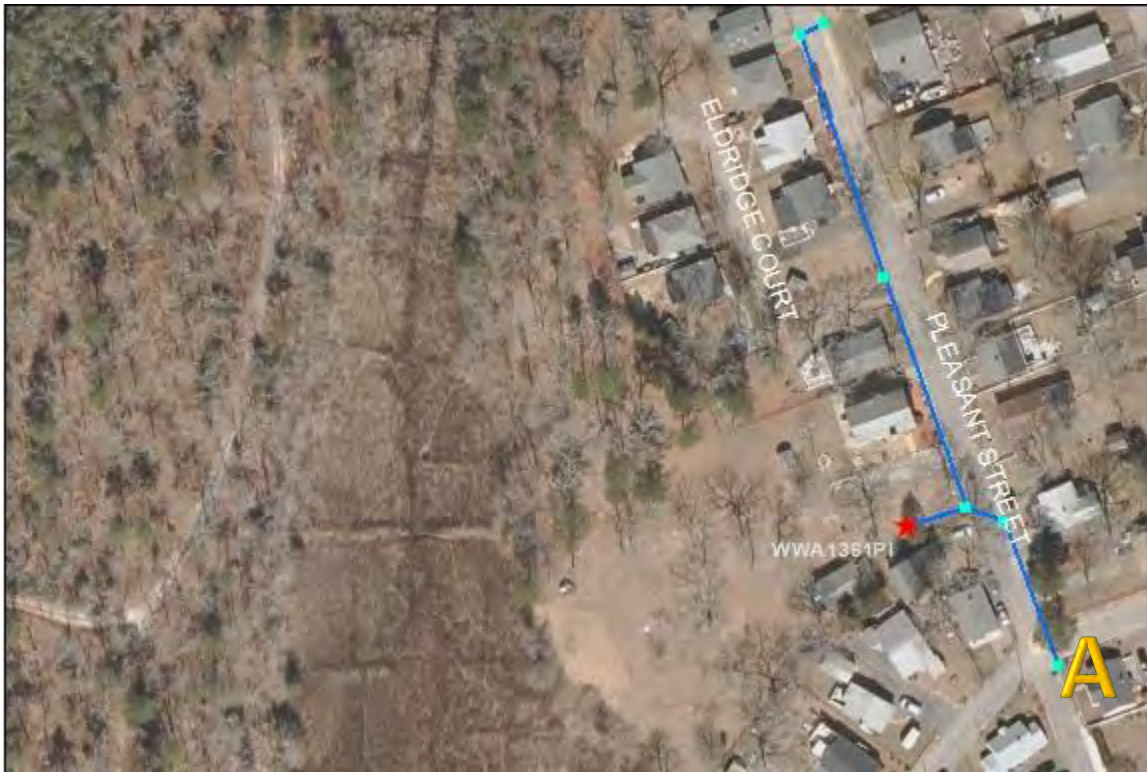
WWA1361PI- Pleasant Street: No significant issues found. At point A the catchbasin had a lot of trash and leaf debris. Further maintenance is suggested.

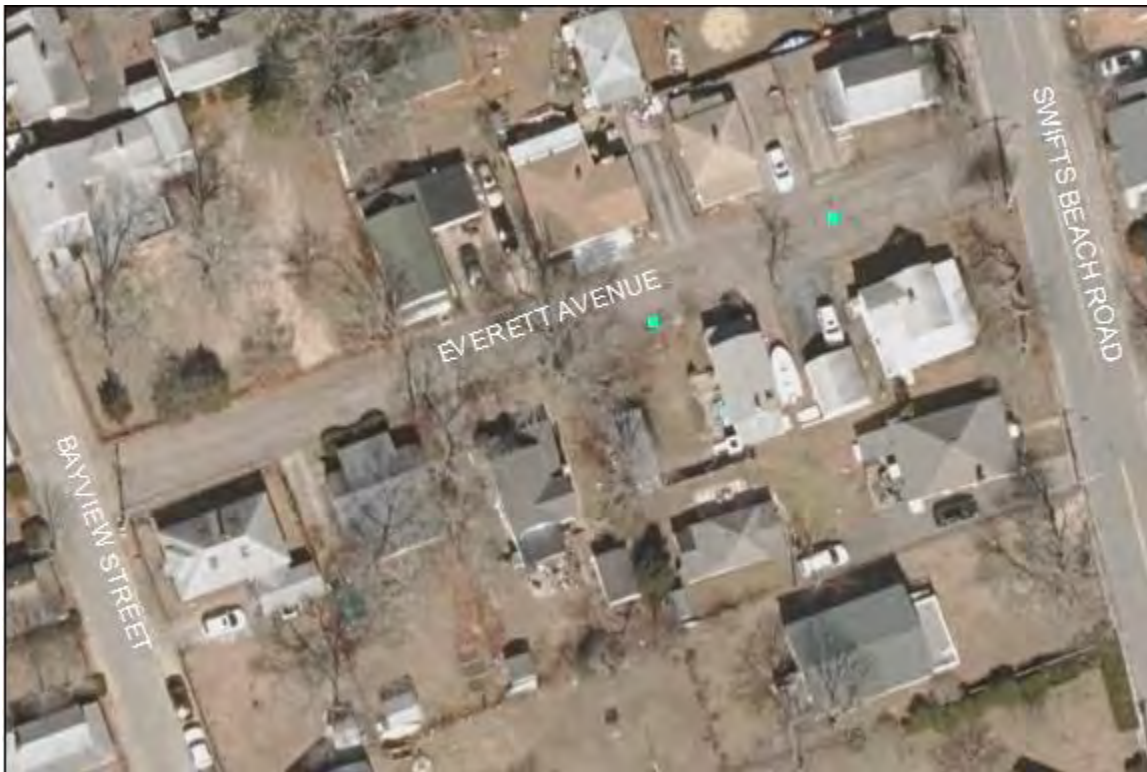
Everett Avenue-. Catchbasins are infiltration basins. The road is dirt and basins are full of sand. Further maintenance is recommended to prevent flooding during rain events.
