**The Buzzards Bay Stormwater Collaborative
Illicit Discharge Investigation Trailer**

Town of Westport Report

August 2022

Westport IDDE Report

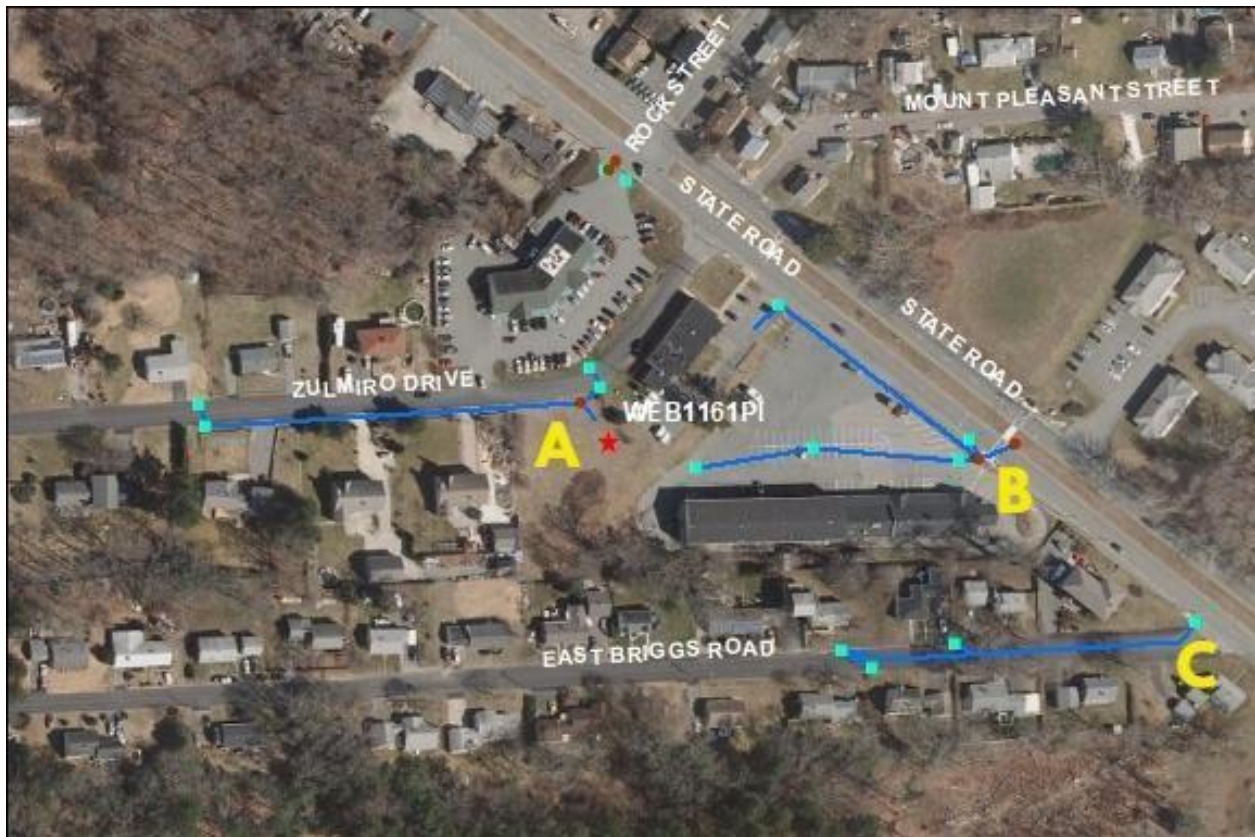
WEB1161PI- Zulmiro Drive: no issues found; discharge pipe not found. The pipe leaving the manhole at point A does not connect to the manhole nearby in the strip mall parking lot. Further investigation is

needed to determine where the pipe discharges. Point B at the strip mall and point C on East Briggs Road show interconnections between the town and state stormwater drainage systems.

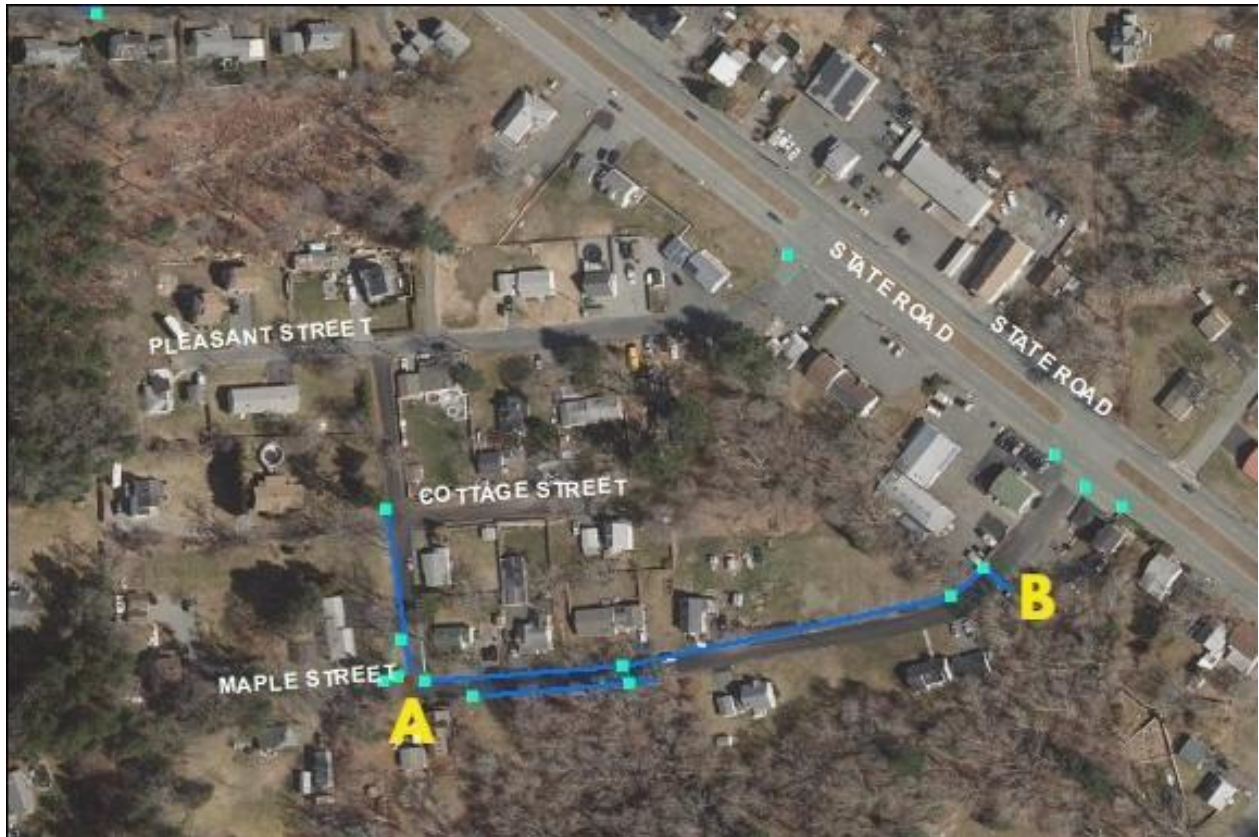
Infiltration Catchbasins not connected to drainage system along County Street. There is a buried manhole at the intersection of County Street and Maple Street. The discharge point for Maple Street is not clear. At point A, pipe leaves the catchbasin, its destination needs further investigation.

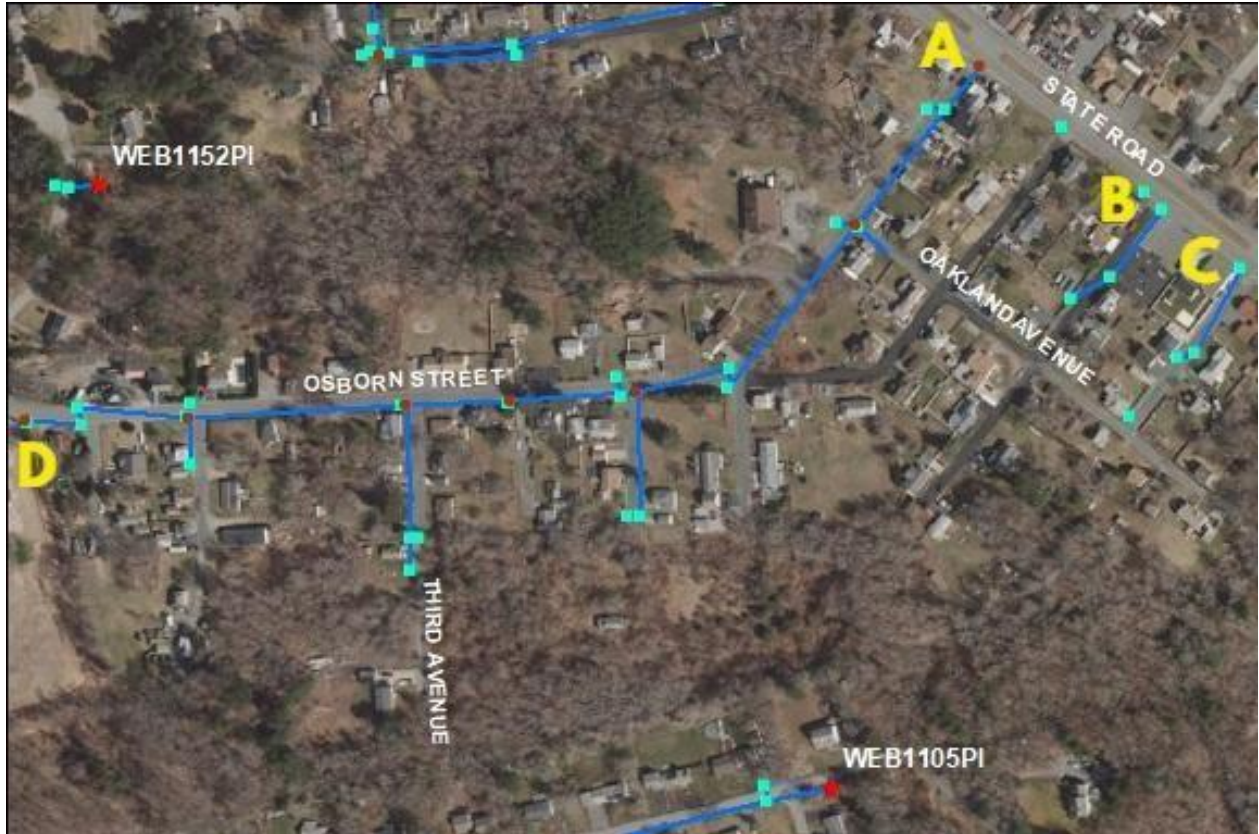
WEB1152PI - Celtic Drive: Minor issues found. Interconnections between the town's stormwater network and the state's network found at point A at Arlington Avenue, point B at Glenwood Avenue, and point C at Elmwood Avenue. Sump pump found at point D on Fifth Avenue. Water sample tested here had high levels of surfactants. Recommend a BOH or other appropriate authority inspection. Third Avenue reports flooding.

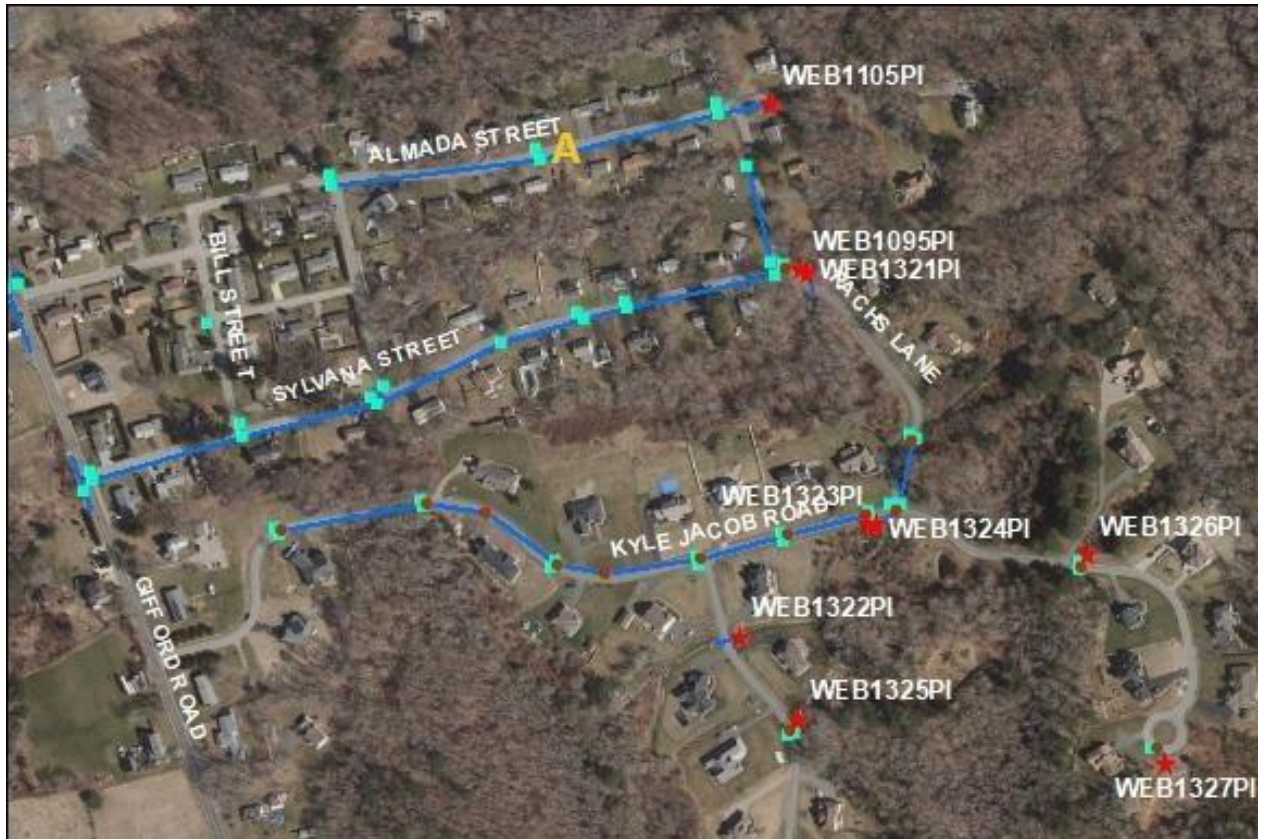
WEB1105PI - Almada Street: No issues found. Catchbasin in front of 44 Almada Street (point A) has significant green growth on and around pipe entering basin. Indicates pipe is constantly flowing but no sign of illicit. Source of flow is unknown. WEB1095PI - Sylvana Street: No issues found. WEB1323PI, WEB1324PI, WEB1326PI, and WEB1327PI - Kyle Jacobs Road: No issues found. WEB1322PI and WEB1324PI - Mellissa Beth Way: No Issues found. WEB1321PI - Rachs Lane: No Issues found. Several outfalls listed here were newly discovered and were inventoried.

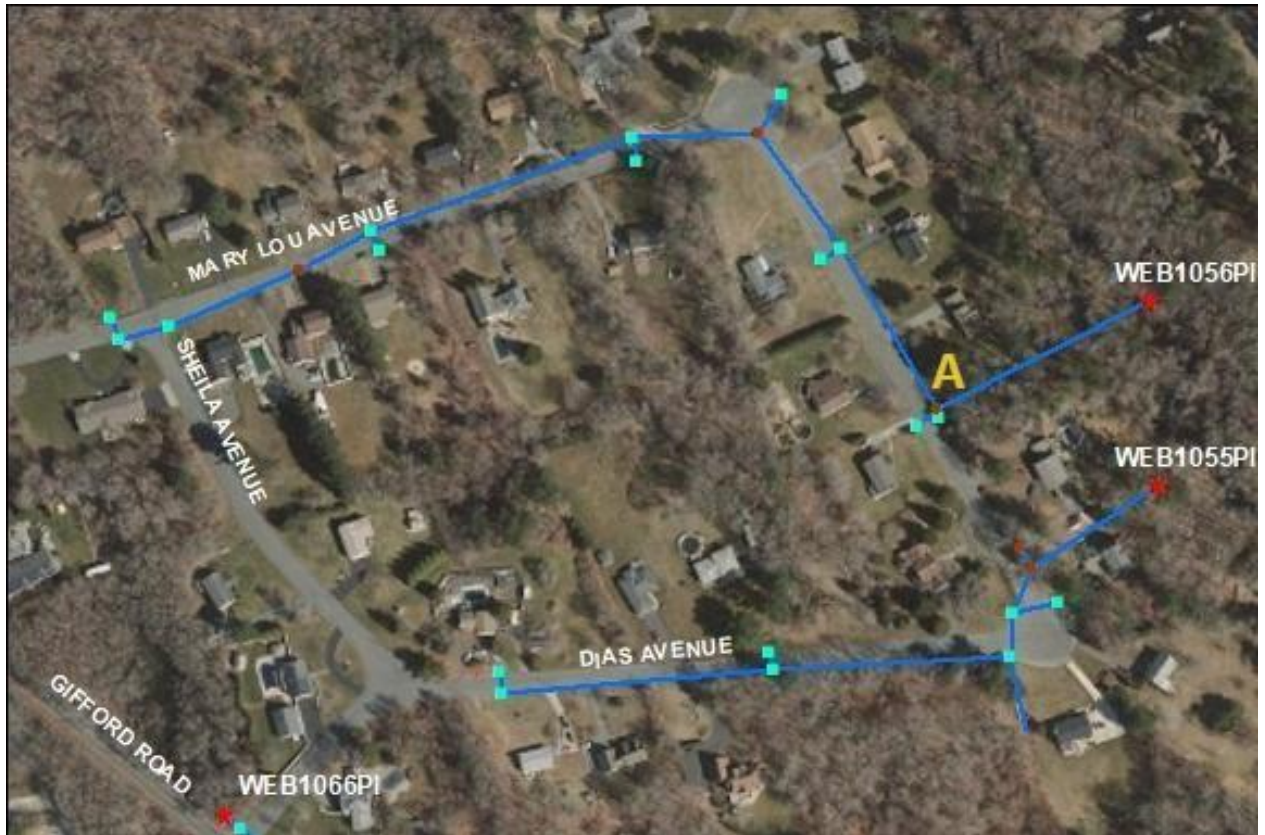
WEB1056PI and WEB1055PI - Brookside Ave: No issues found. At point A an unknown pipe enters manhole. Camera was deployed and could not reach destination. Further investigation is required.
WEB1066PI - Dias Avenue: No issues found.

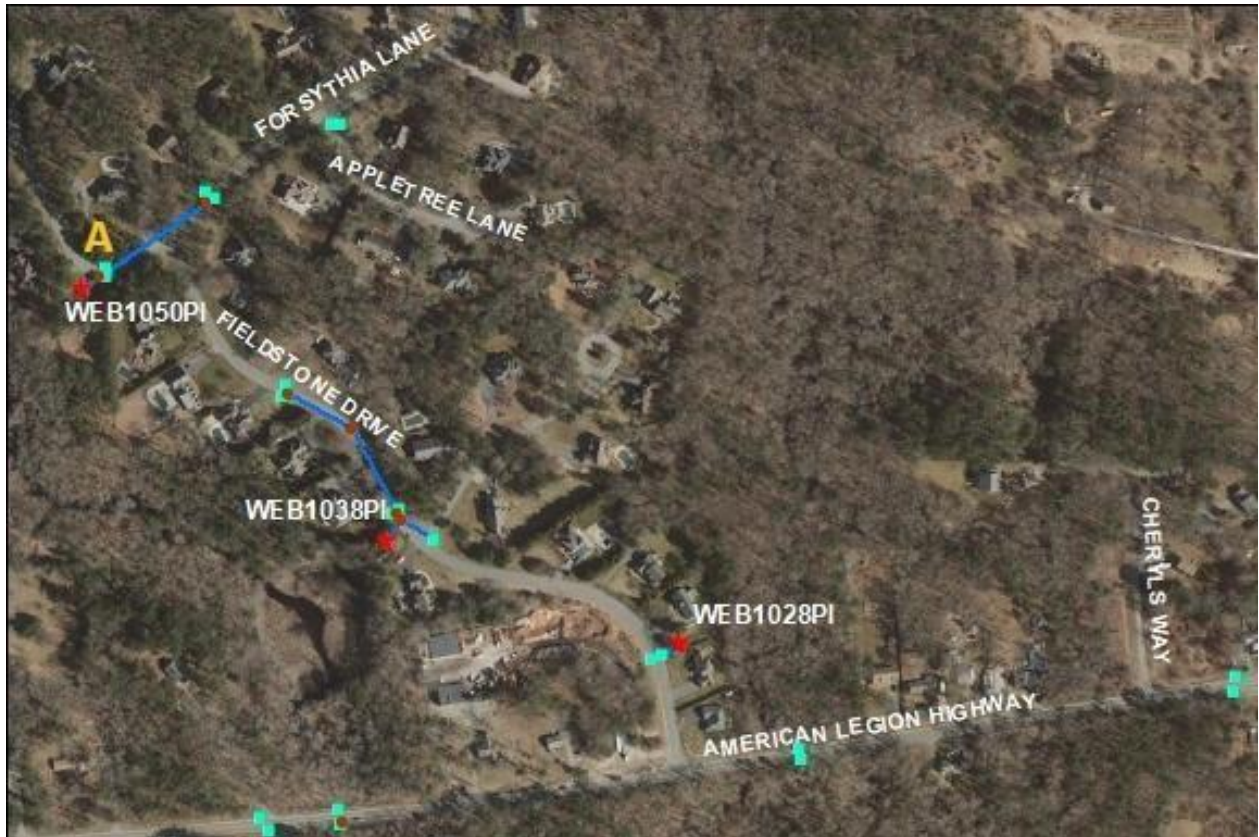
WEB1028PI and WEB1038PI - Fieldstone Drive: No issues found. WEB1050PI - Forsythia Lane: Manhole at point A is sinking and repairs are recommended.

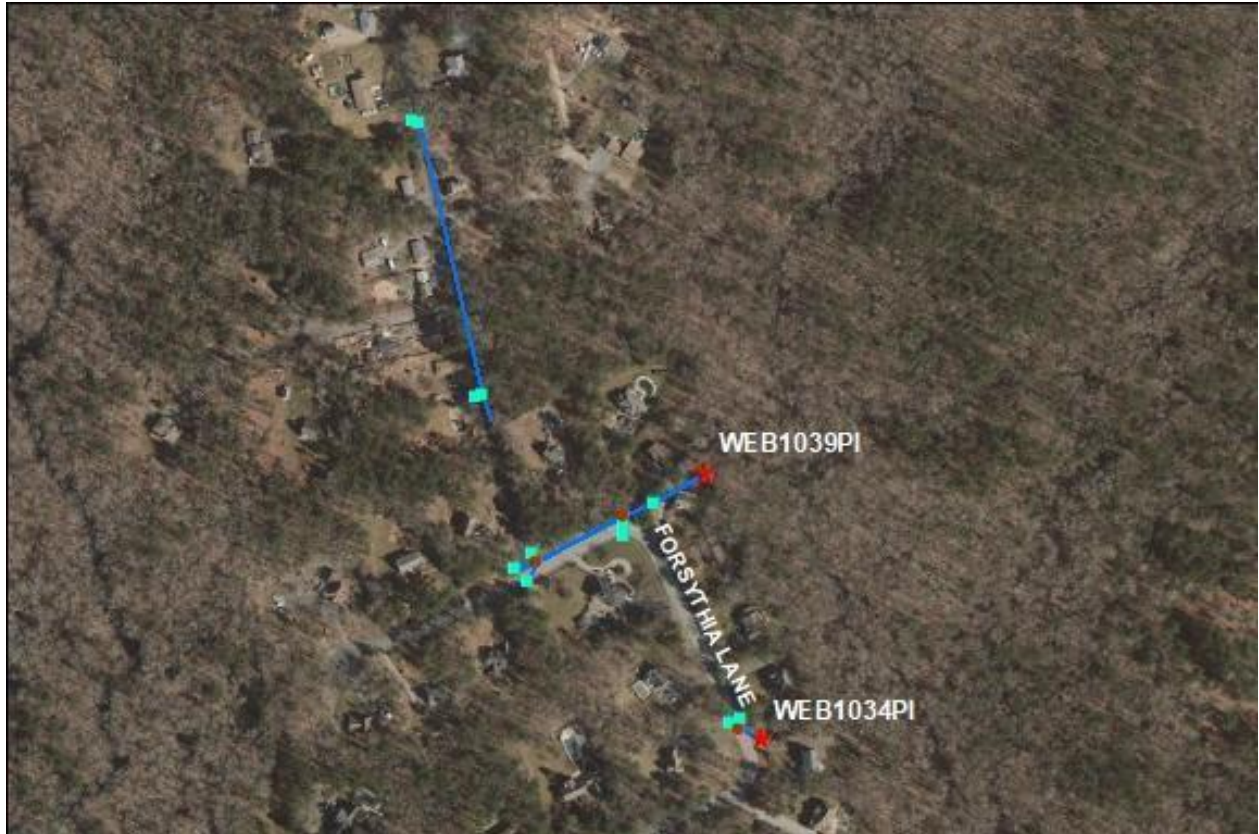
WEB1034PI - Forsythia Lane: No Issues found. Catchbasins on Center Street are infiltration basins, destination of pipe leaving last catchbasin unknown. Further investigation required.

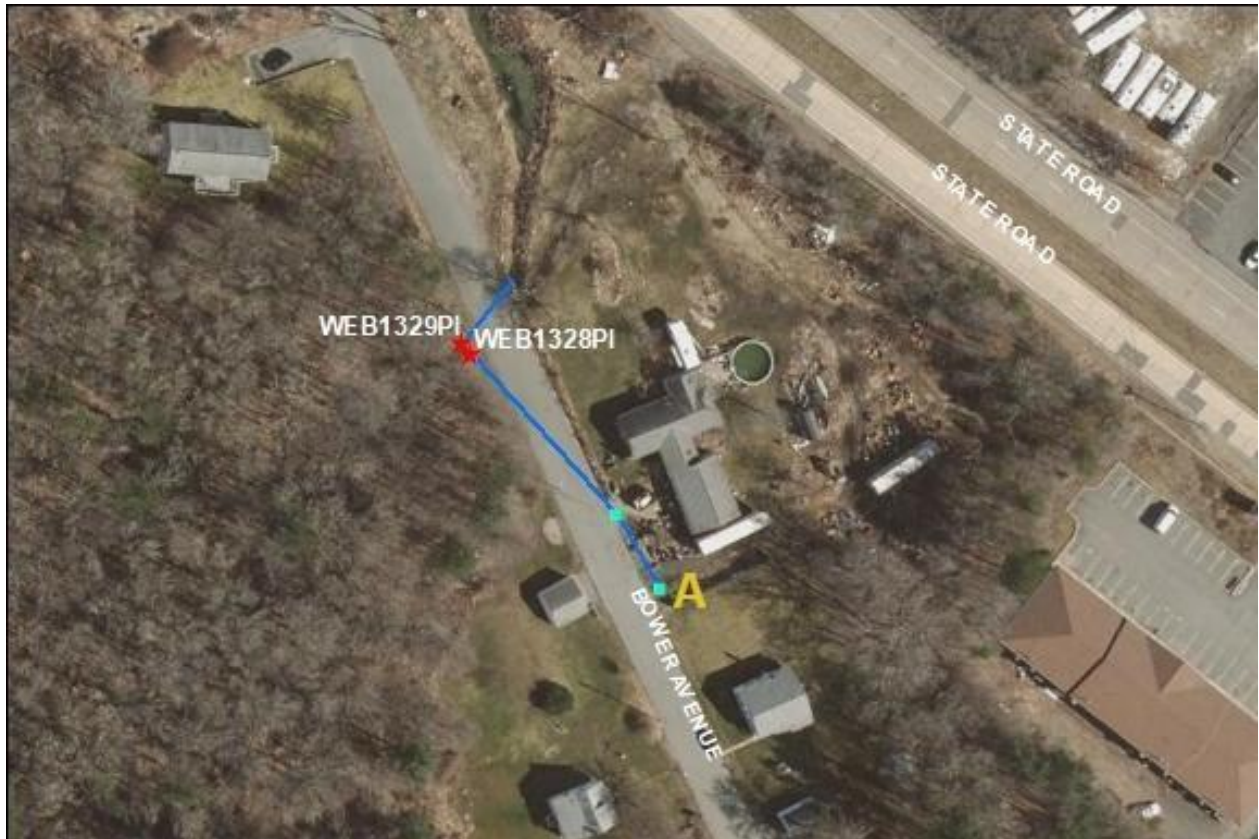
WEB1329PI and WEB1328PI - Bower Avenue: Potential Issue Found. At point A, catchbasin had grey water. Surfactants results came back high. Catchbasins are on a gravel driveway. Most likely from car washing however sump pump connection is present; recommend follow-up surfactant test.

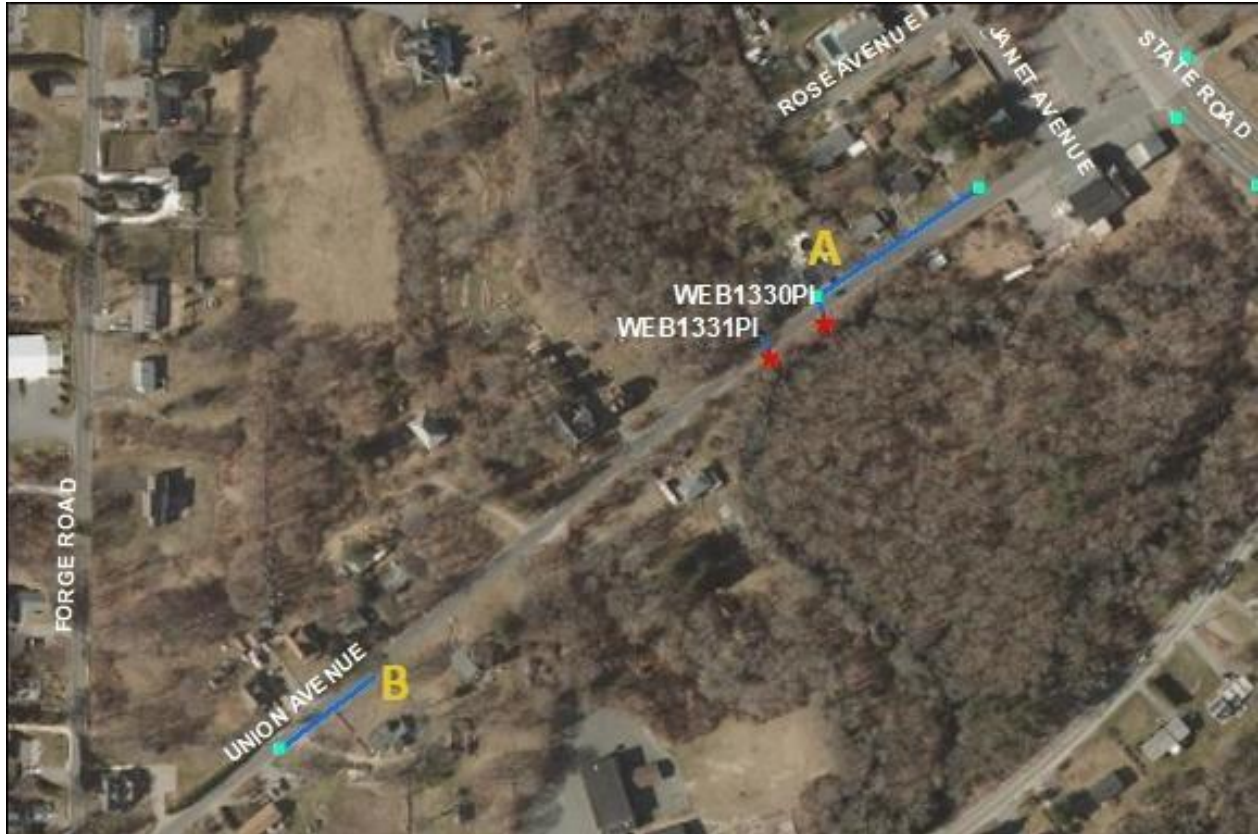
WEB1330PI and WEB1331PI - Union Avenue: Potential issues found. At point A catchbasin had grey standing water. Surfactant and Nitrates results were high. Sump pump present. Most likely from car washing; recommend follow-up surfactant test. At point B, pipe left catchbasin in direction of culvert. Road work was in process. Outfall for catchbasin needs to be inventoried.

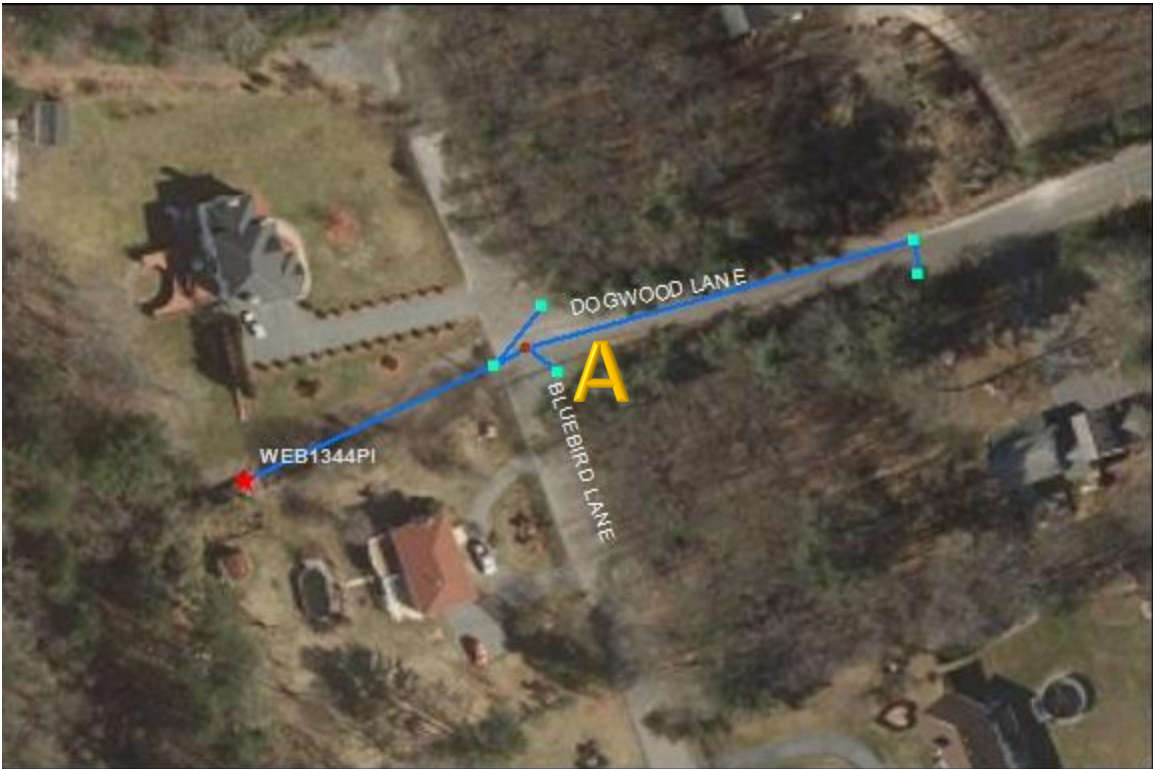
WEB1344PI- Bluebird Lane: No significant issues found. Outfall was inventoried. At point A the catchbasin has begun to sink. Preventative work by the town is suggested.

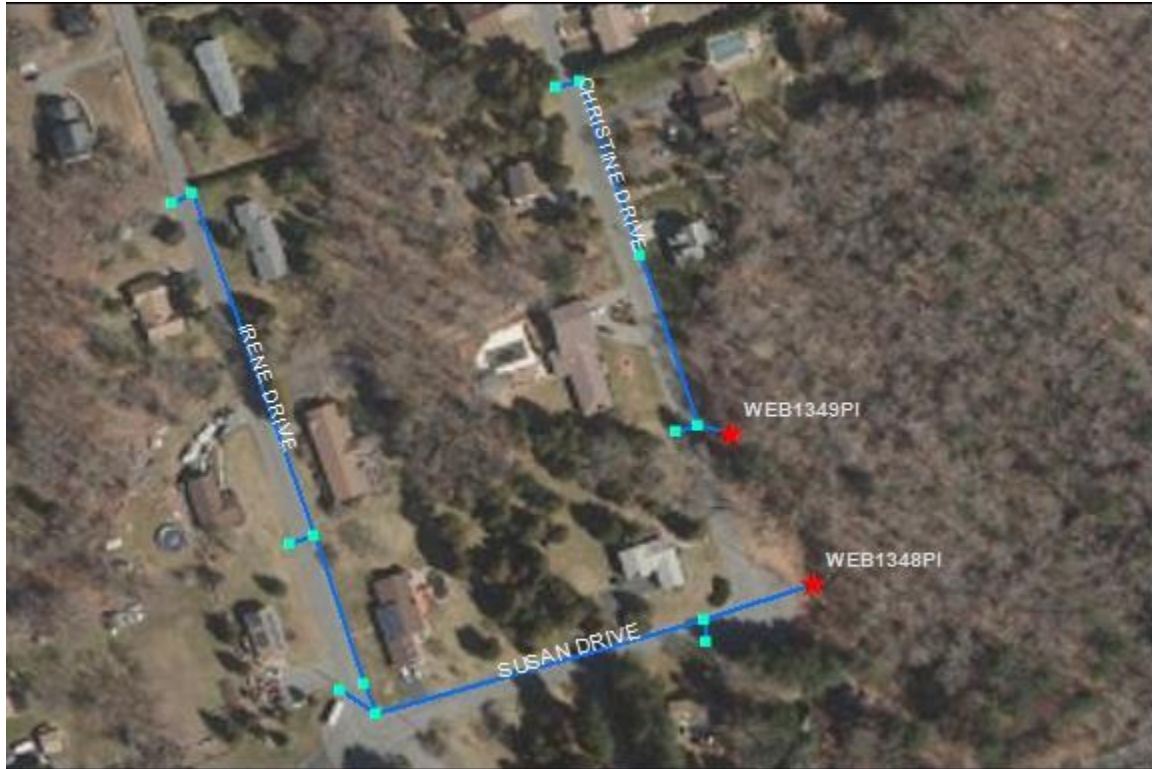
WEB1348PI and WEB1349PI- Susan Drive and Christine Drive: No significant issues found. Lots of baggies with dog waste inside catch basins all over the neighborhood. Educational outreach is suggested.

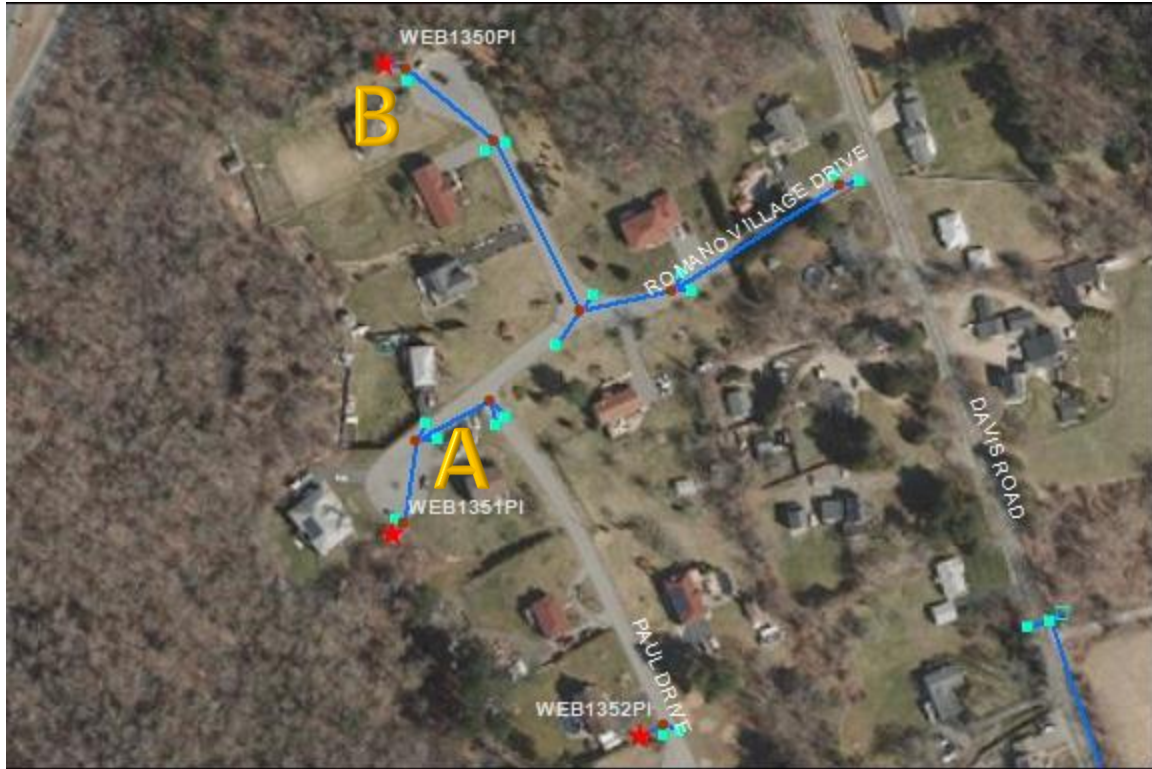
WEB1350PI, WEB1351PI, and WEB1352PI- Romano Village Drive and Paul Drive: No major issues found. At point A small holes are forming around catchbasin. Preventative work by the town is suggested. At point B an excessive number of cigarettes found along the area immediate to the outfall near house #14 on Romano Village Drive.

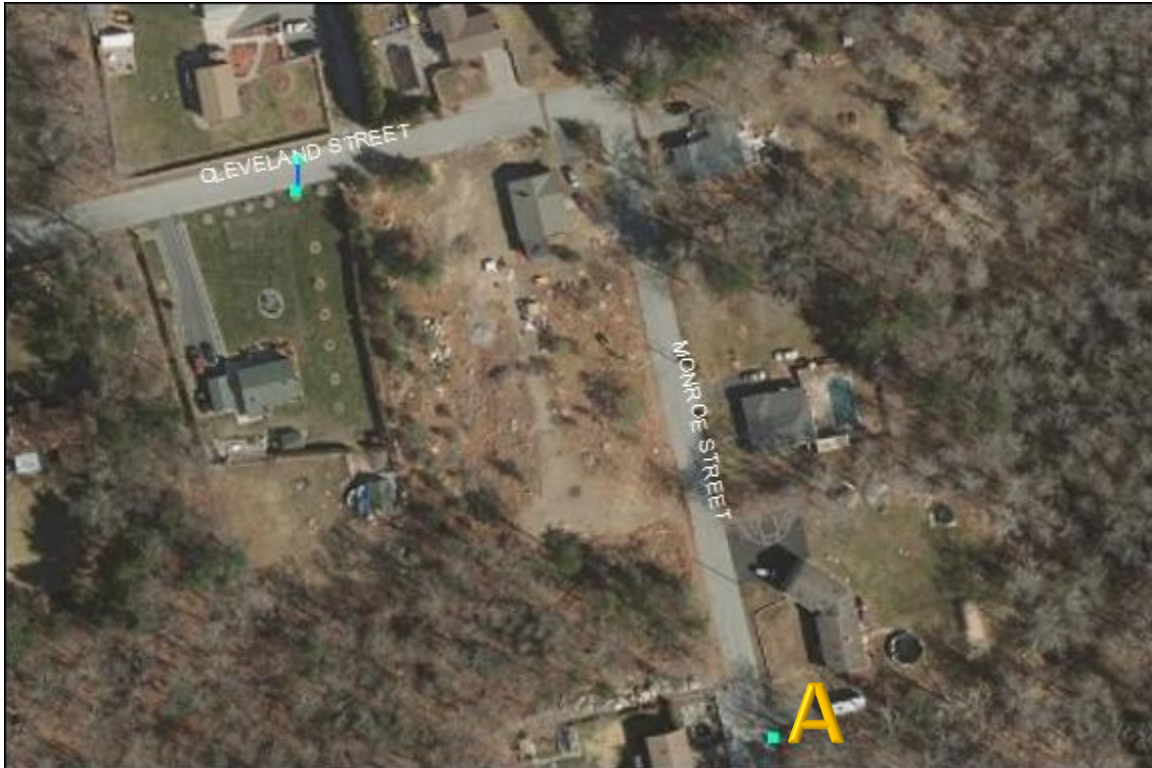
Cleveland Street and Monroe Street: No significant issues found. Two 6" PVC pipes enter basin at point A, both are extremely clogged. No outfall pipes were observed exiting any of the catchbasins.

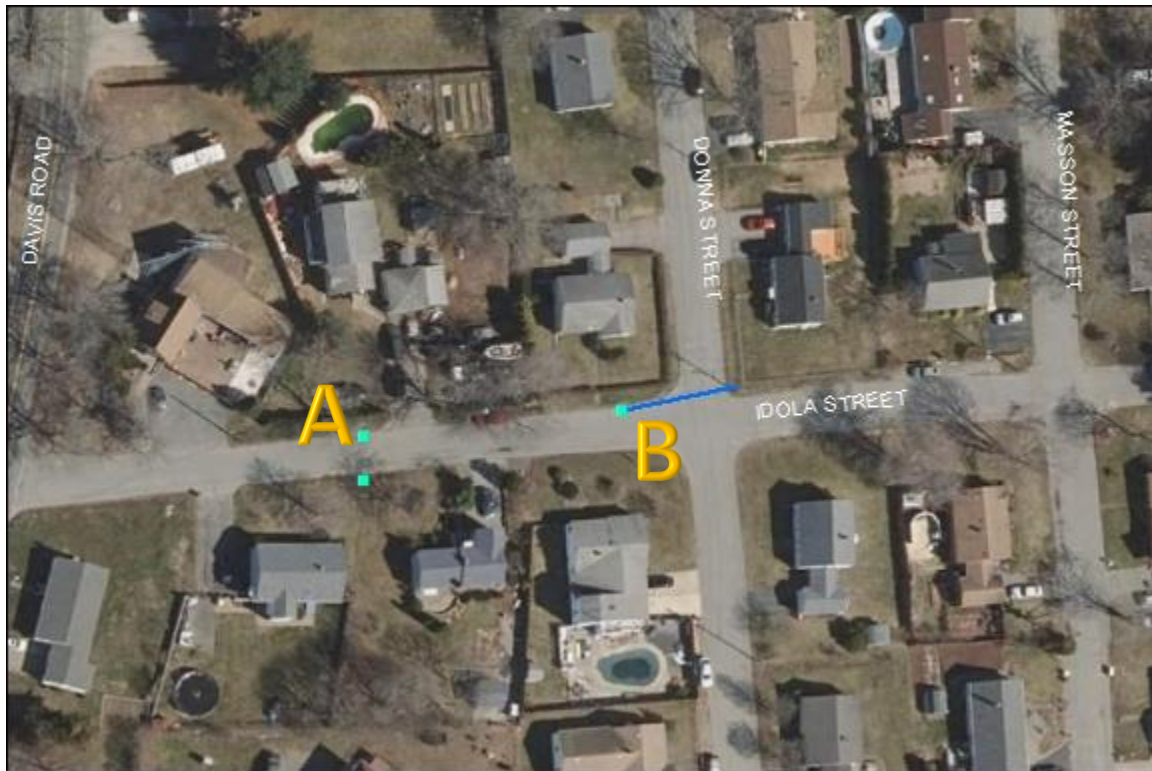
Idola Street: No significant issues found. At point A cooked crawfish were found dumped in the basin. At point B a pipe enters the catch basin. Its origin is unknown. Further investigation is recommended.

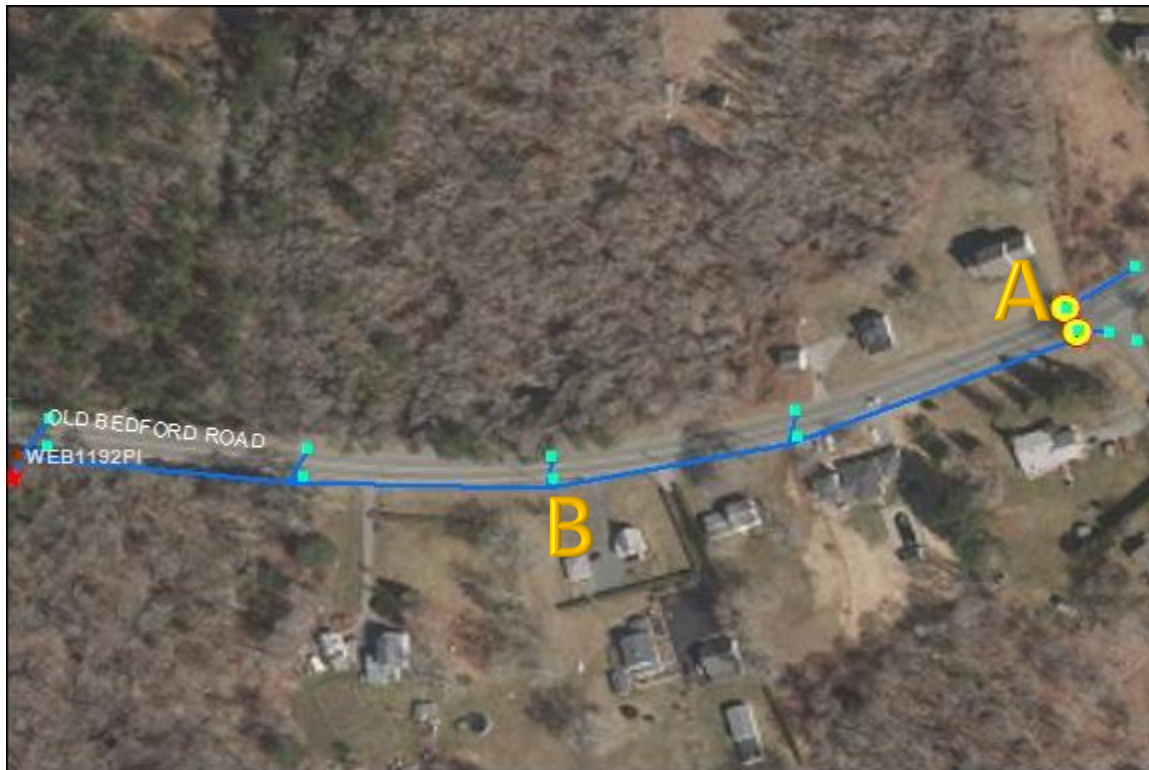
WEB1192PI- Old Bedford Road: No issues found. At point A two interconnections are shown between the town of Dartmouth and the Town of Westport. At point B, the catchbasin is beginning to sink. Preventative work by the town is suggested.

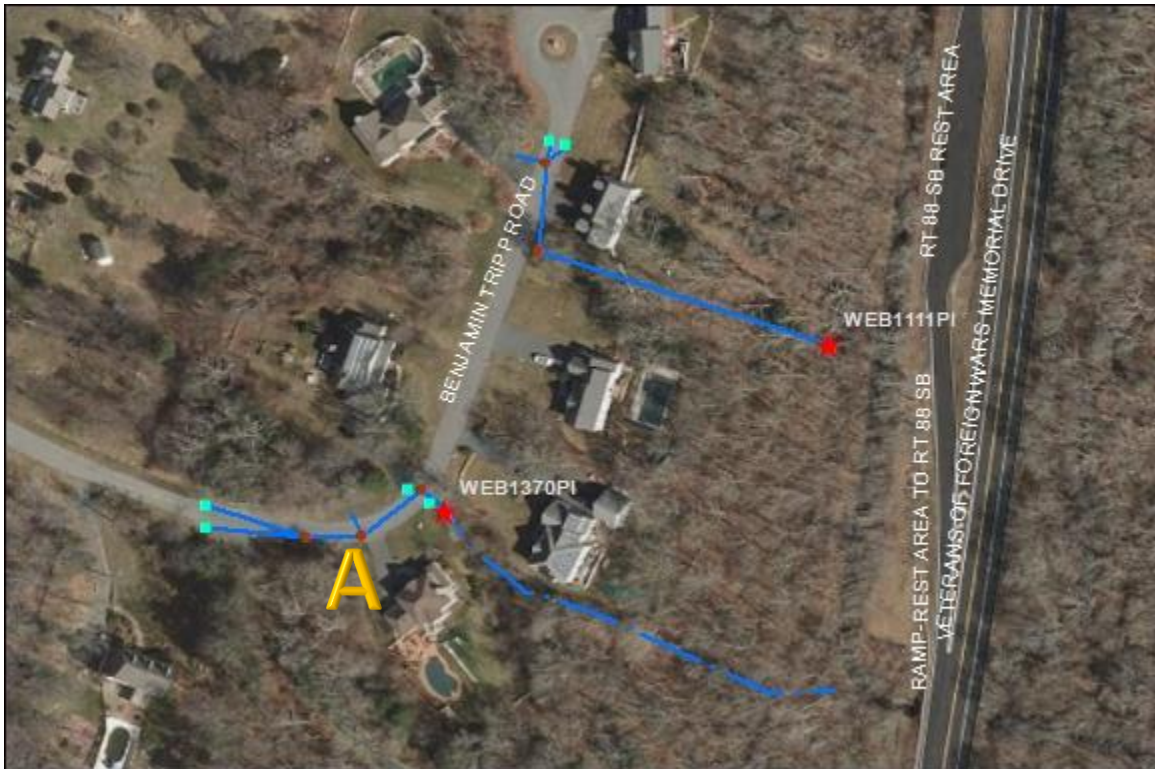
WEB1111PI and WEB1370PI- Benjamin Tripp Road: The pipe entering the manhole at point A has an unknown origin. Further investigation is recommended.

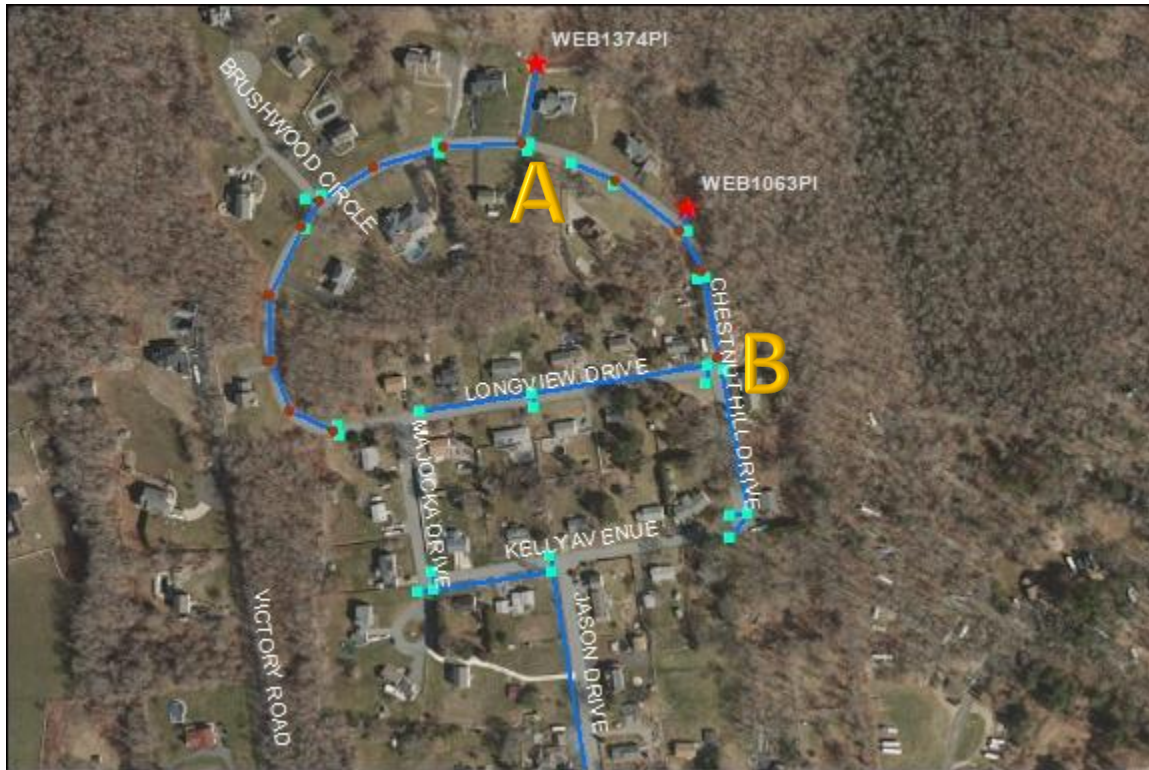
WEB1374PI and WEB1063PI- Chestnut Hill Drive: No significant issues found. At point A the catchbasin is slightly sunken. At point B, the bricks inside the catchbasin have begun to crumble. Preventative work is suggested.

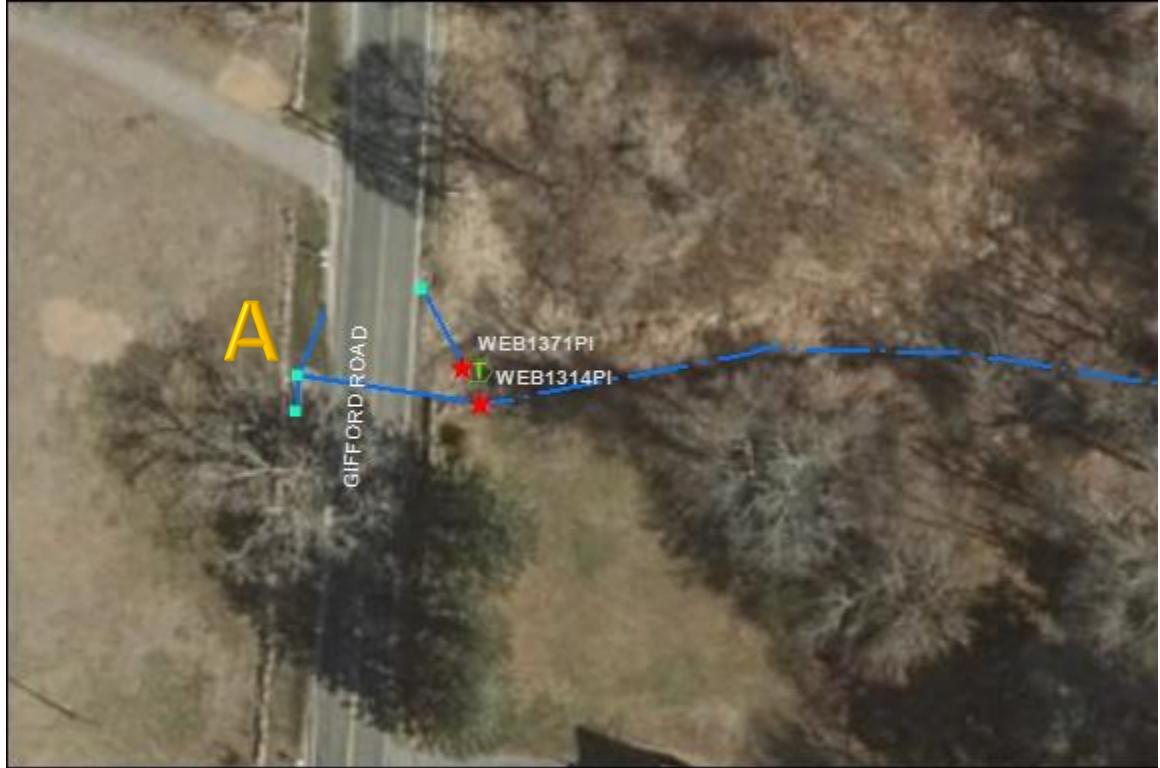
WEB1371PI and WEB1314PI- Gifford Road: No significant issues found. At point A, a pipe enters the catchbasin its origin is unknown. Further investigation is recommended.

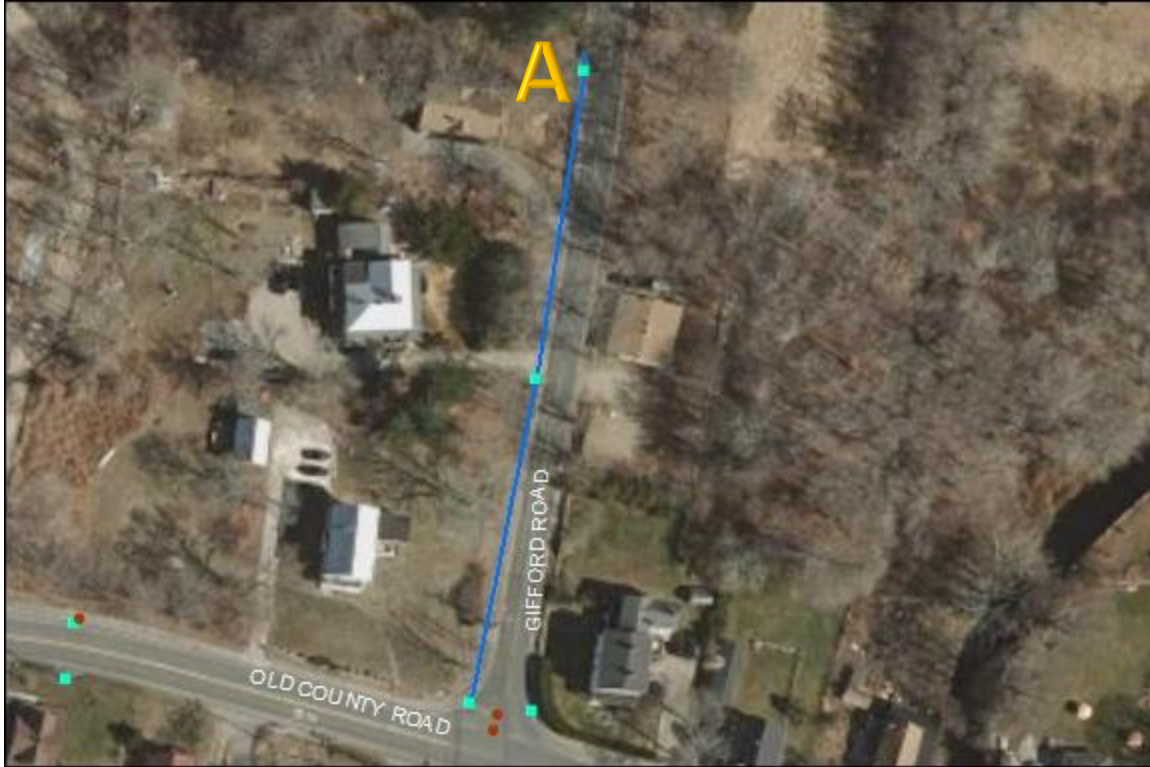
Gifford Road: At point A, a pipe enters the catchbasin. Its origin is unknown. Further investigation is recommended. The catchment continues to Old County Road and discharges into the Westport River. A police detail will be needed to investigate Old County Road.

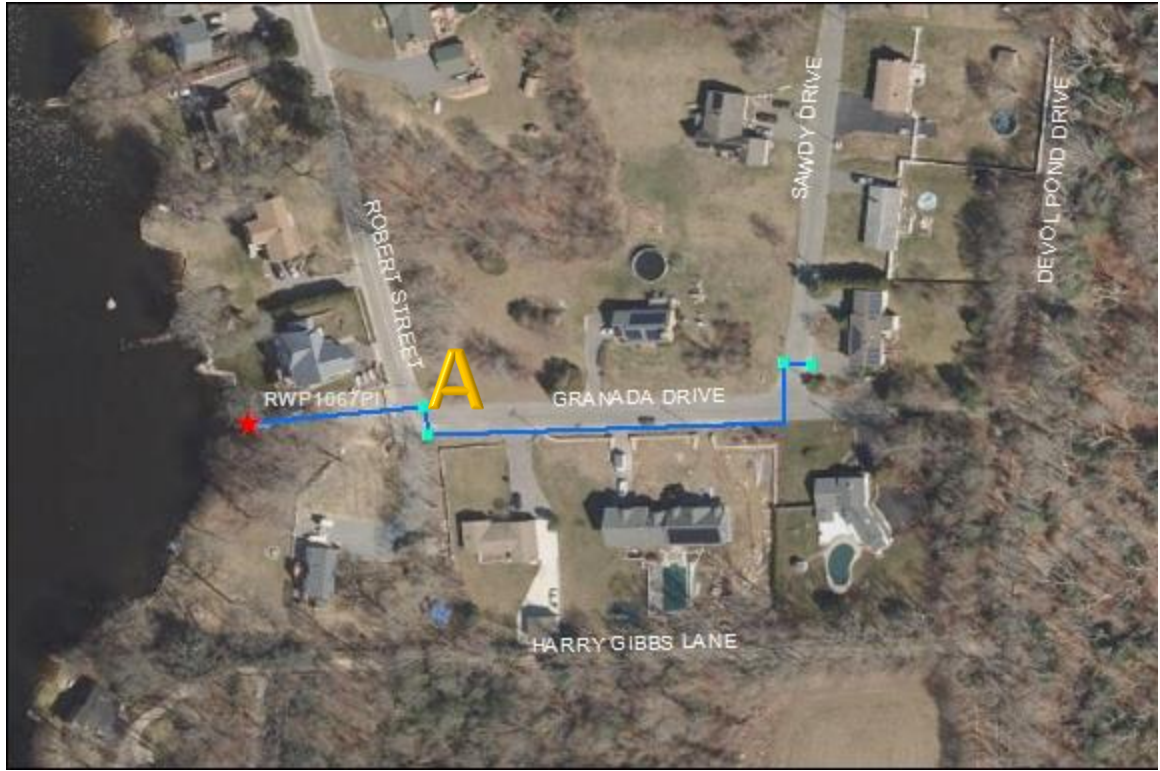
RWP1067PI- Granada Drive: At point A, the catchbasin is caving in. Further attention by the town is strongly recommended.

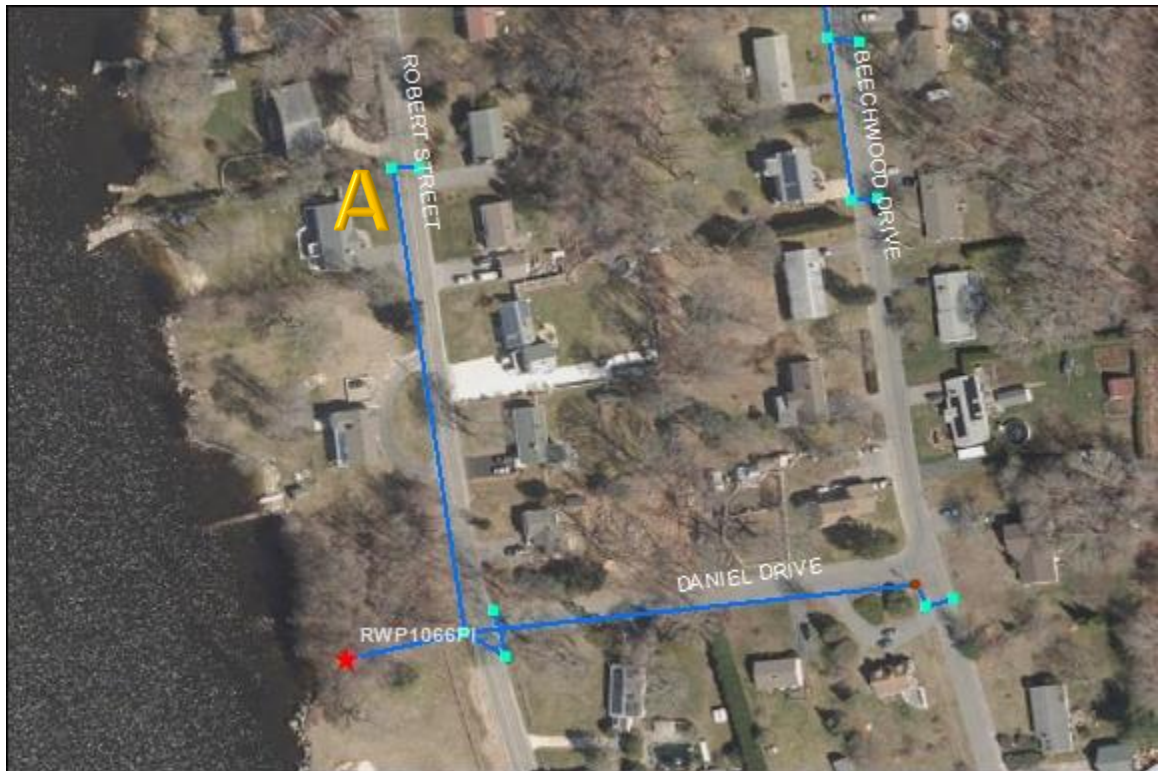
RWP1066PI- Robert Street and Daniel Drive: No significant issues found. At point A the catchbasin is beginning to sink. Preventative measures recommended.

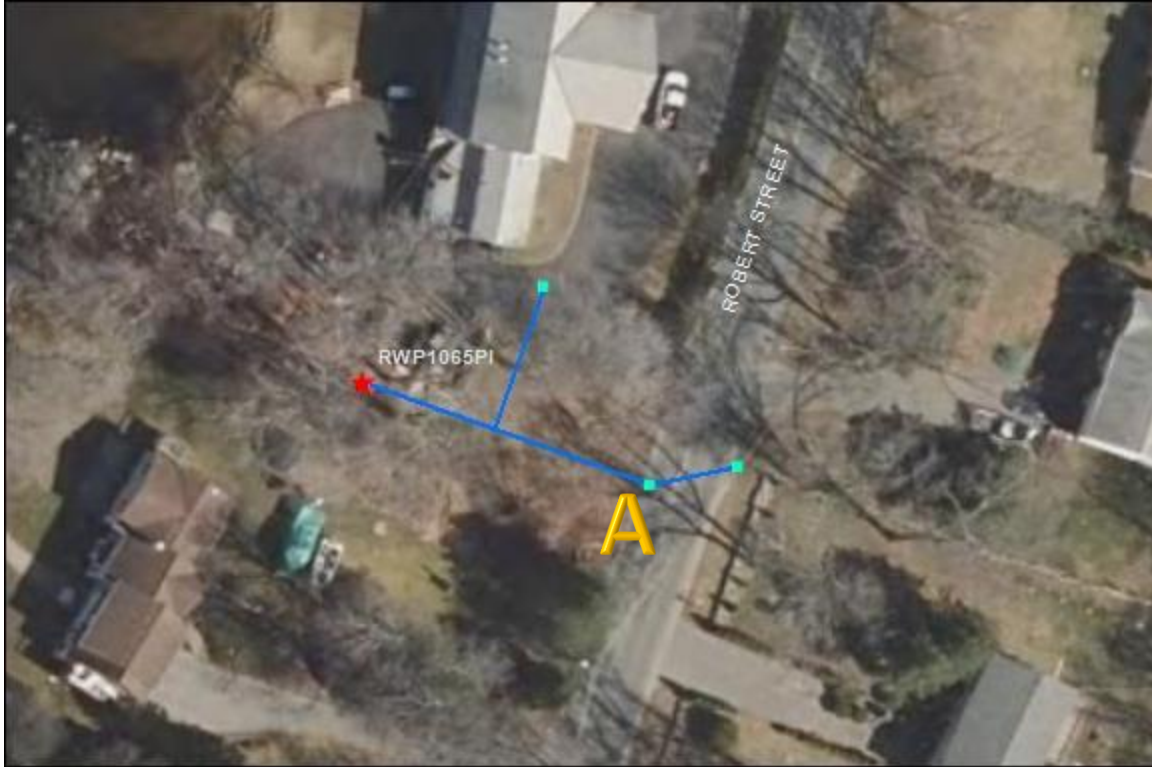
RWP1065PI- Robert Street- No significant issues found. At point A the catchbasin is starting to sink. Preventive measures are recommended.
