**The Buzzards Bay Stormwater Collaborative
Illicit Discharge Investigation Trailer**

Town of Westport Report

August 2022

Westport IDDE Report

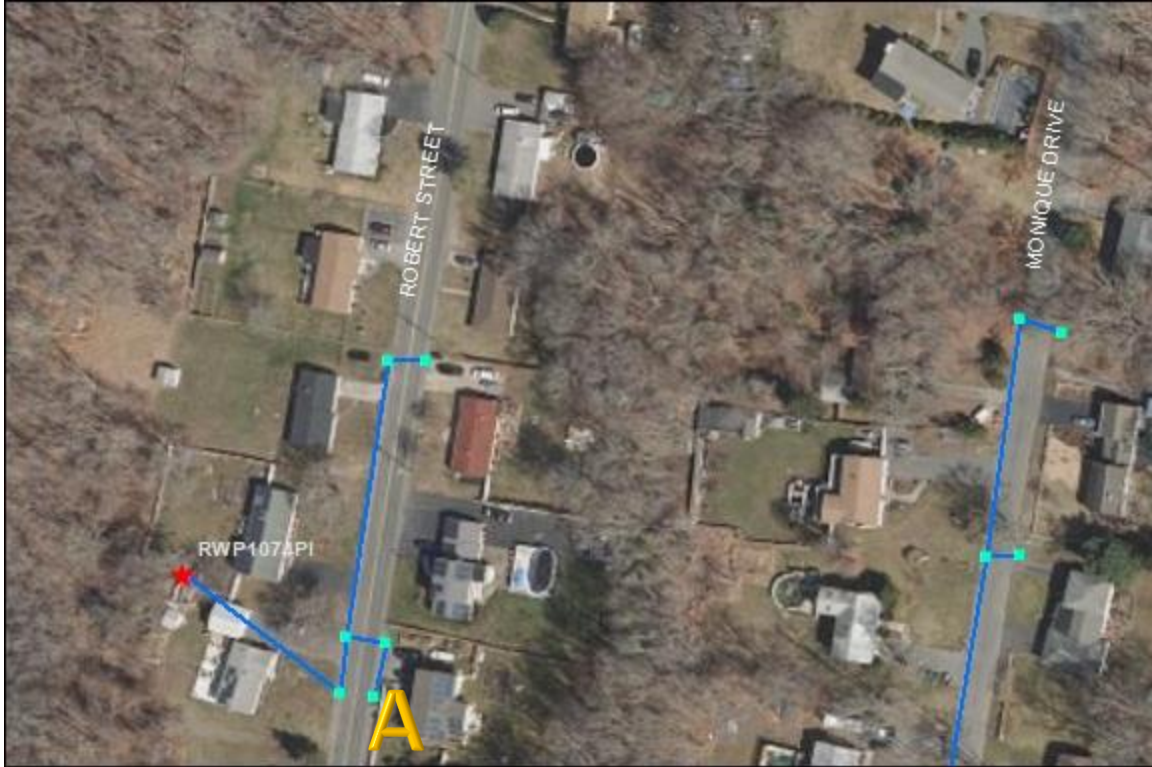
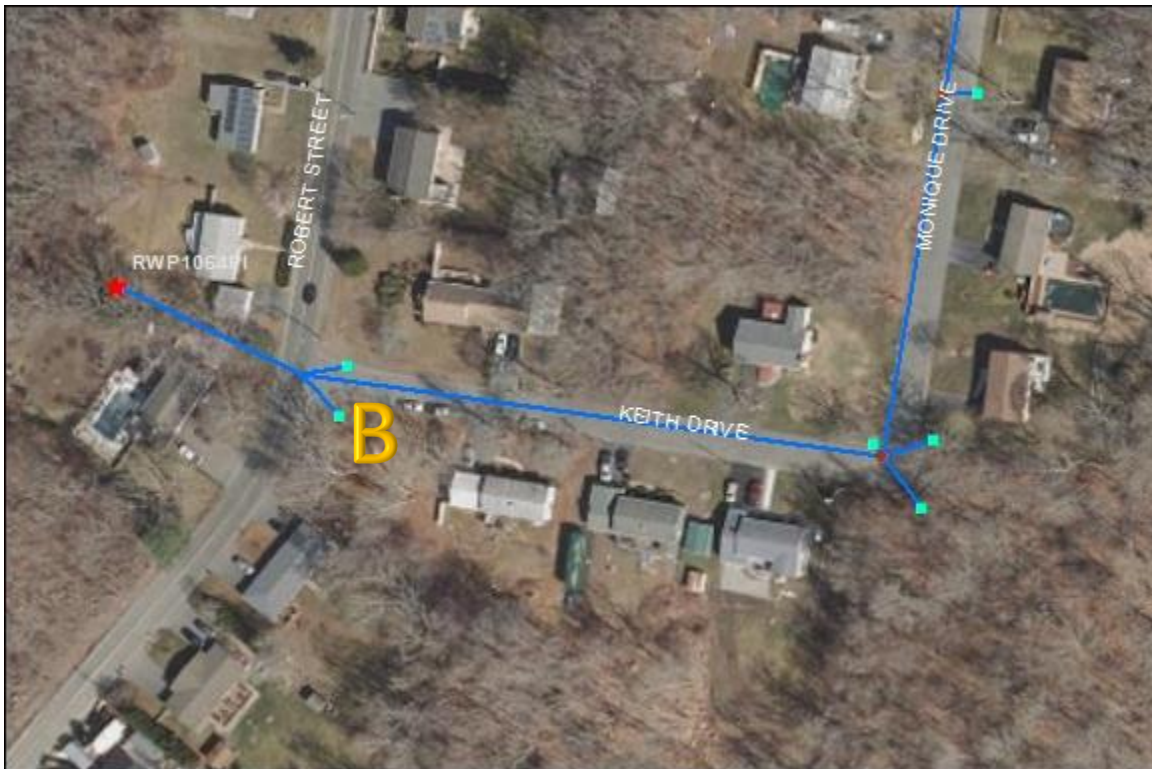
RWP1074PI and RWP1064PI- Robert Street, Keith Drive, and Monique Drive: At point A and B the bricks making up the catchbasins' walls are crumbling or missing. Further attention is strongly recommended.

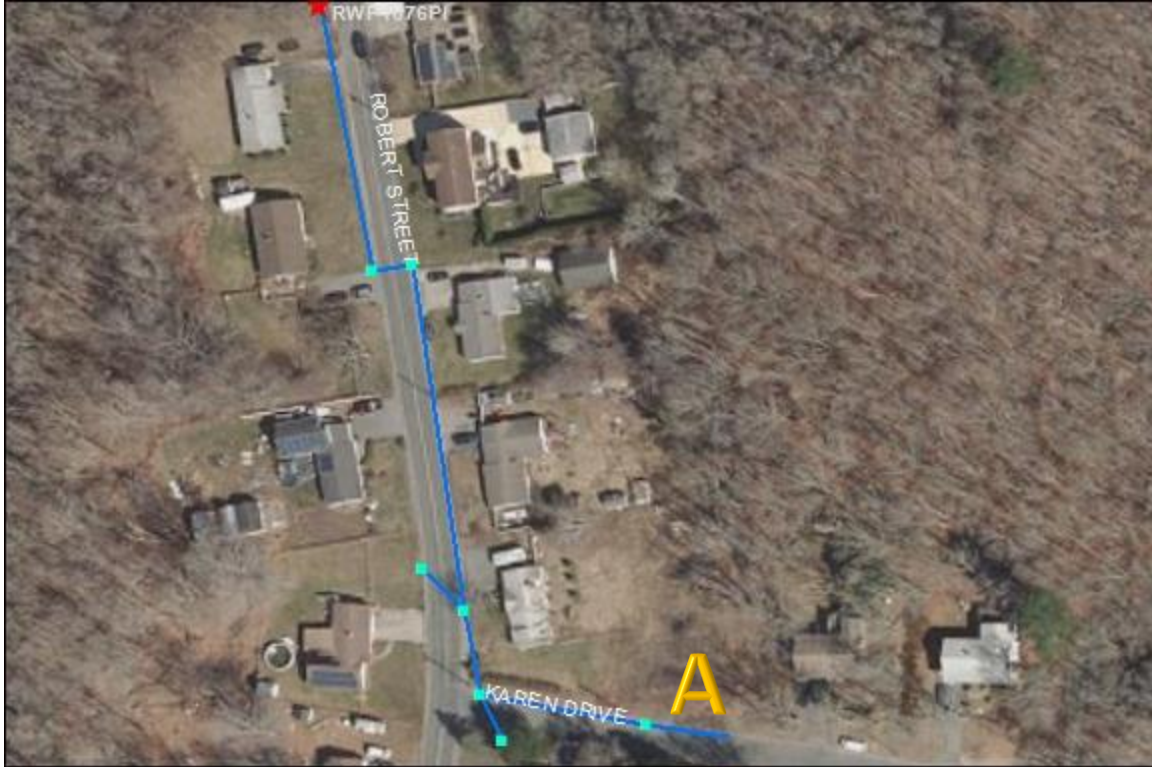
RWP1076PI-Robert Street: No issues found. A twelve-inch metal pipe was observed entering the catchbasin at point A. Its origin is unknown. Further investigation is suggested. Outfall was inventoried.

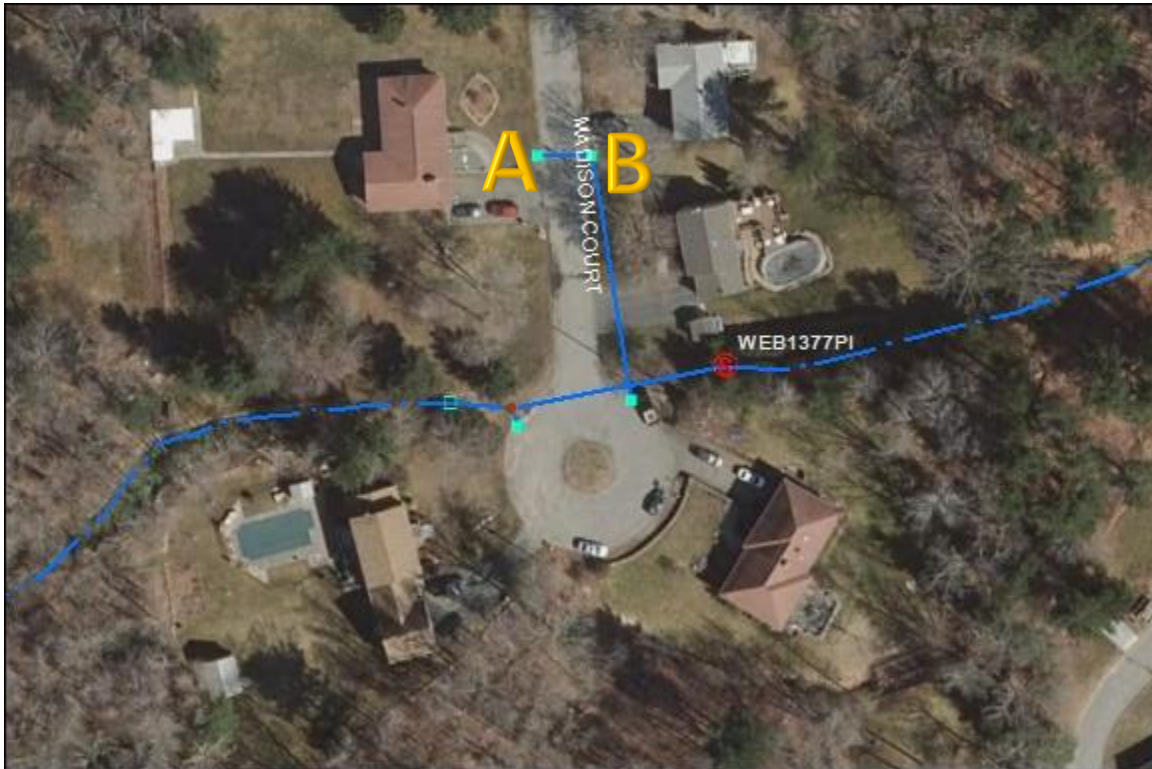
WEB1377PI- Madison Court: SUSPECTED ILLICIT CONNECTION. At point A the catchbasin was full of white suds. It is believed that the source is a 4" PVC pipe coming from the direction of house #15 on Madison Court. Further action is NECESSARY. At point B there are two incoming pipes, one from the North and one from the East, both with unknown origins. Further investigation is recommended.

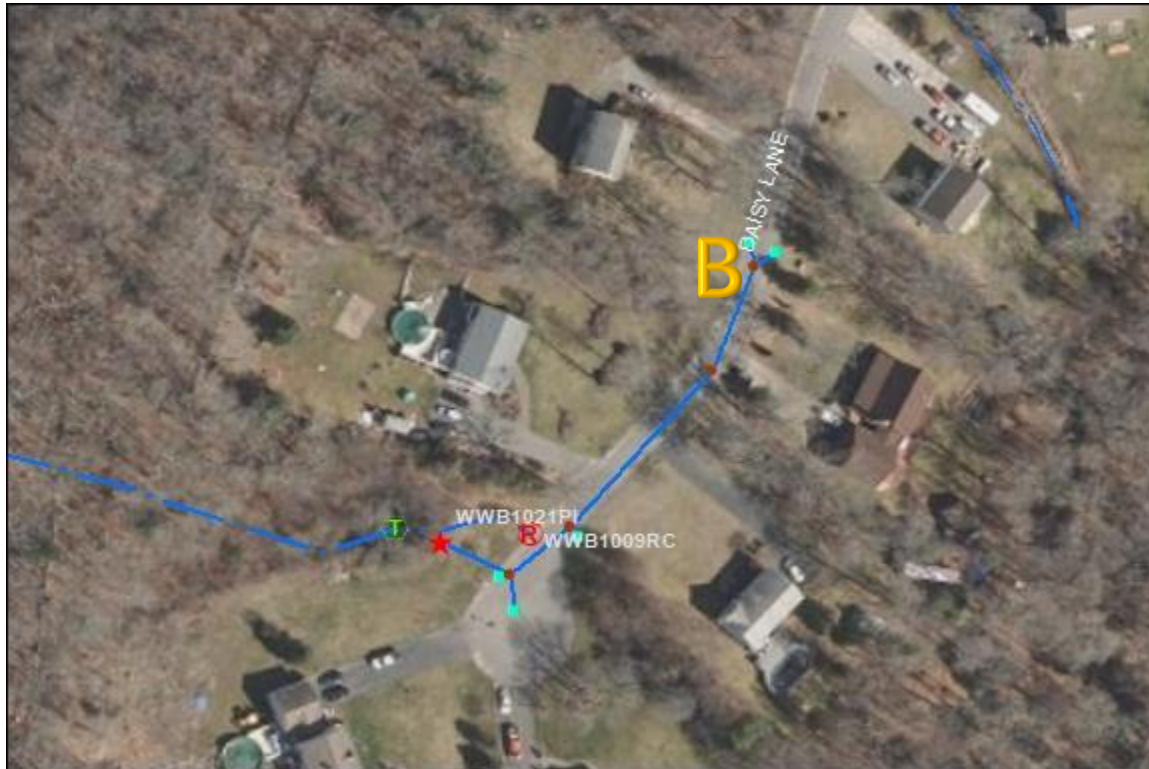
WWWB1021PI and WWWB1009RC- Daisy Lane: No significant issues. Manhole at point B is cracked. A replacement is recommended.

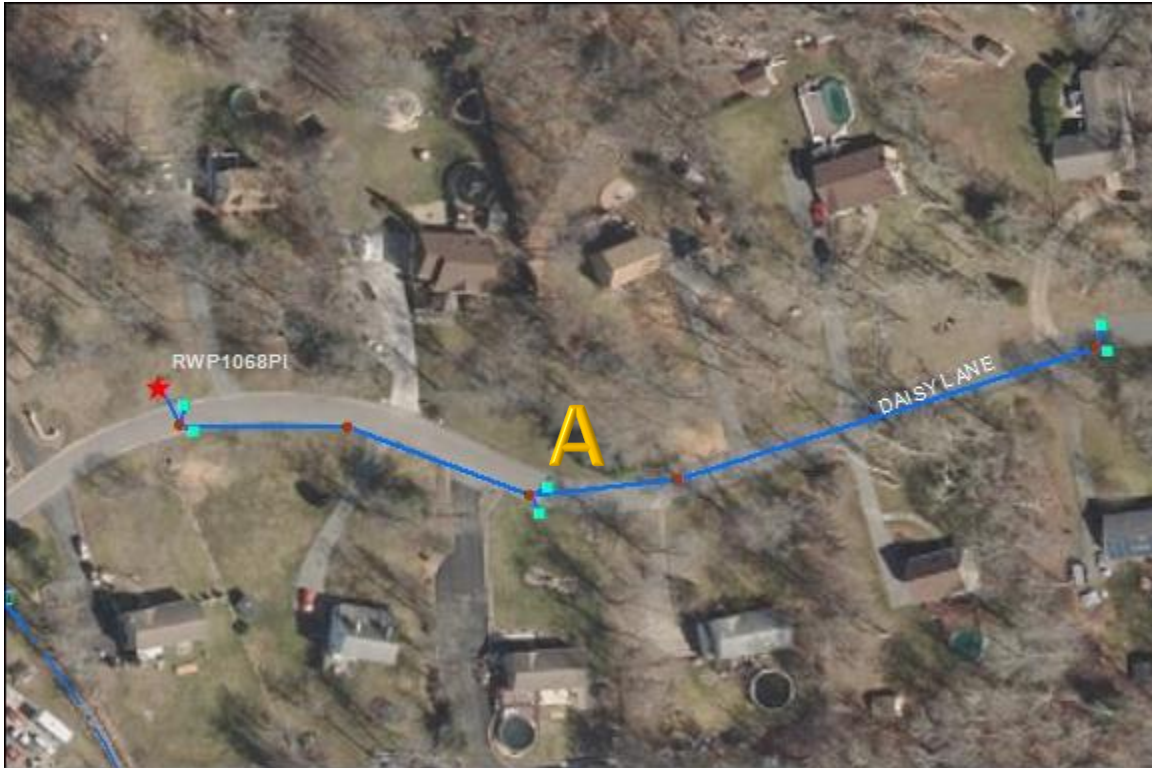
RWP1068PI- Daisy Lane: No significant issues found. At point A, the catchbasin is beginning to sink. Preventative measures are recommended.

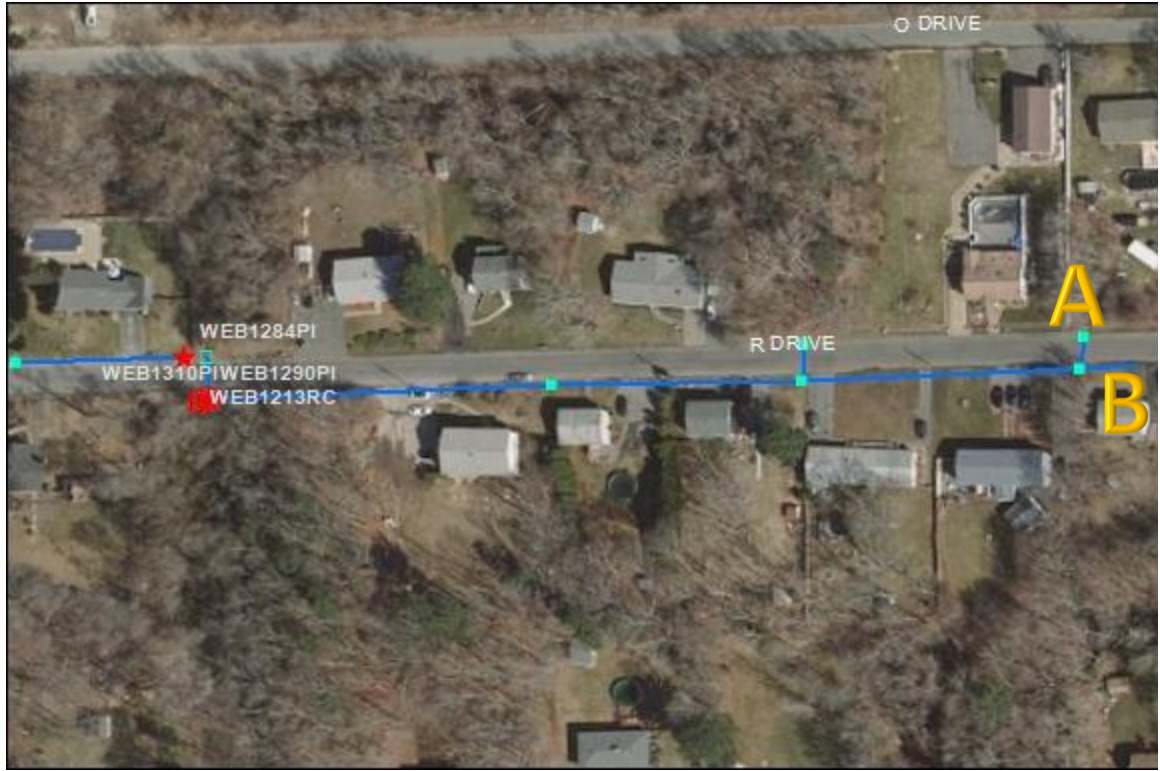
WEB1310PI, WEB1284PI, WEB1290PI, and WEB1213RC- R Drive: At point A the area around the catchbasin has sunken significantly. Further attention is strongly recommended. At point B a pipe enters the catchbasin its origin is unknown. Further investigation is recommended.

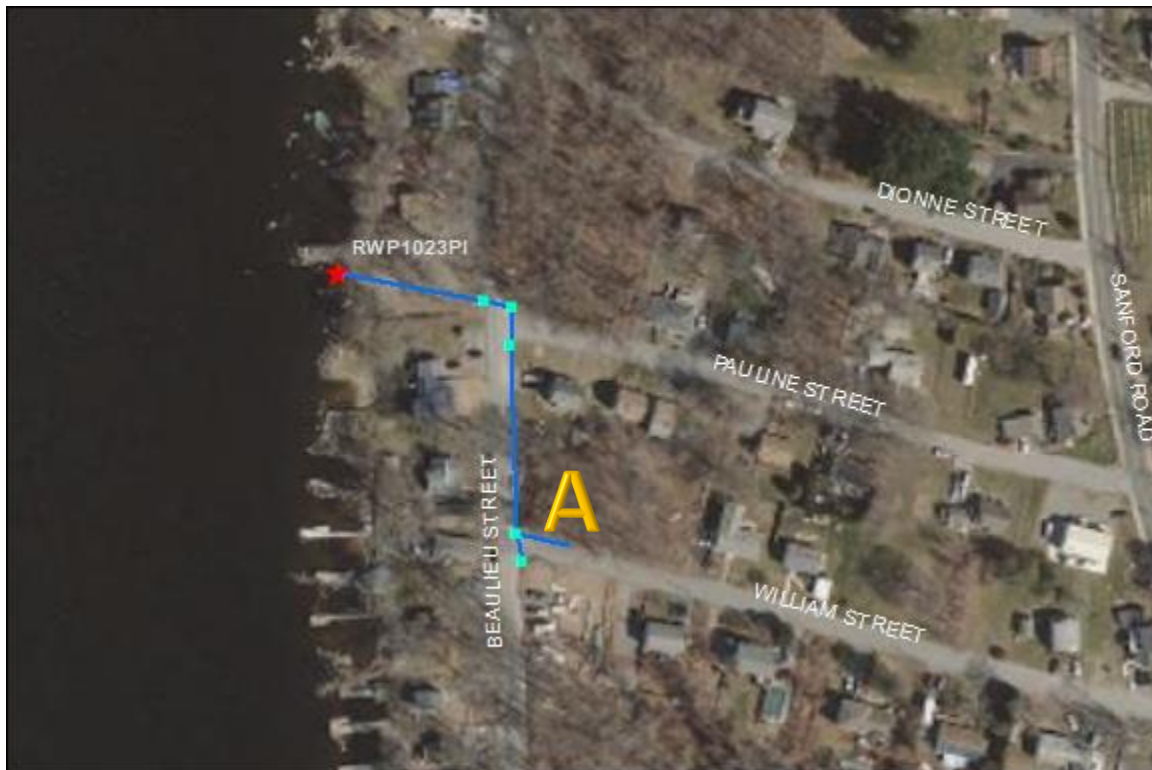
RWP1023PI- Beaulieu Street: No issues found. At point A, a 15" metal pipe enters the catchbasin. Its origin is unknown. Further investigation is suggested.

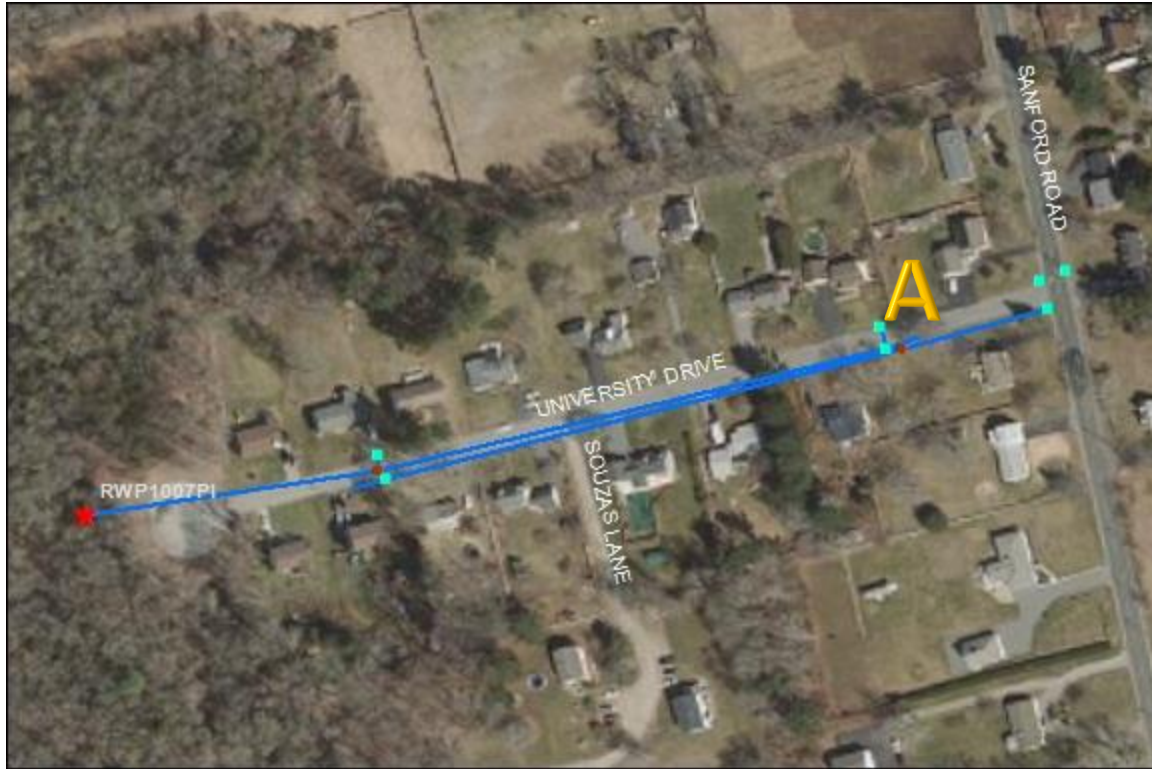
RWP1007PI- University Drive: SUSPECTED ILLICIT CONNECTION. At point A the catchbasin was full of white suds. It is believed that the source is a 4" HDPE pipe coming from the direction of house #725 off the adjacent Sanford Road. Further action by the town is NECESSARY.
