How Land Use Affects Water Quality Characteristics of Stormwater:
A Study of Tub Mill Brook

A Thesis in
Civil and Environmental Engineering
by
Tyler Nunes Jacob

Submitted in Partial Fulfillment of the
Requirements for the Degree of
Master of Science

January 2022

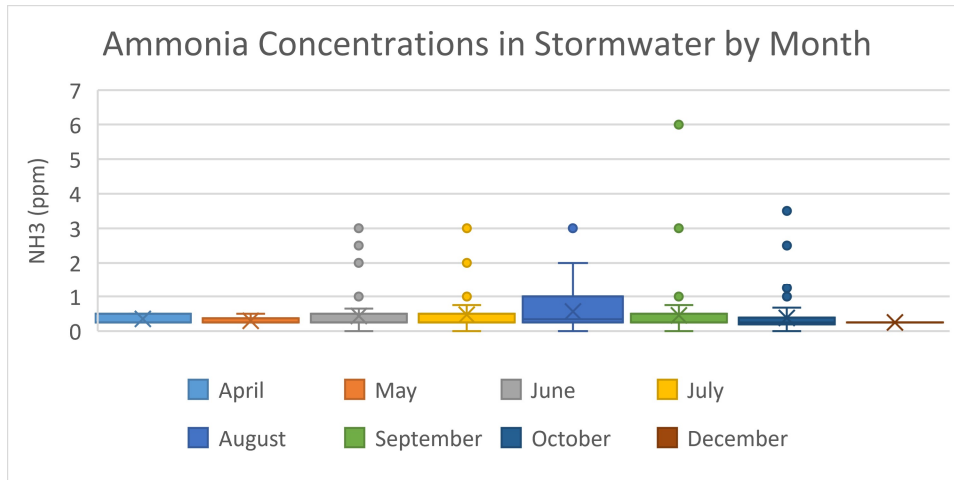
Figure 2.1 Box and Whisker Plot of Monthly Data Trends in Ammonia Concentrations with Outliers Included

To visually show the variations in contaminant concentrations from month to month, box and whisker plots are shown below for ammonia. The box and whisker plots show the mean concentration of Ammonia by month labeled as the “x” and the “boxes” represent the range of values encompassed by the median 50% of the data. The “whiskers,” or the lines extending from the central box, show the highest and lowest values in the data set that are not outliers. Outliers are marked as individual colored points. Data points are considered outliers when they exceed one and a half times the interquartile range (IQR, difference between 1st and 3rd quartiles) above the 3rd quartile or below the 1st quartile. Take an example data set, which has a minimum value of 2, a maximum value of 52, the 1st quartile is 5, and the 3rd quartile is 21. In this example data set, interquartile range (IQR) is 16, which means any value below -19 or above 45 would be considered an outlier. In the context of statistics, these outliers tend to skew the data set and significantly change the mean value of the data set, especially when all the outliers are positioned on the same extreme of the data range. Figure 2.2 graphs the same box and whisker plot without showing the outliers. This gives a more focused view on the range of values not considered outliers, which clarifies and visualizes the major variations of ammonia concentrations without showing the influence of values that fall on the extreme ends of the data sets.

From viewing both figures, the concentration of ammonia does not vary greatly during the months of April, May, and December, with Figure 2.2 showing that the mean ammonia concentration during each month was close to 0.25 ppm, and the range of values extending from 0.25 ppm to 0.5 ppm. Variations in ammonia concentration during the months of June, July,

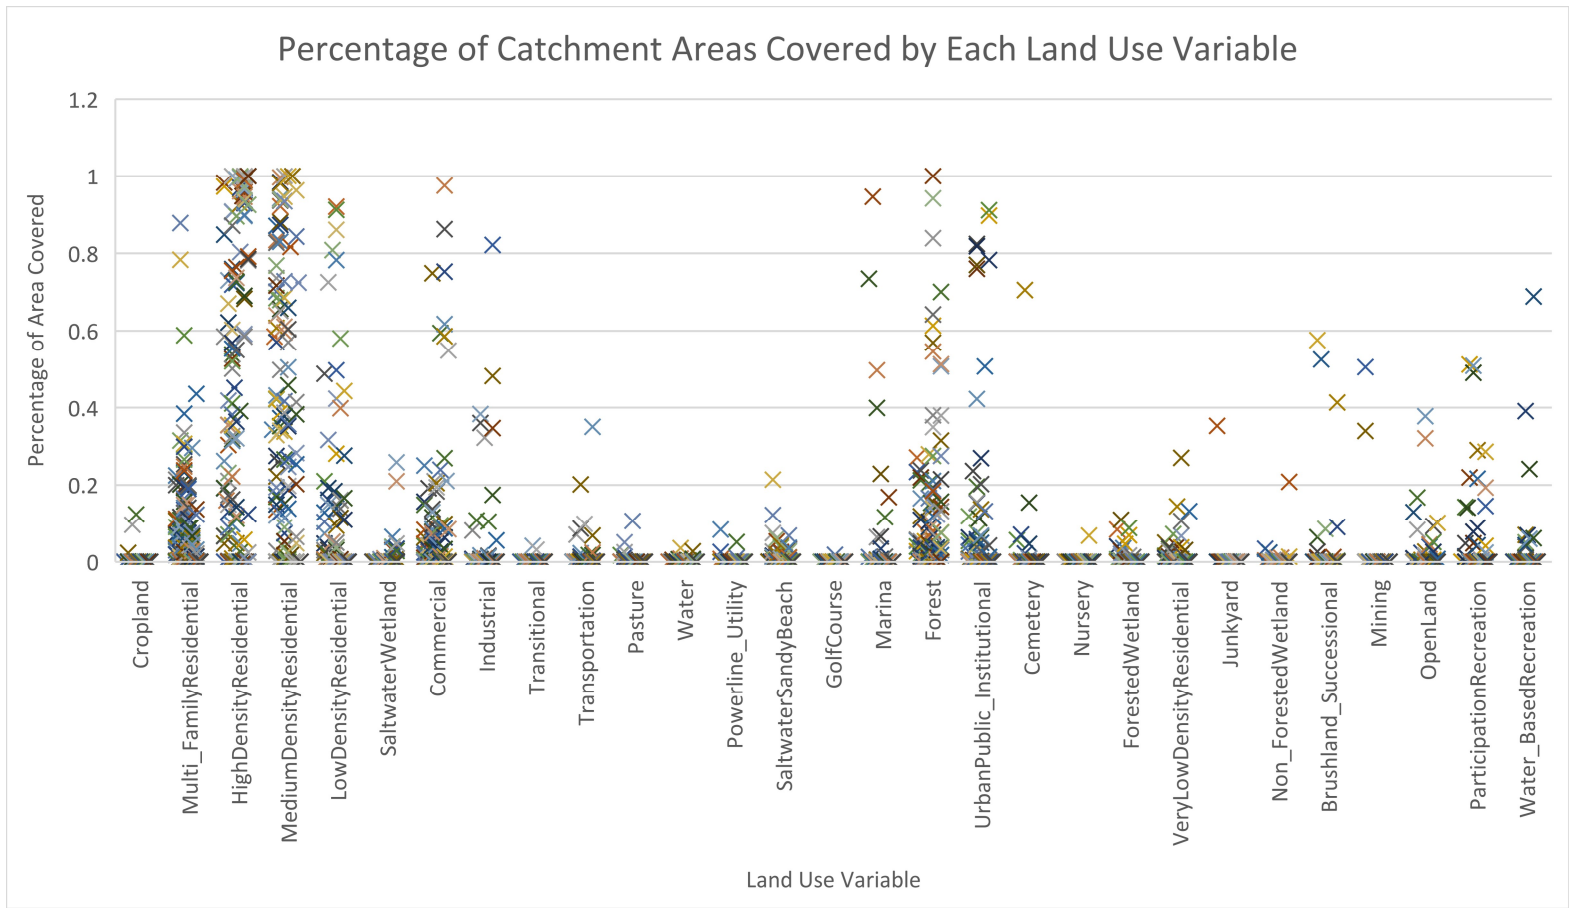
Figure A.1: Percentage of Area Covered by Land Use Variables, with Each Catchment Marked in a Different Color
