**The Buzzards Bay Stormwater Collaborative
Illicit Discharge Investigation Trailer**

Town of Bourne Report

November 2022

Bourne IDDE Report

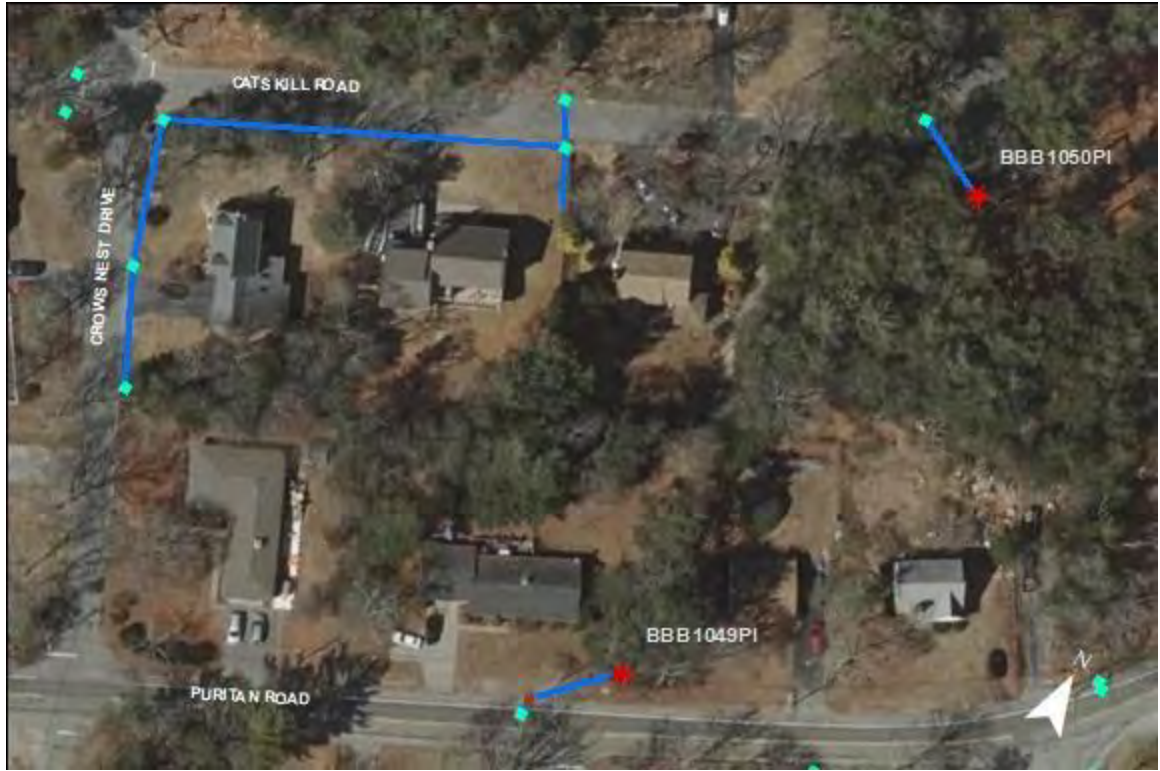
BBB1050PI- Catskill Road: No issues found. Former discharge pipe on Catskill Road blocked. Location of current discharge unknown. Further investigation needed. BBB1049PI- Puritan Road: No issues found.

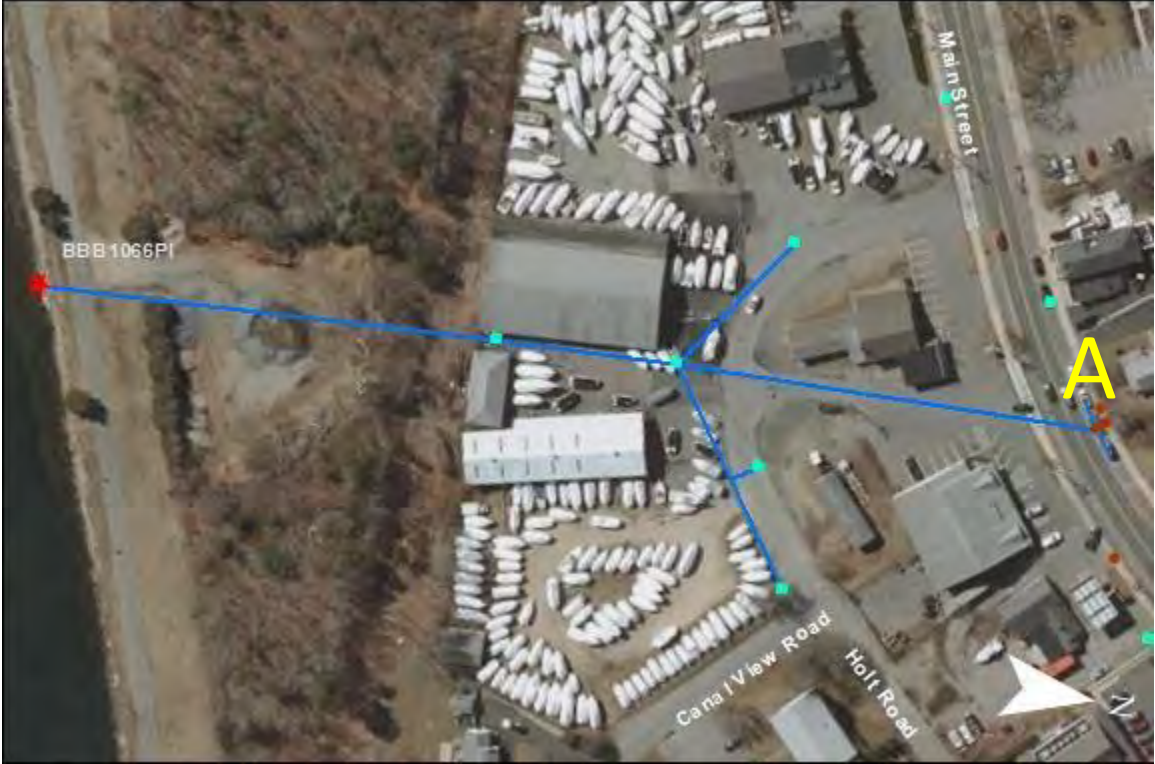
Canal View Road: No issues found. At point A, a pipe enters the catchbasin, its origin is unknown. Further investigation is recommended.

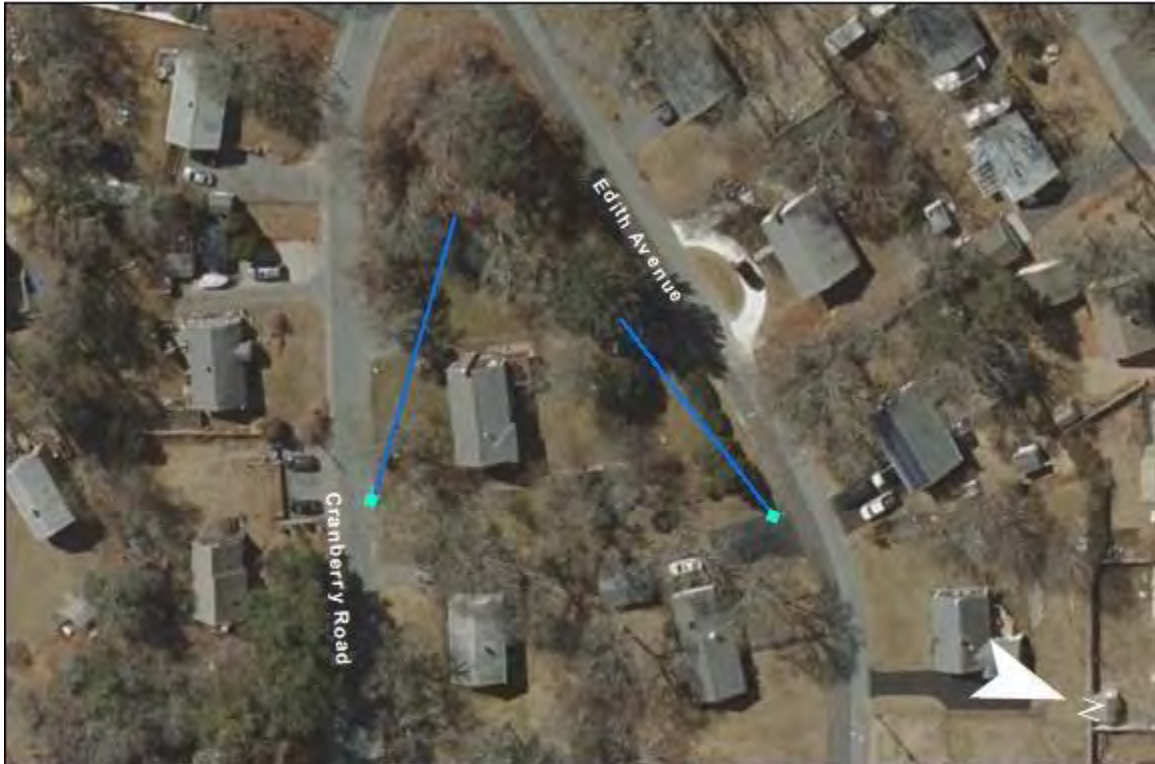
Cranberry Road and Edith Avenue: No issues found. Both pipes travel toward large depression, neither of their destinations could be determined. Further investigation is suggested.

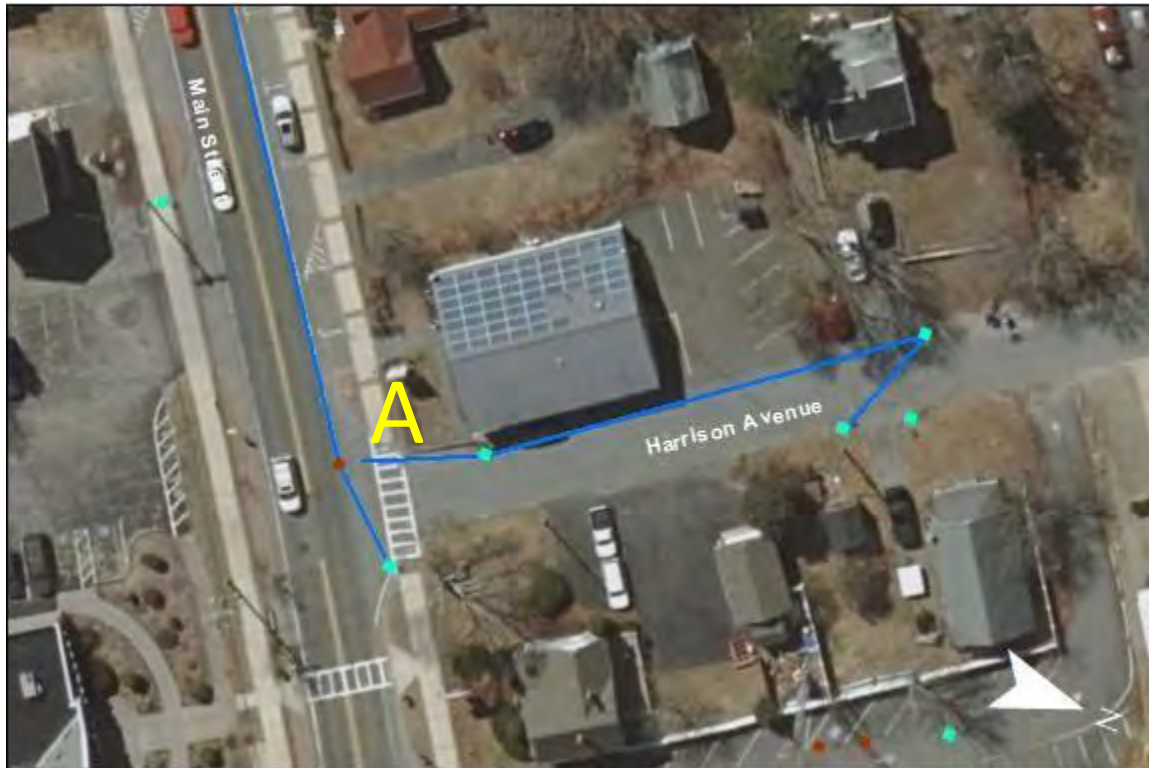
BBB1068PI- Harrison Avenue: No issues found. Pipe Enter catchbasin at point A does not appear to have any present function. Further investigation is suggested to confirm this.

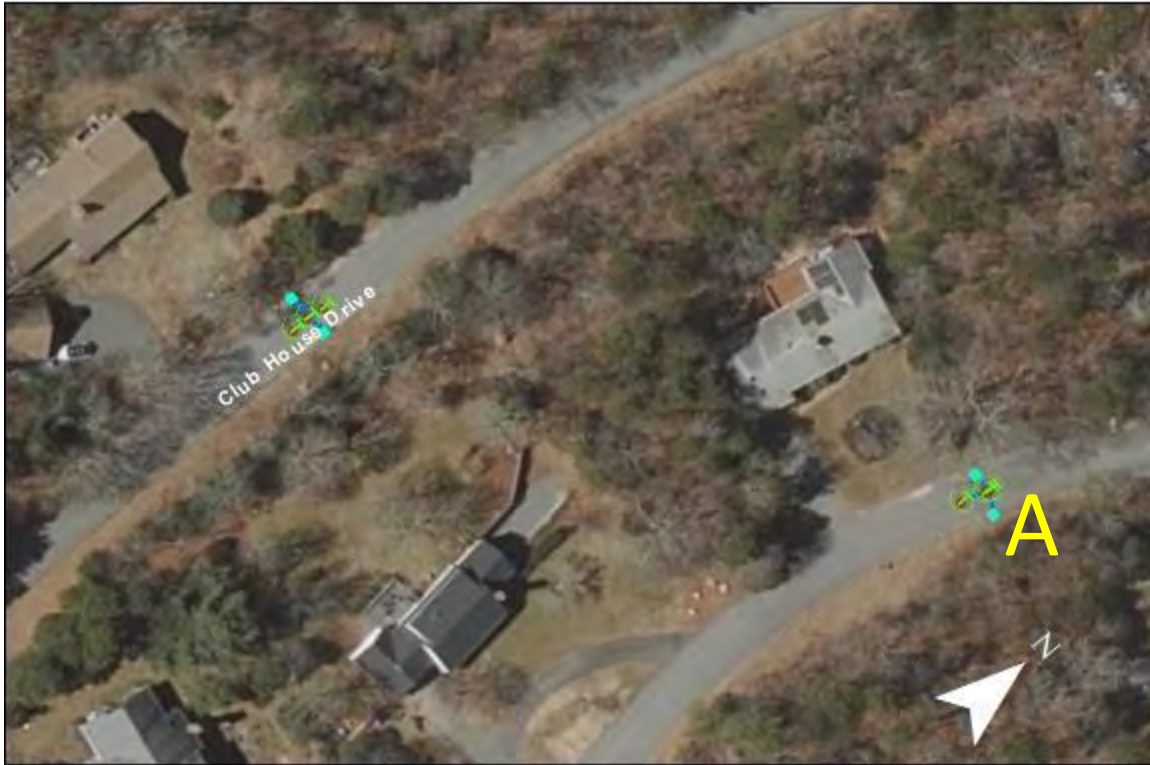
Club House Drive: No significant issues found. The catchbasin at point A is slightly sunken and may need repair.

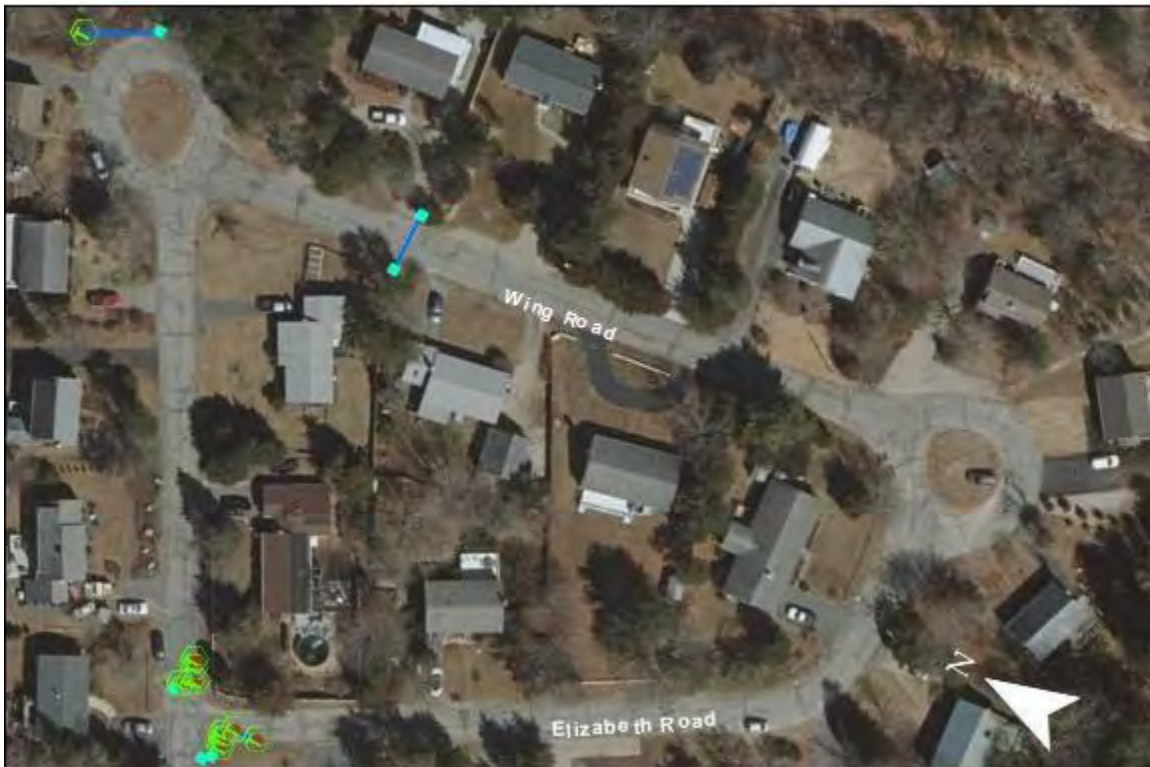
Elizabeth Road and Wing Road: No issues found.

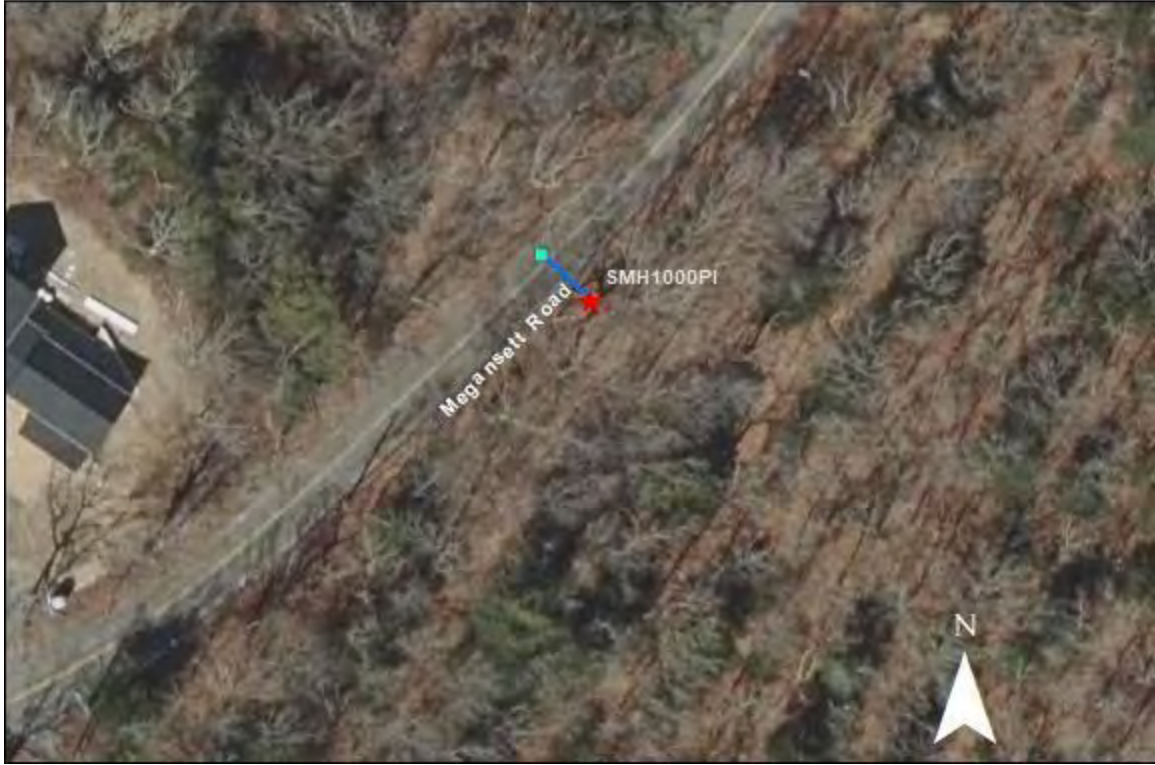
SMH1000PI- Megansett Road: No issues found.

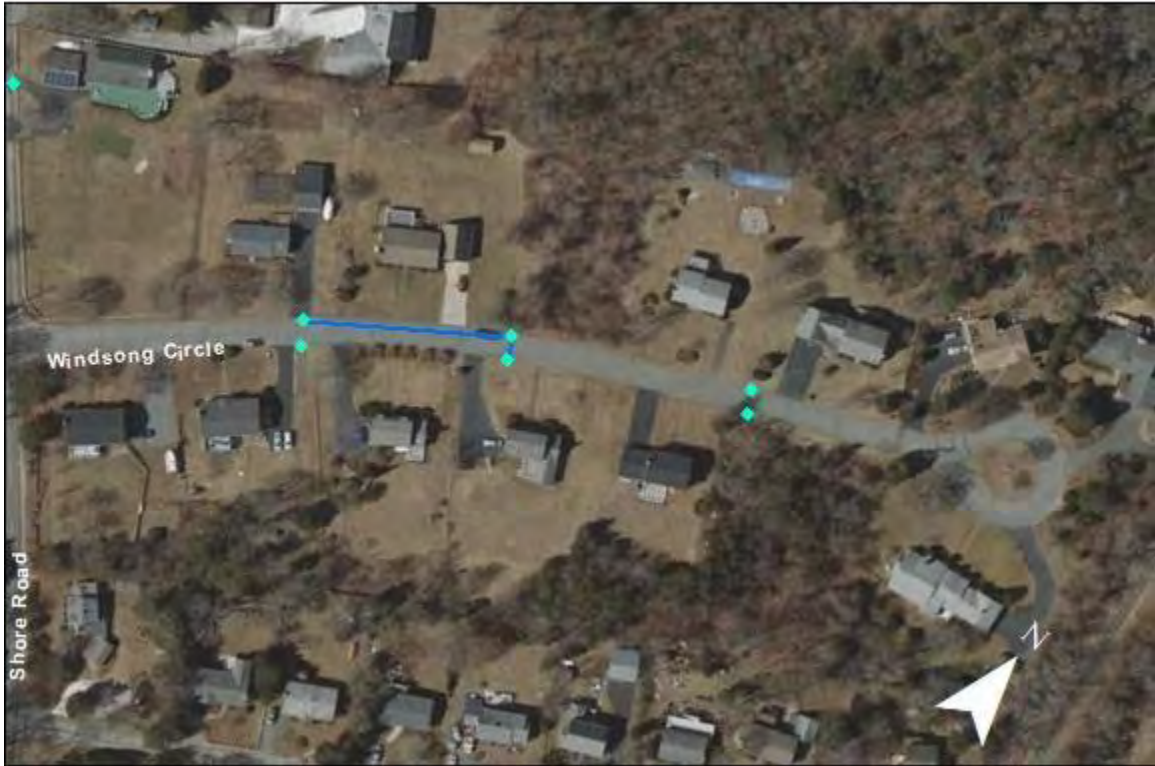
Windsong Circle: No issues found.

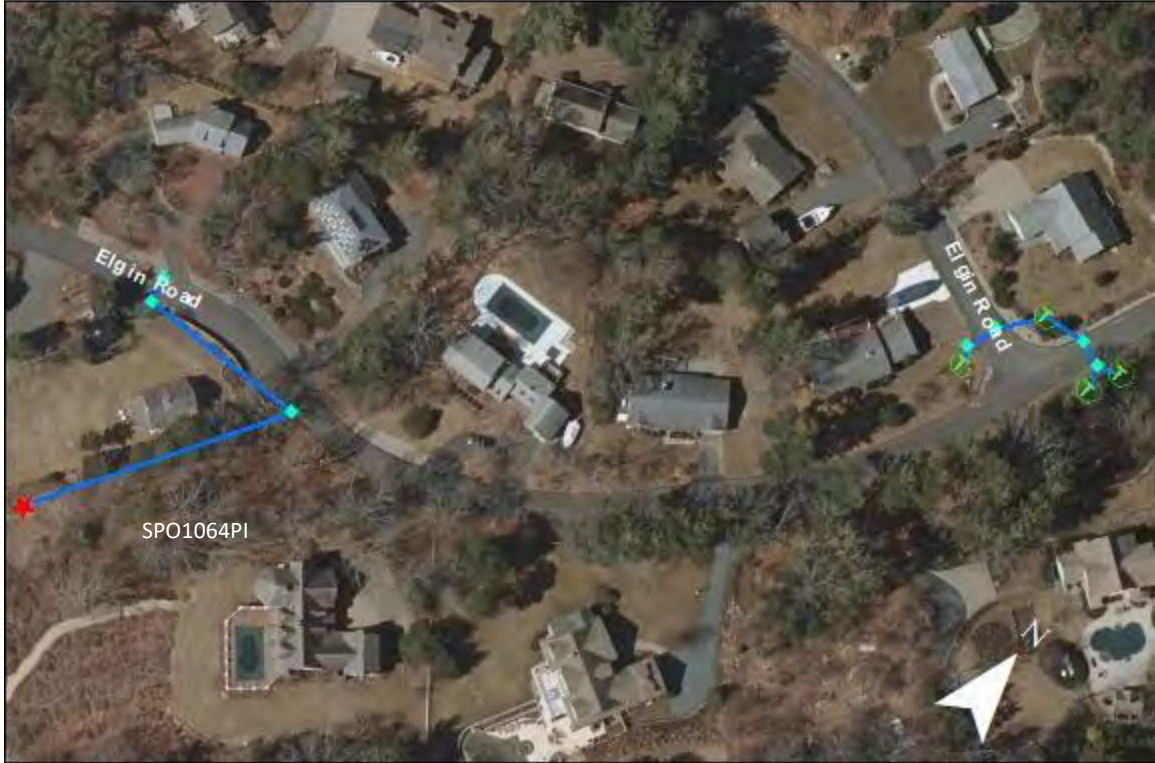
SPO1064PI- Elgin Road: No issues found. Outfall is buried but still functions.

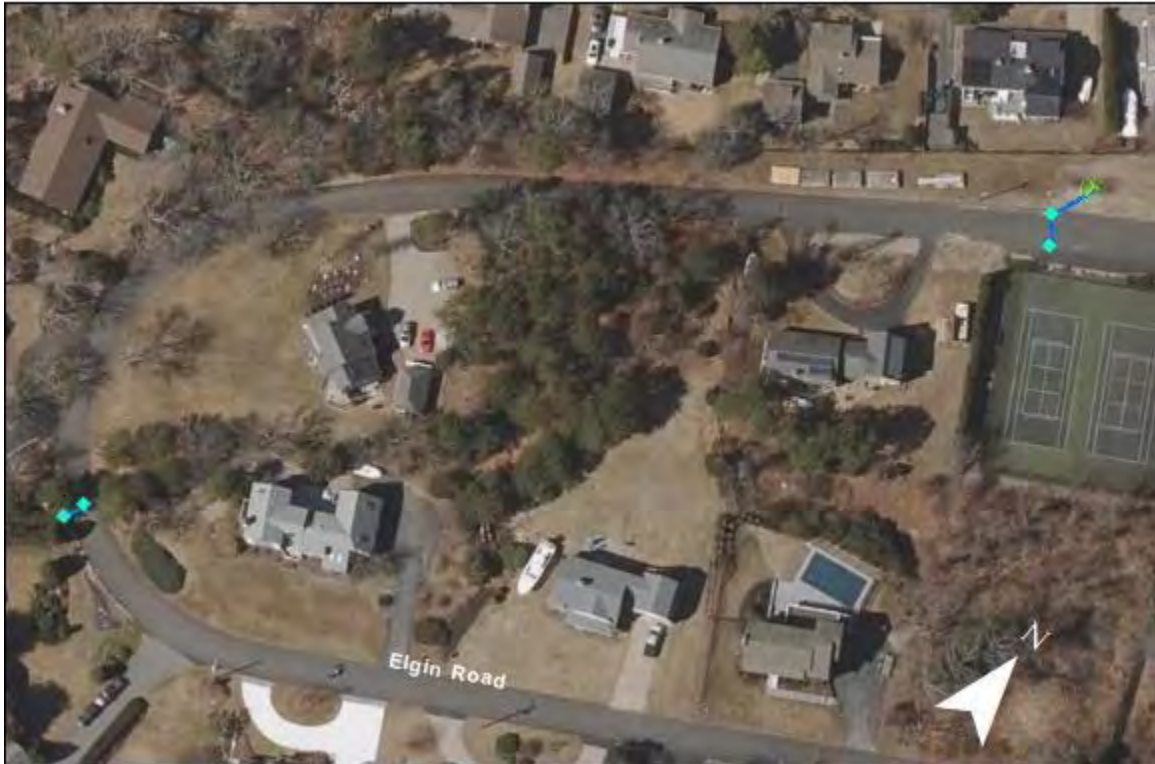
Elgin Road: No issues found.

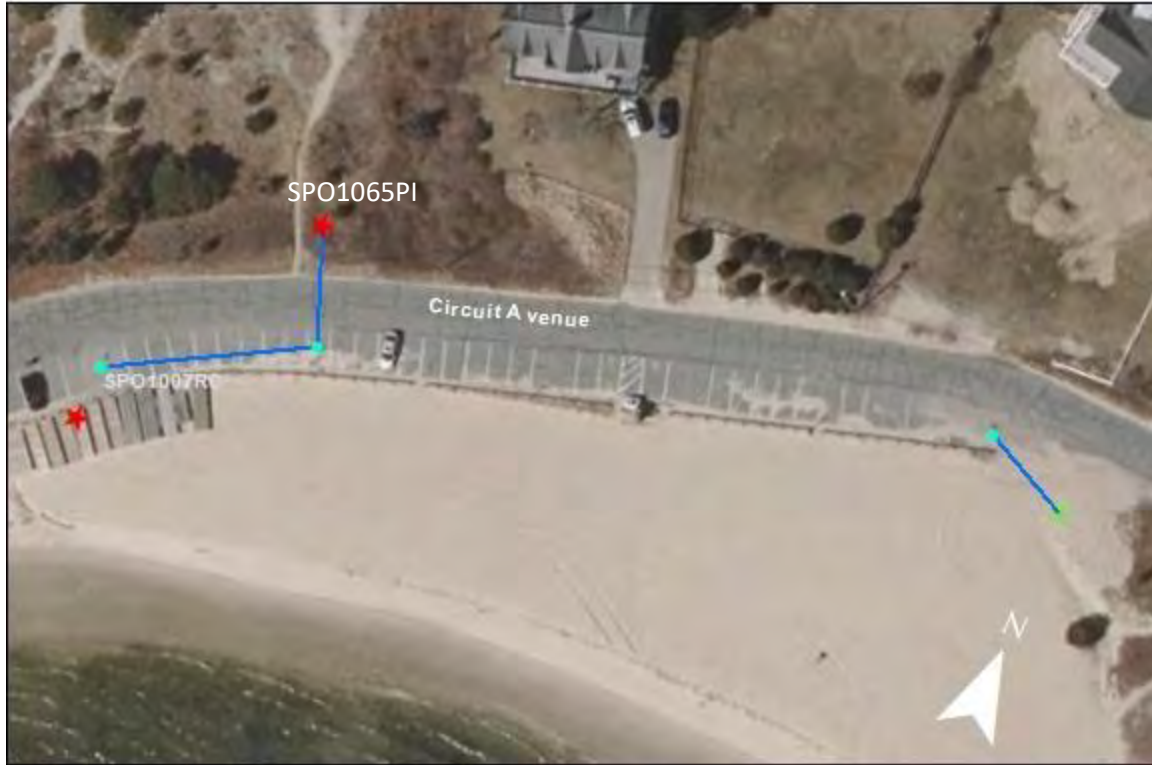
SPO1007RC and SPO1065PI- Circuit Avenue: No issues found.

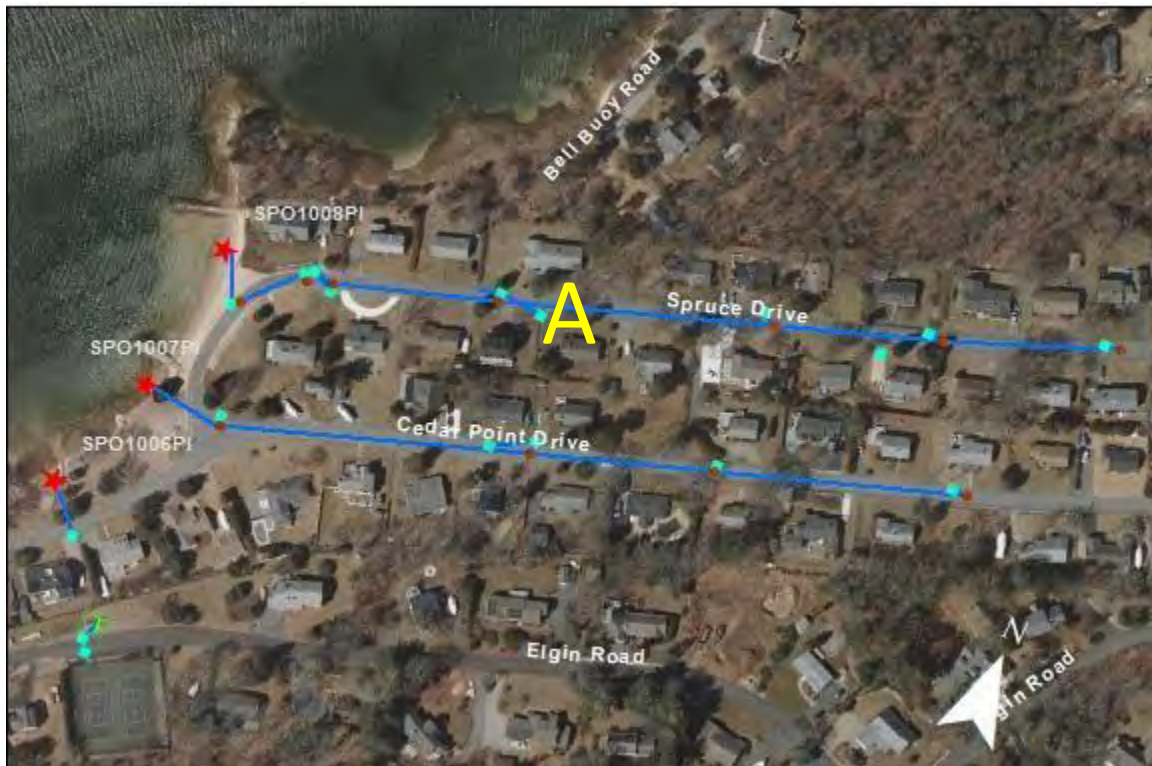
SPO1006PI, SPO1007PI, and SPO1008PI- Cedar Point Drive and Spruce Drive: Catchbasin at point A is collapsing and in need of repair.

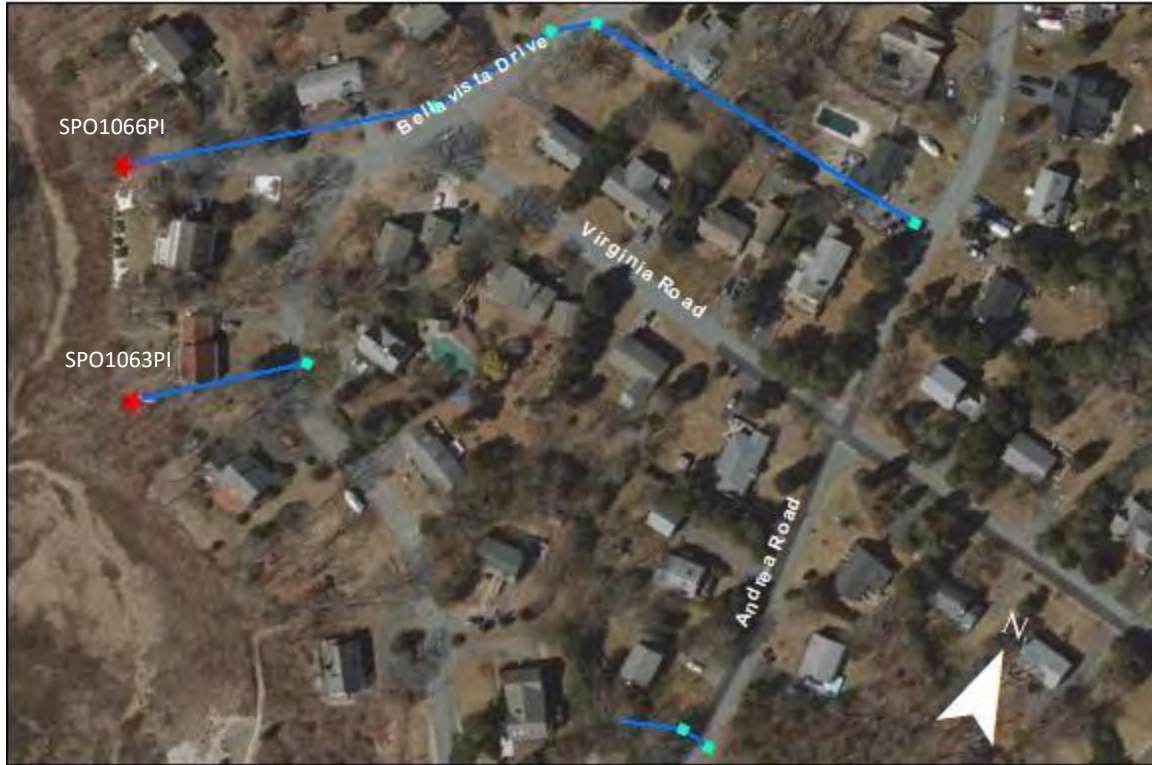
SPO1063PI and SPO1066PI- Bellavista Road and Andrea Road: No issues found.

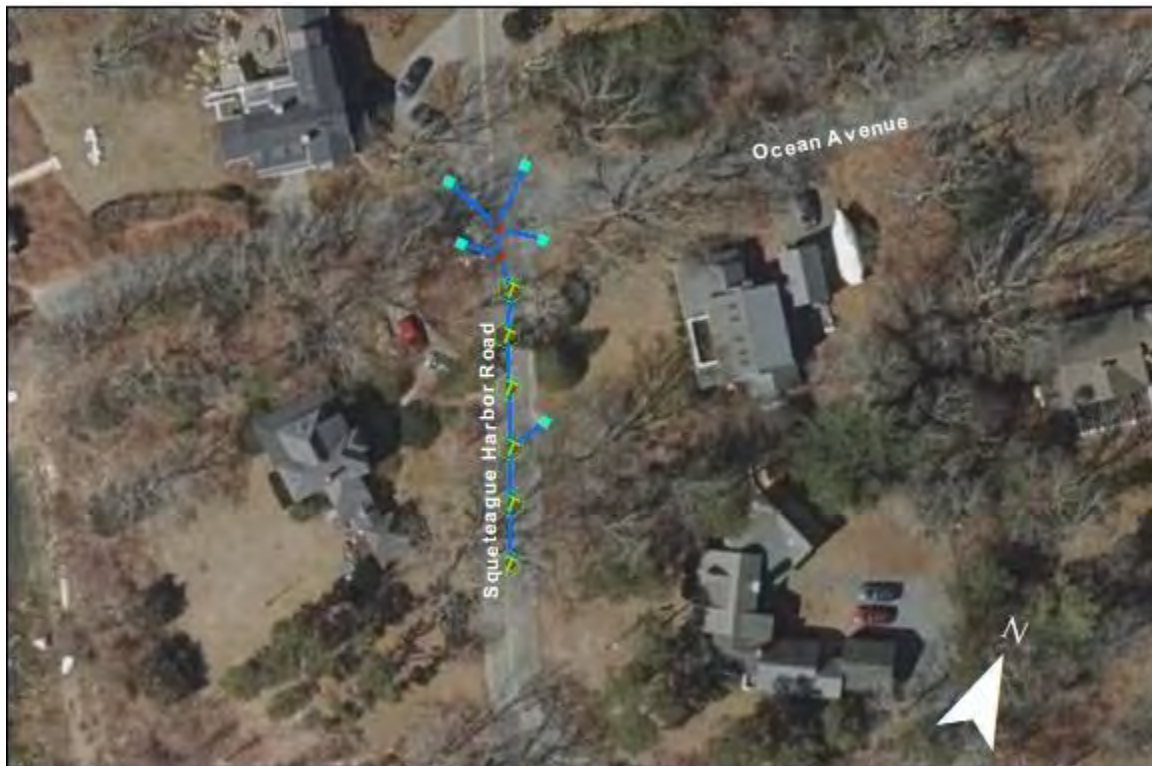
Squeteague Harbor Road: No issues found.

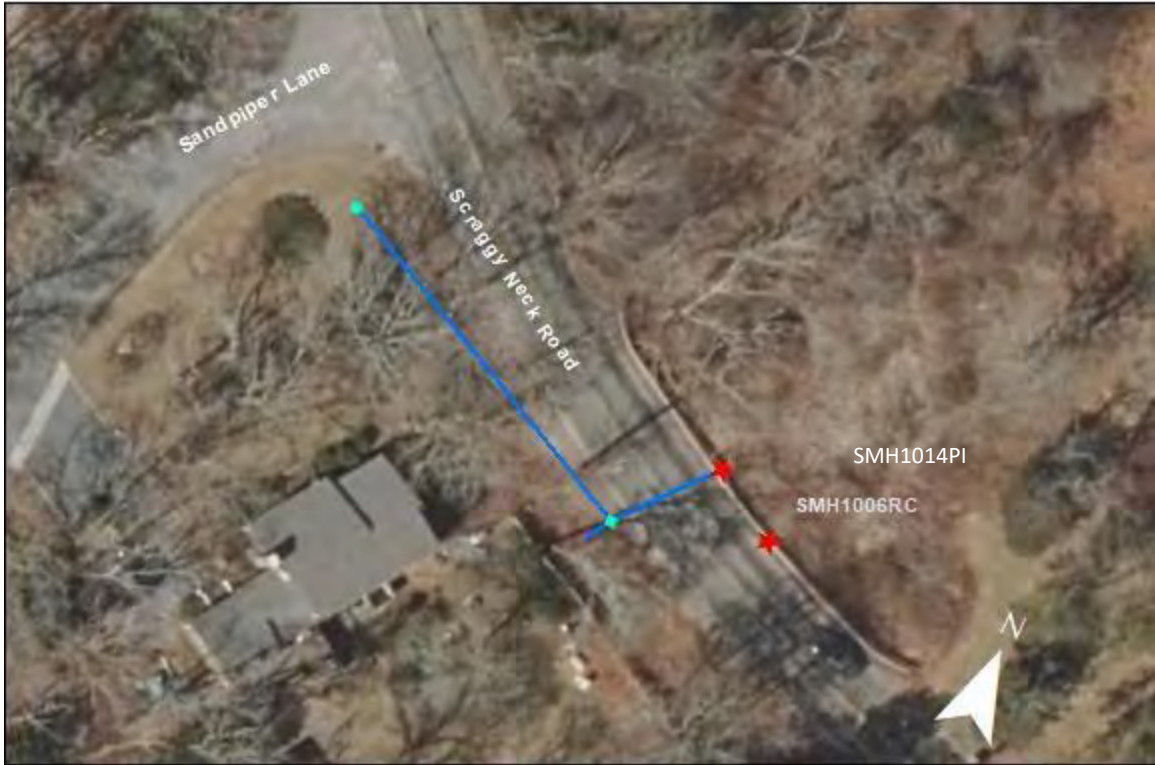
SMH1014PI and SMH1006RC- Scraggy Neck Road: No issues found.

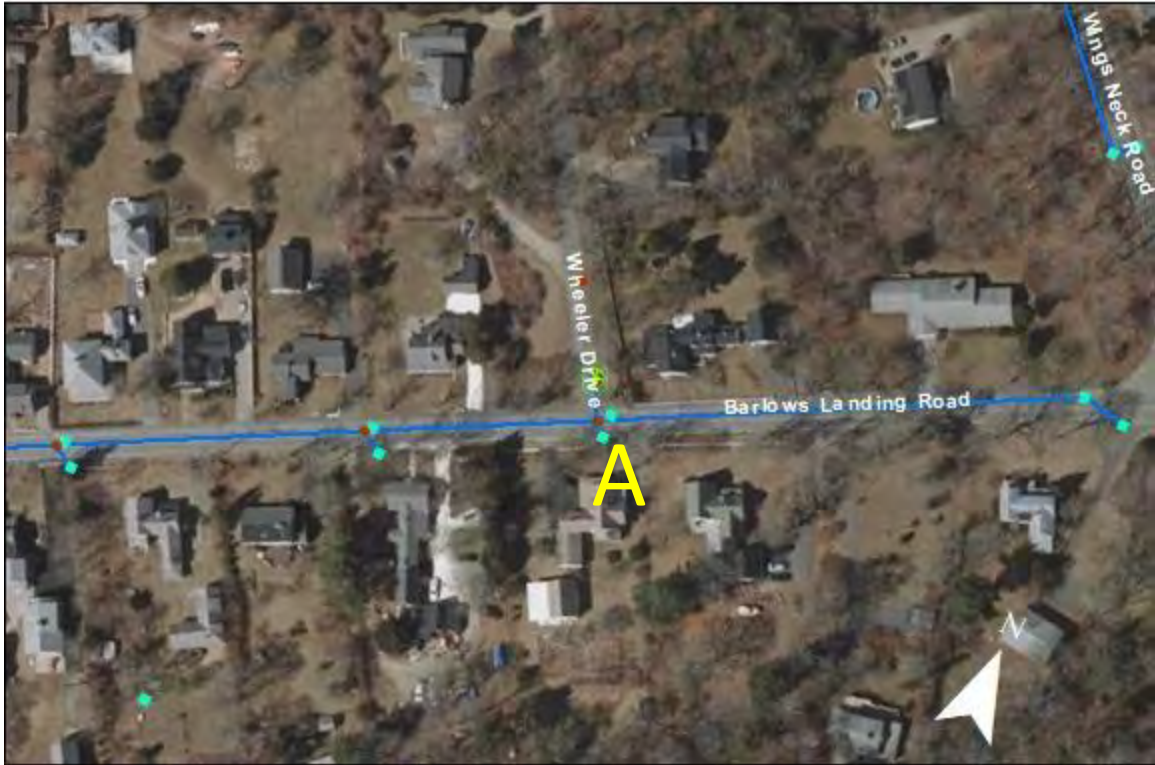
Barlows Landing Road: No significant issues found. Catchbasin at point A is slightly sunken. Preventative maintenance is suggested.

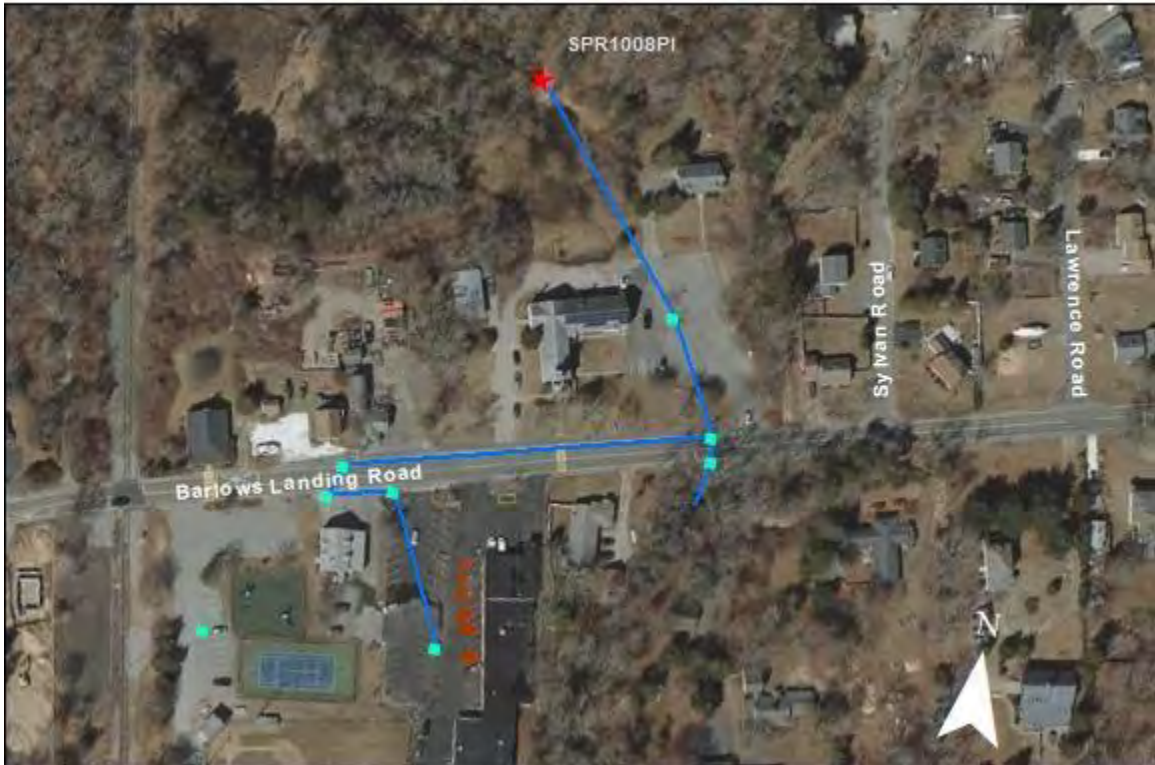
SPR1008PI- Barlows Landing Road: Discharge is slow to drain, may be slightly obstructed. Significant flooding in multiple areas during wet weather.

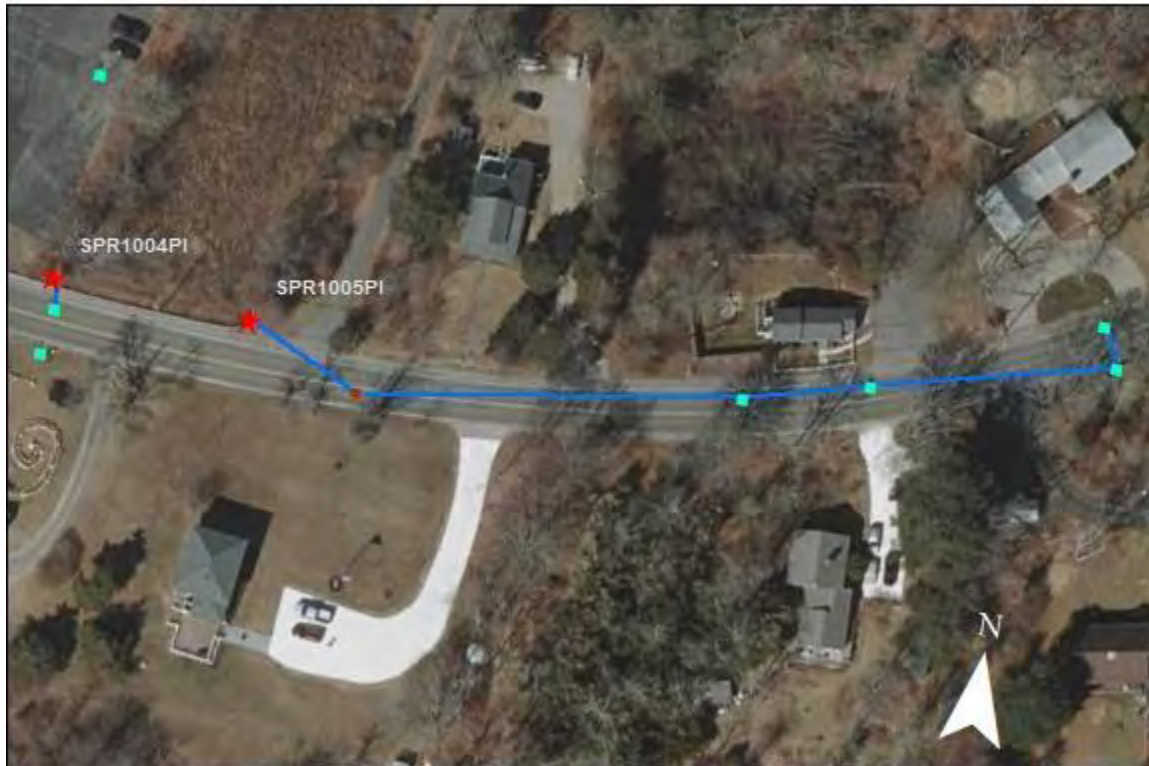
SPR1004PI and SPR1004PI- Barlows Landing Road: No issues found. Catchments not yet completed. Further investigation is recommended.

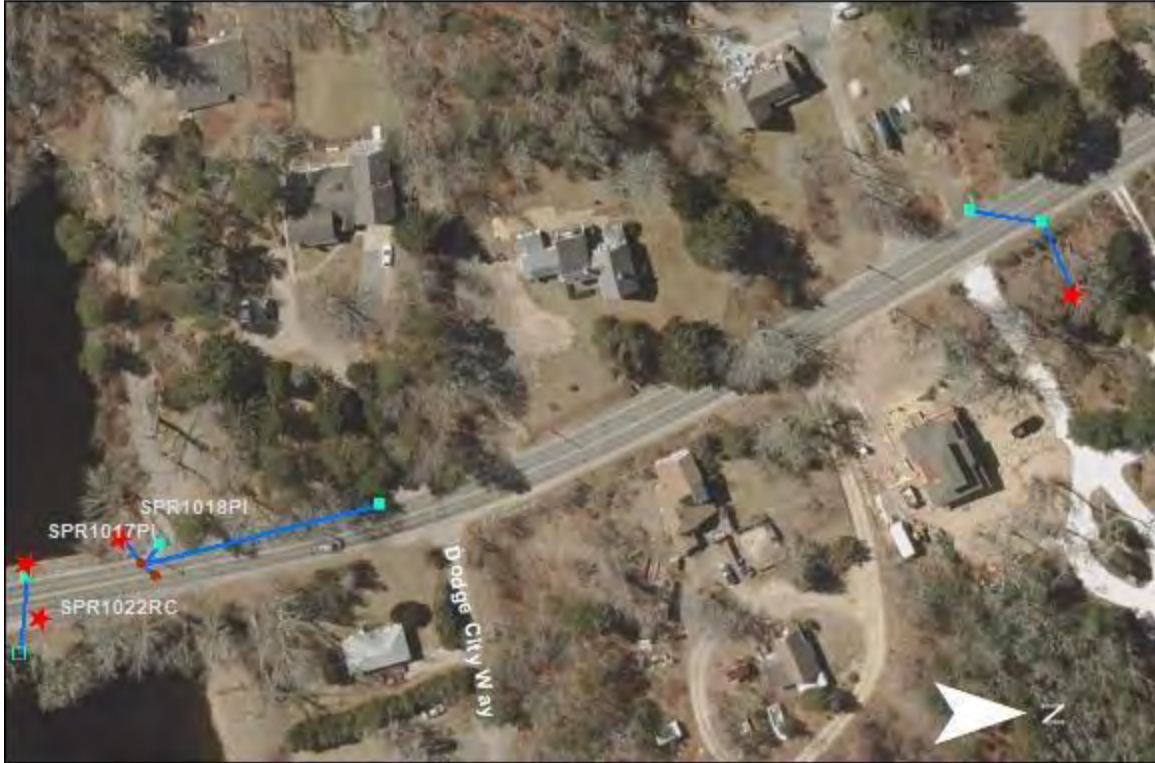
SPR1017PI, SPR1018PI, SPR1022RC, and SPR1045PI- Barlows Landing Road: No issues found.

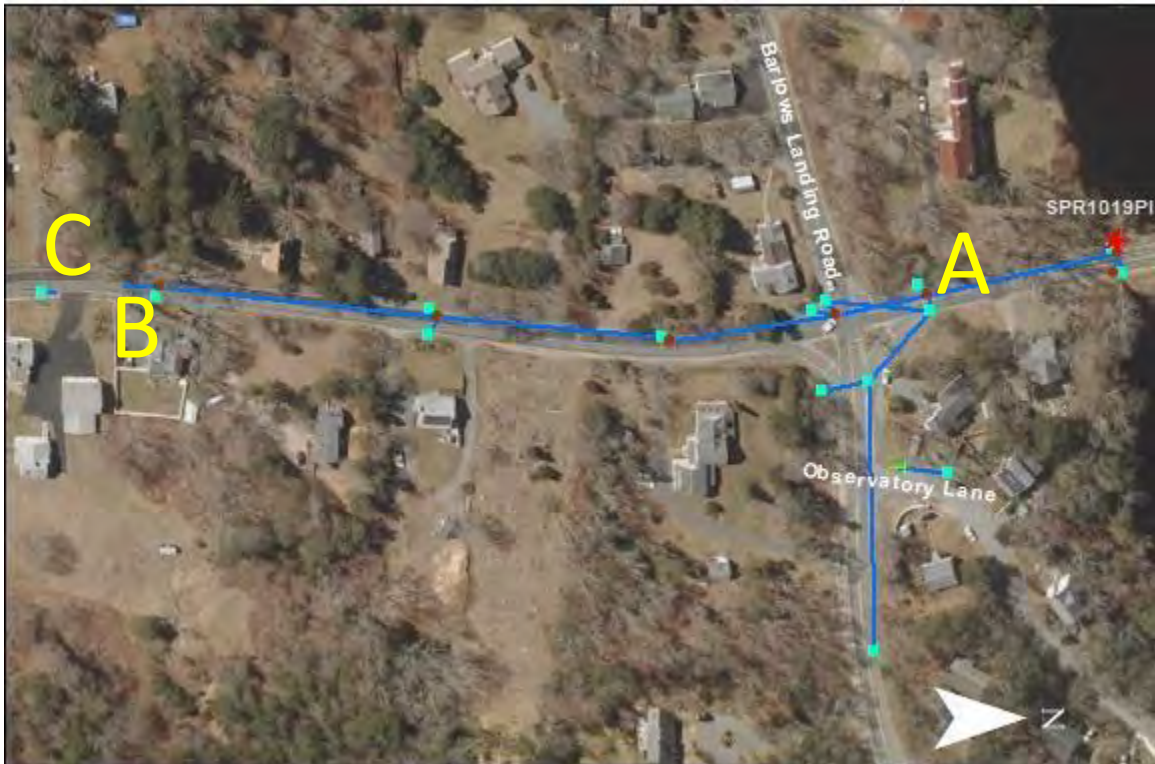
SPR1019PI- County Road: A manhole at point A had large piles of animal waste inside of it. At points B and C there are pipes leaving or entering the structures with no obvious origin. Pipes were clogged and difficult to inspect. Further investigation is suggested.

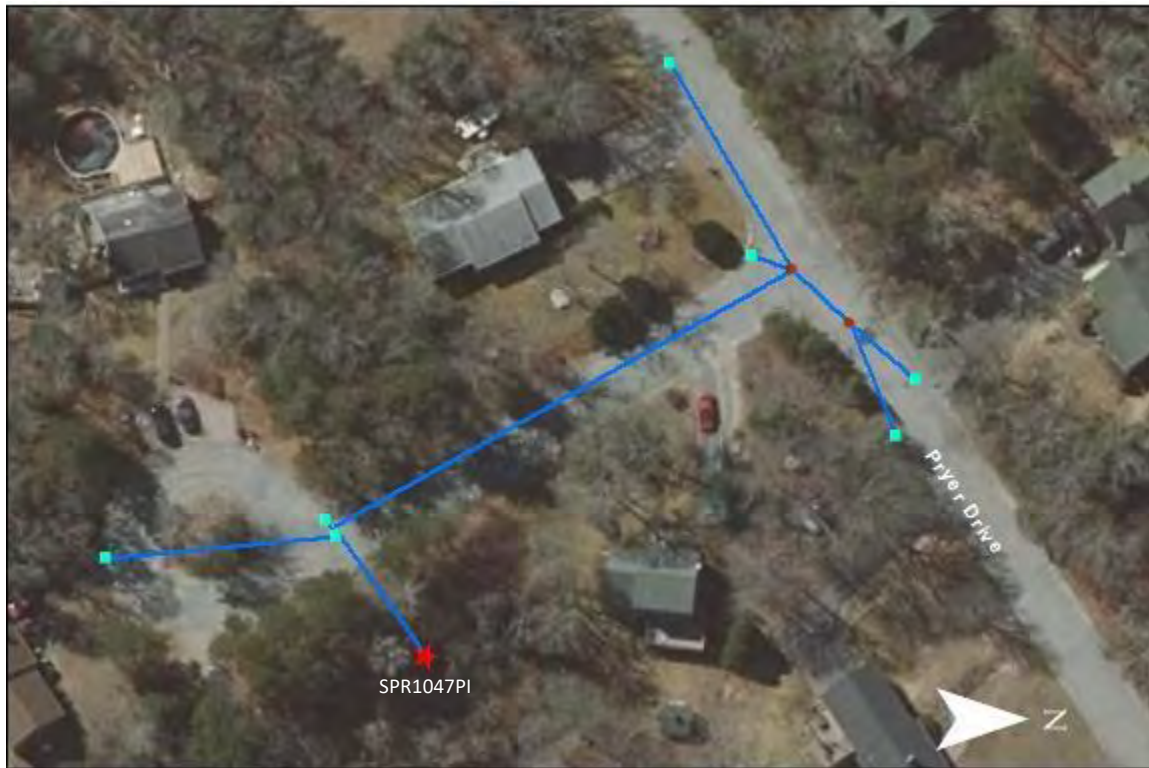
SPR1047PI- Pryer Drive: No issues found.

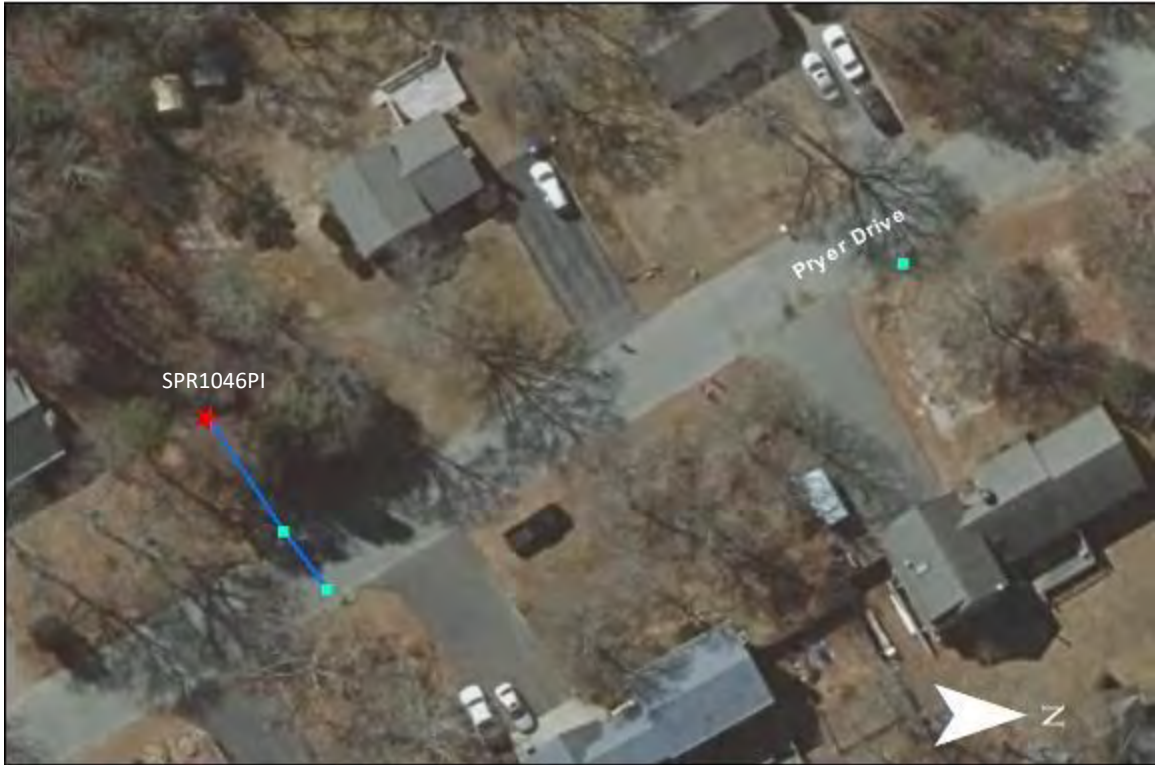
SPR1046PI- Pryer Drive: No issues found.

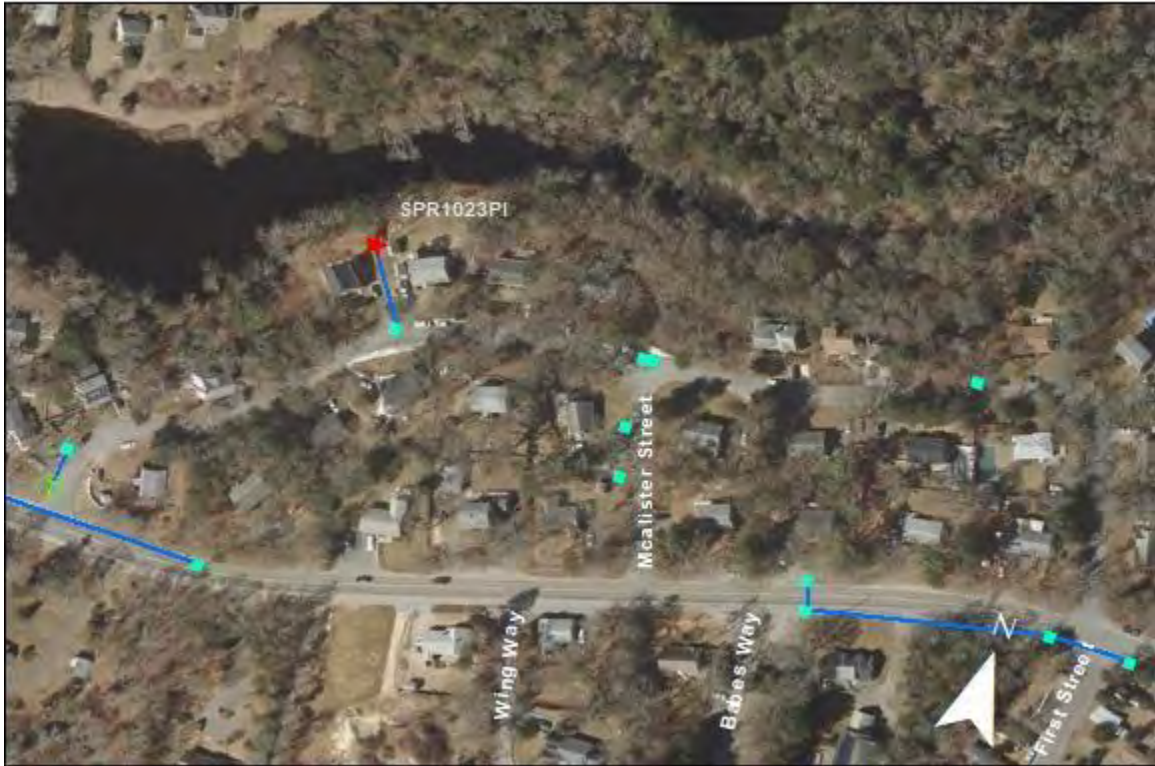
SPR1023PI- Observatory Lane: No issues found.

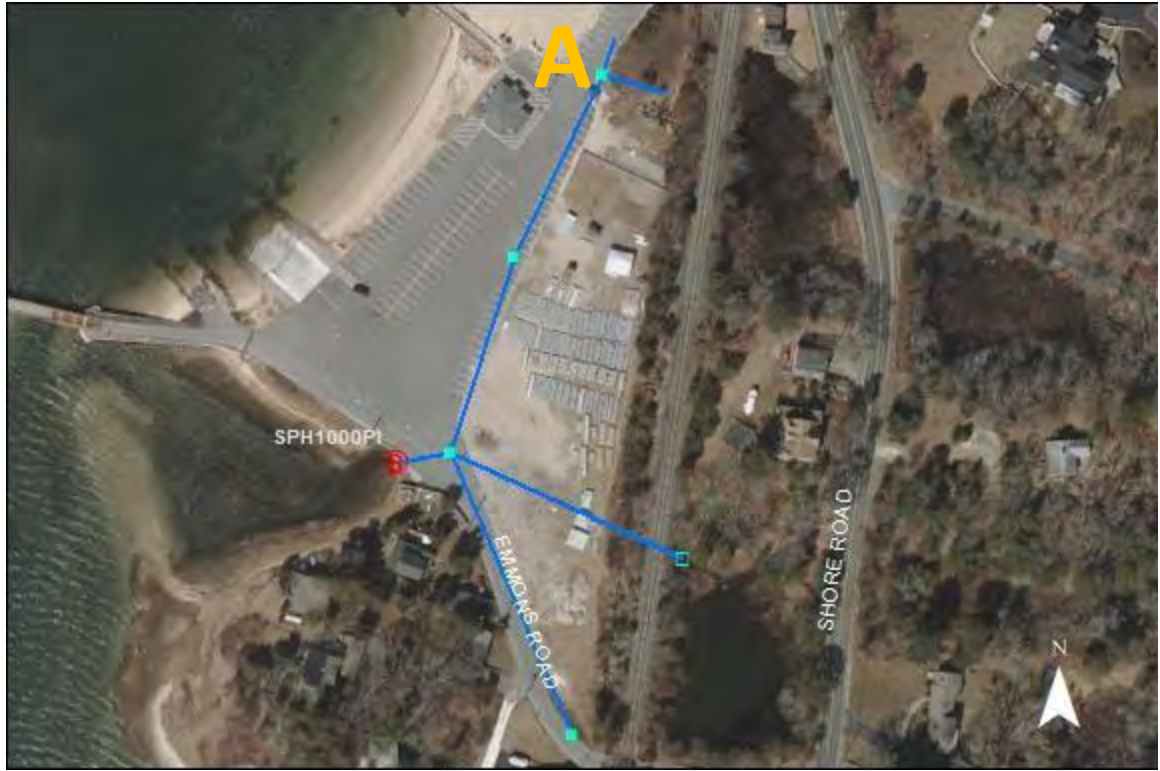
SPH1000PI- Emmons Road and Monument Beach: No significant issues found. At point A, a 15" concrete pipe enters the catchbasin its origin is unknown. Further investigation is recommended.

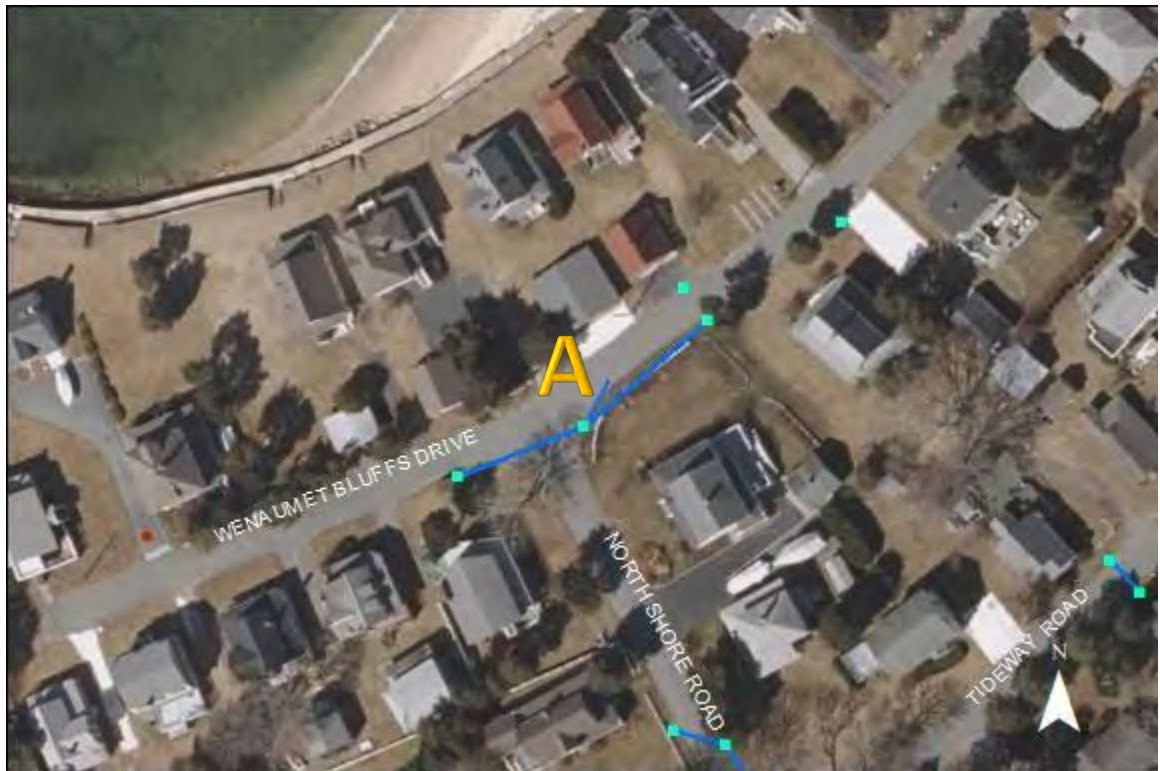
Wenaumet Bluffs Drive- No significant issues. At point A an 8" concrete pipe enters the catchbasin. Its origin is unknown. Further investigation is suggested.
