**The Buzzards Bay Stormwater Collaborative
Illicit Discharge Investigation Trailer**

Town of Bourne Report

November 2022

Bourne IDDE Report

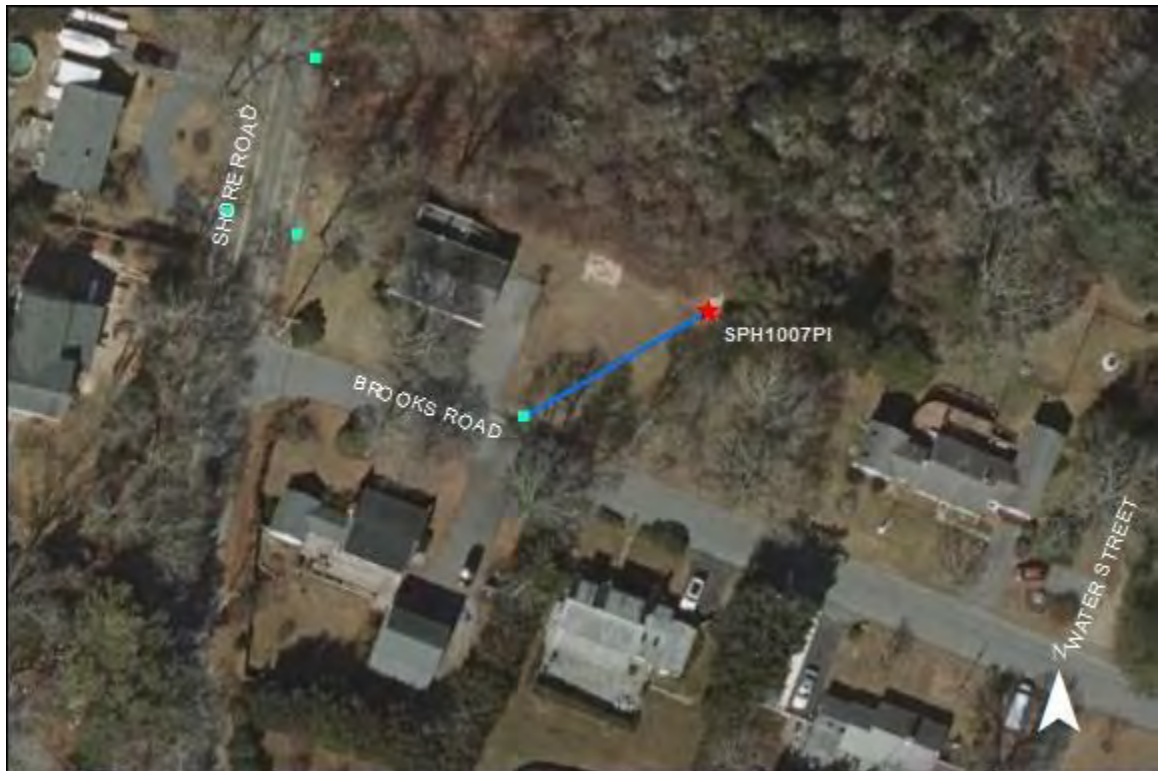
SPH1007PI- Brooks Road: No issues found.

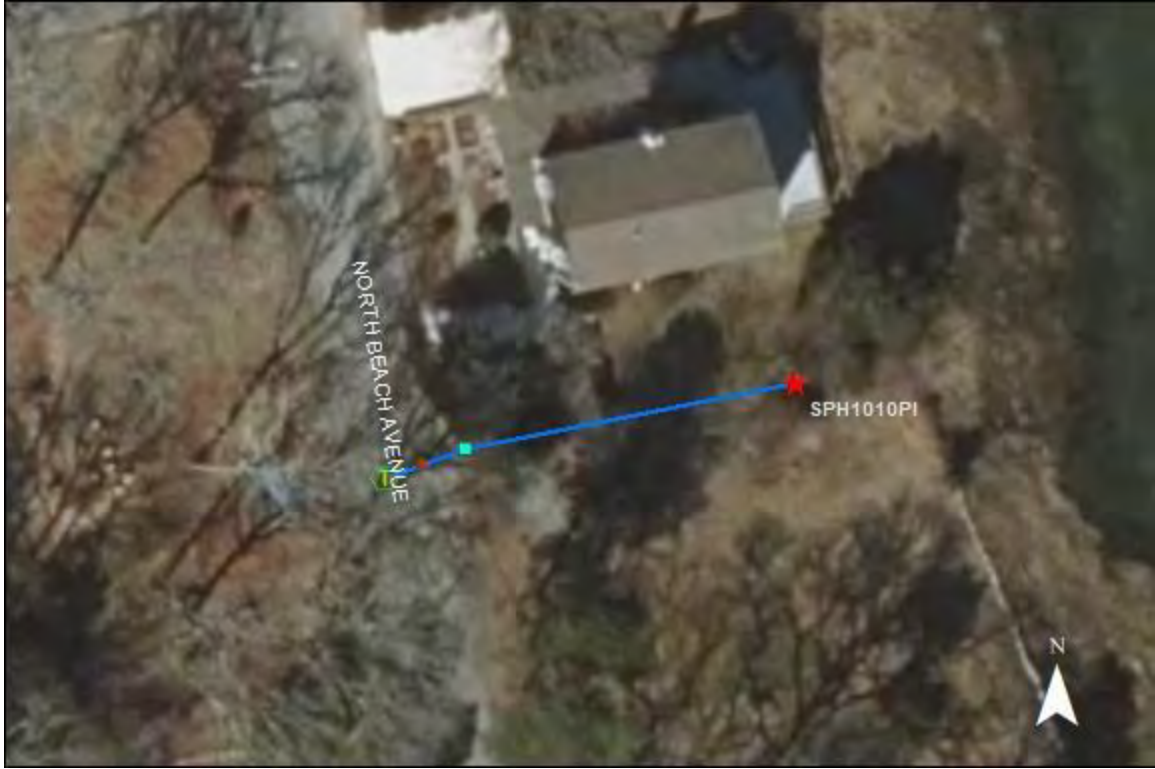
SPH1010PI- North Beach Avenue: No issues found.

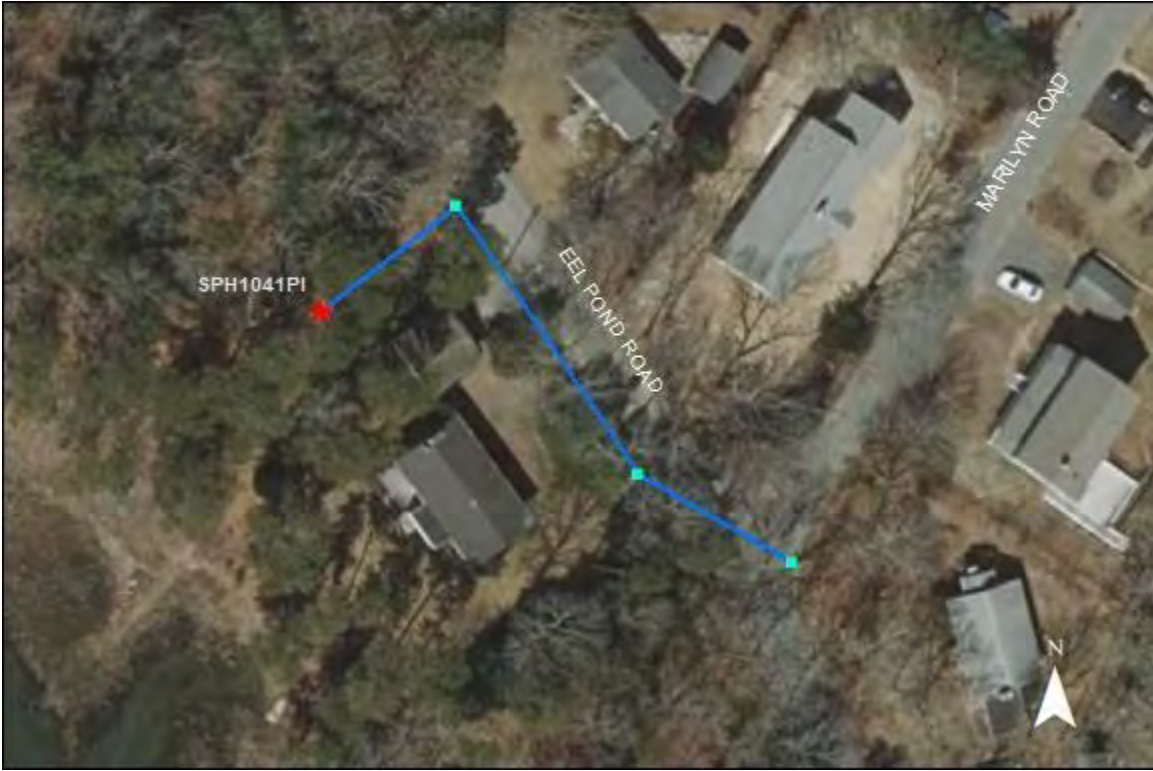
SPH1041PI- Eel Pond Road: No issues found.

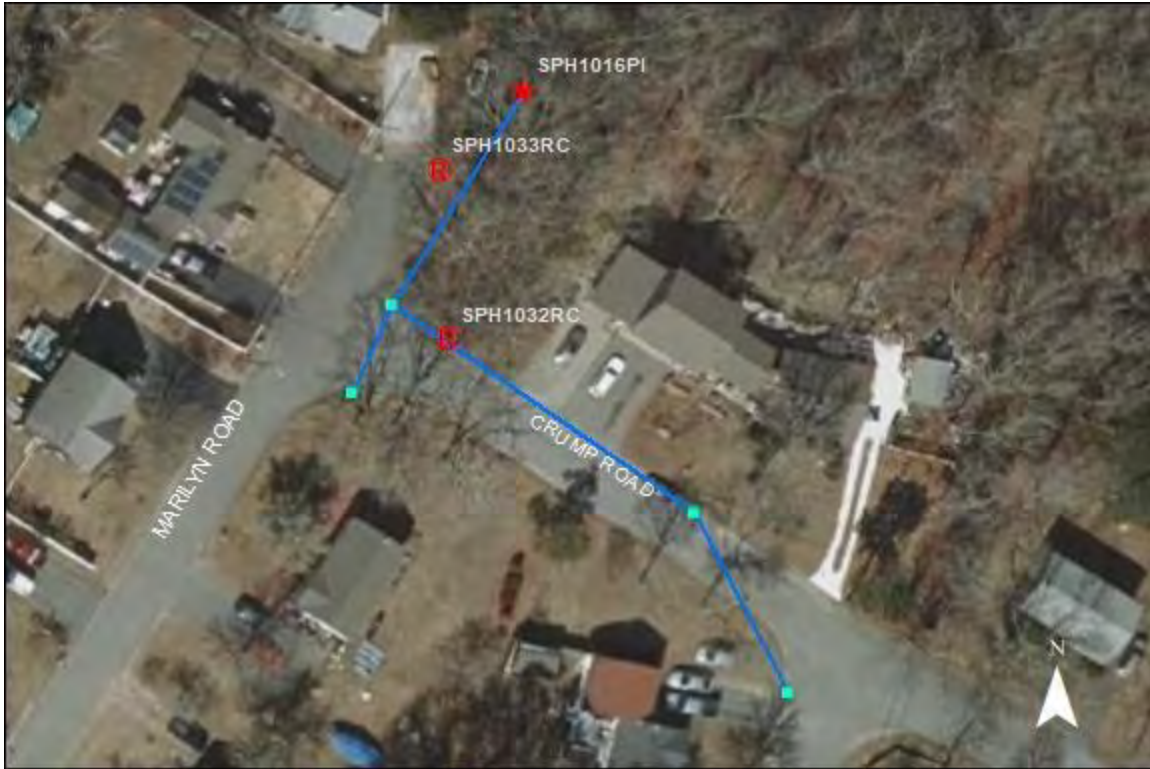
SPH1016PI, SPH1033RC, SPH1032RC- Marilyn Road and Crump Road: No issues found.

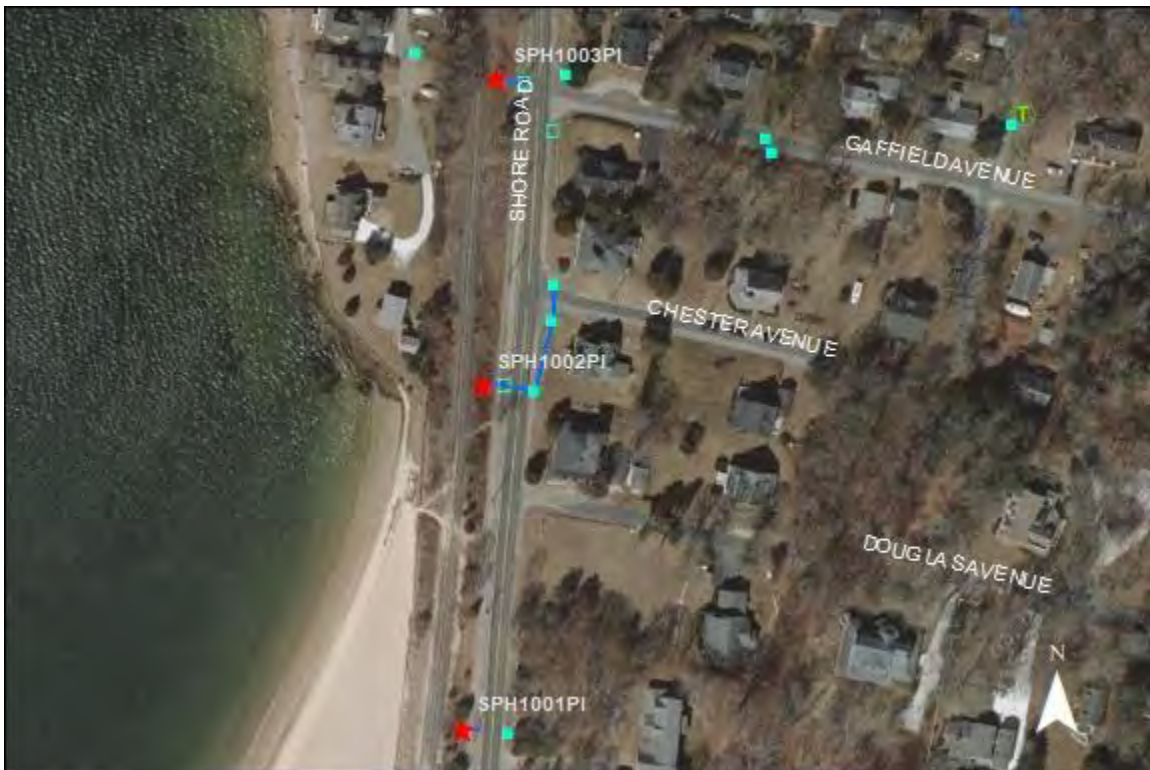
SPH1003PI, SPH1002PI, and SPH1001PI- Shore Road: No issues found.

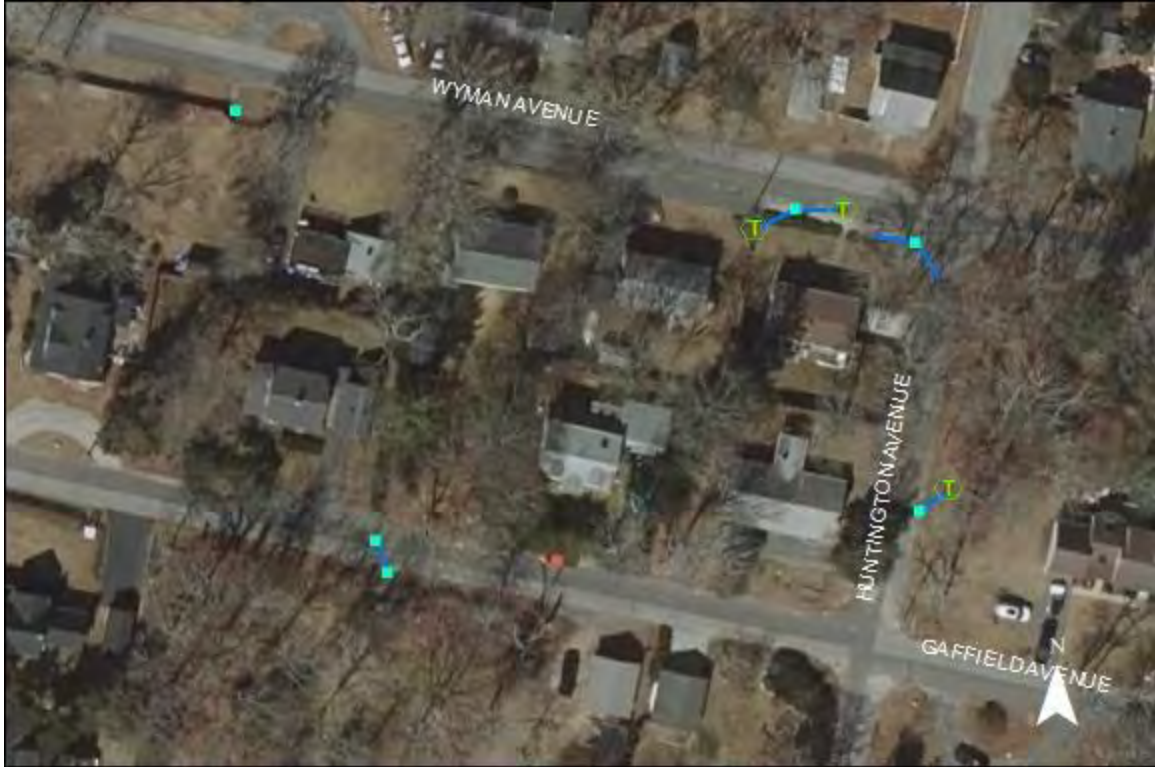
Wyman Avenue, Huntington Avenue, and Gaffield Avenue: No issues found. Catchment drains into underground infiltration chambers.

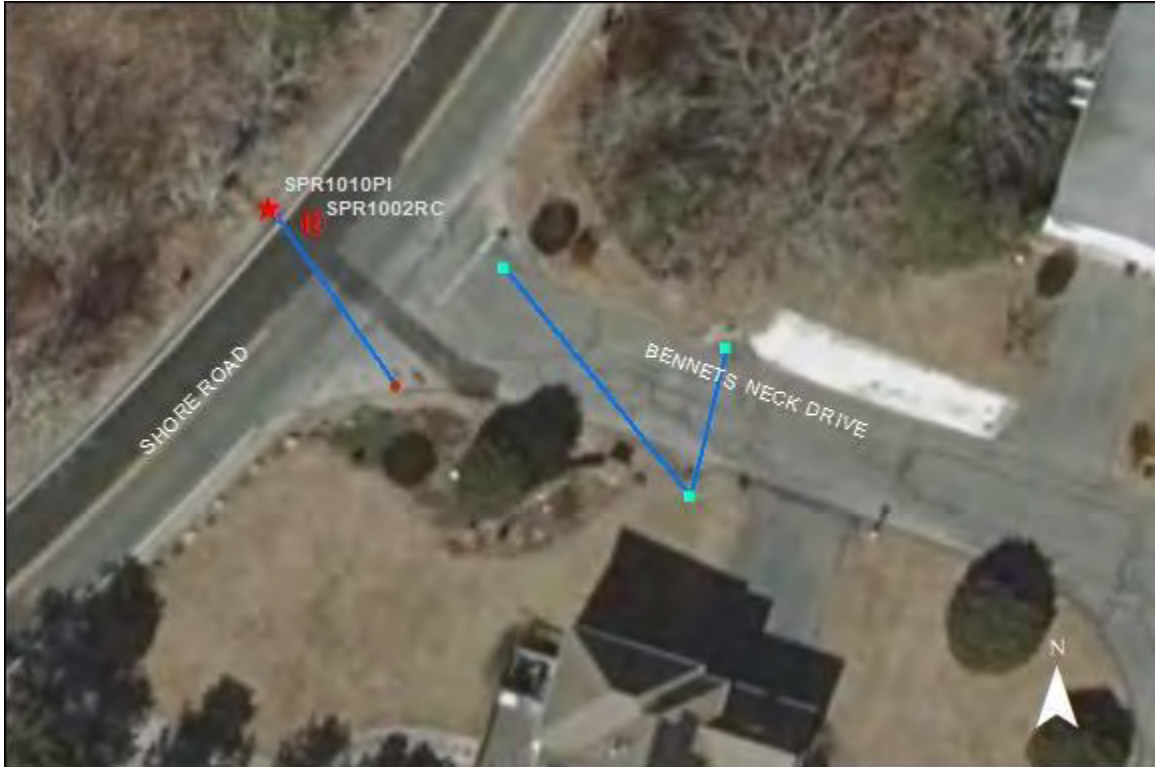
SPR1010PI and SPR1002RC- Shore Road and Bennets Neck Drive: No issues found. Need to revisit to complete catchment investigation. Police detail needed for structures on Shore Road.

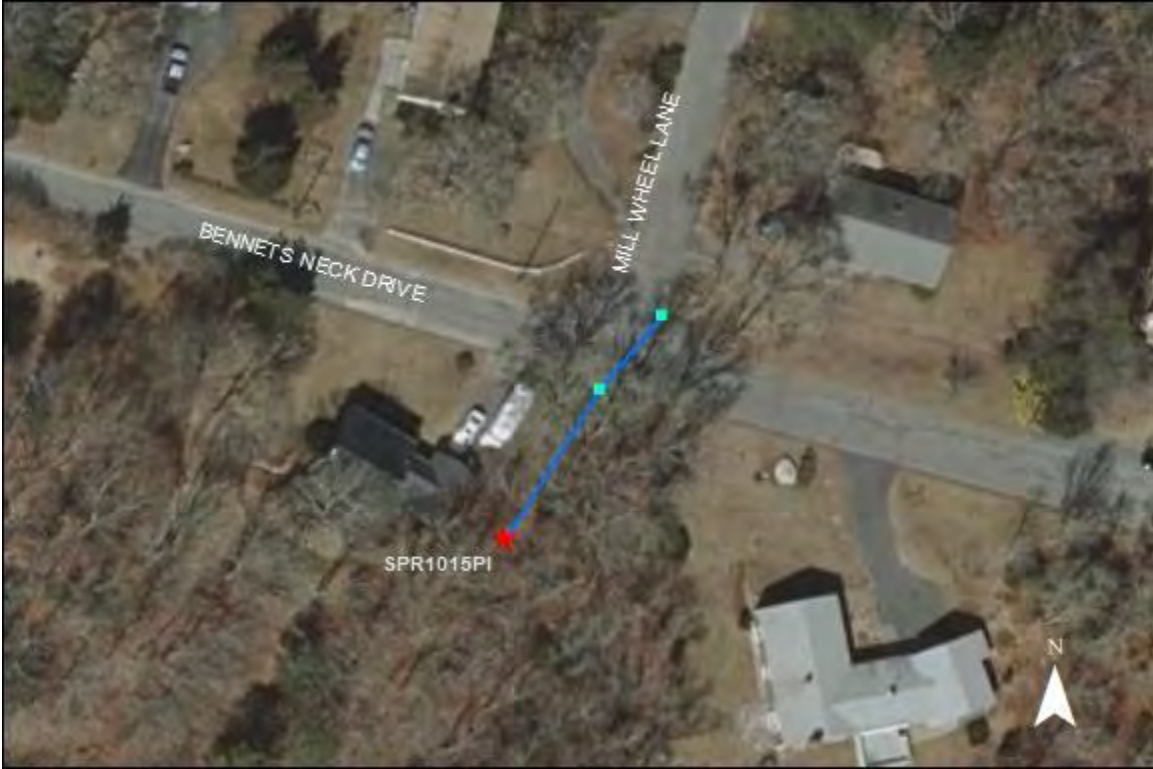
SPR1015PI- Bennets Neck Drive: No issues found.

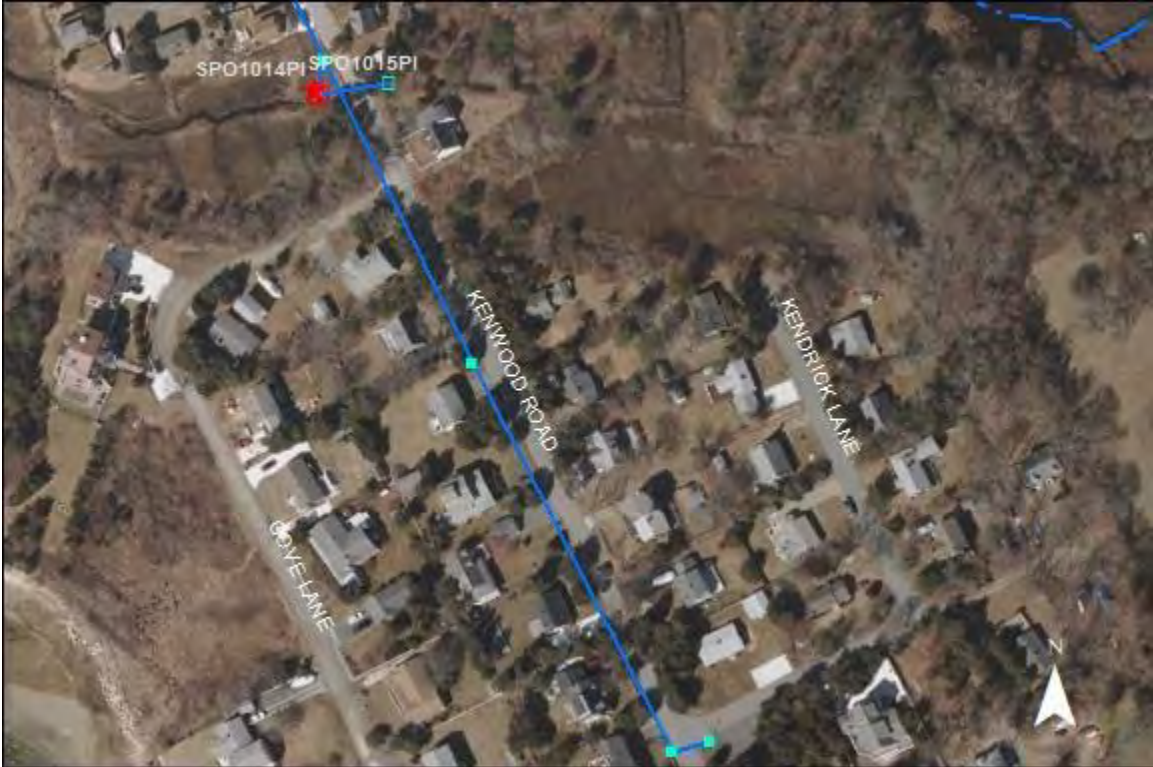
SPO1014PI and SPO1015PI- Kenwood Road: No issues found. The catchbasins directly connected with the outfalls are affected by tide. The IDDE team will revisit at low tide to complete catchment investigation.

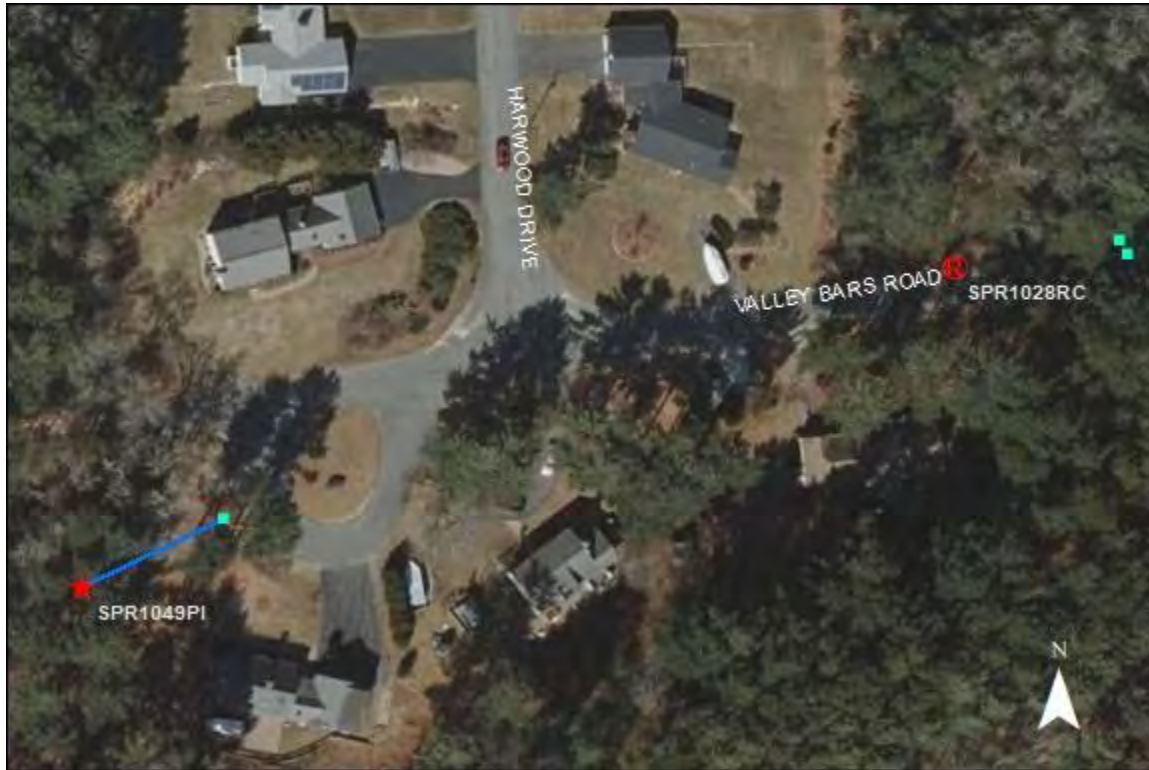
SPR1049PI- Valley Bars Road: No issues found.

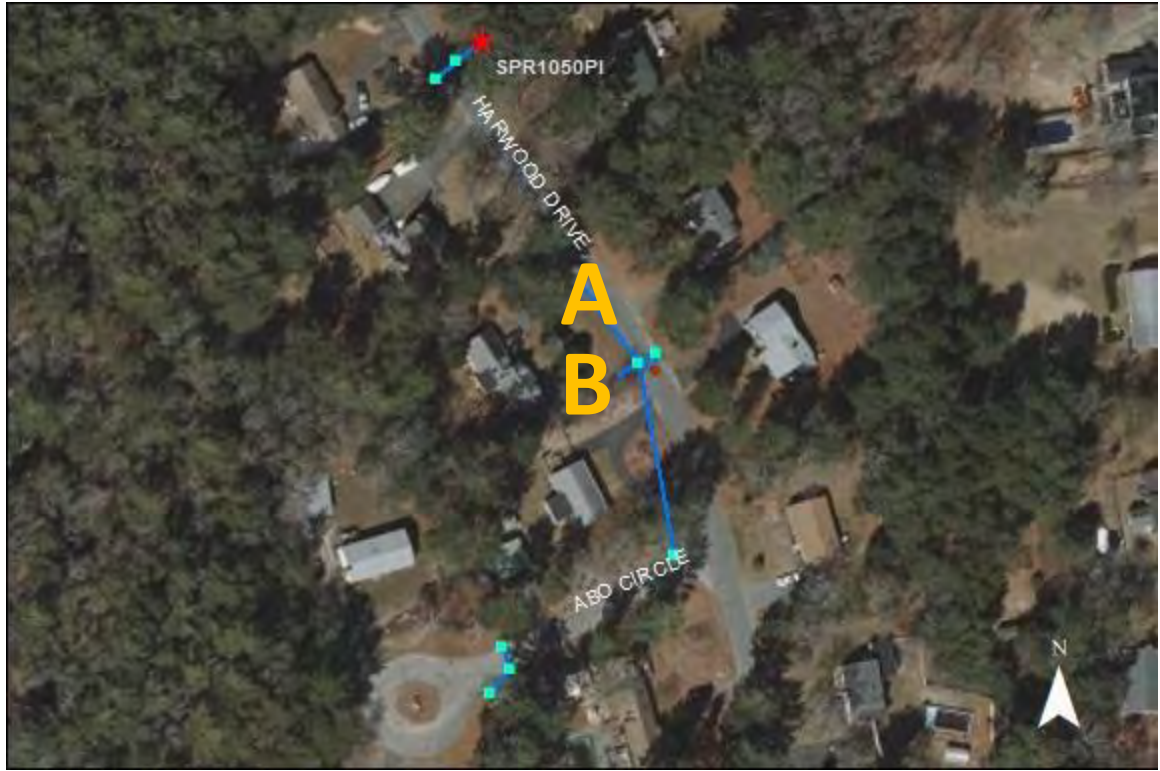
SPR1050PI- Harwood Drive: No significant issues found. At point A and B, two pipes enter the catchbasin. Their origins are unknown. Further investigation is recommended.

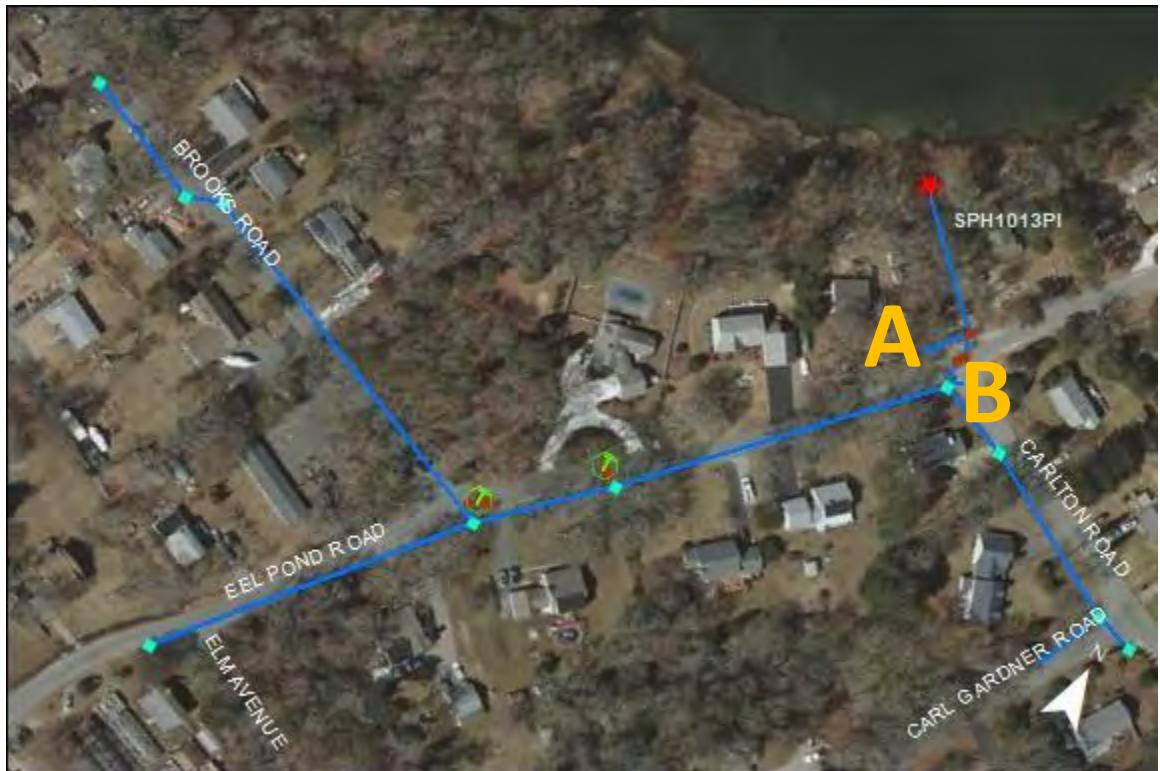
SPH1013PI- Eel Pond Road, Brooks Road, Carlton Road: No significant issues found. At points A and B, a pipe enters the manhole and catchbasin. Their origins are unknown. Further investigation is recommended.

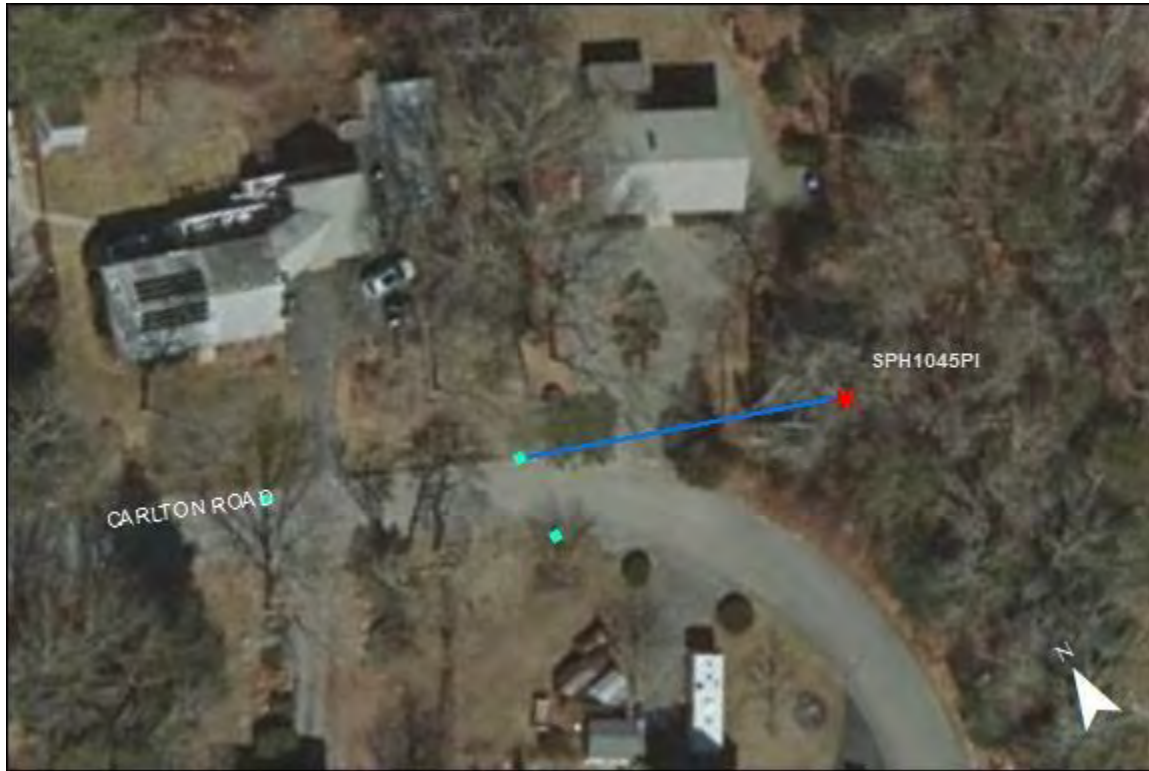
SPH1045PI- Carlton Road: No issues found.

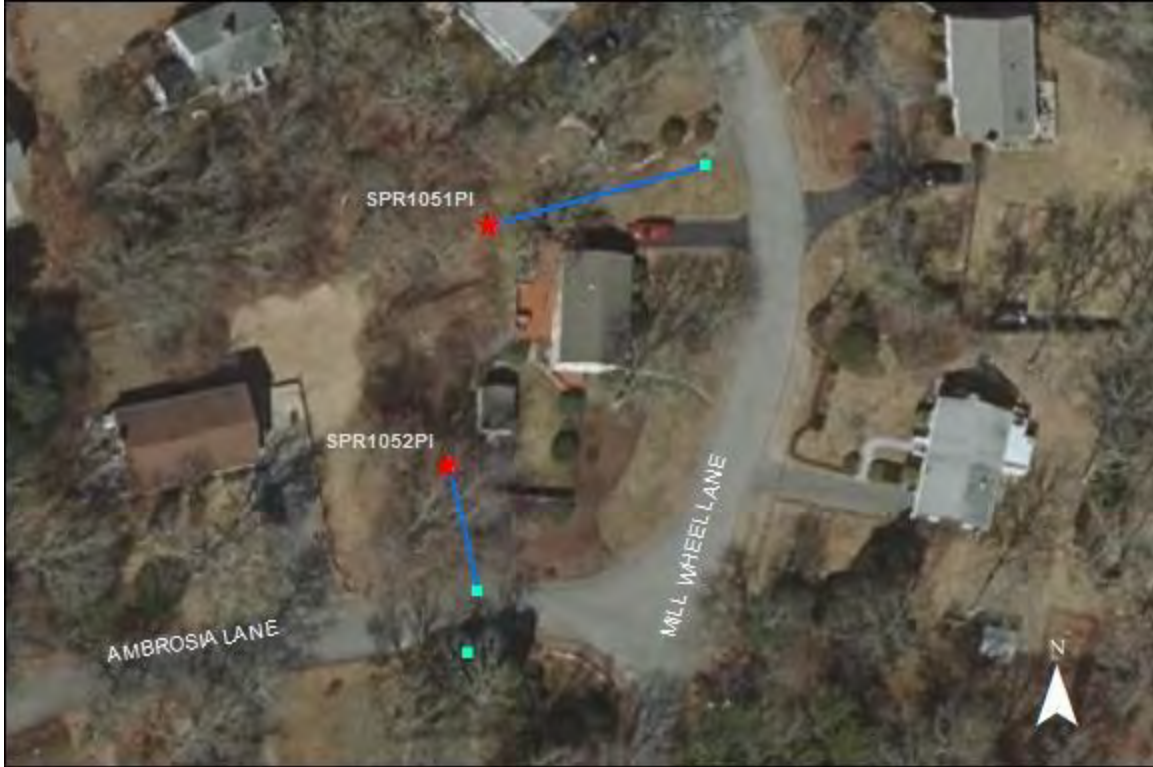
SPR1051PI and SPR1052PI- Mill Wheel Lane: No issues found.

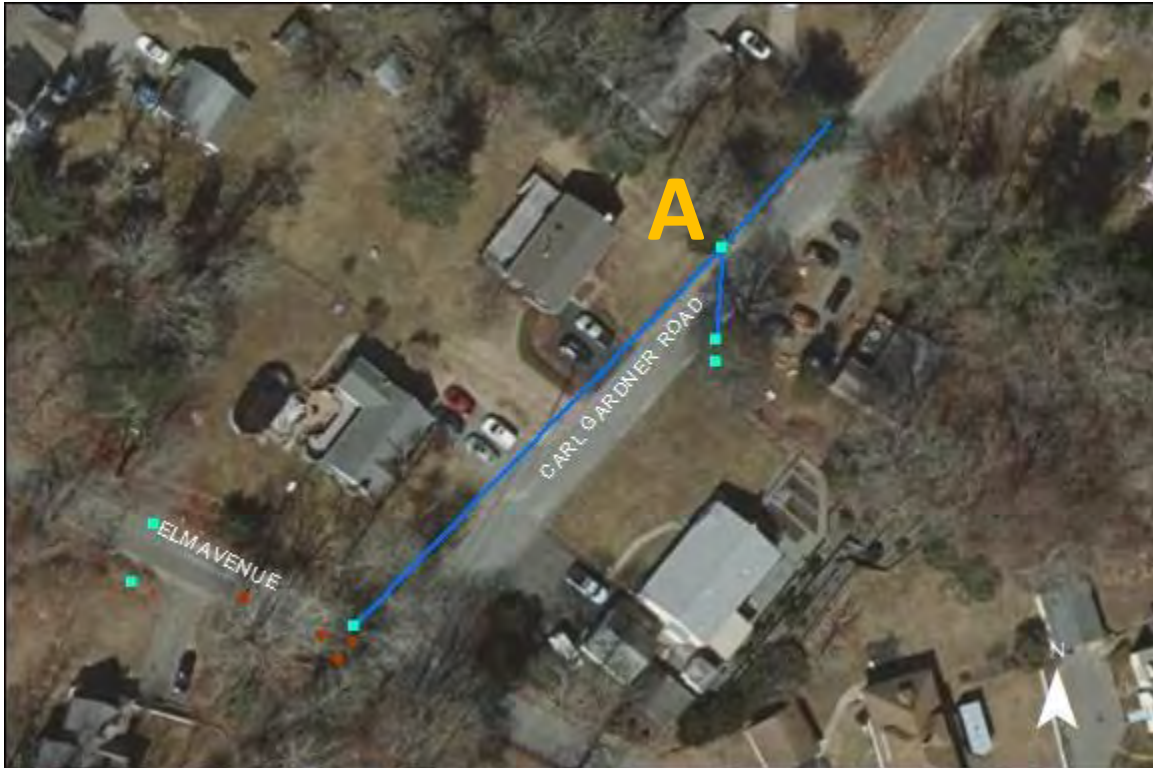
Carl Gardner Road: No significant issues found. Pipe enters catchbasin at point A. Its origin is unknown. Catchment investigation is not complete.

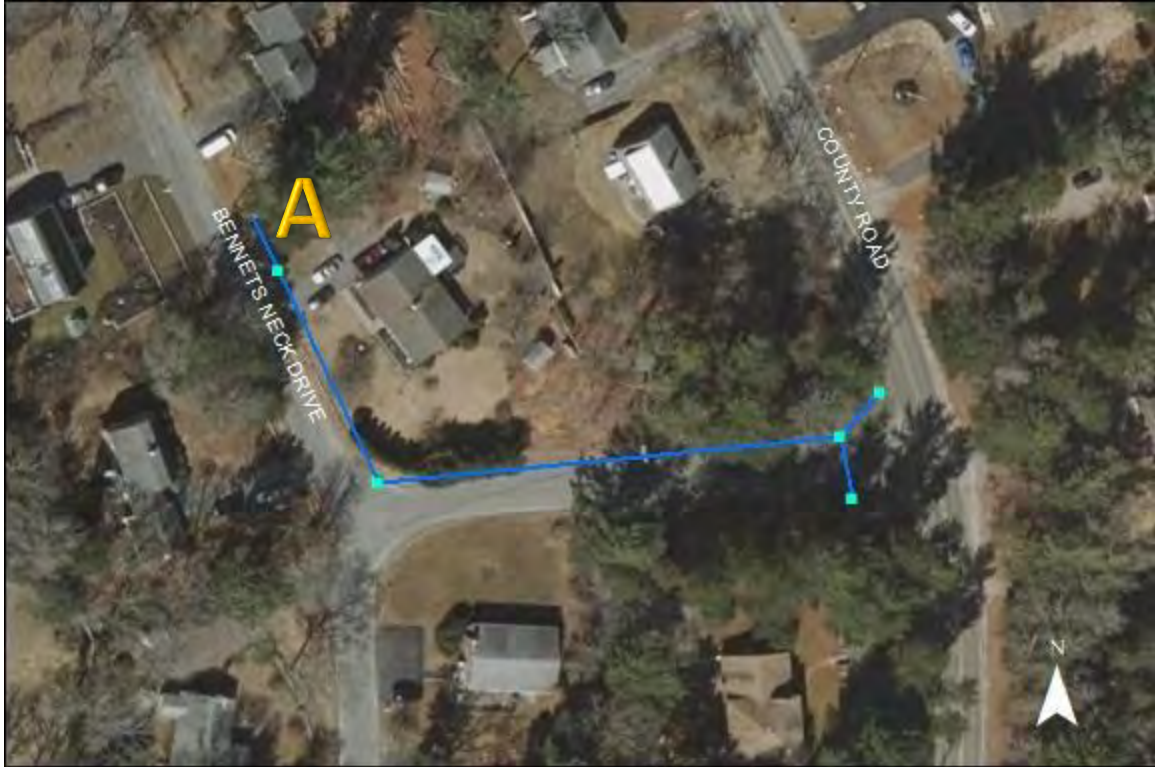
Bennets Neck Drive: No issues found. Need a police detail to complete the catchment investigation onto County Road. Origin of pipe entering catchbasin at point A is unknown. Further investigation is suggested.

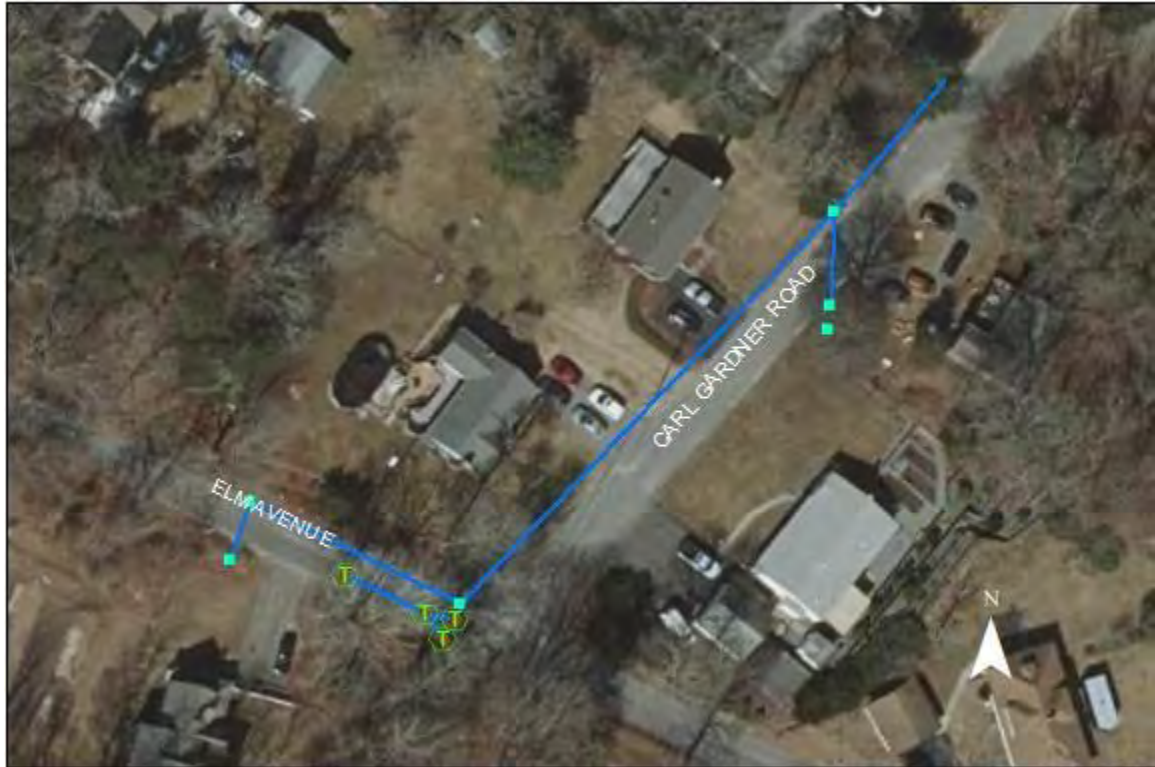
Carl Gardener Road: No issues found.

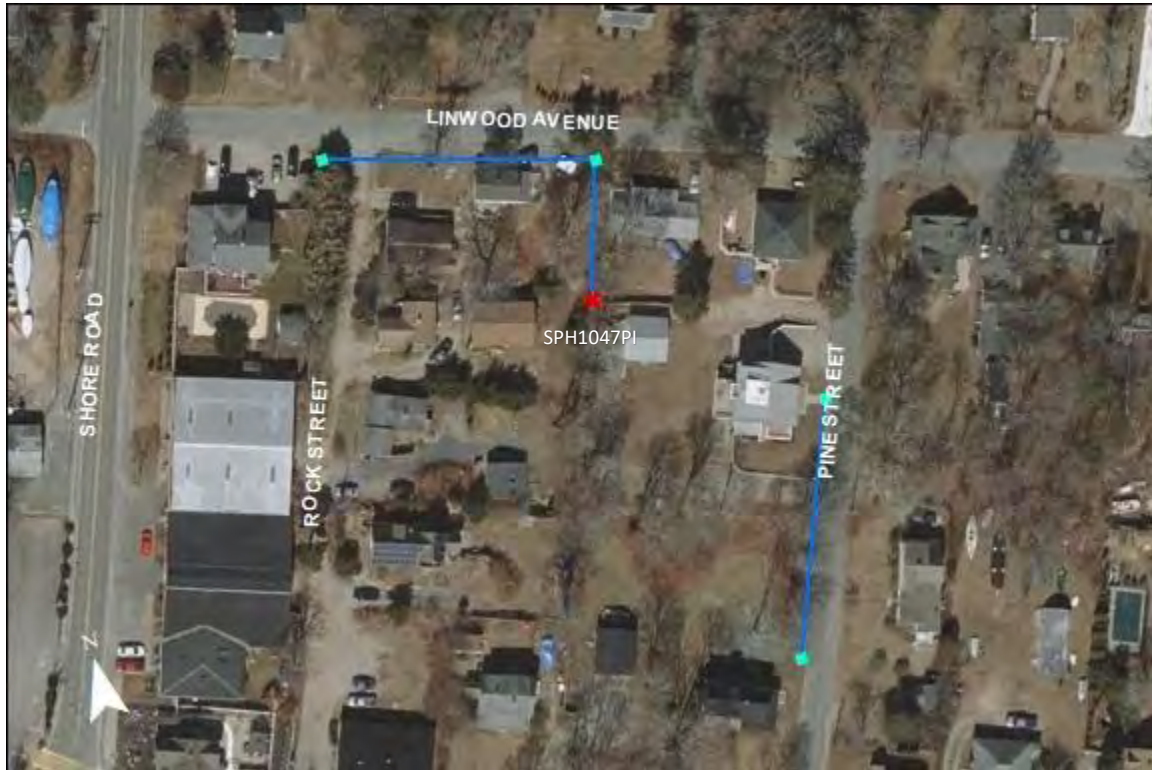
SPH1047PI- Linwood Avenue and Pine Street: No Issues found.

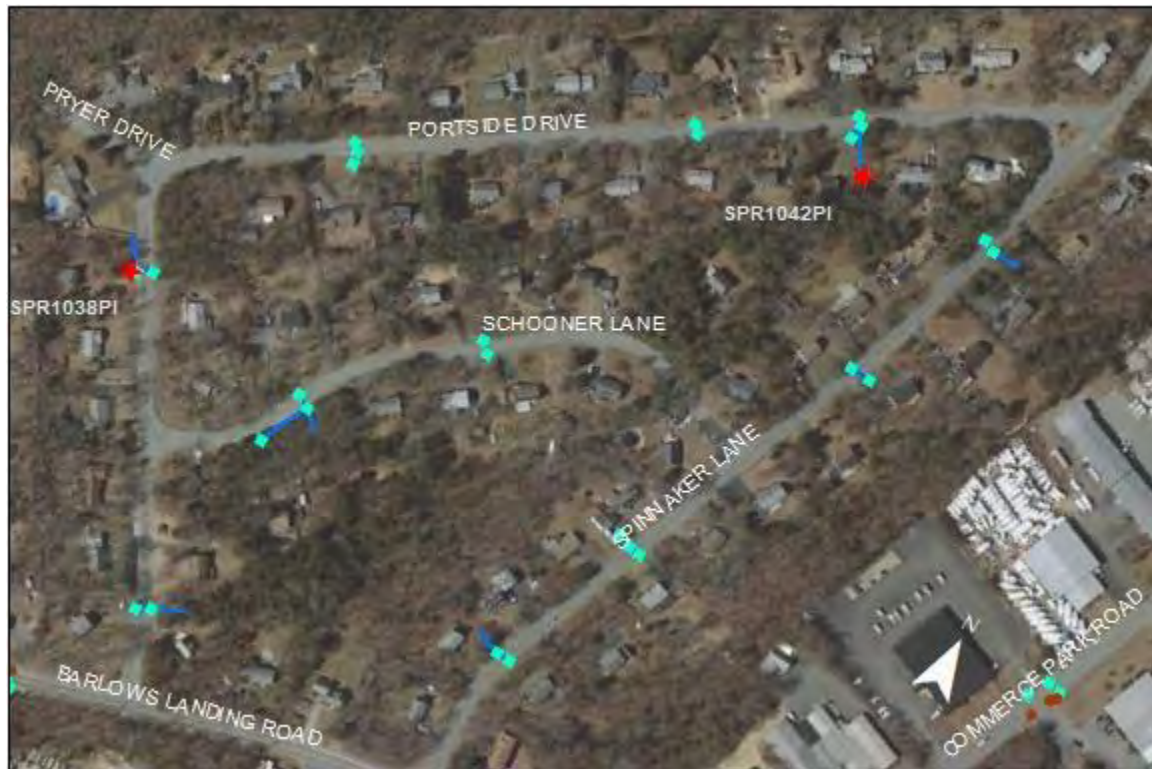
SPR1038PI and SPR1042PI- Schooner Lane and Portside Drive: No issues found.

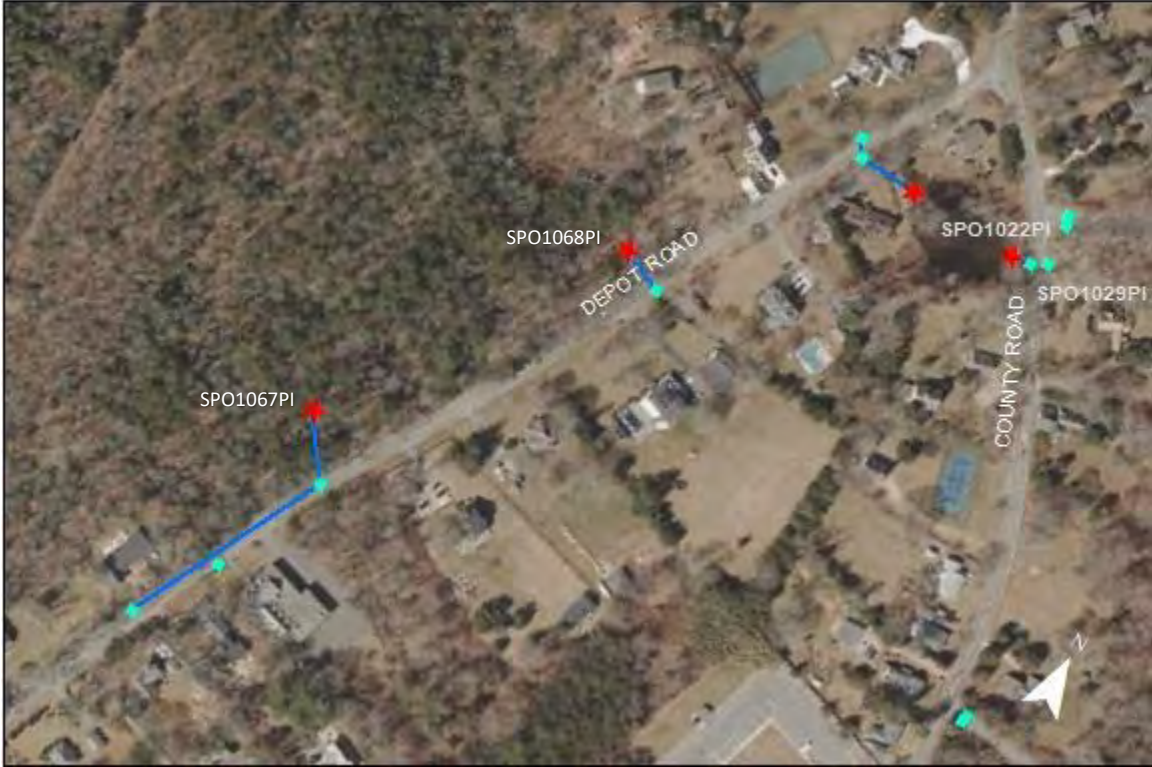
SPO1067PI, SPO1068PI, SPO1022PI and SPO1029PI- Depot Road: No issues found.

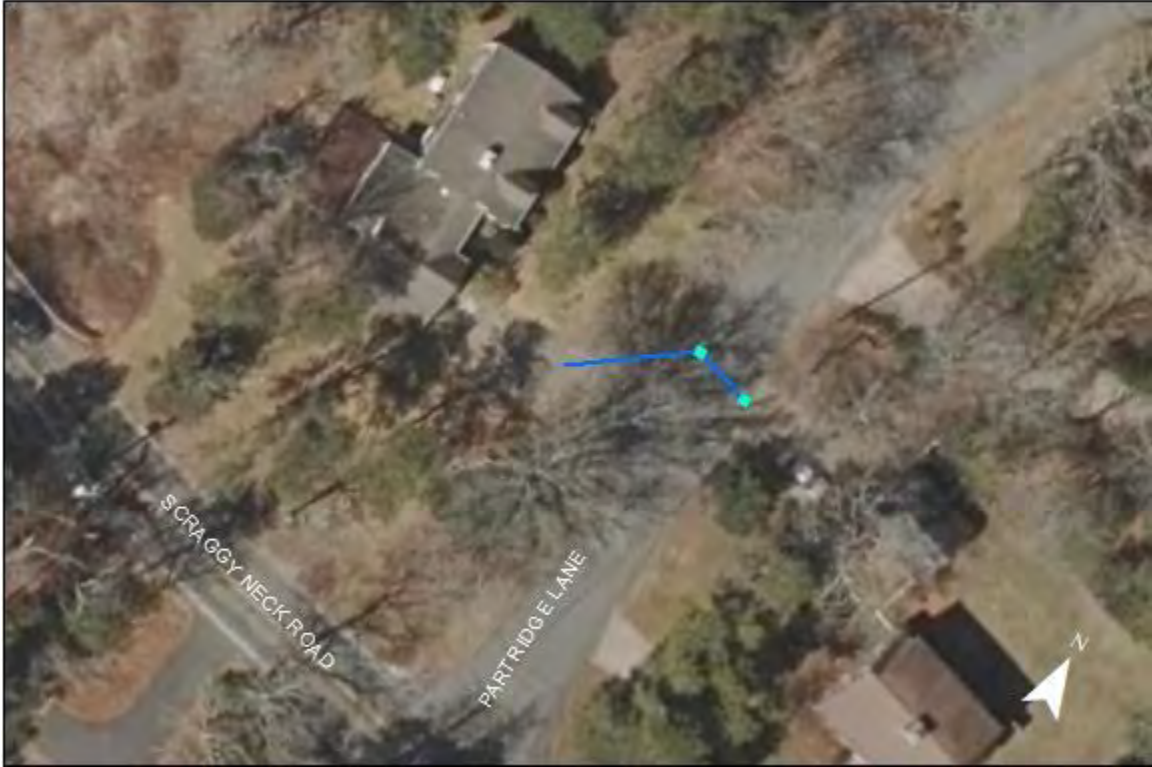
Partridge Lane: Pipes are extremely clogged. Not sure if pipe leads to an infiltration chamber or outfall. Area floods during rain events. Maintenance is strongly recommended.

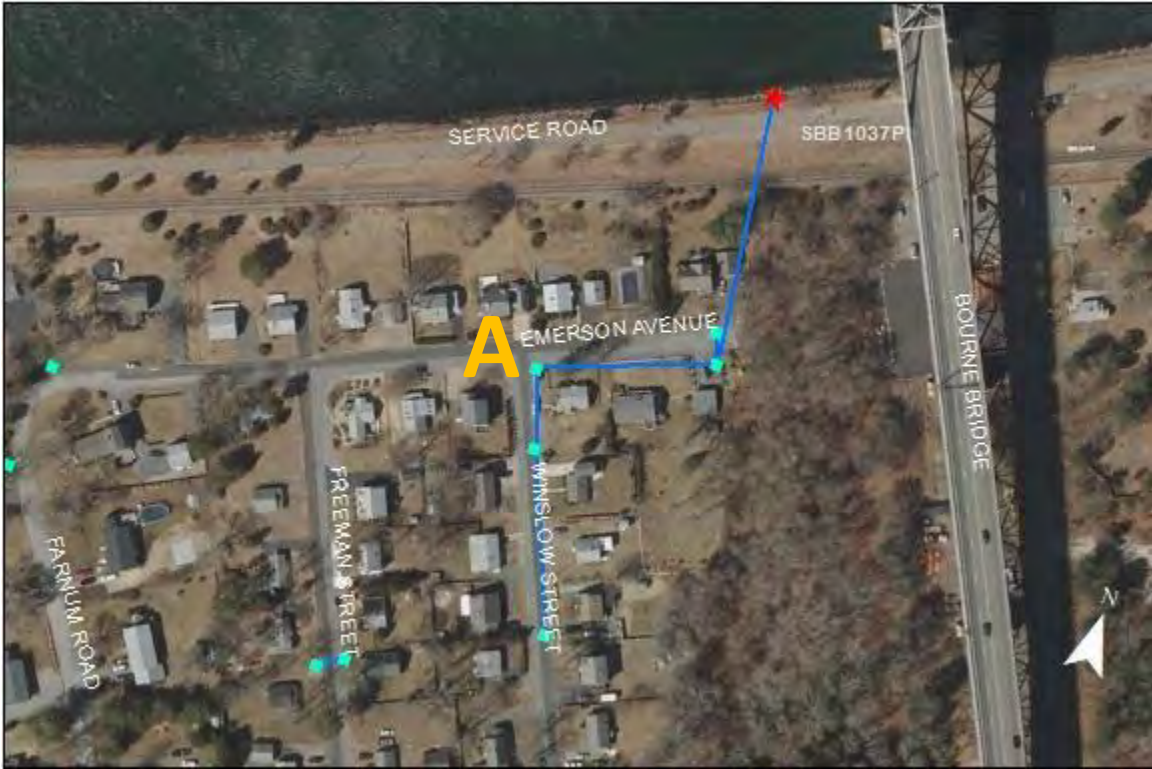
SBB1037PI- Winslow Street, Freeman Street, Farnum Road, and Emerson Avenue: No issues found. Unable to lift catchbasin at point A.

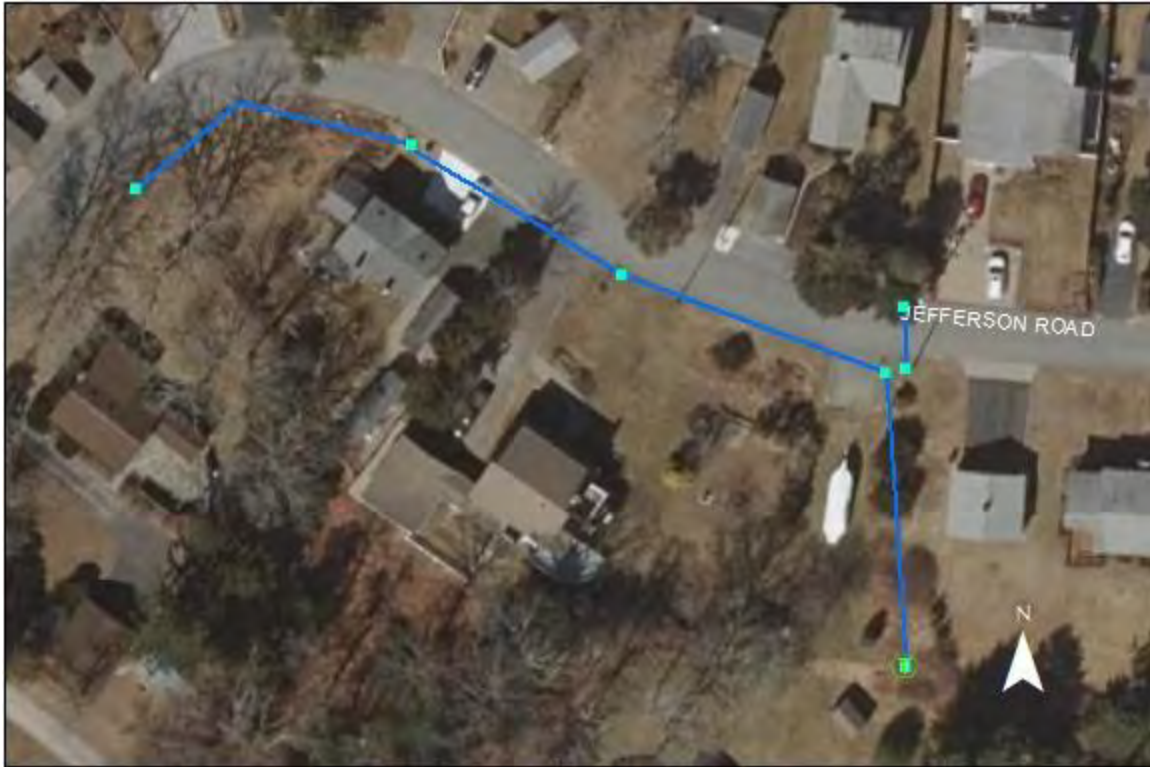
Jefferson Road: No issues found.

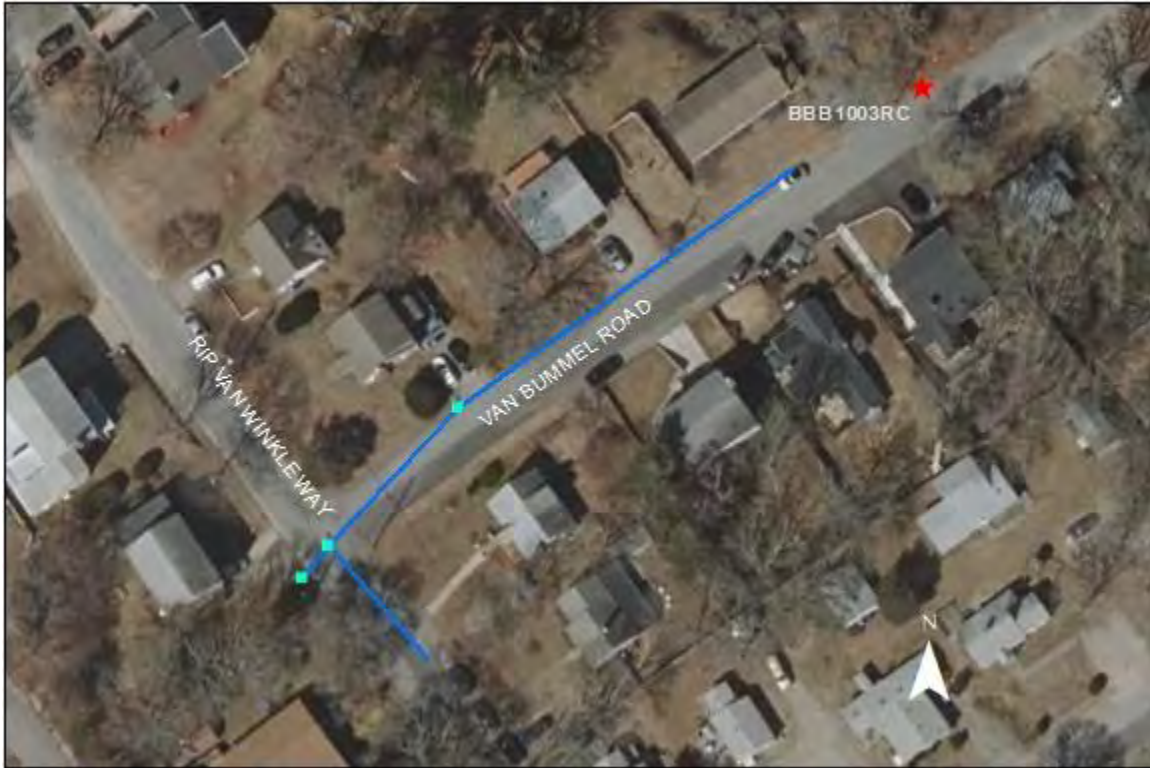
Van Bummel Road: No issues found. Catchment investigation is not complete.

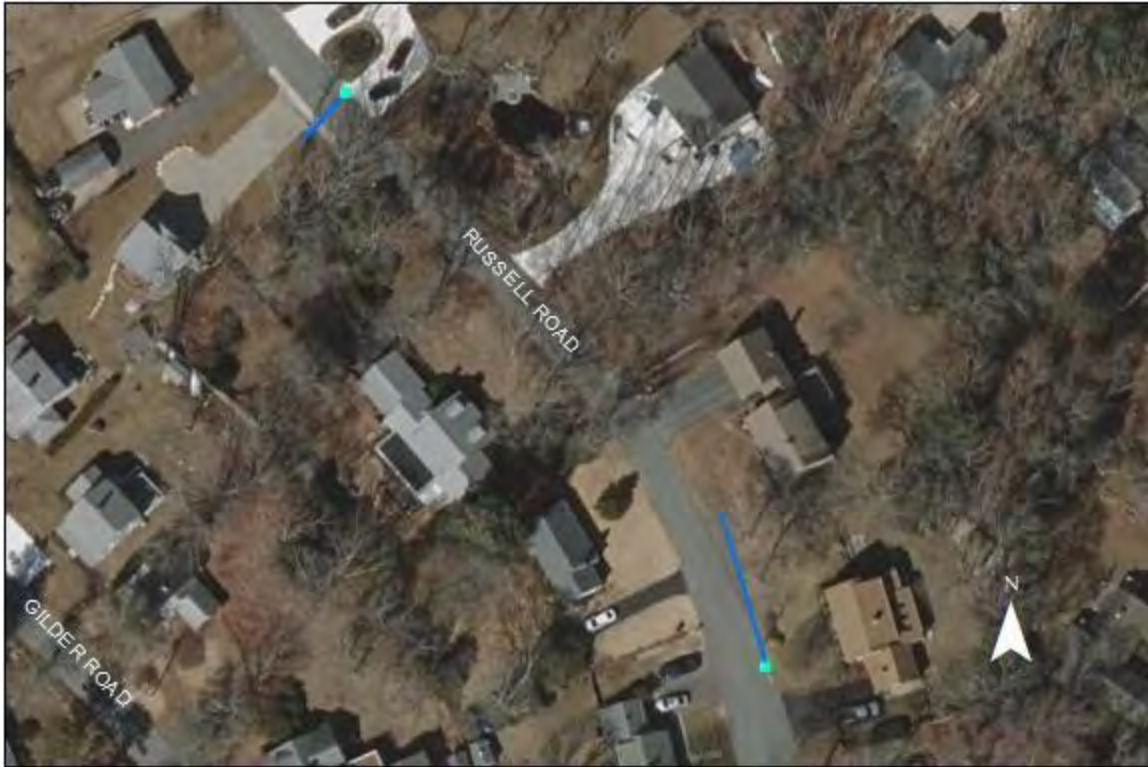
Russell Road: No issues found. The origin of the pipe entering each catchbasin is unknown. Further investigation is recommended.
