**The Buzzards Bay Stormwater Collaborative
Illicit Discharge Investigation Trailer**

Town of Bourne Report

November 2022

Bourne IDDE Report

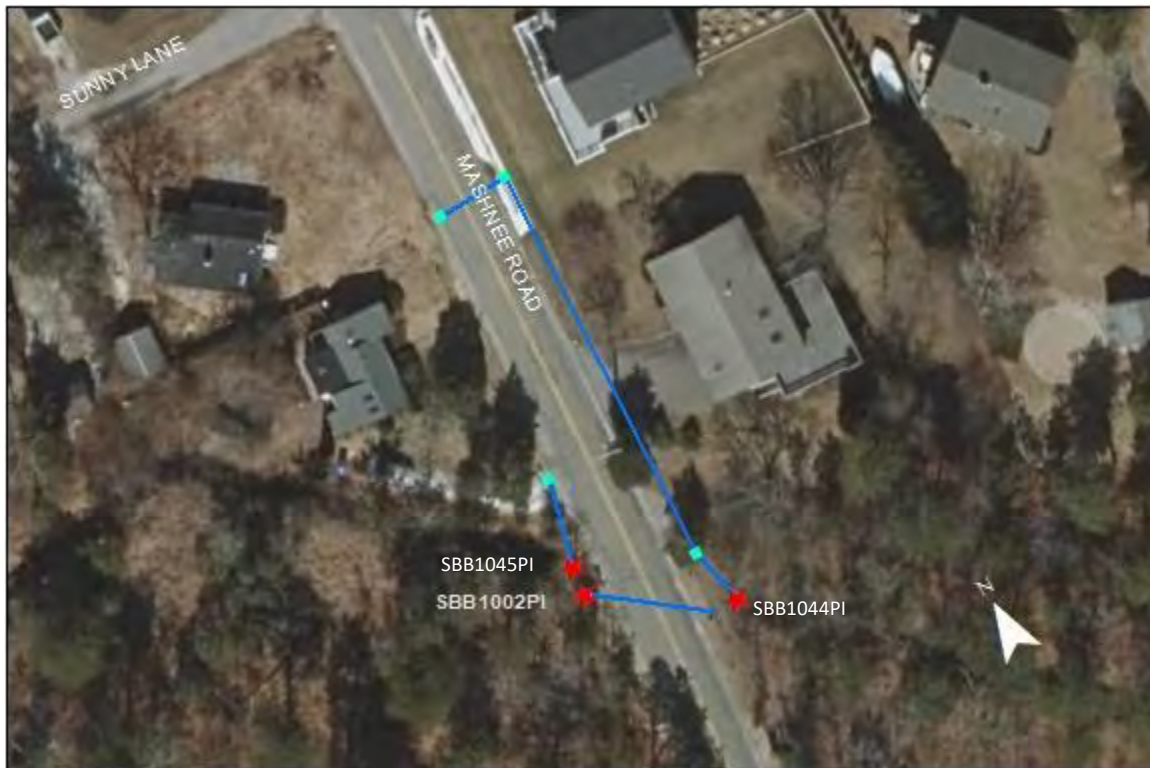
SBB1045PI, SBB1002PI, and SBB1044PI- Mashnee Road: All catchbasins were packed full of dirt. Further maintenance is suggested.

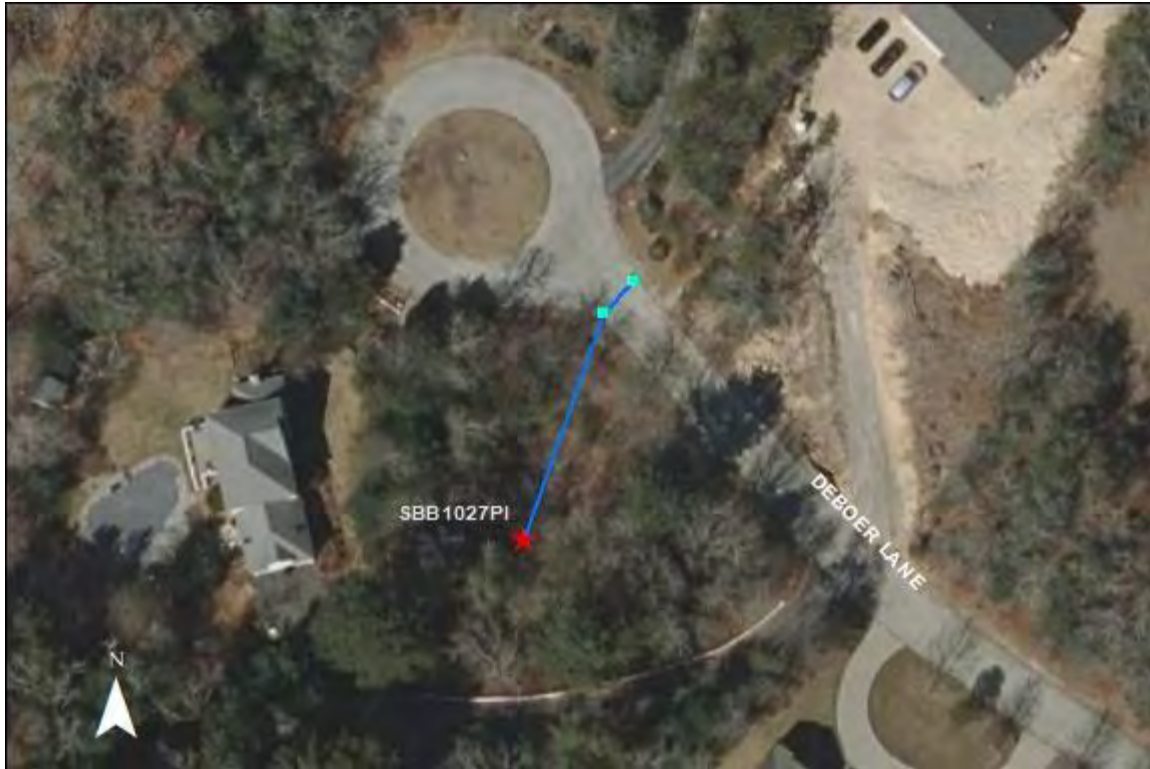
SBB1027PI- Deboer Lane: No issues found.

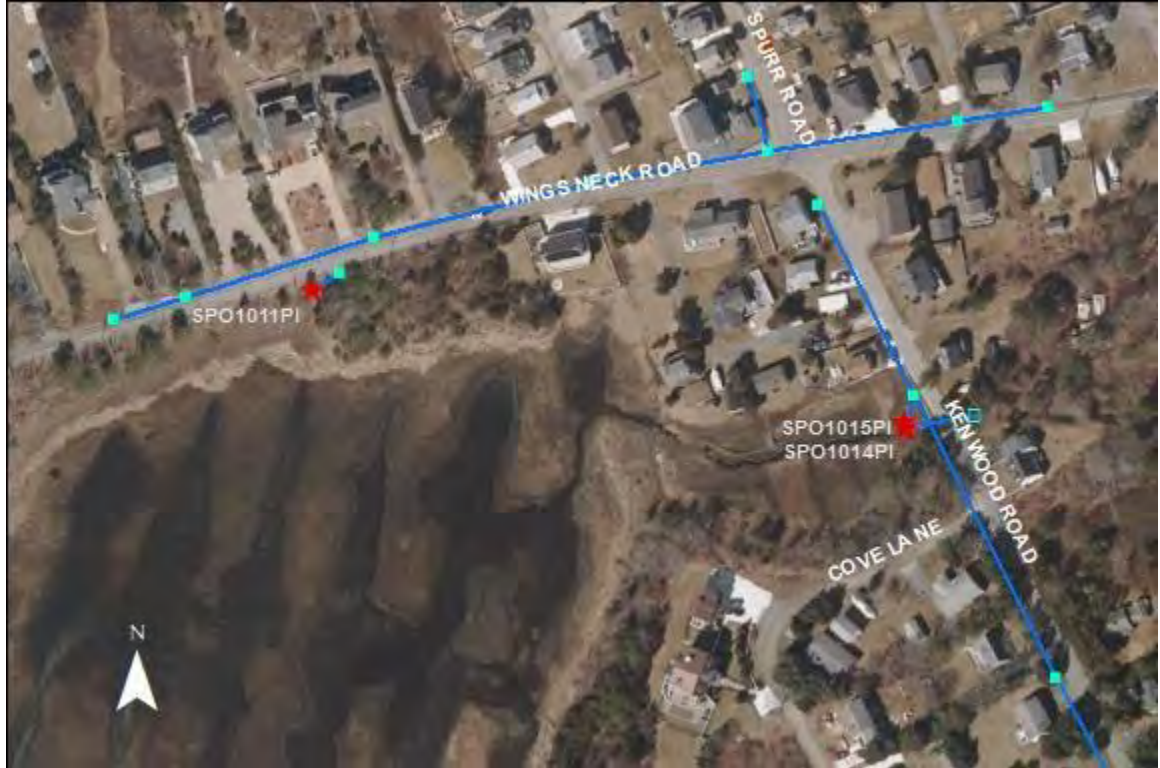
SPO1011PI- Wings Neck Road: No issues found. Uncertain where this part of Wings Neck Road drains to. Catchbasins were full of water at high tide. Further investigation during low tide is recommended.

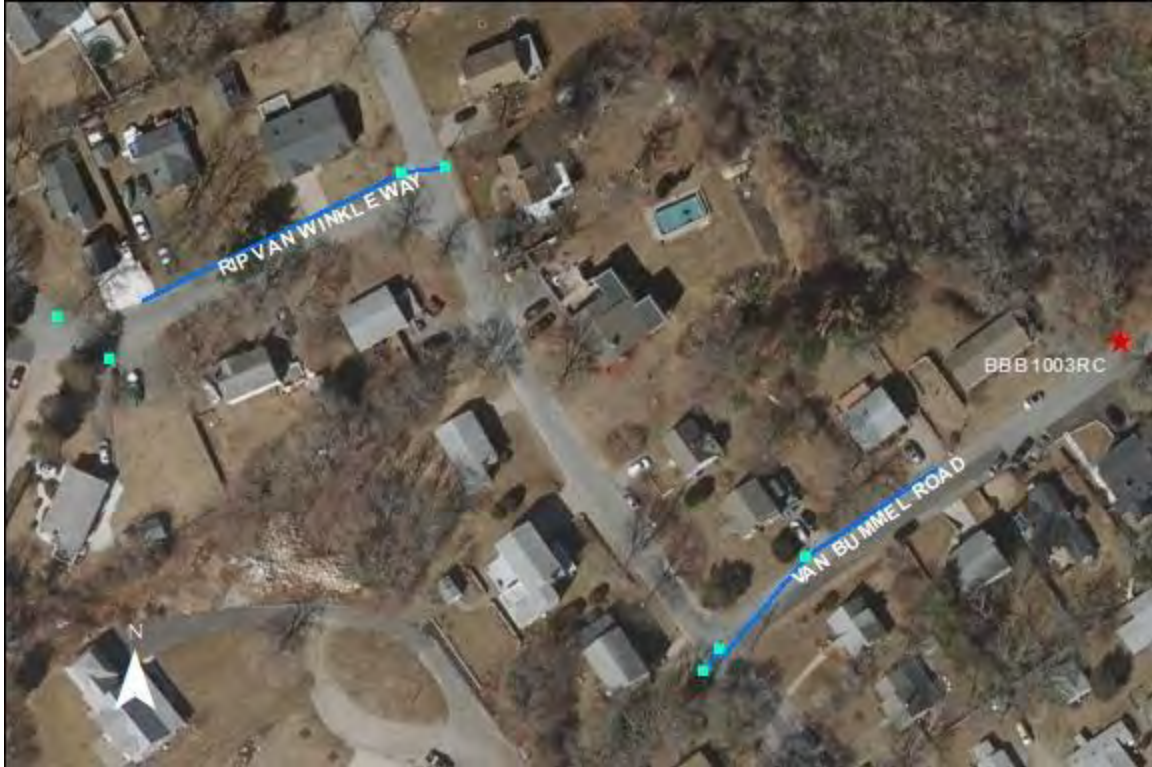
Rip Van Winkle Way and Van Bummel Road: No issues found. Catchment to be completed at a later date.

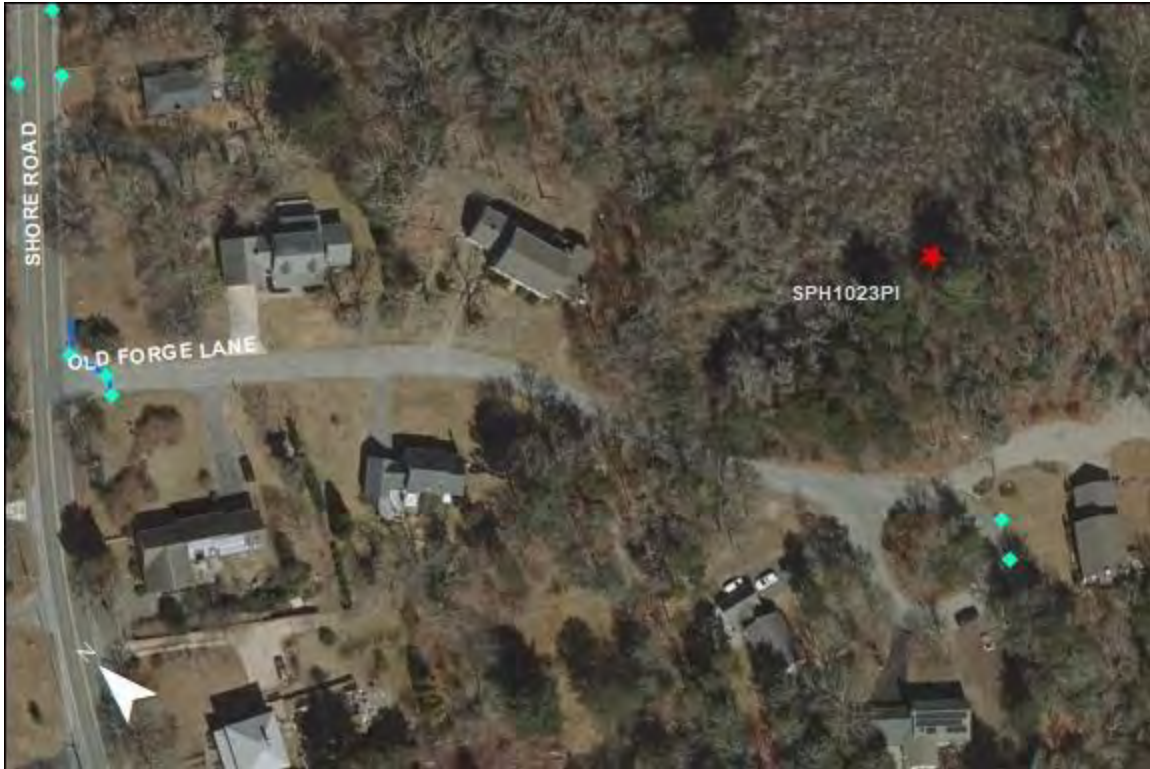
Old Forge Lane: Catchment continues onto Shore Road. Police detail needed for further inspection. Catchbasins at the cul-de-sac were completely full of water. The existence of SPH1023PI could not be confirmed. There could be a blockage, or they could be infiltration basins. Further investigation is recommended.

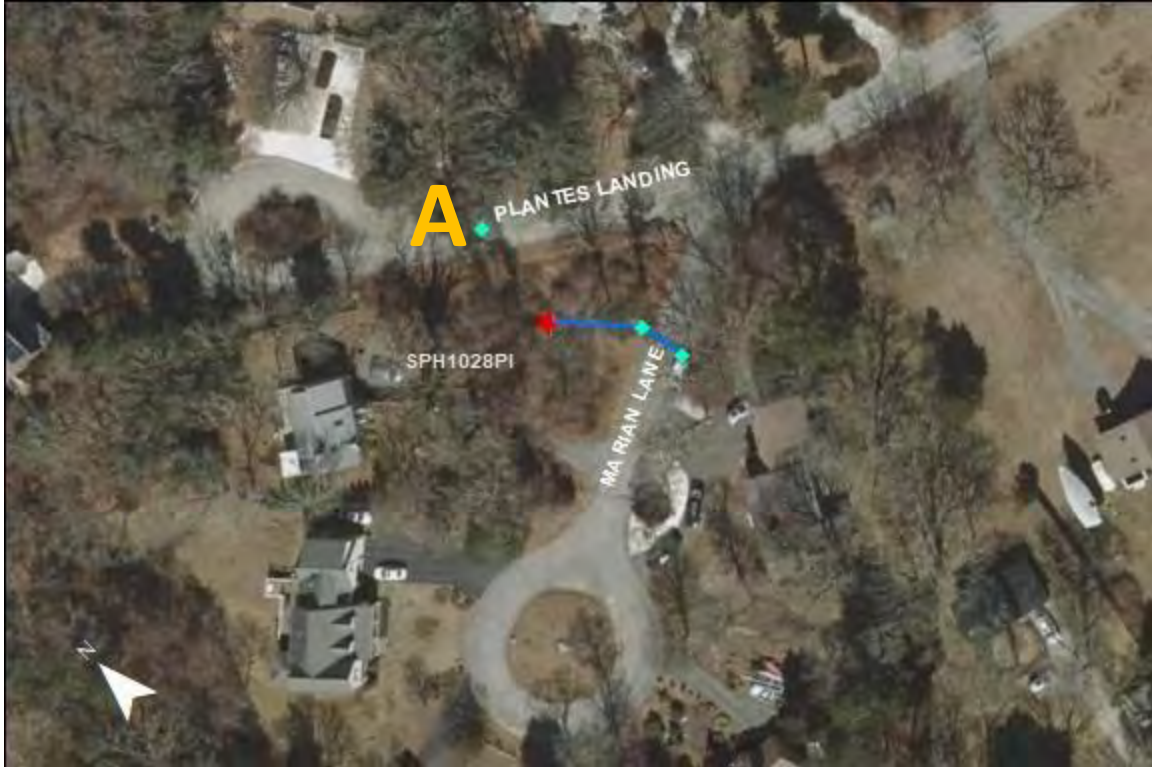
SPH1028PI- Marian Lane and Planter's Landing: No significant issues found. At point A the catchbasin has begun to sink. Preventative measures are suggested.

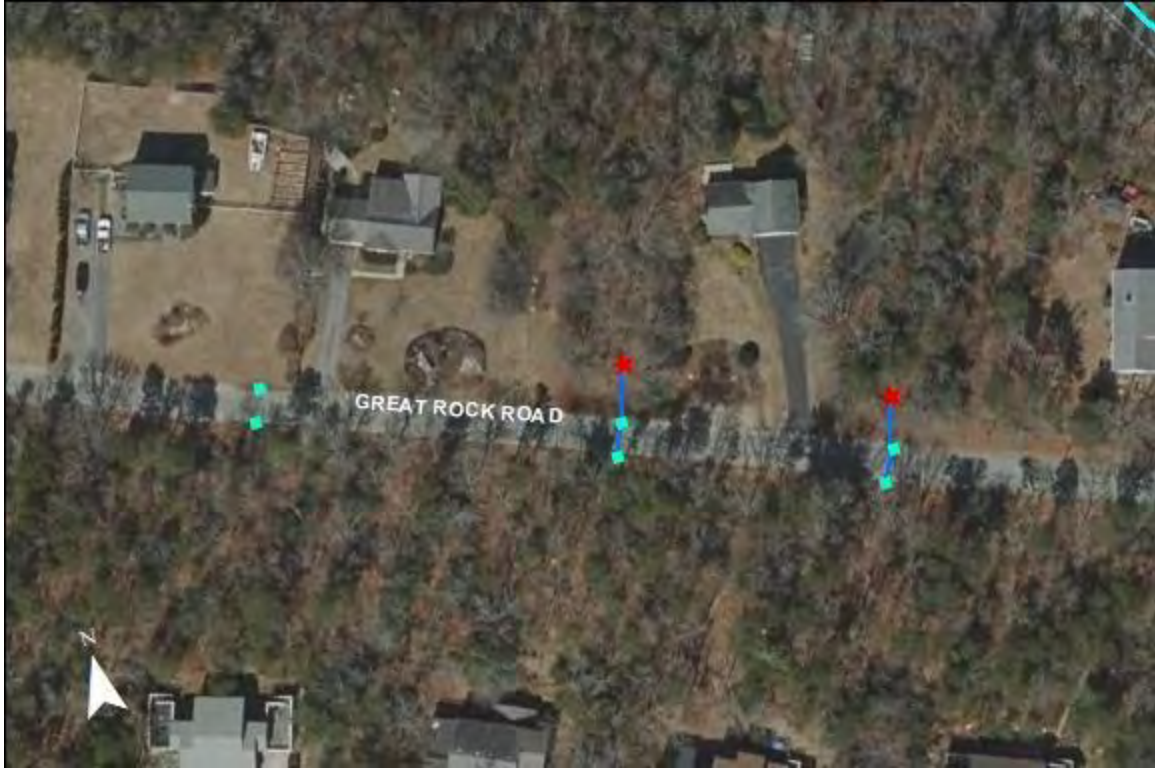
Great Rock Road: No issues found. Further investigation to determine if pipes lead to outfalls or underground treatment structures is recommended.
