**The Buzzards Bay Stormwater Collaborative  
Illicit Discharge Investigation Trailer**

**Town of Fairhaven Report**

**November 2022**

### **Fairhaven IDDE Report**

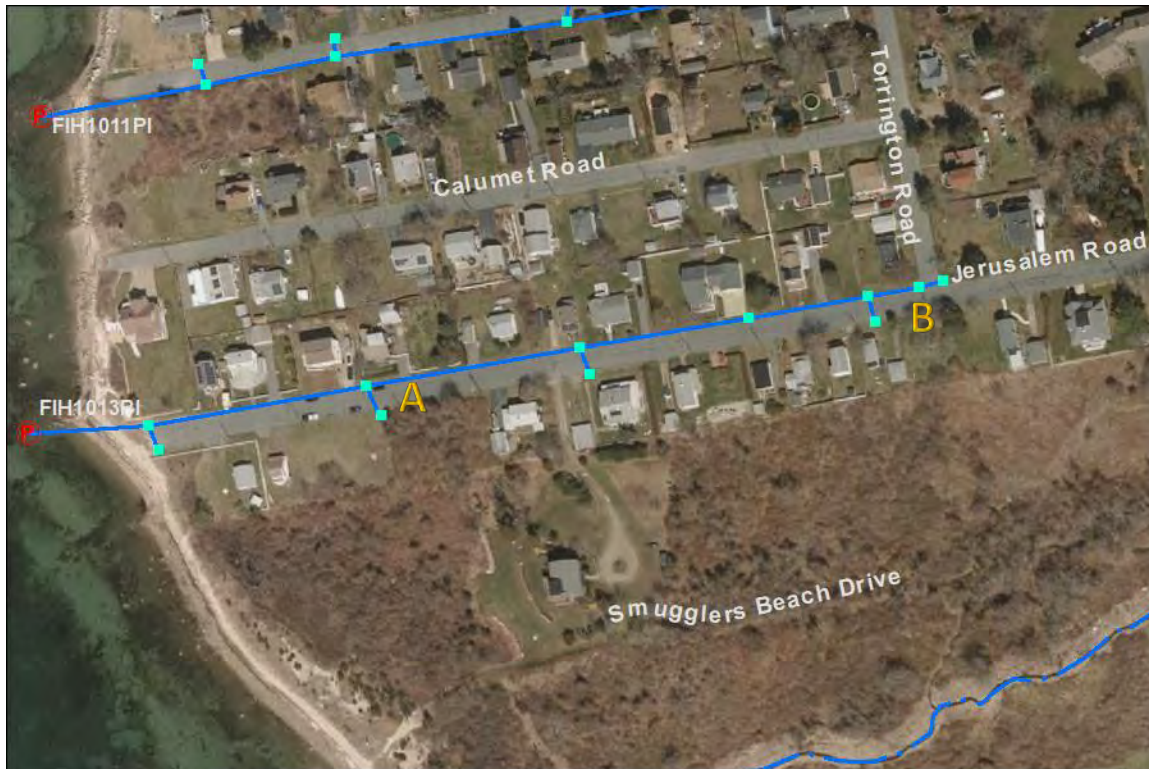
FIH1013PI – Jerusalem Road: at location A there was a broken drain pipe observed with ground water entering; water department determine it was not a waterline break; at location B a sheen that could be petroleum based was observed. Recommend pumping and cleaning catchbasin with the sheen.

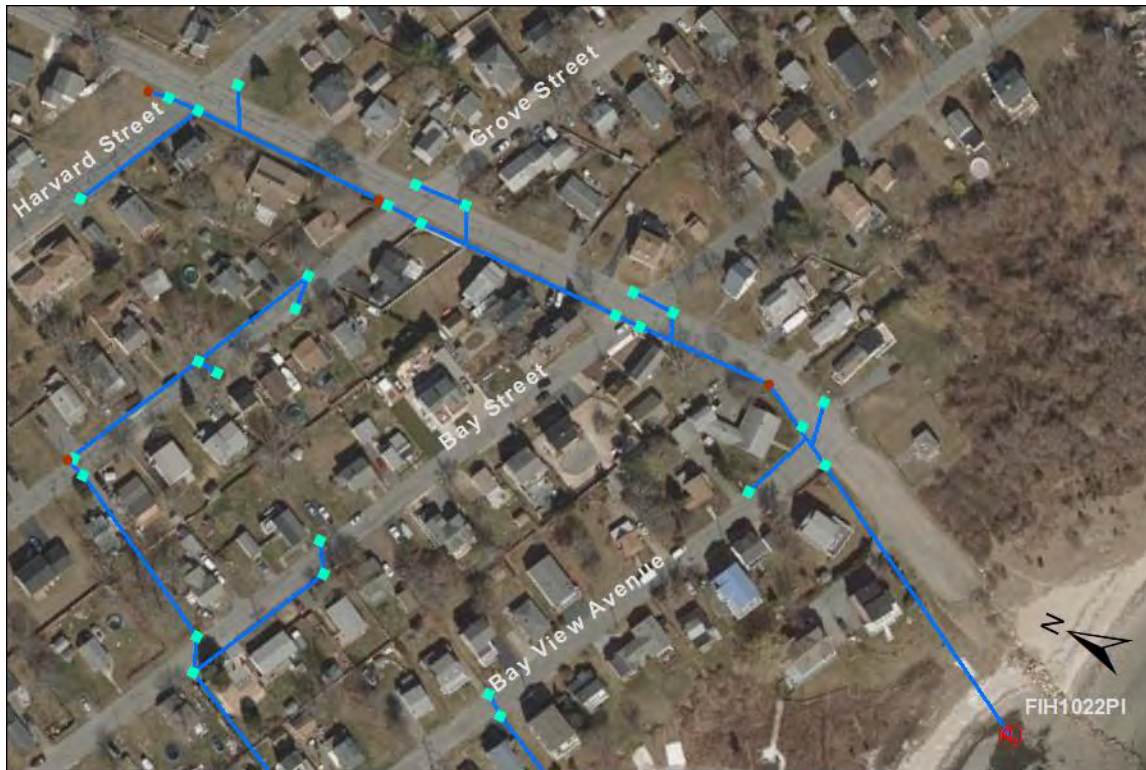
FIH1022PI – Manhattan Ave: no issues found but many of the catchbasins connect to the main drain line without a junction structure.

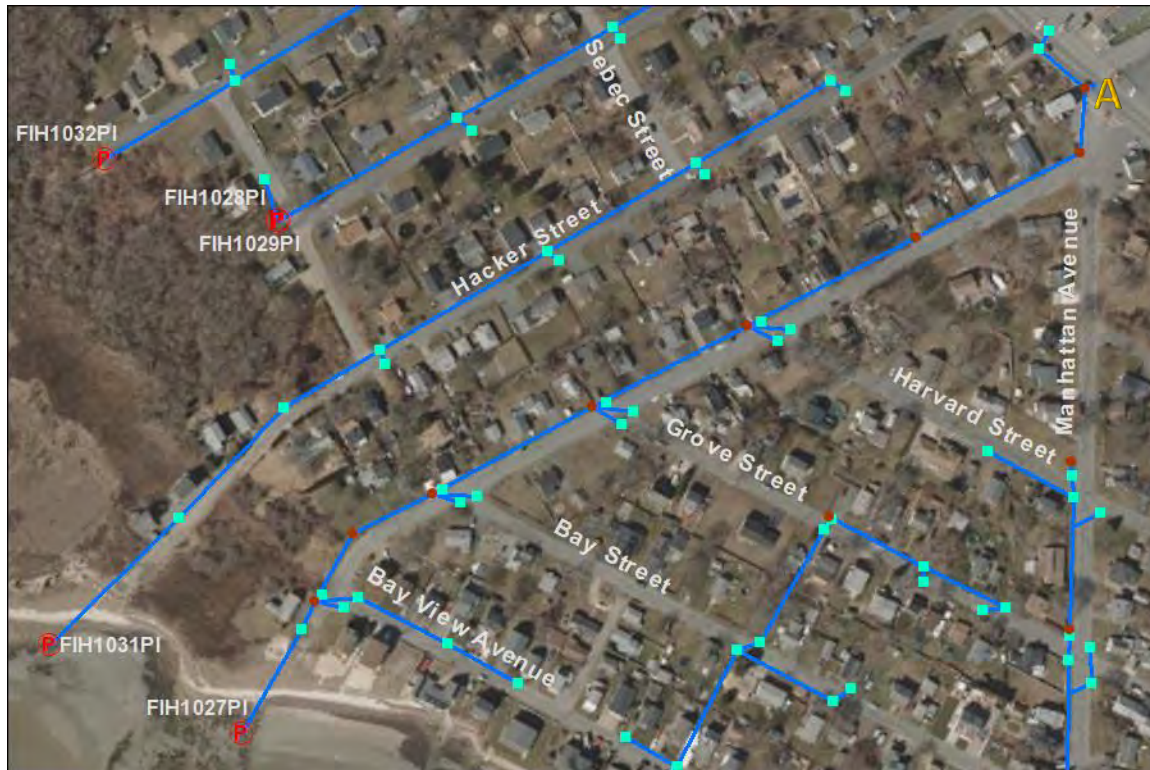
FIH1031PI – Hacker Street: no issues found. FIH1027PI – Highland Ave: last manhole in the network on Sconticut Neck Road (location A) has a blocked pipe directed towards a sewer manhole (15ft away). There was no odor but there appeared to be some composted material in the structure. Upon inspection, there was no indication of a connection in the sewer manhole but recommend pipe be capped and drain manhole cleaned.

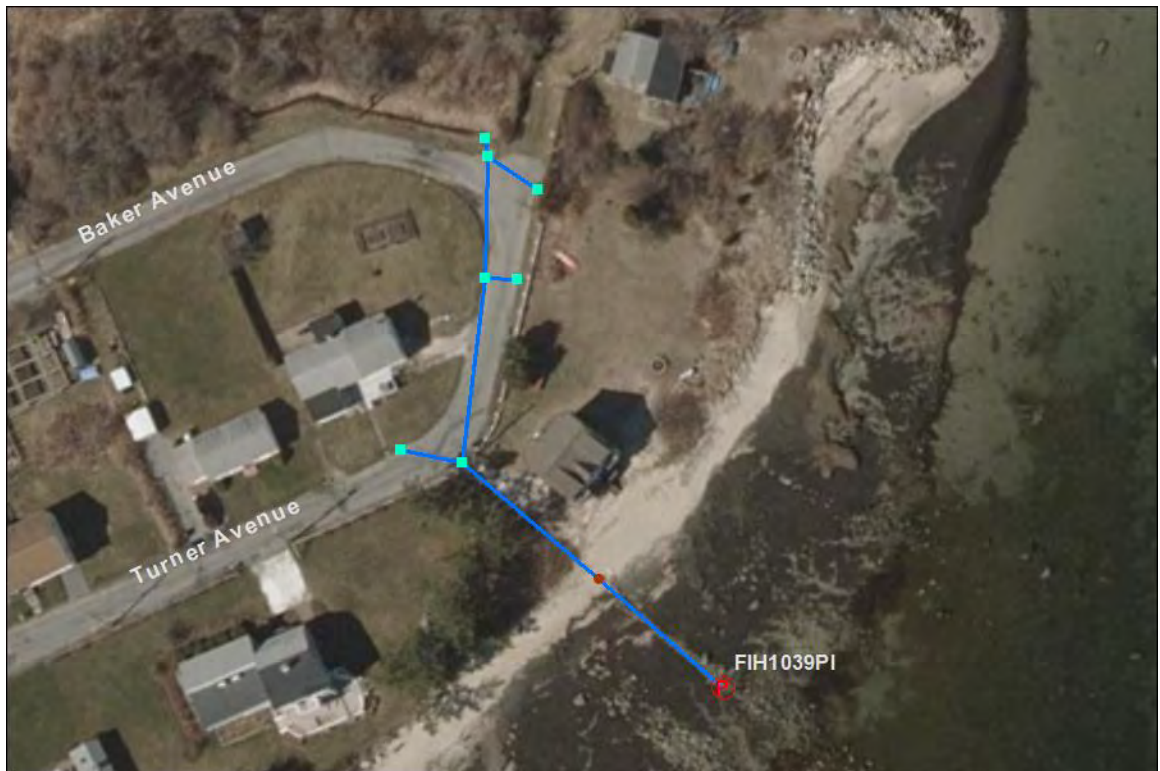
FIH1039PI – Turner Ave: no issues found. Before inspection, this was mapped as two separate drain systems with one draining into the ditch; however the ditch pipe is an inlet and the entire system is connected and drains to the outfall pipe in the bay.

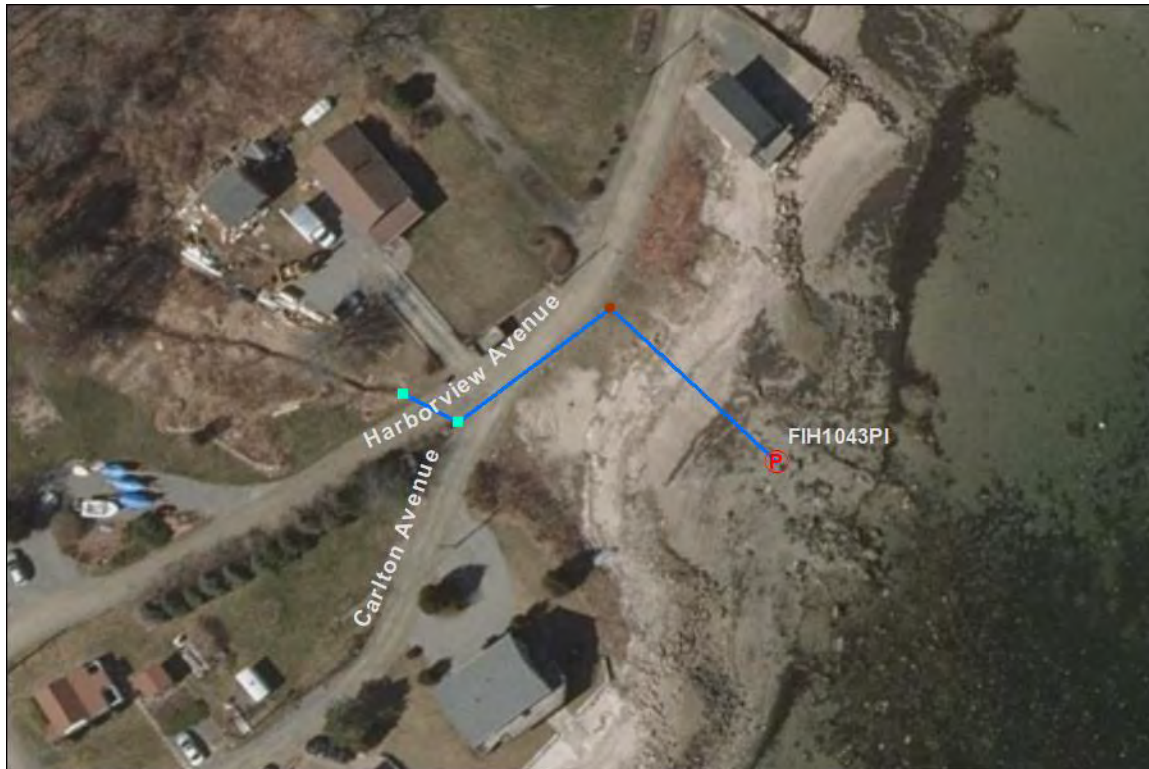
FIH1043PI – Harborview Ave: no issues found but structures are in poor condition.

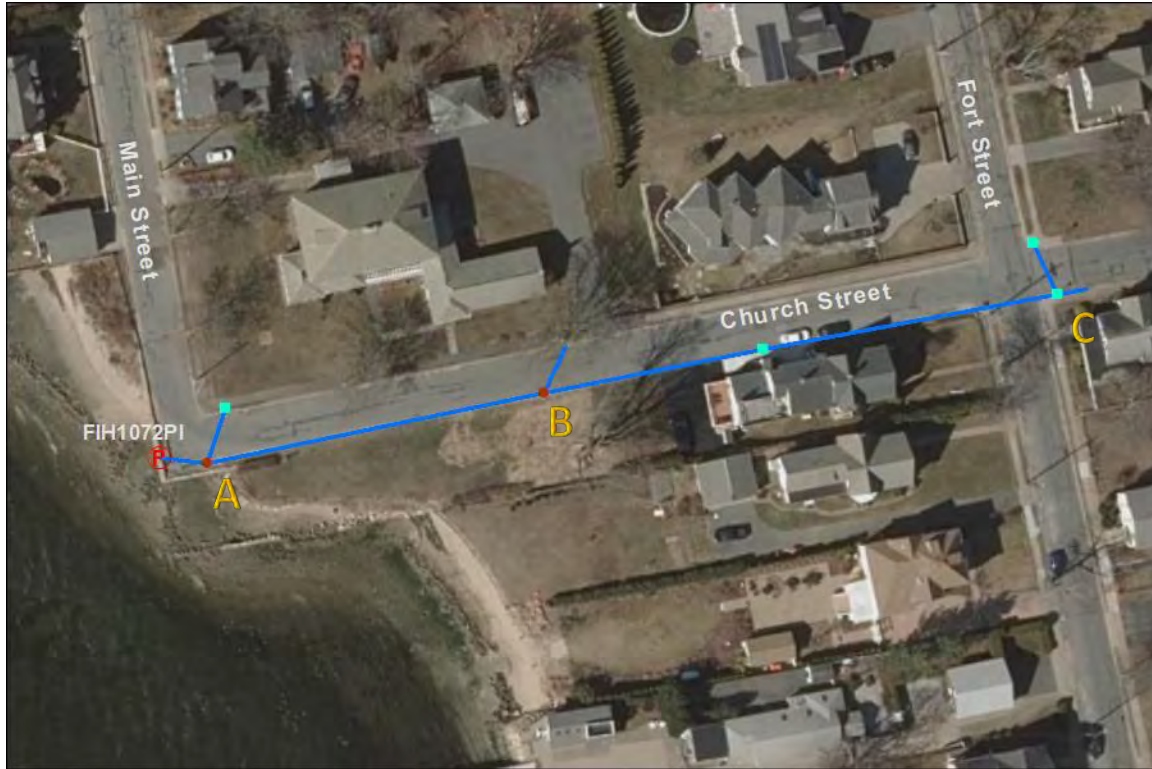
FIH1072PI – Church St: no issues found; at location A the manhole structure is buried, a camera was used from the adjacent catchbasin to determine; at location B there is a collapsed 24-inch concrete pipe; and at location C there is a clay pipe that appears to be capped or blocked 2 feet from the structure.

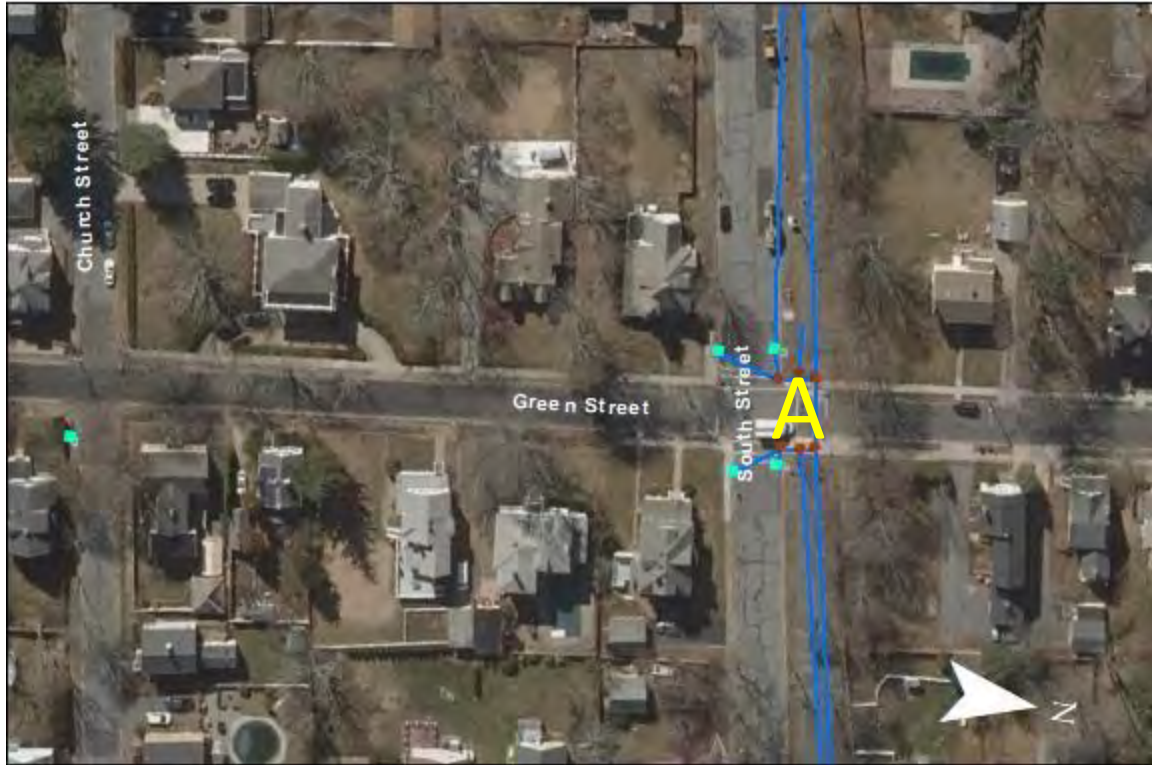
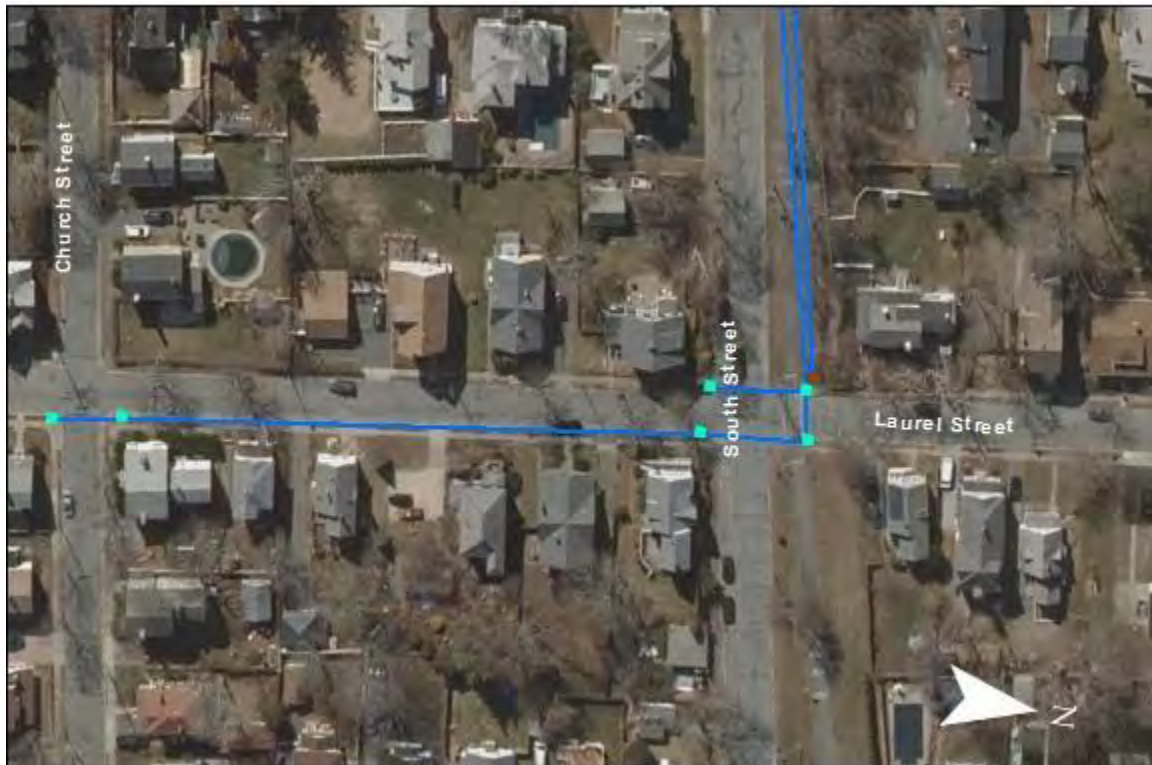
FIH1077PI- South Street: No issues found. At point A, a pipe exits the manhole. Its destination is unknown. Further investigation is recommended.

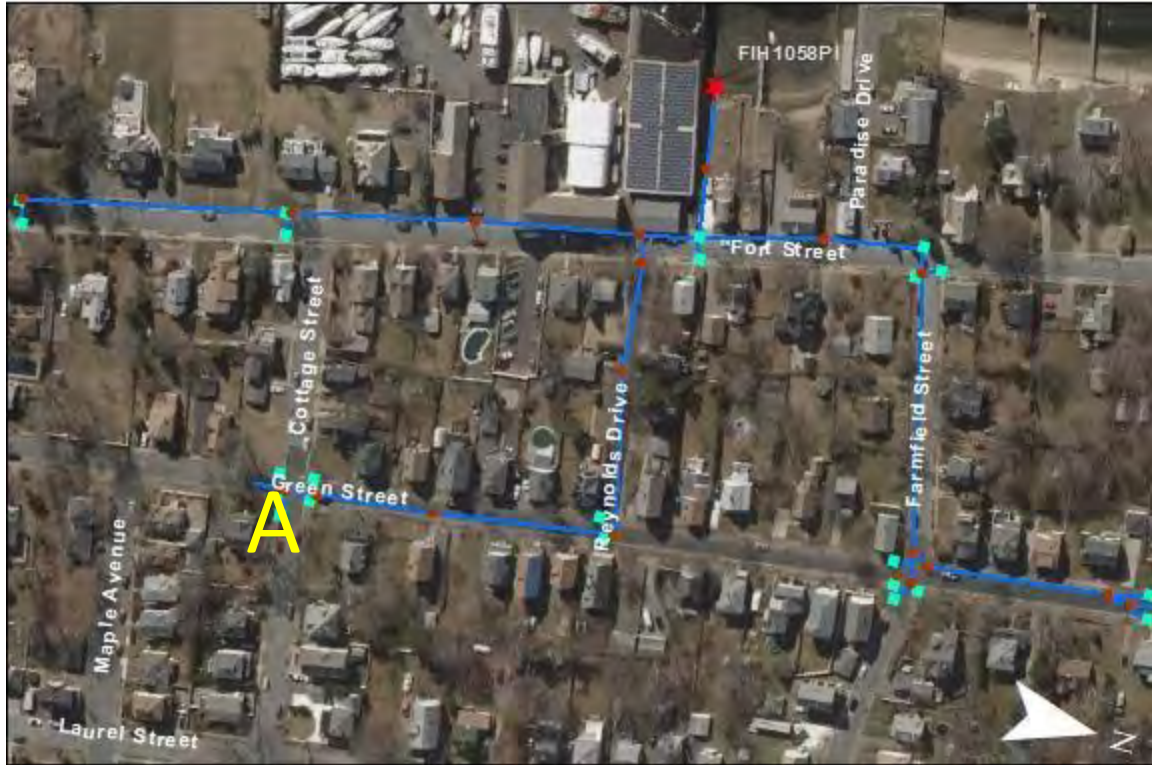
FIH1058PI- Fort Street and Green Street: No issues found. At point A, a pipe enters the manhole. Its origin is unknown. Further investigation is suggested. Catchment needs an additional visit to complete the investigation further North on Green Street.

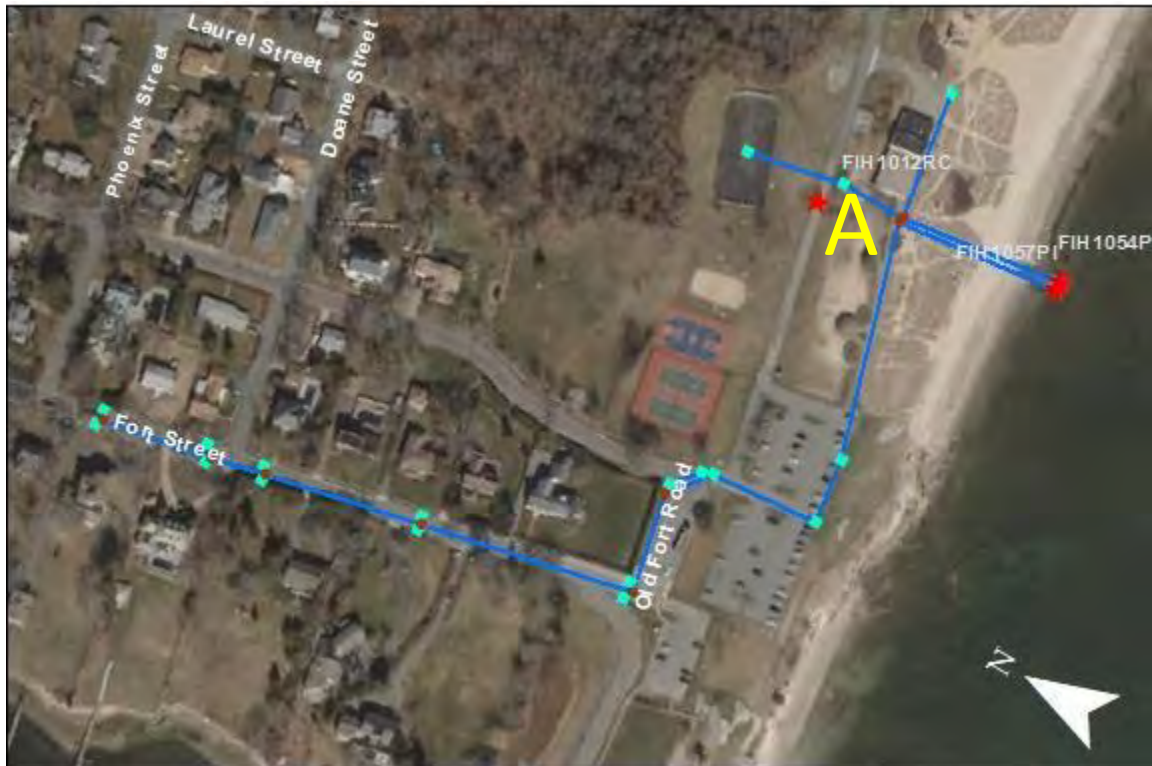
FIH1057PI, FIH1054PI, and FIH1012RC- Fort Phoenix: No issues found. A pipe enters the catchbasin at point A. Its origin is unknown. Further investigation is suggested. Also, multiple silt screens were found still deployed in several catchbasins in the parking lot of Fort Phoenix.

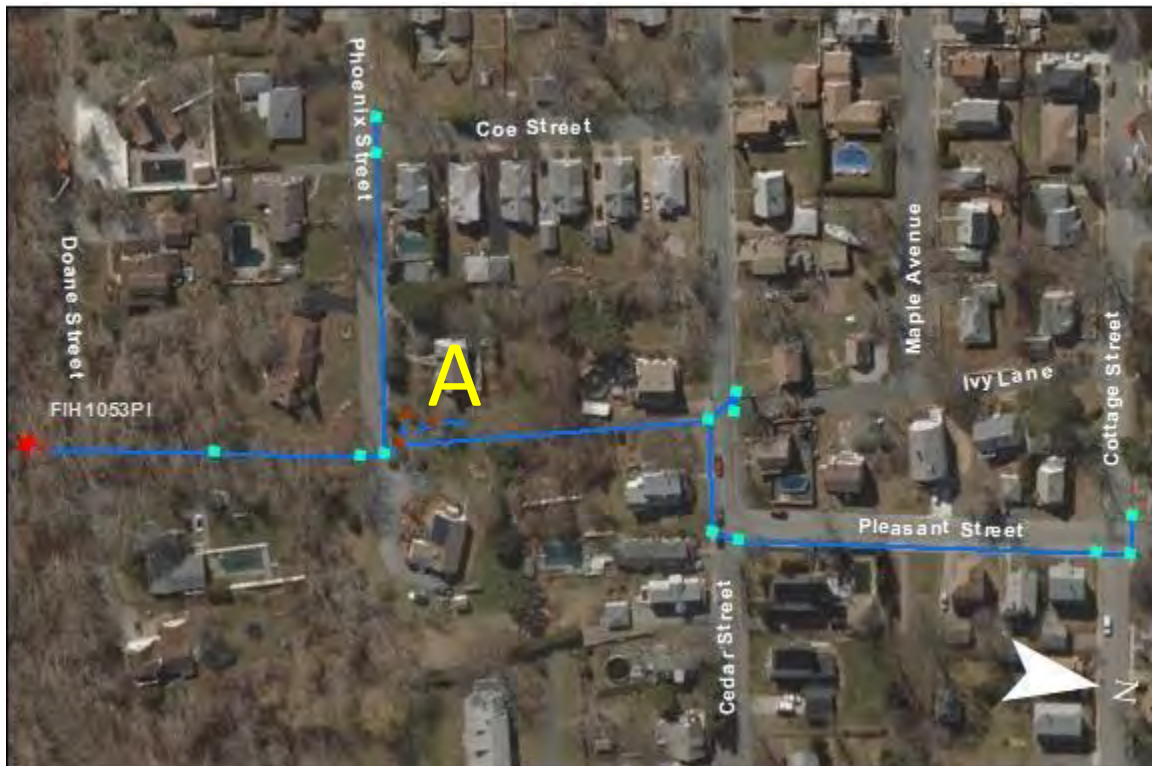
FIH1053PI- Phoenix Street, Cedar Street, and Pleasant Street: No issues found. At point A there is a very old manhole with a pipe entering and exiting. The origin and destination of these pipes is unknown.

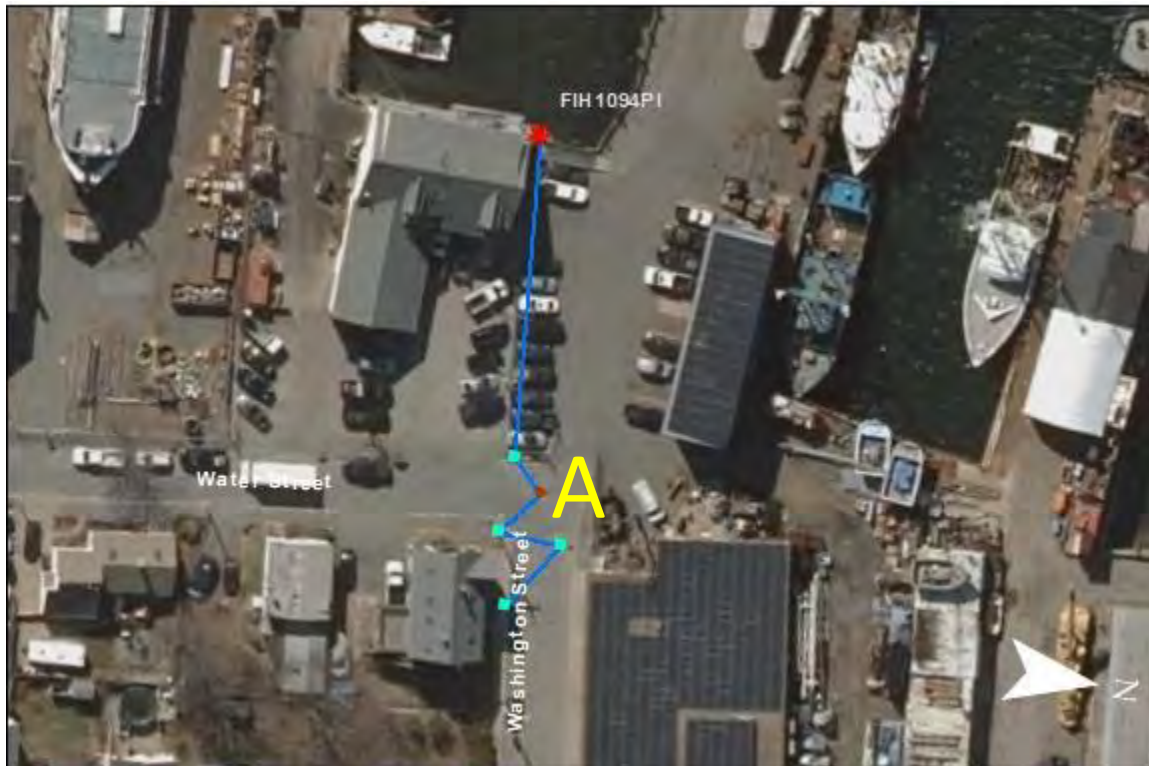
FIH1094PI- Washington Street: No significant issues found. The manhole at point A is cracked and needs to be replaced.

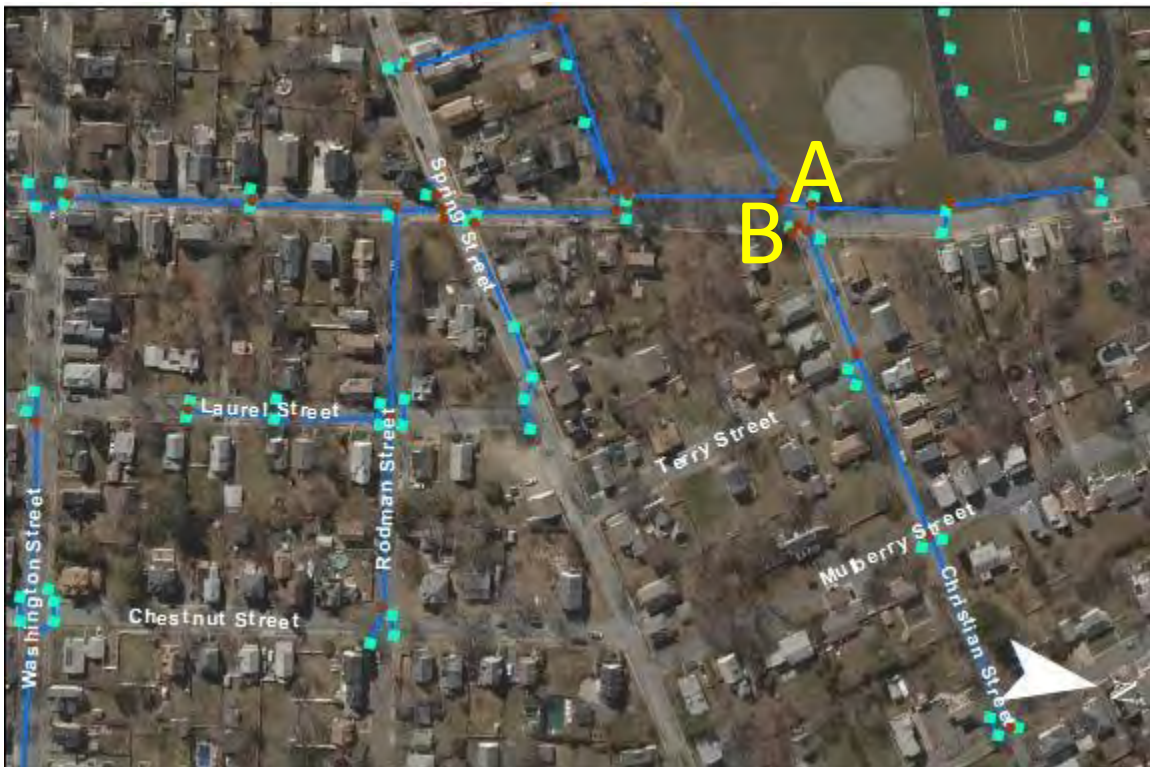
FIH1090PI (3/3)- Green Street, Spring Street, Christian Street, Rodman Street, and Laurel Street: No issues found. Pipe enters catchbasins at points A and B. The origin of these pipes is unknown. Further investigation is suggested.

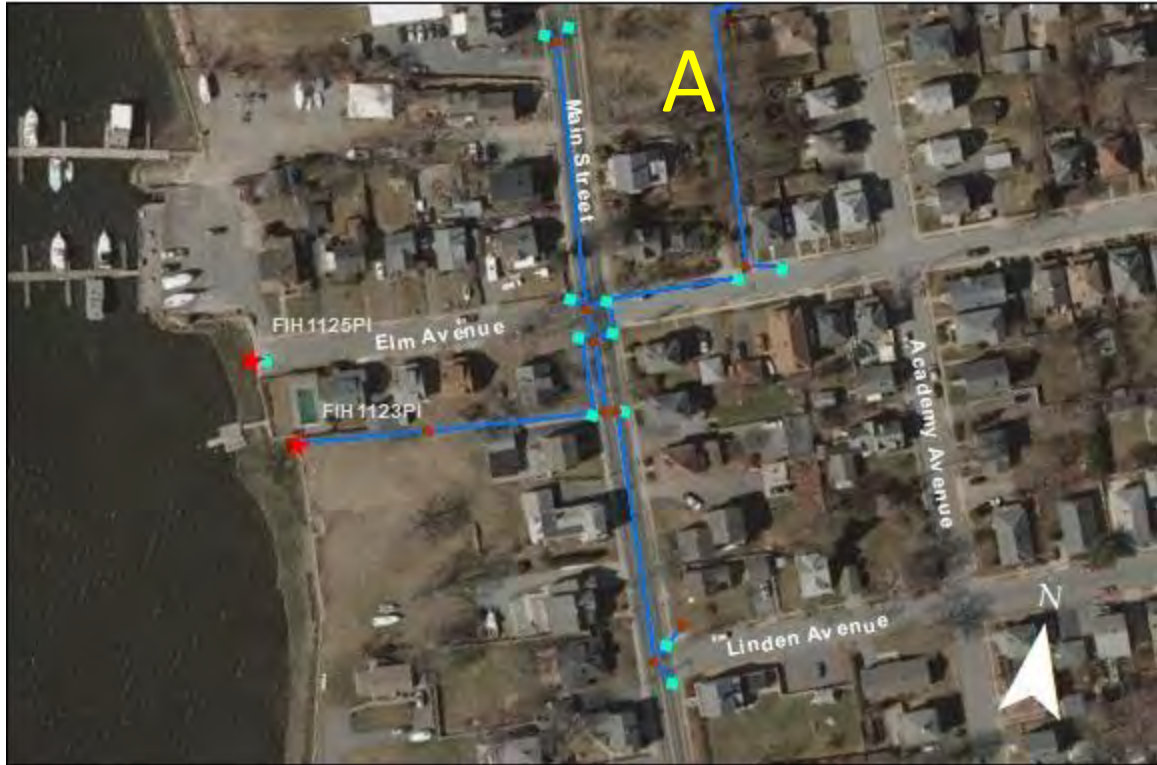
FIH1123PI- Main Street: No issues found. Note that this catchment is connected to catchment FIH114PI by way of an underground culvert illustrated at point A.

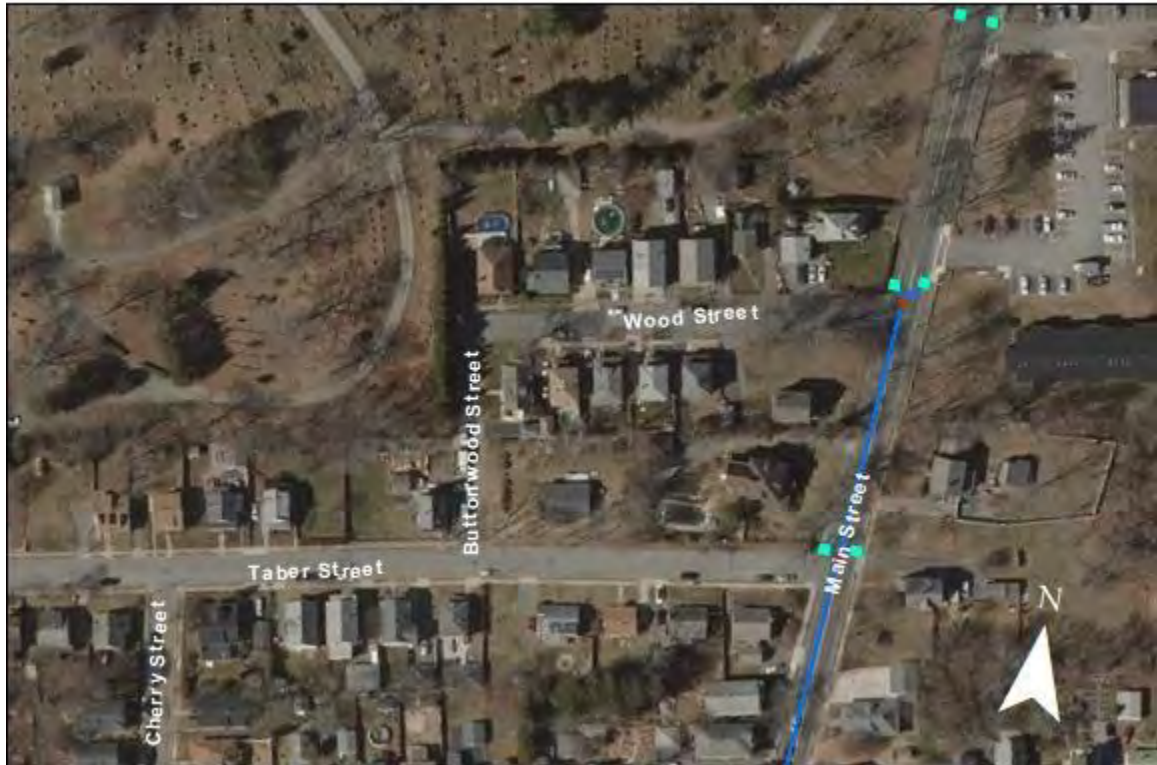
FIH1130PI, FIH1129PI, and FIH1128PI- Pilgrim Avenue, Cherry Street, and Main Street: No issues found. The catchbasin at point A has a silt screen on it. Removal of the silt screen is recommended.

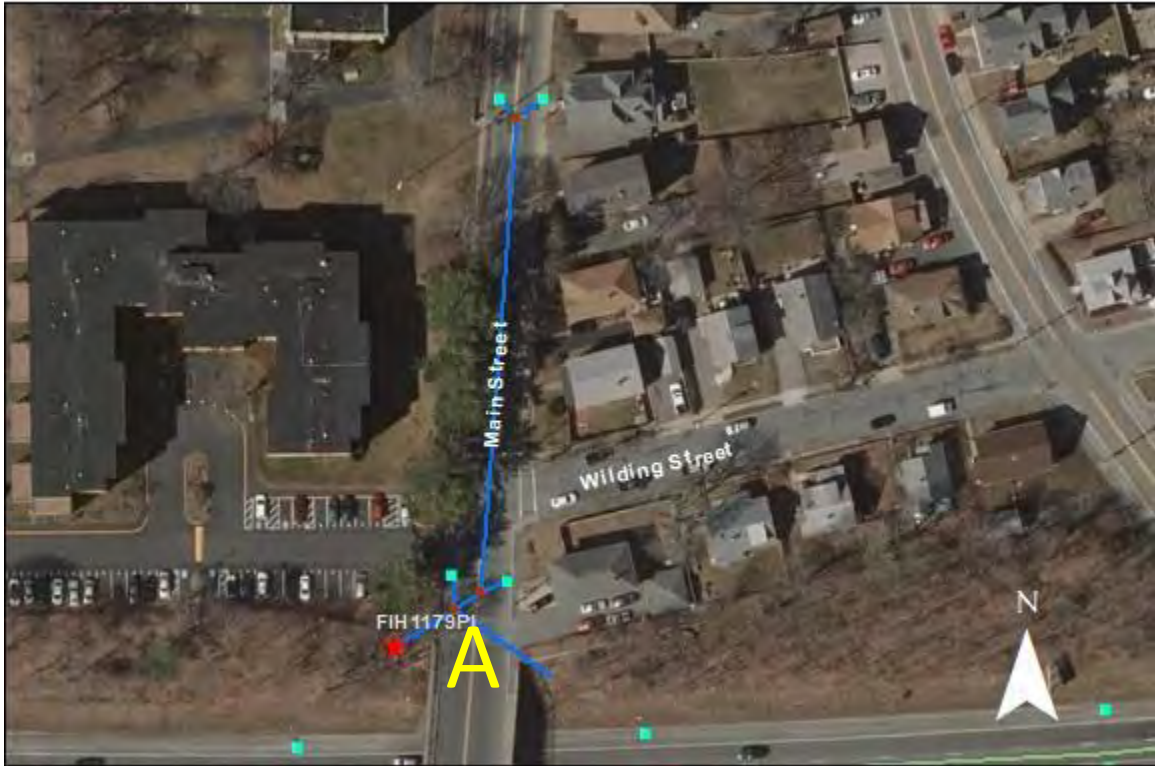
FIH1179PI- Main Street: No issues found. The manhole at point A has an incoming pipe with an unknown destination. Further investigation is suggested.

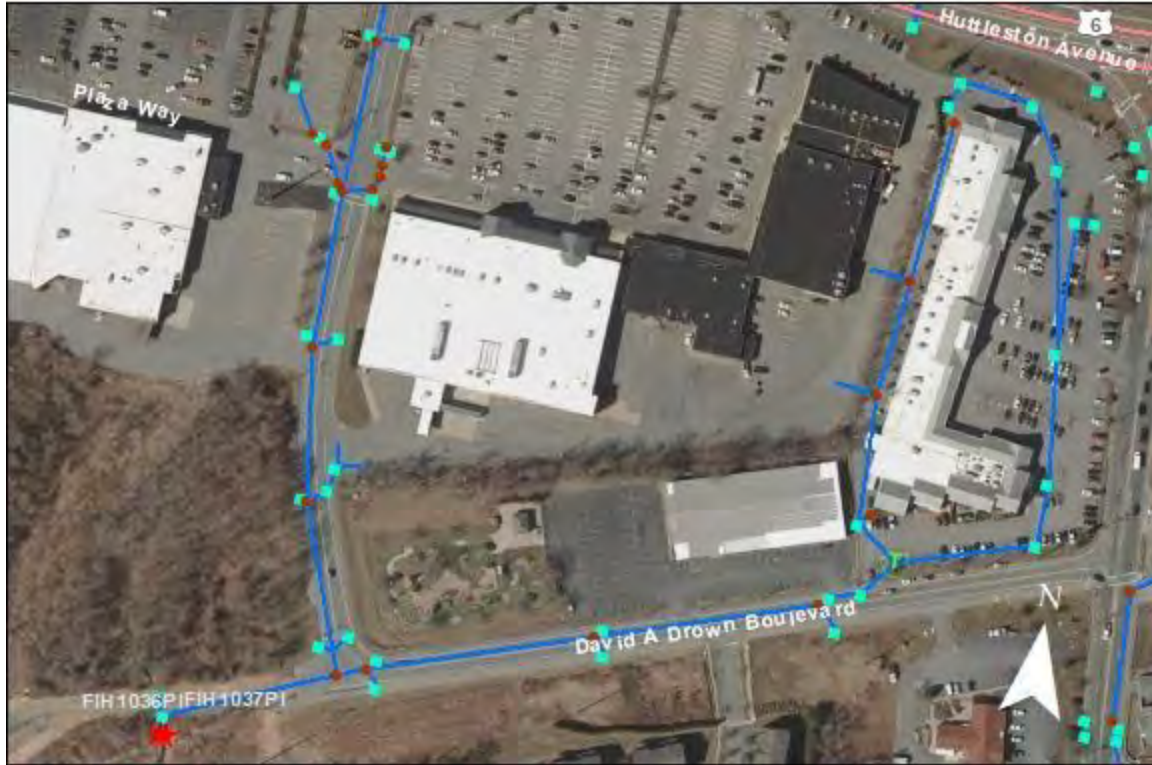
FIH1036PI and FIH1037PI- David A Drown Boulevard and Alden Road: No issues found. At points A and B there are pipes entering the manholes in the direction of the back lot of The Berdon Plaza. Further investigation of that lot is suggested.

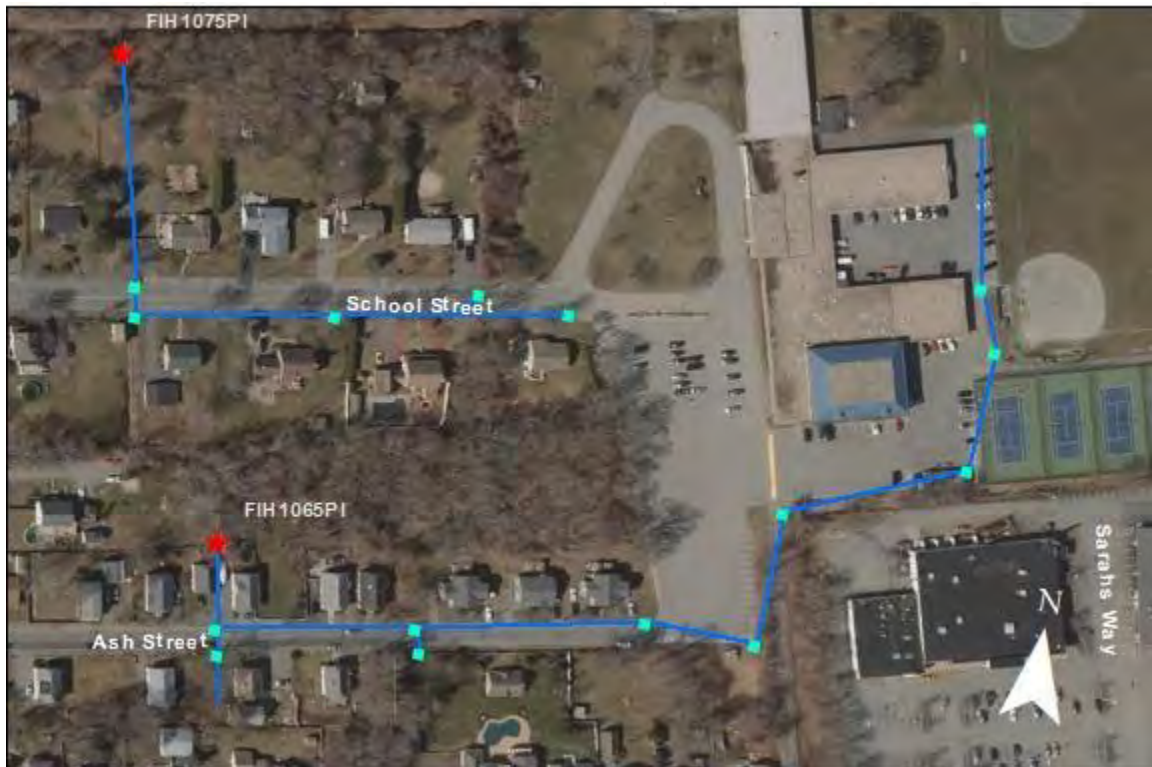
FIH1075PI and IH1065PI- Ash Street and School Street: No issues found. Structures next to and behind the school were not investigated due to the parking lot being full during school hours. Further investigation when school is out of session is recommended.

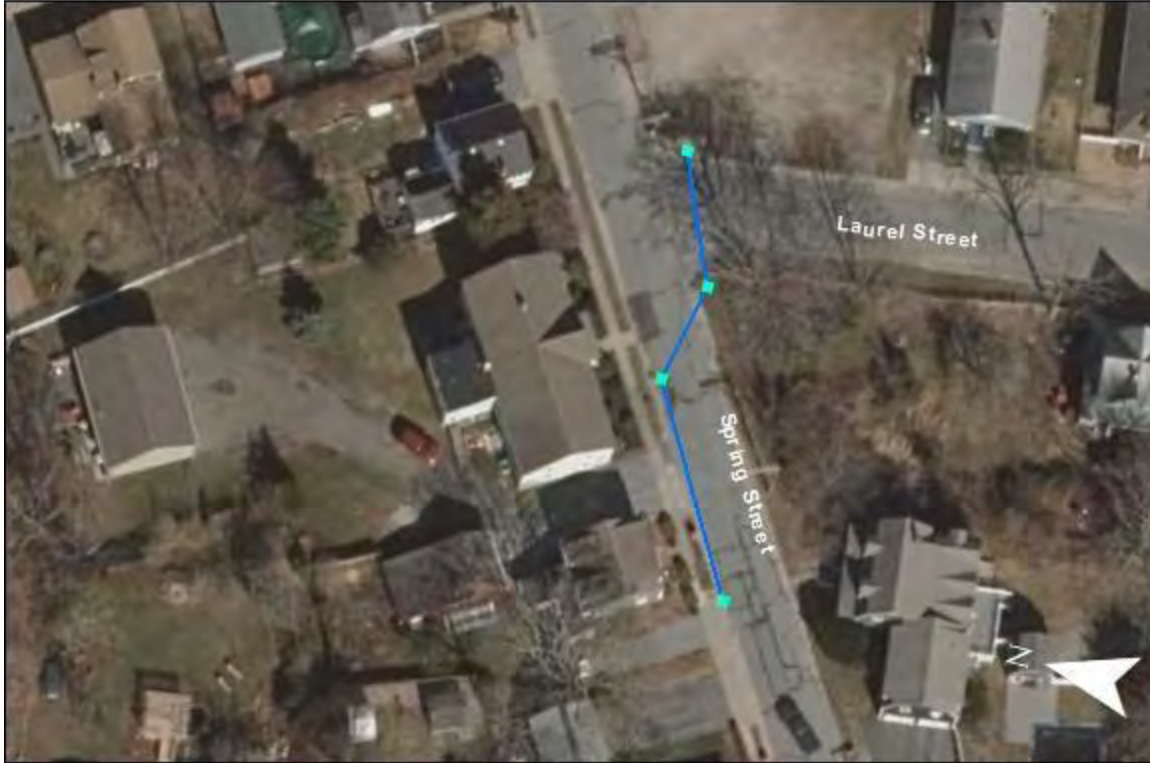
Spring Street: No issues found. Maps suggested that the West most catchbasin pictured above was connected to the basin at the corner of spring street and Green Street. There were no indications observed in the field to confirm this. Further investigation is suggested to determine its connection to a catchment.

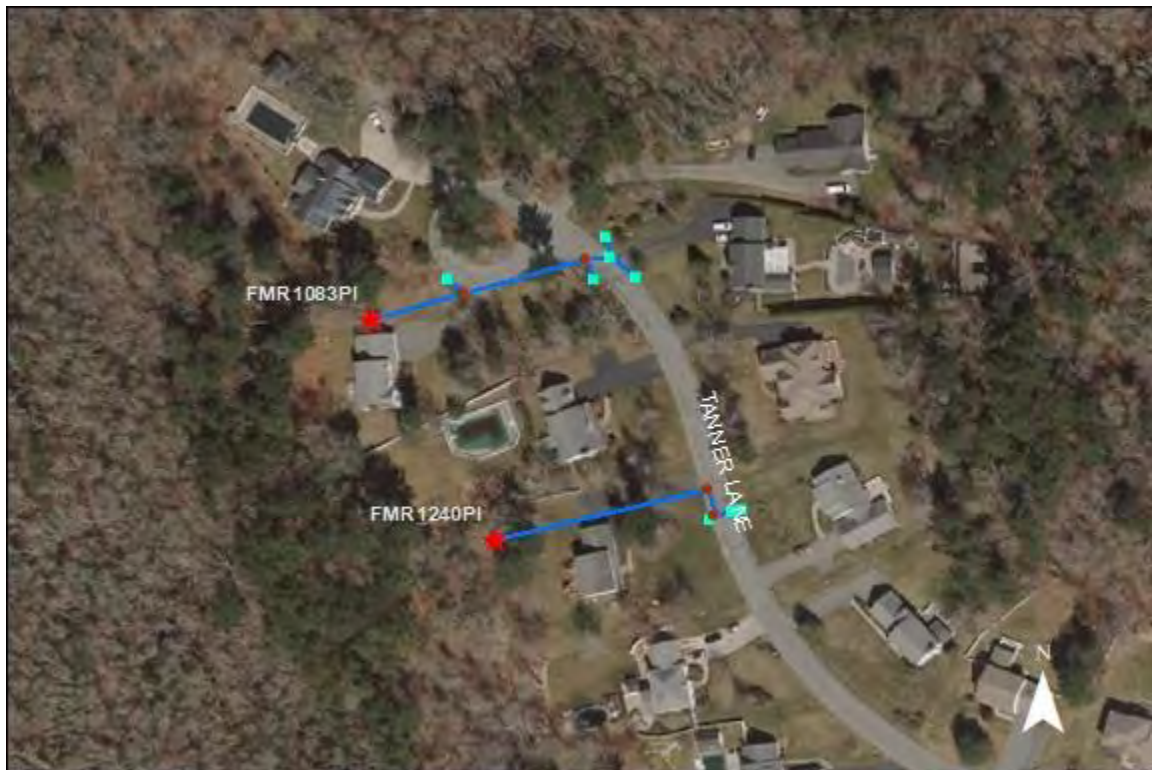
FMR1083PI and FMR1240PI- Tanner Lane: No issues found. Newly found outfall inventoried.

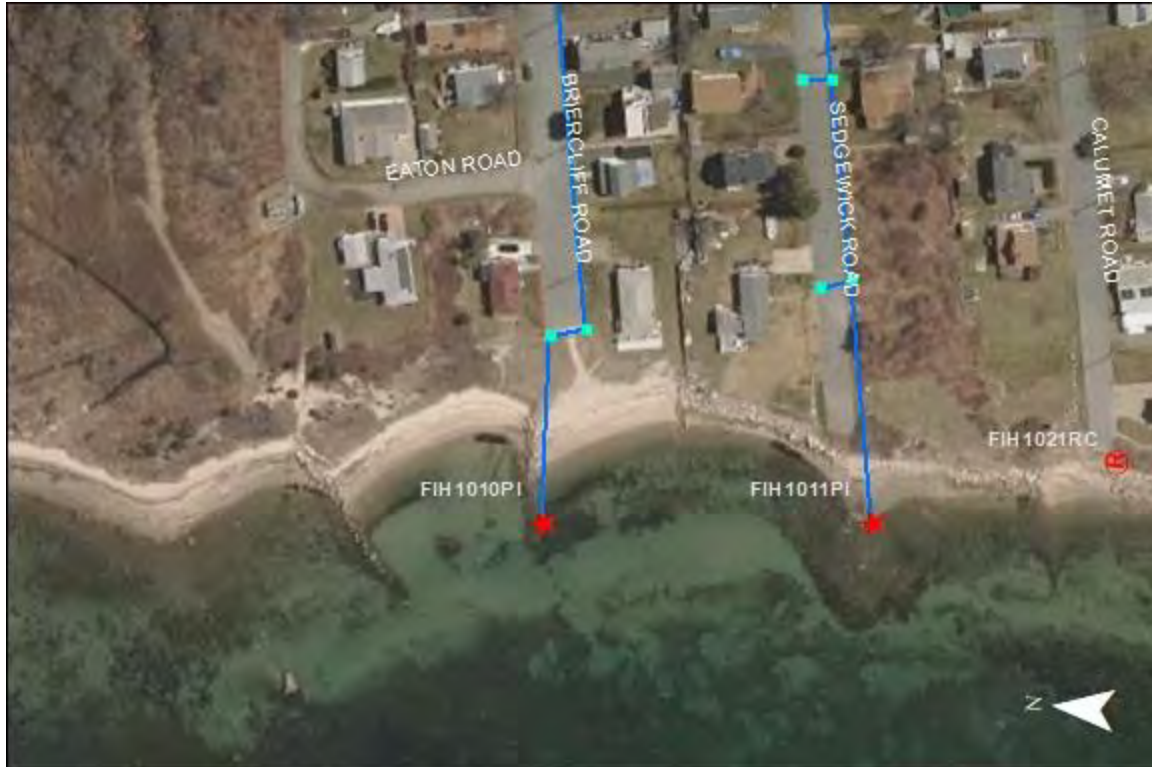
FIH1010PI and FIH1011PI- Briercliff Road and Sedgewood Road: At point A the bricks on the inside of the catchbasin are missing or starting to crumble. Preventative maintenance is recommended. The catchbasin had suds in the water of the sump of the basin. There was a sump pump coming from house #42. Could not confirm if the soap was from the pipe or from recent car washing. Further investigation is recommended. No issues found on Sedgewick Road.

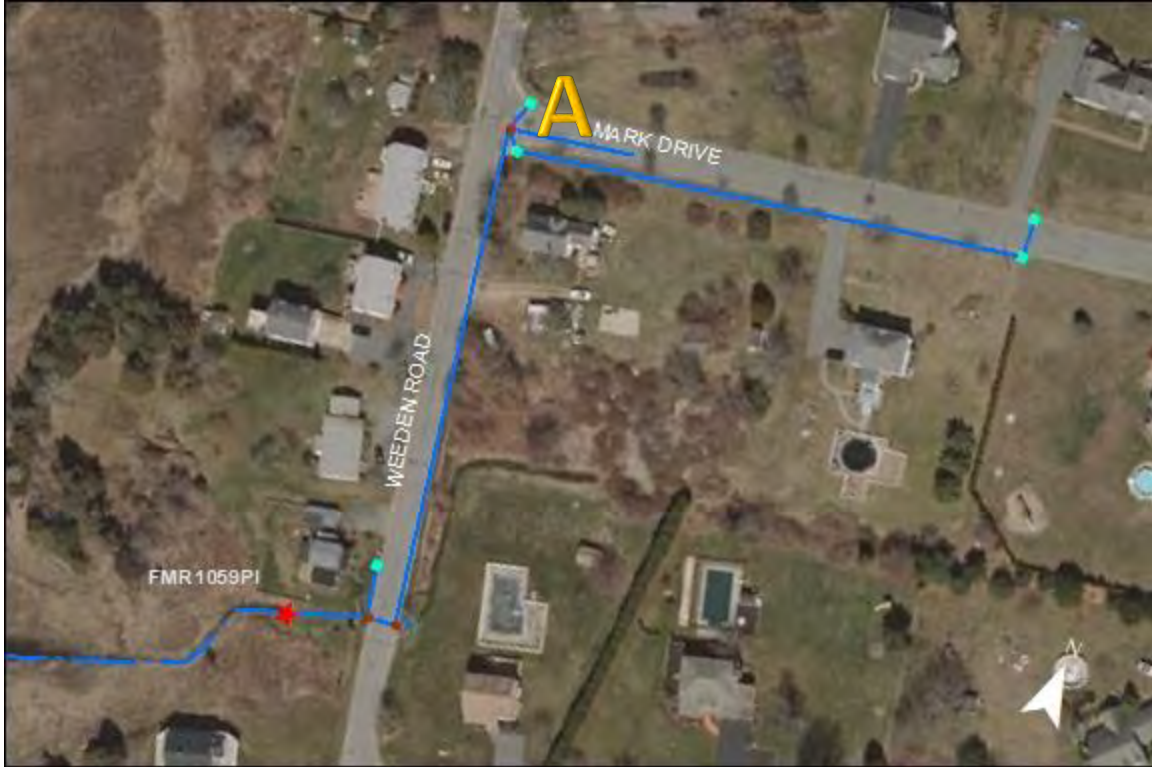
FMR1059PI- Weeden Road and Mark Drive: No significant issues found. At point A, a 12" concrete pipe enters the manhole. Its origin is unknown. Further investigation is recommended.

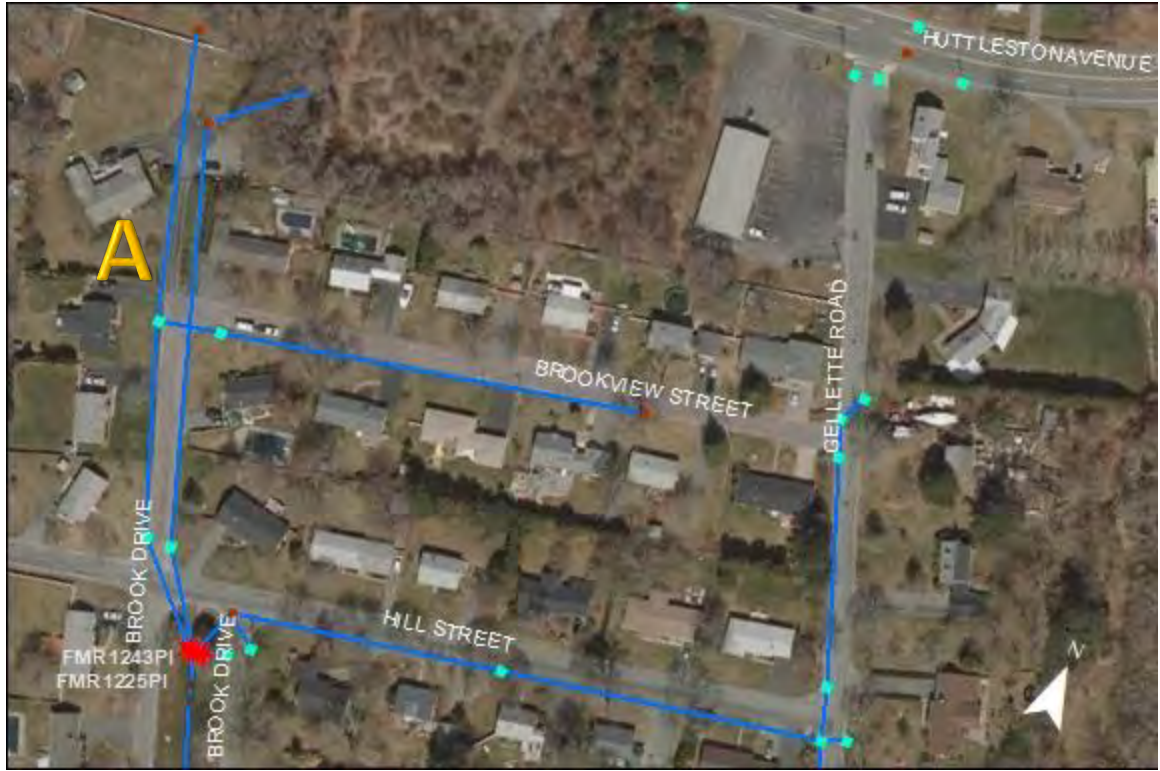
FMR1243PI, FMR1225PI, FMR1225PI, FMR1058PI- Brookview Street, Gellette Road, Hill Street, and Brooke Drive: No significant issues found. The catchbasin at point B has an incoming pipe. Town maps indicate it connects to a manhole behind house #347 on Route 6. Homeowner would not allow us on property. Connection not confirmed.

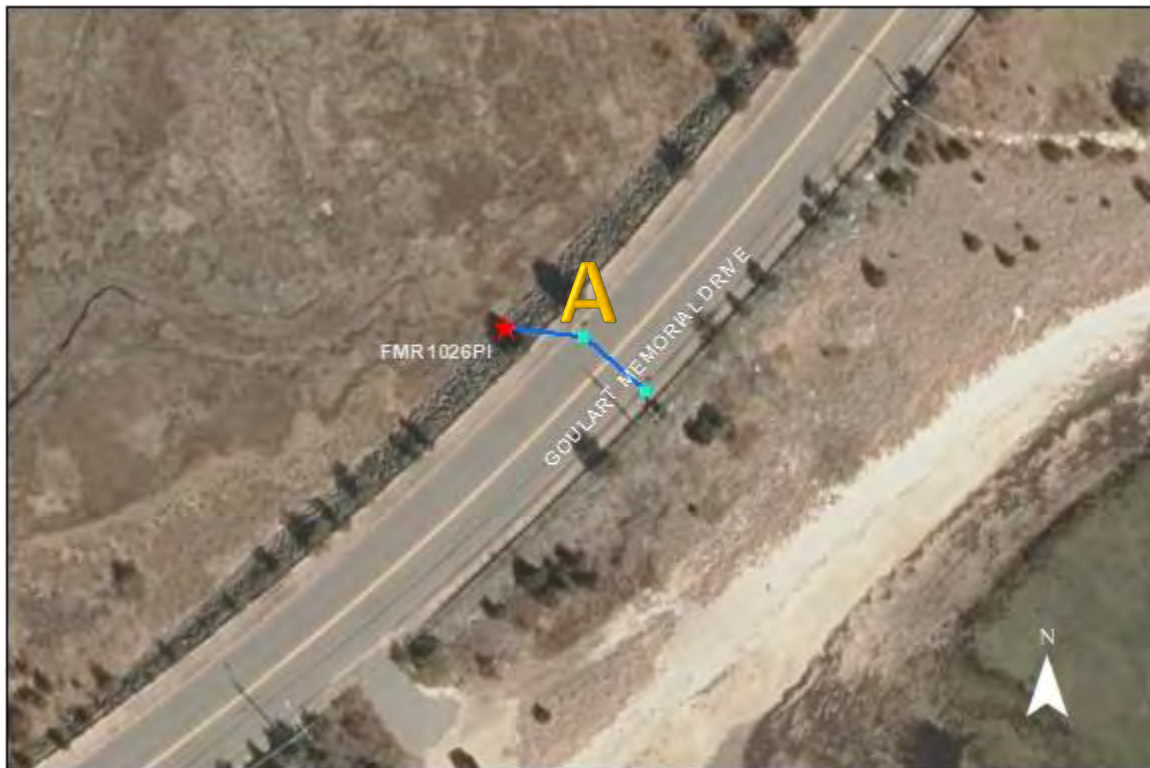
FMR1026PI- Goulart Memorial Drive: No major issues found. At point A the catchbasin cover has two broken corners.
