**The Buzzards Bay Stormwater Collaborative  
Illicit Discharge Investigation Trailer**

**Town of Fairhaven Report**

**November 2022**

### **Fairhaven IDDE Report**

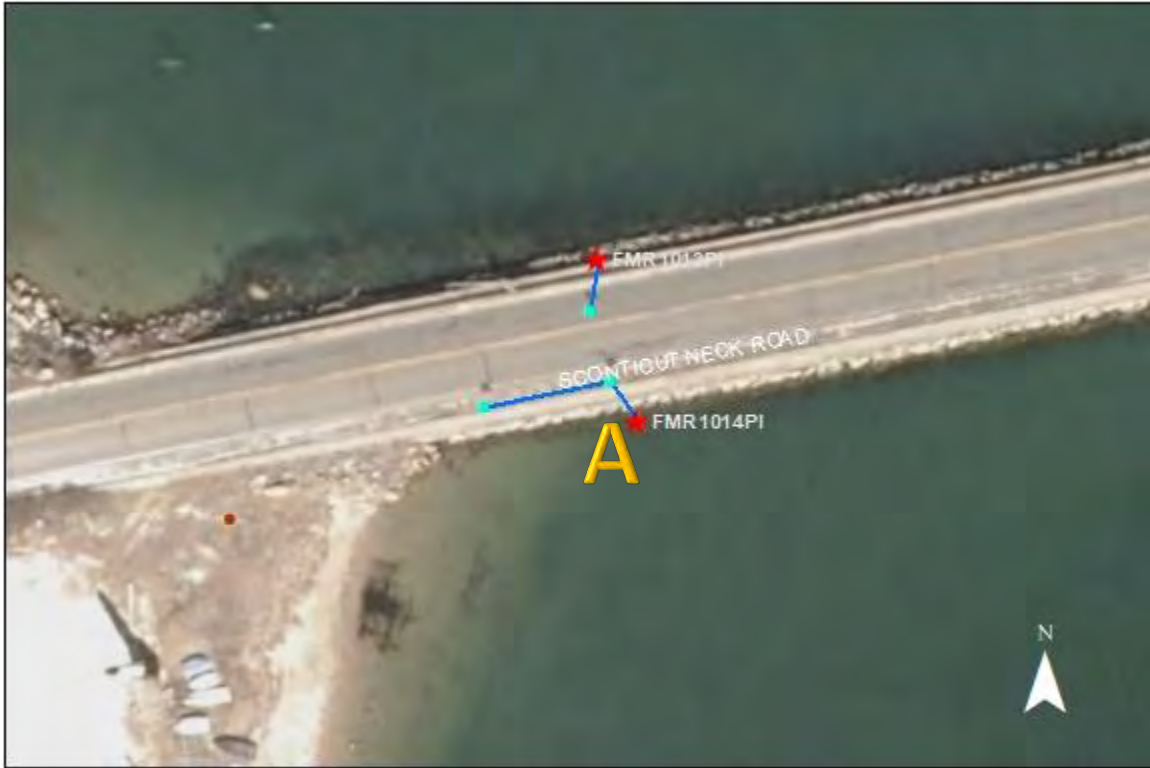
FMR1013PI and FMR1014PI- Scenticut Neck Road: No major issues found. At point A catchbasin is sinking.

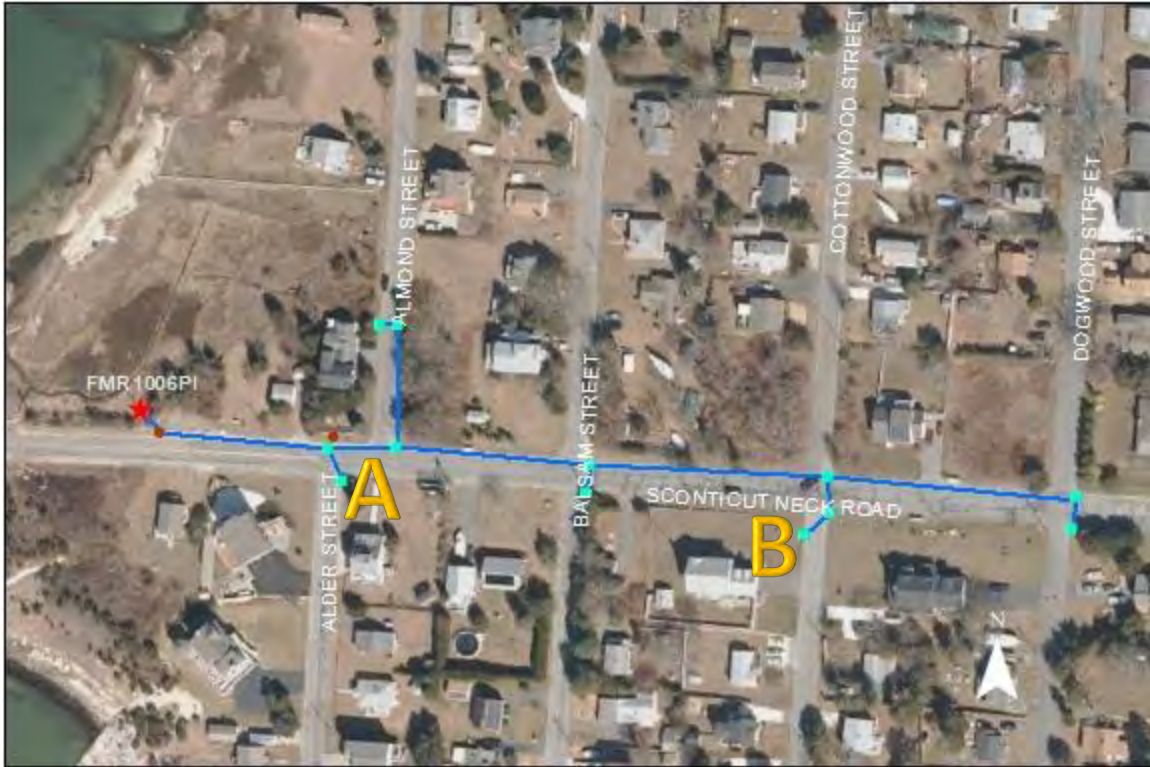
FMR1006PI- Causeway Road: Catchbasins at point A and B are in need of repair.

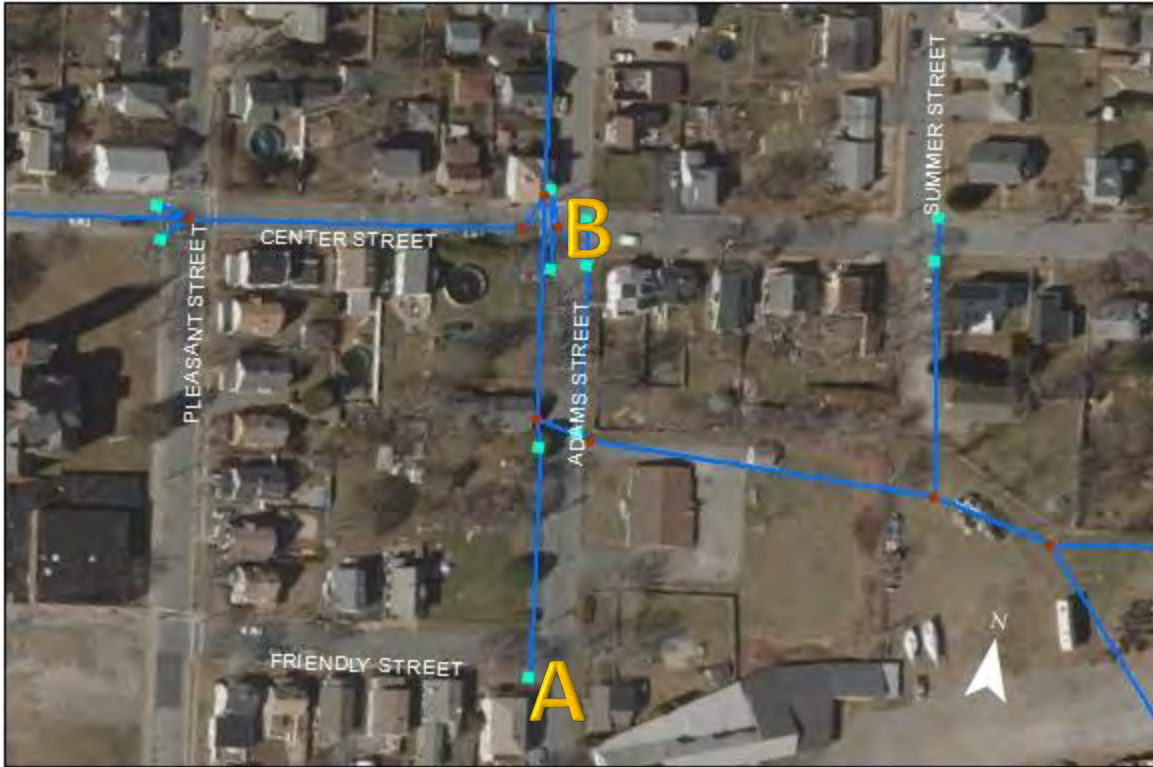
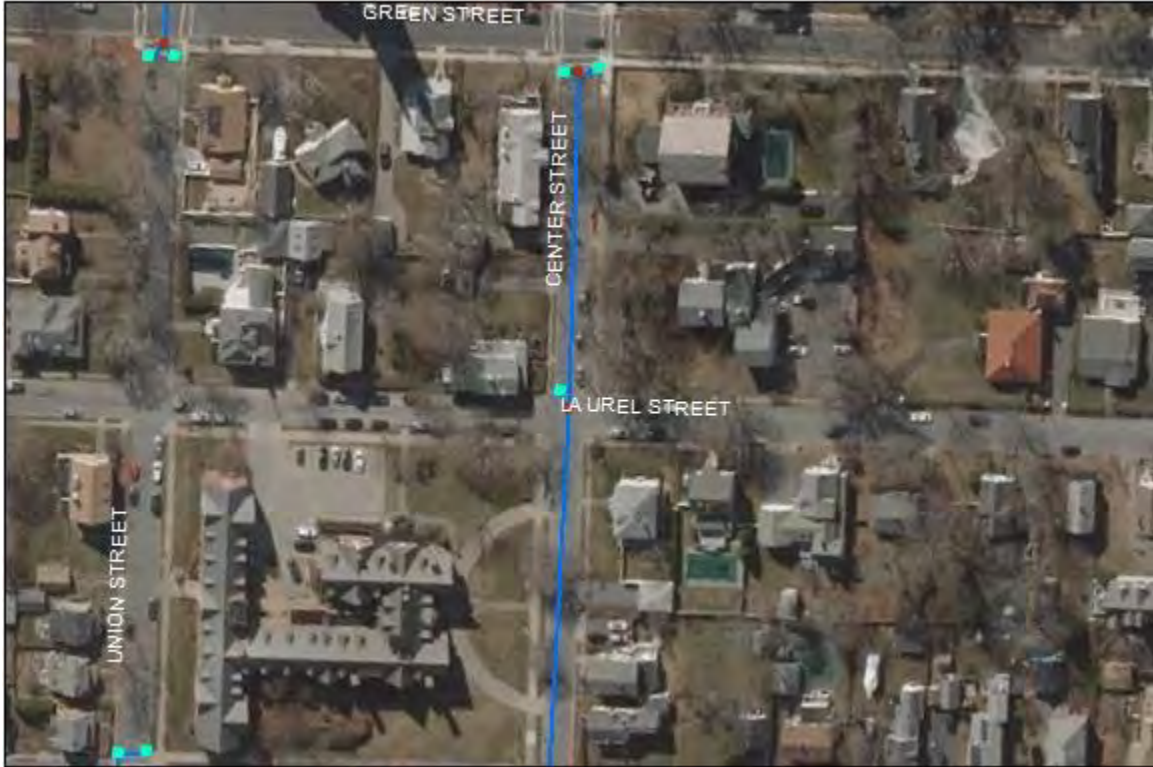
(1/2) FIH1051PI- Adams Street: At point A and B the structures were full of water. Likely that there is a blockage in each one. Friendly Street floods during rain events. Further maintenance is highly suggested.

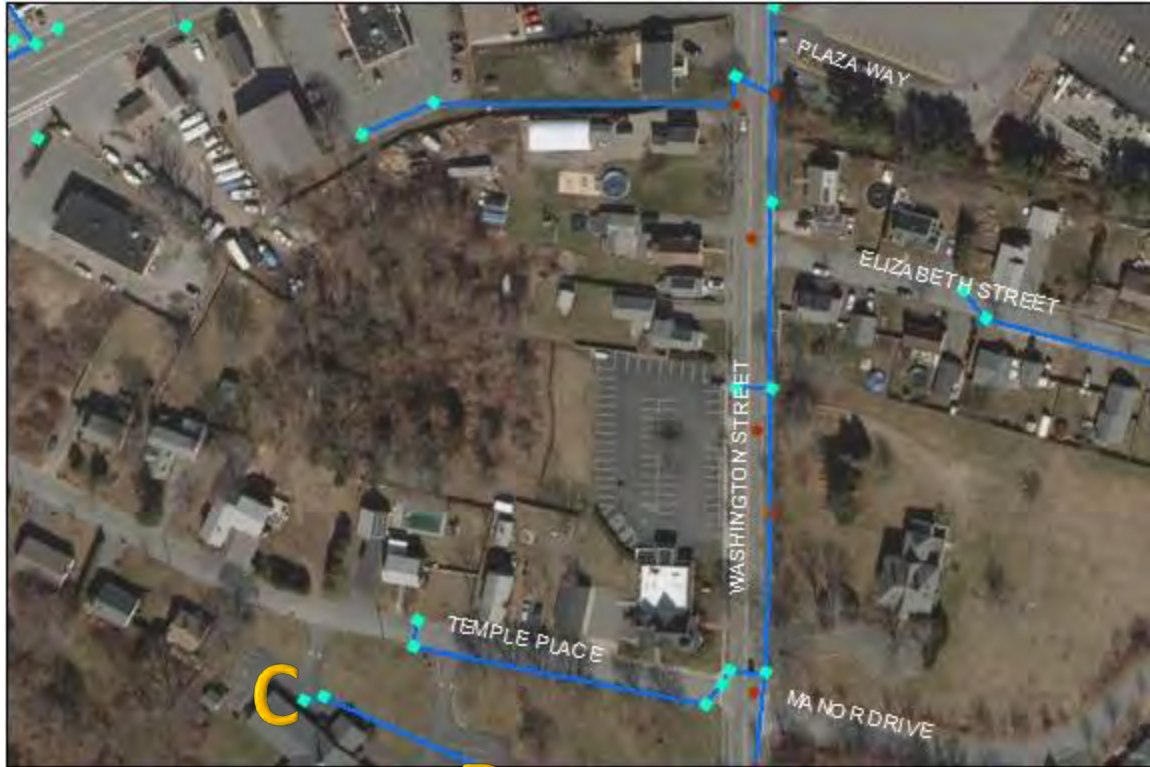
(2/2) FIH1048PI- Washington Street, Sunset Lane, and Temple Place: Catchbasins at point A, B, and C have begun to sink. Further maintenance is suggested.
