**The Buzzards Bay Stormwater Collaborative
Illicit Discharge Investigation Trailer**

Town of Mattapoisett Report

June 2023

Mattapoisett IDDE Report

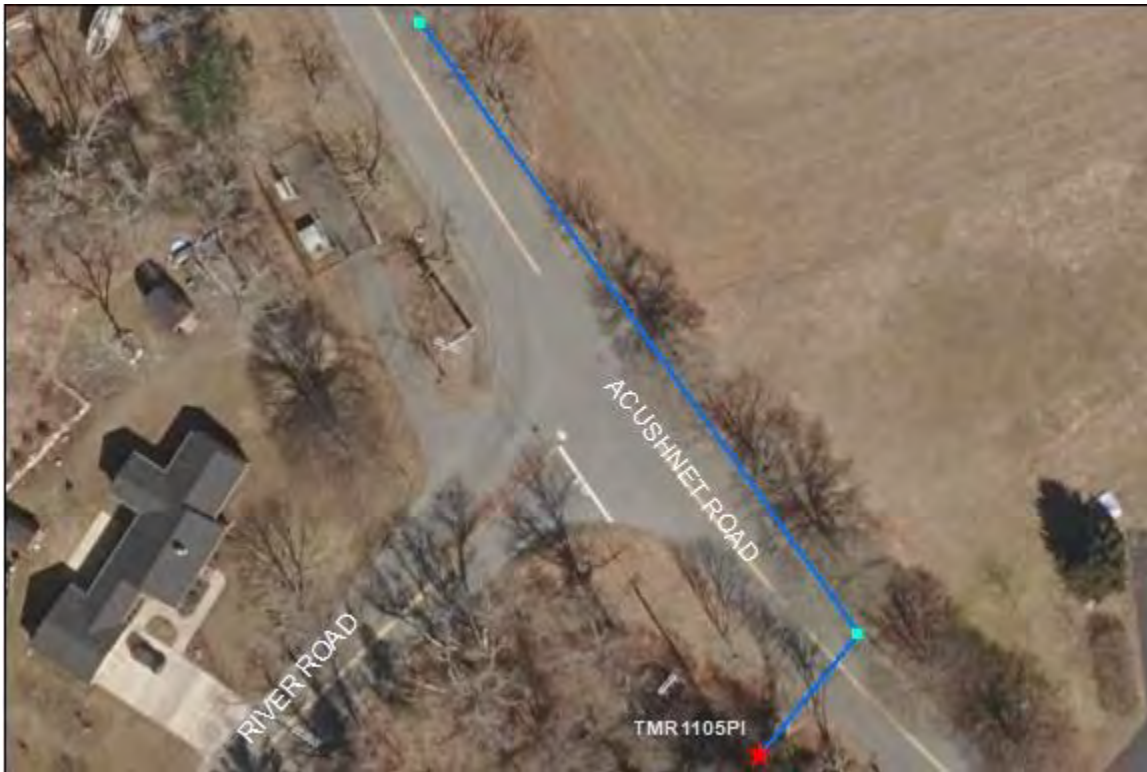
TMR1105PI- Acushnet Road: No issues found.

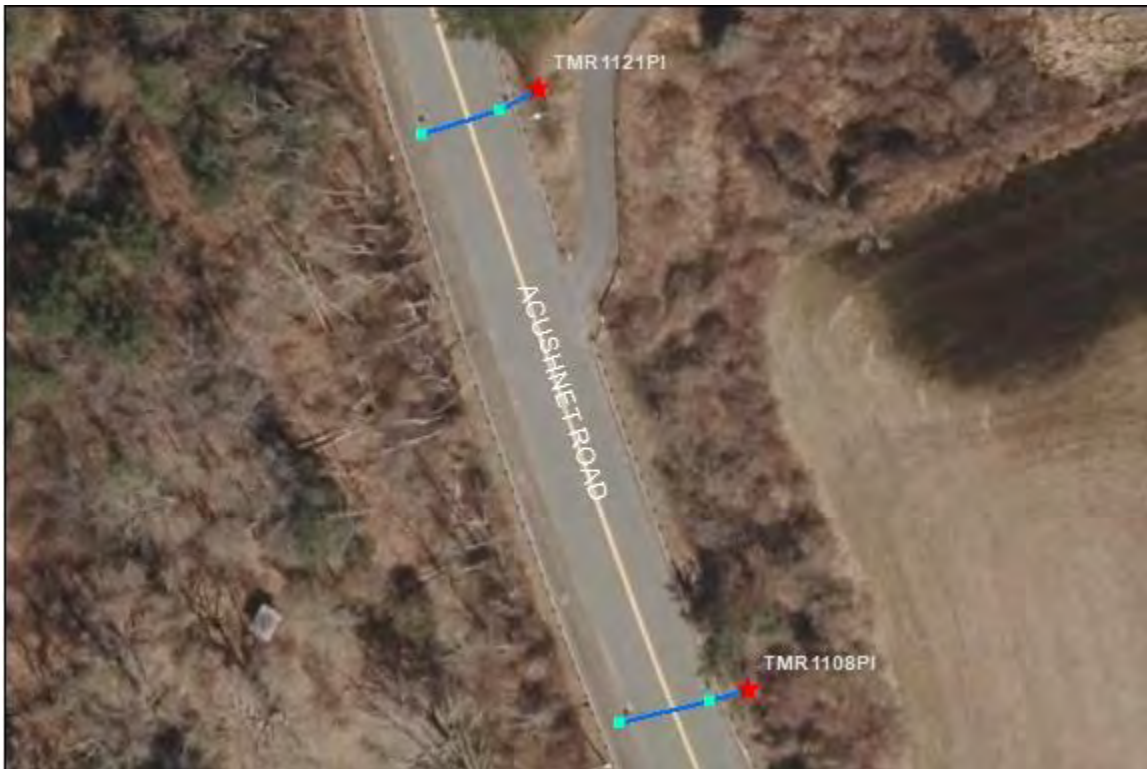
TMR1121PI and TMR1108PI- Acushnet Road: No issues found.

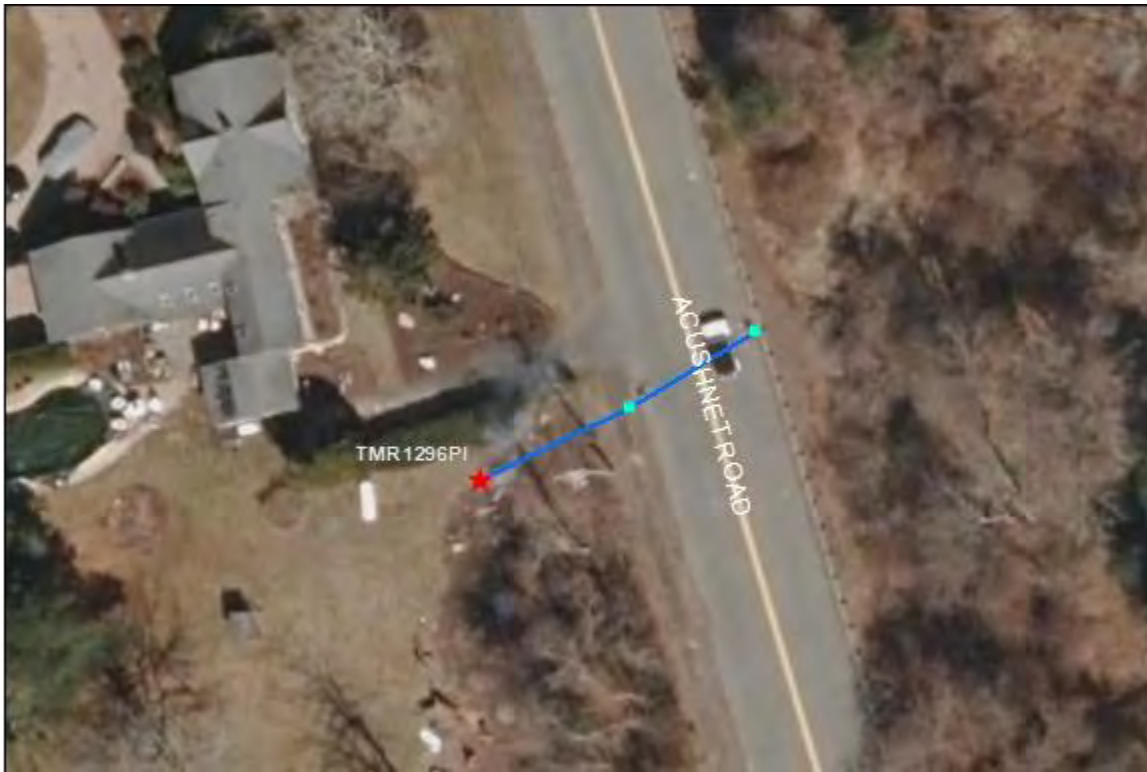
TMR1296PI- Acushnet Road: No issues found.

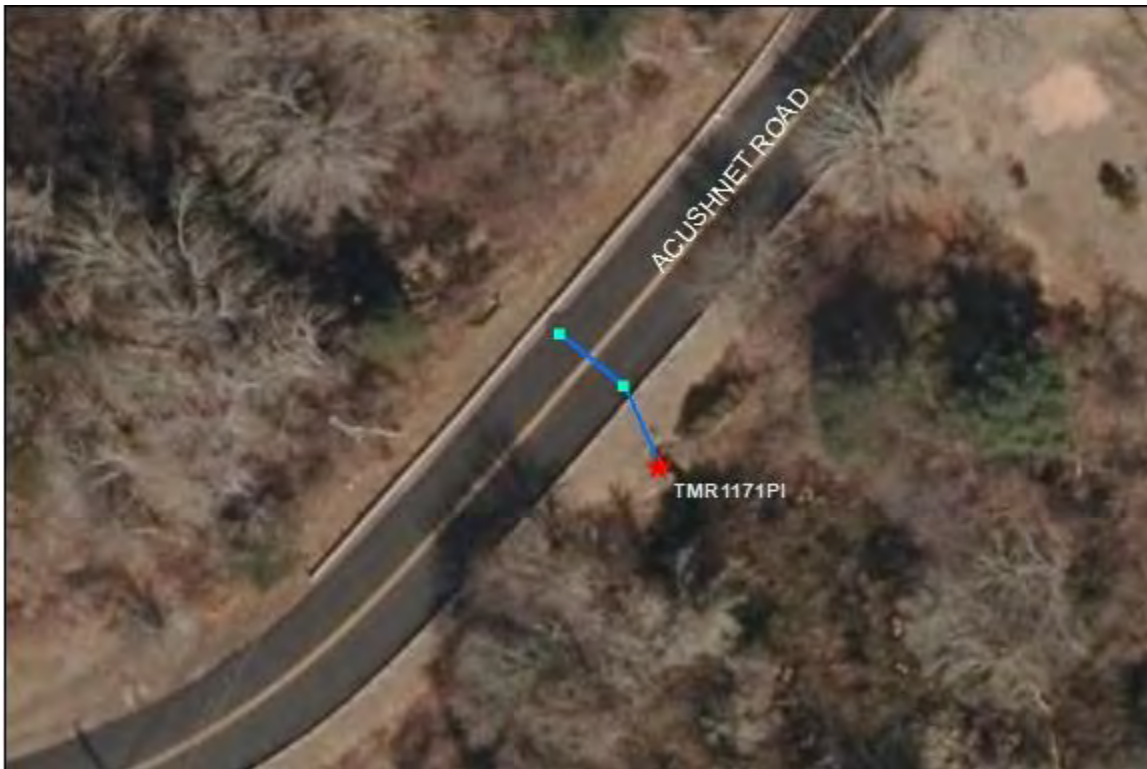
TMR1171PI- Acushnet Road: No issues found.

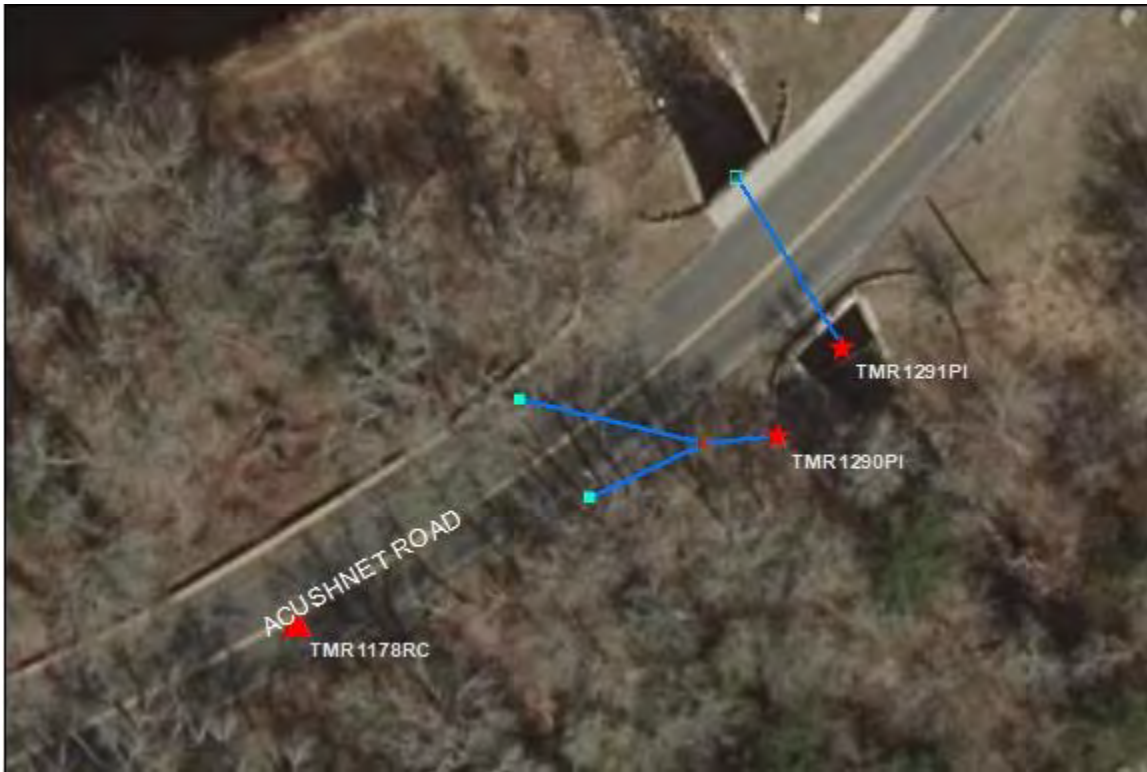
TMR1291PI and TMR1290PI- Acushnet Road: No issues found.

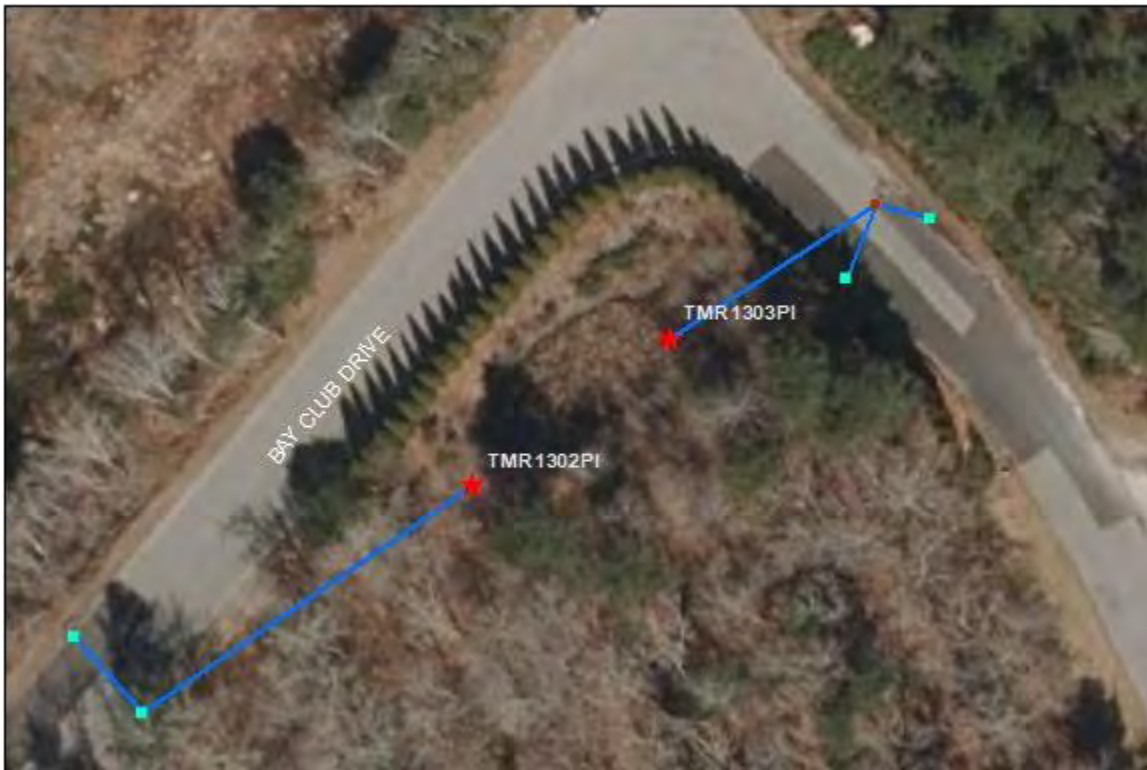
TMR1303PI and TMR1302PI- Industrial Drive and Bay Club Drive: No issues found.

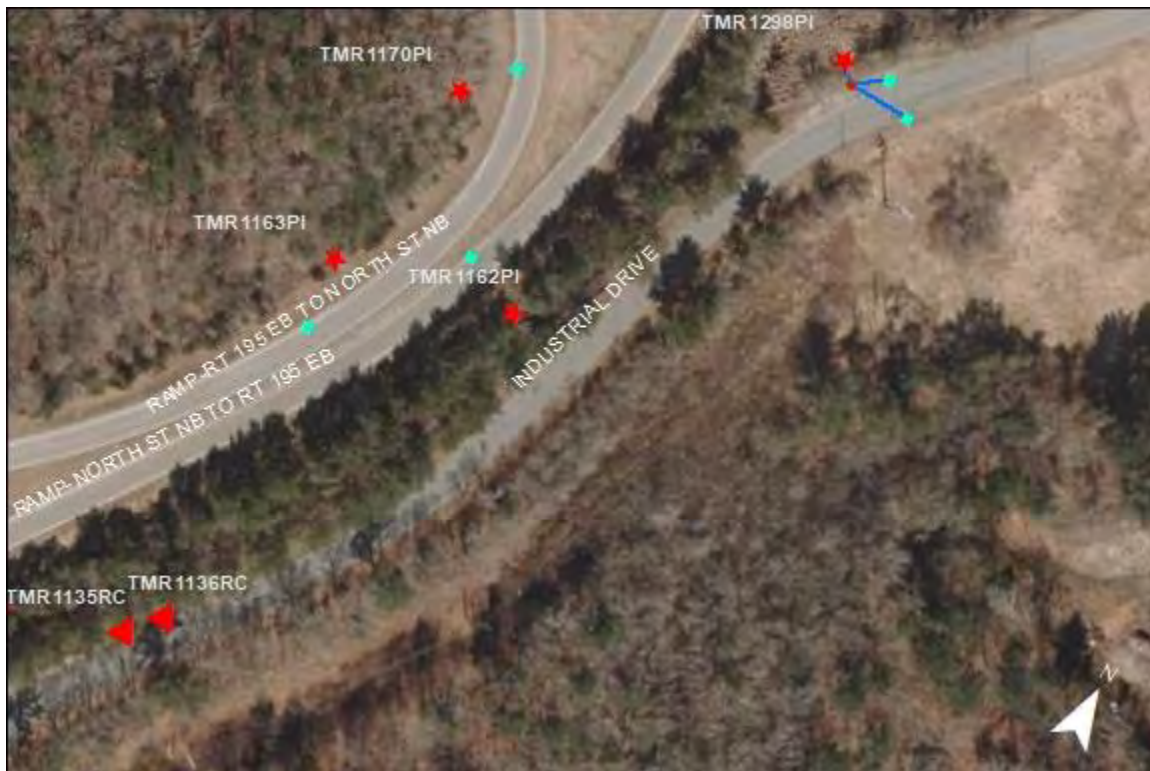
TMR1298PI, TMR1136RC, and TMR1135RC- Industrial Drive: No issues found. All other outfalls depicted on the above picture are state outfalls and were not investigated.

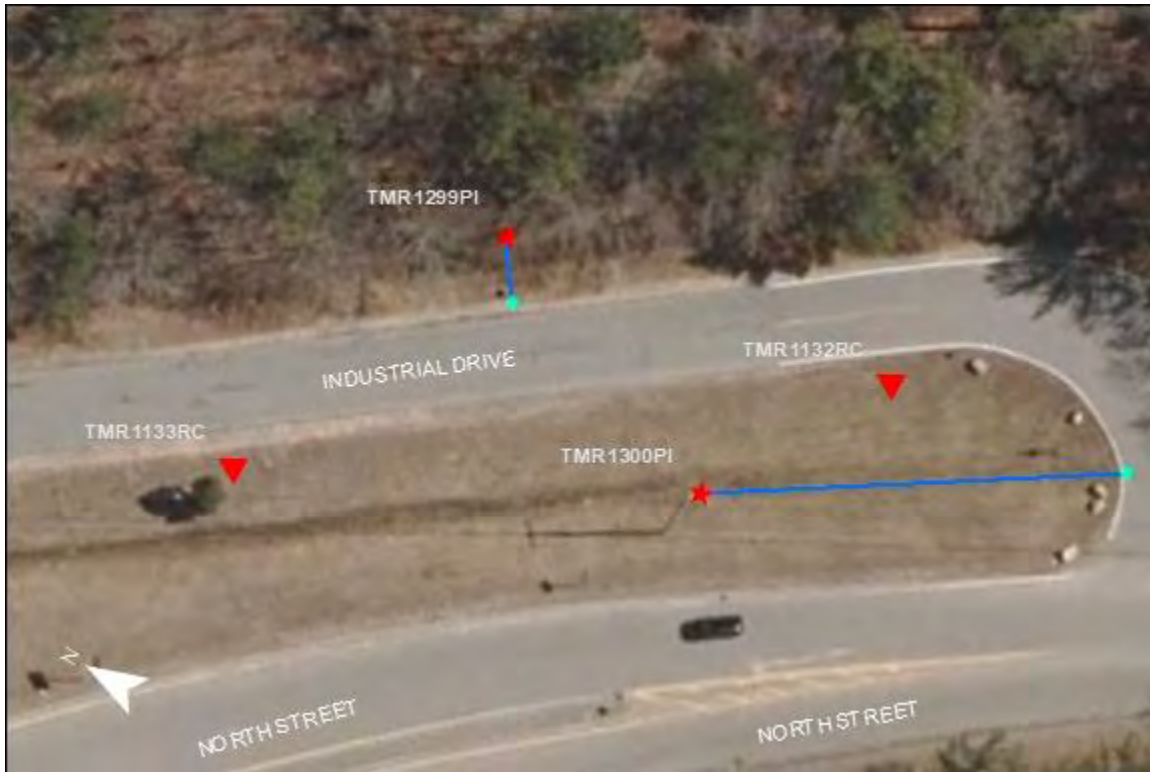
TMR1299PI and TMR1300PI- Industrial Drive: No issues found.
