**The Buzzards Bay Stormwater Collaborative
Illicit Discharge Investigation Trailer**

Town of Wareham Report

November 2nd, 2022

Wareham IDDE Report

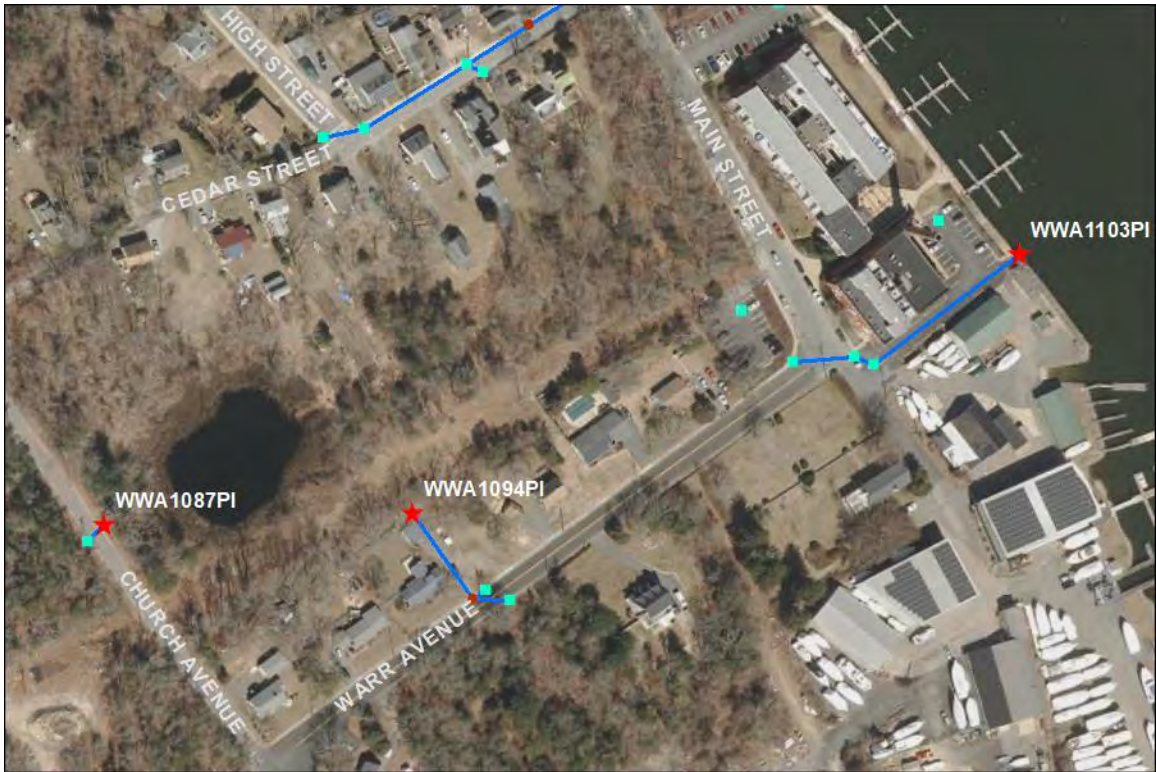
WWA1087PI, WWA1094PI, and WWA1103PI – Church Avenue and Warr Avenue: No issues found; the outfall for WWA1094PI could not be located.

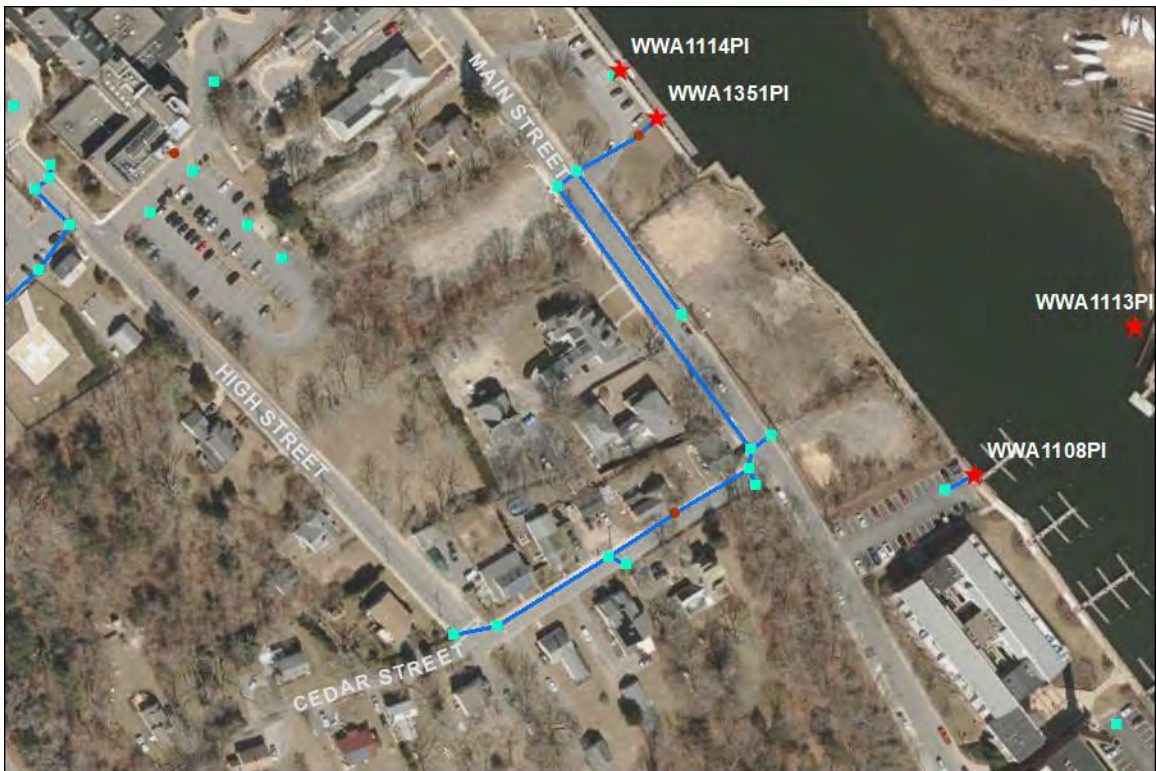
WWA1114PI and WWA1351PI – Main Street: No issues found; trash was observed in several catch basins; catch basin at Besse Park was full to rim; WWA1108PI network on private property, not inspected.

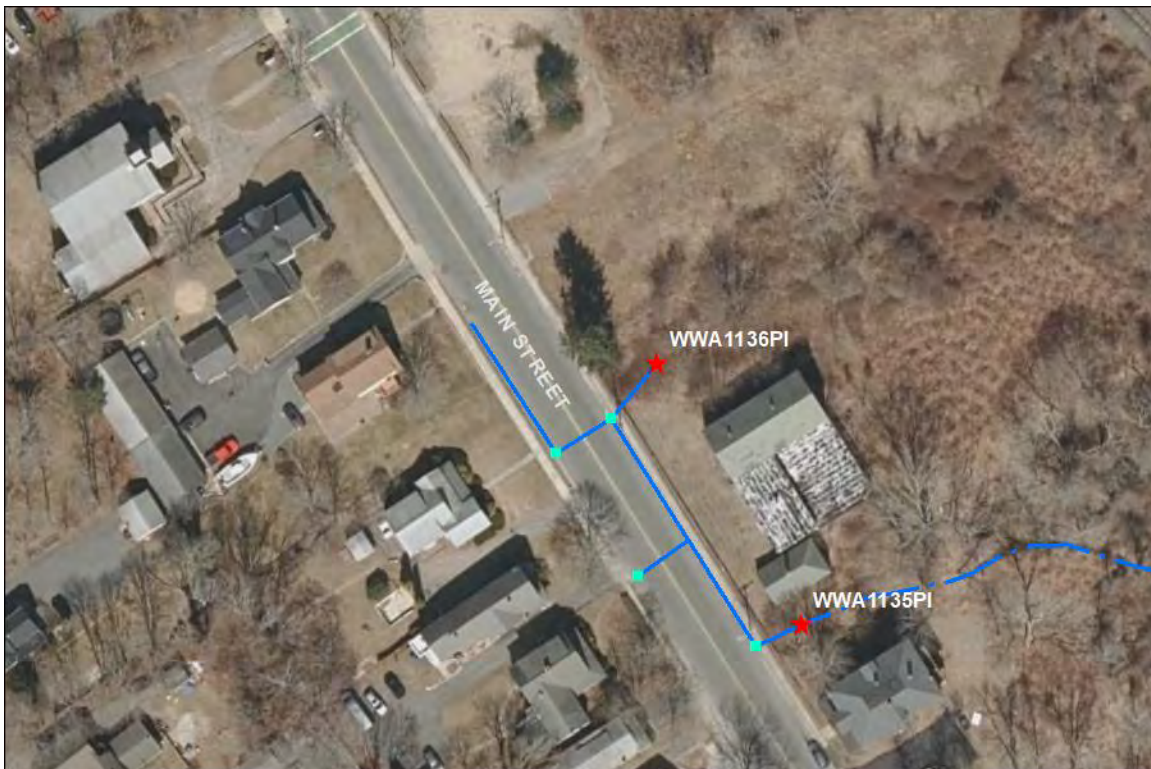
WWA1135PI and WWA1136PI – Main Street: No issues found but most structures too full to inspect; it's suspected that WWA1136PI is an inlet instead of an outfall.

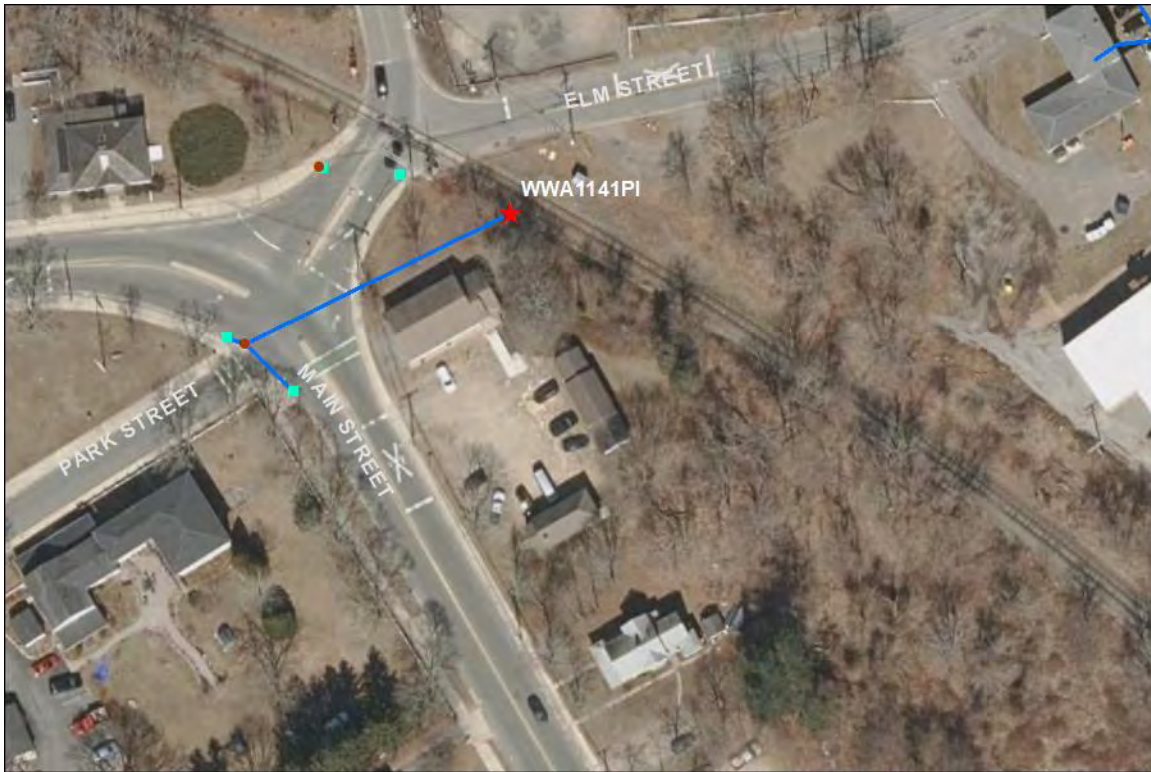
WWA1141PI – Main Street: No issues found but most structures were too full to inspect. Further maintenance is strongly recommended.

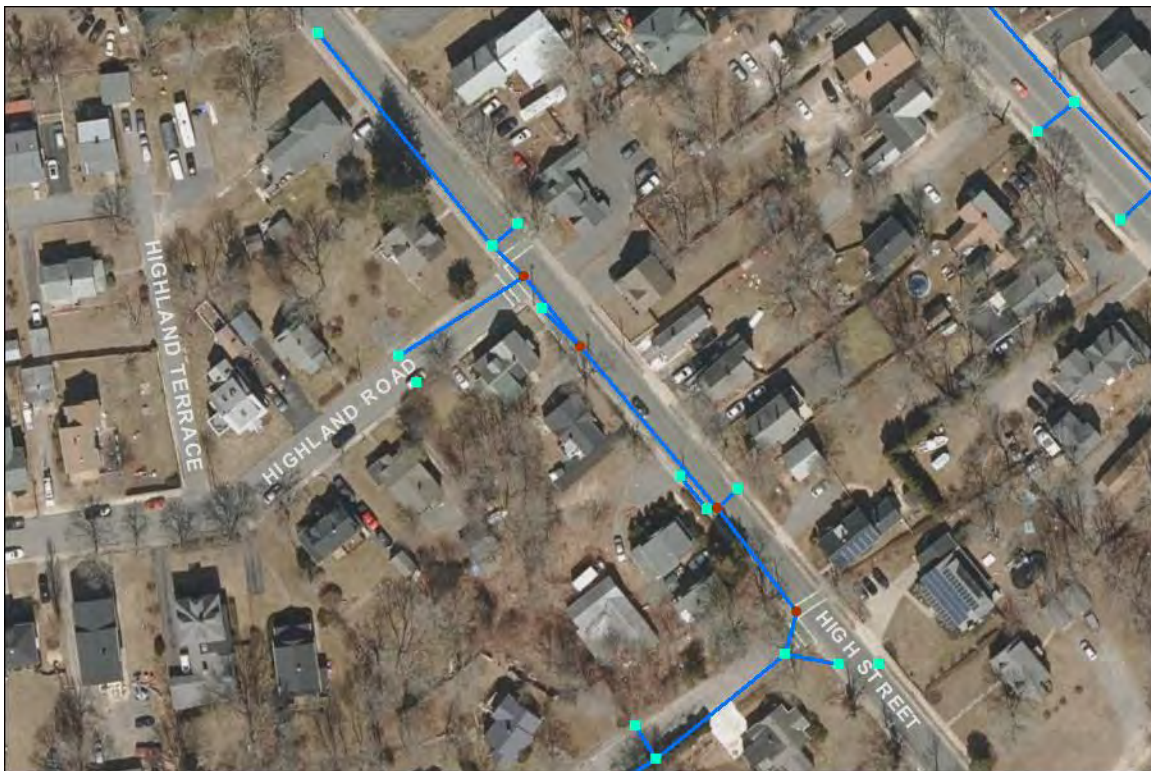
High Street: No issues found; partial network inspection; this area drains to Broad Marsh; new asphalt on road – seen observed in structures; wildlife intrusion detected but no action required.

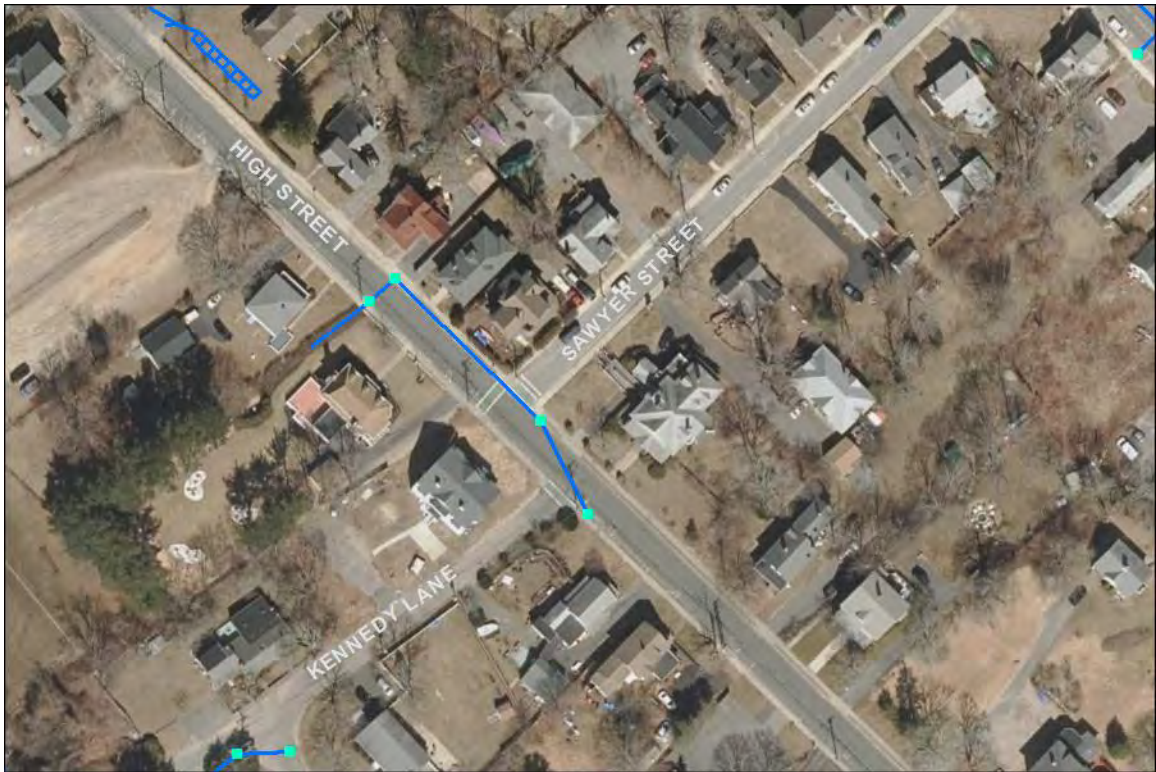
High Street: No issues found; partial network inspection; new asphalt on road – seen observed in structures; this area drains to Broad Marsh.

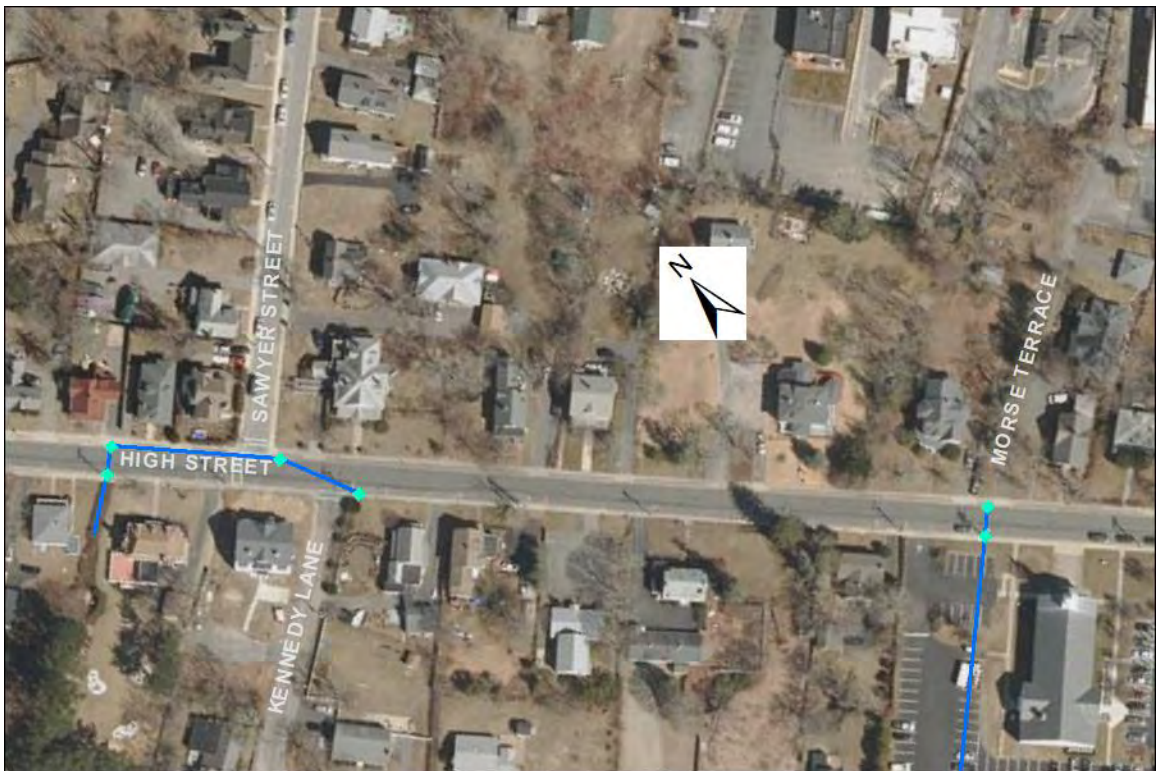
High Street: No issues found; partial network inspection; new asphalt on road – seen observed in structures; this area drains to Broad Marsh.

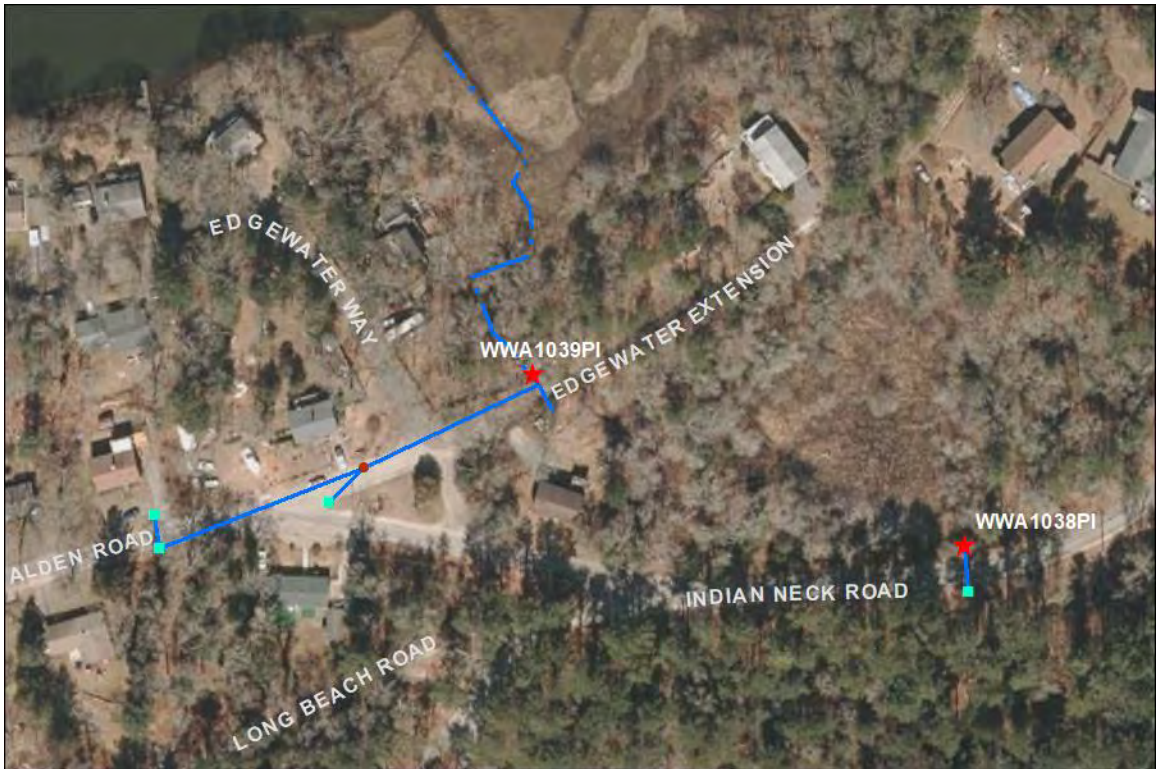
WWA1038PI and WWA1039PI – Indian Neck Road and Alden Road: No issues found.

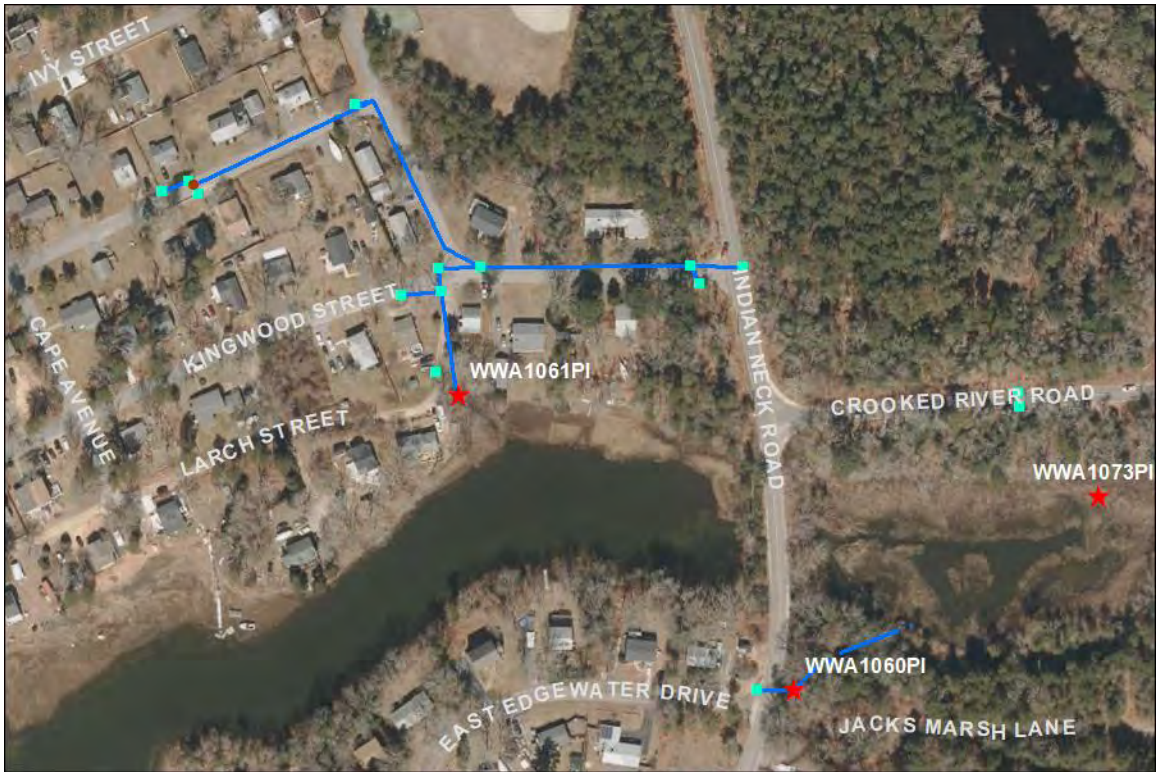
WWA1060PI and WWA1061PI – Indian Neck Road and Larch Street: No issues found; catchbasins at Kingwood were too full to inspect.

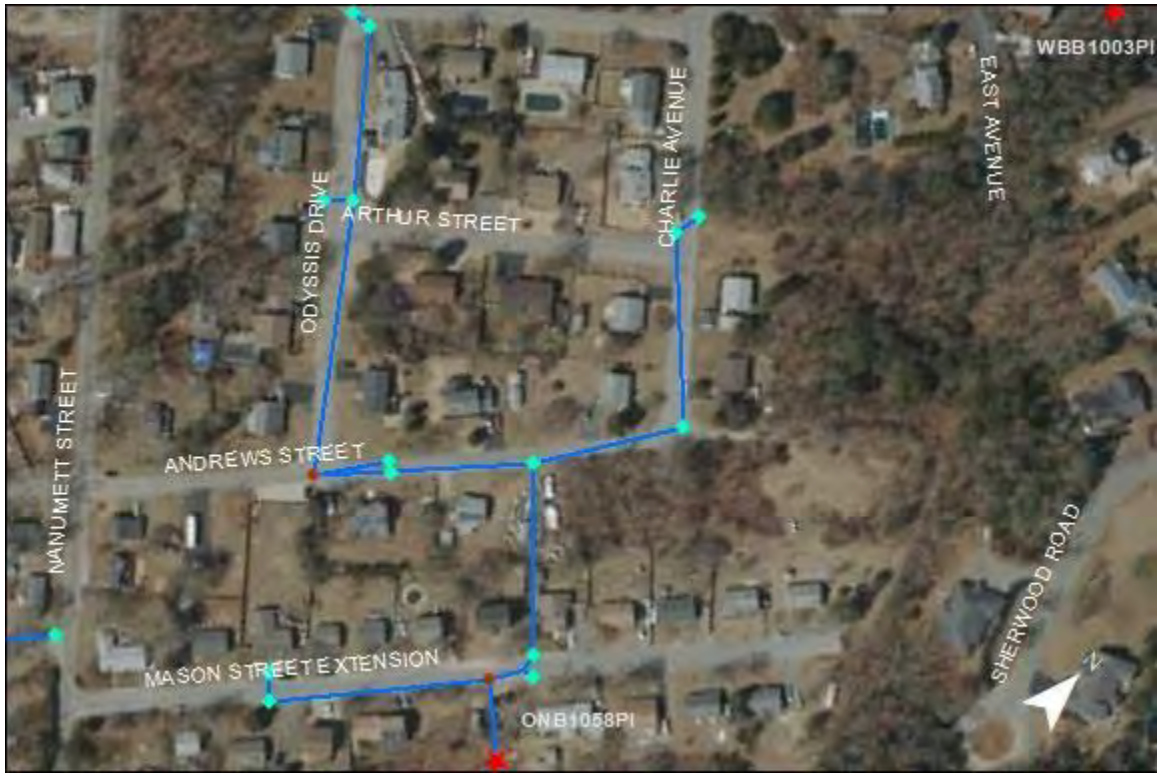
ONB1058PI- Mason Street Extension, Andrews Street, Odysseys Drive, and Charlie Avenue: No issues found.
ONB1056PI does not exist. Entire catchment drains to ONB1058PI.

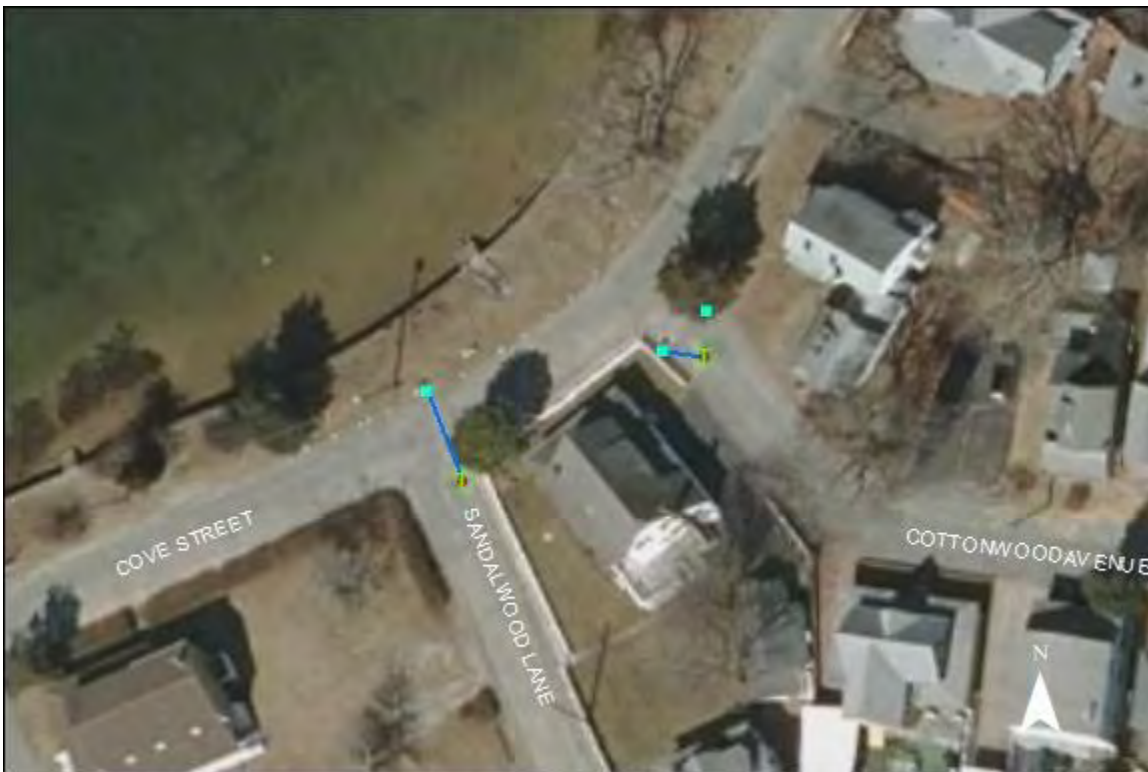
Sandalwood Lane and Cottonwood Avenue: No issues found. Both catchments drain to underground treatment structures.

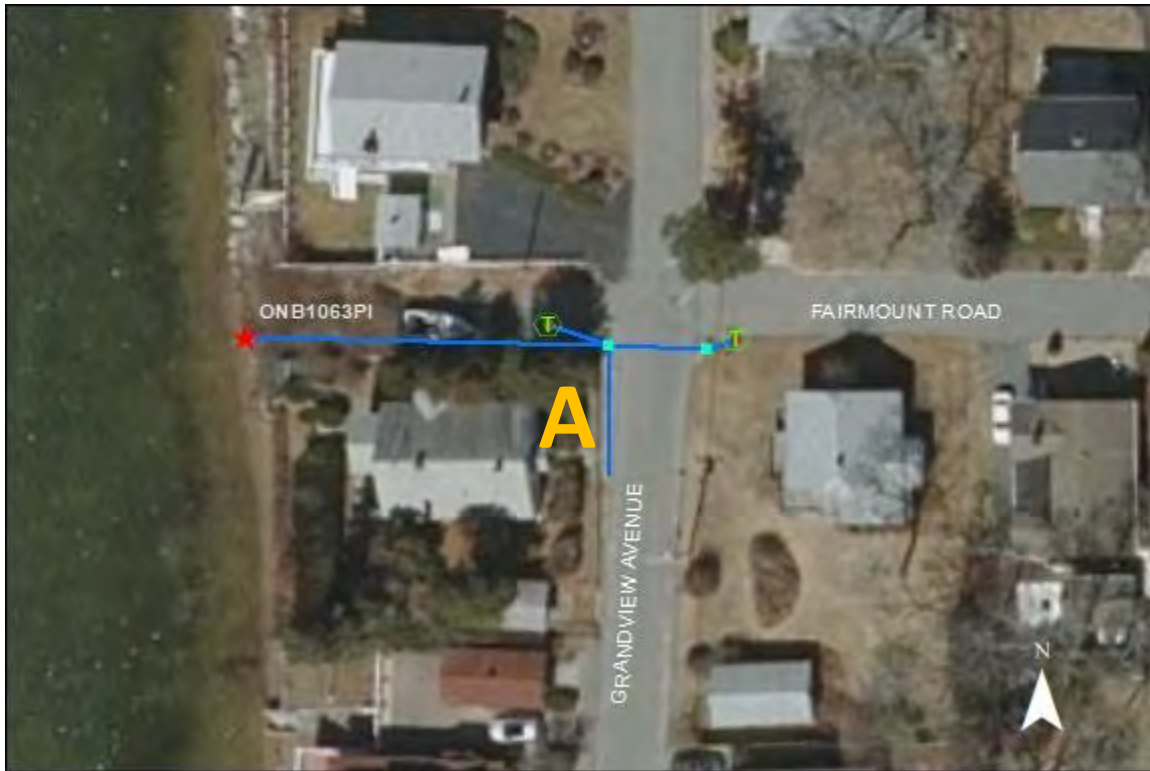
ONB1063PI- Grandview Avenue at Fairmount Road: Structures were full of sand. They need to be cleaned out and reinspected. A pipe enters the catch basin at point A. Its origin is unknown. Further maintenance and investigation is strongly encouraged.

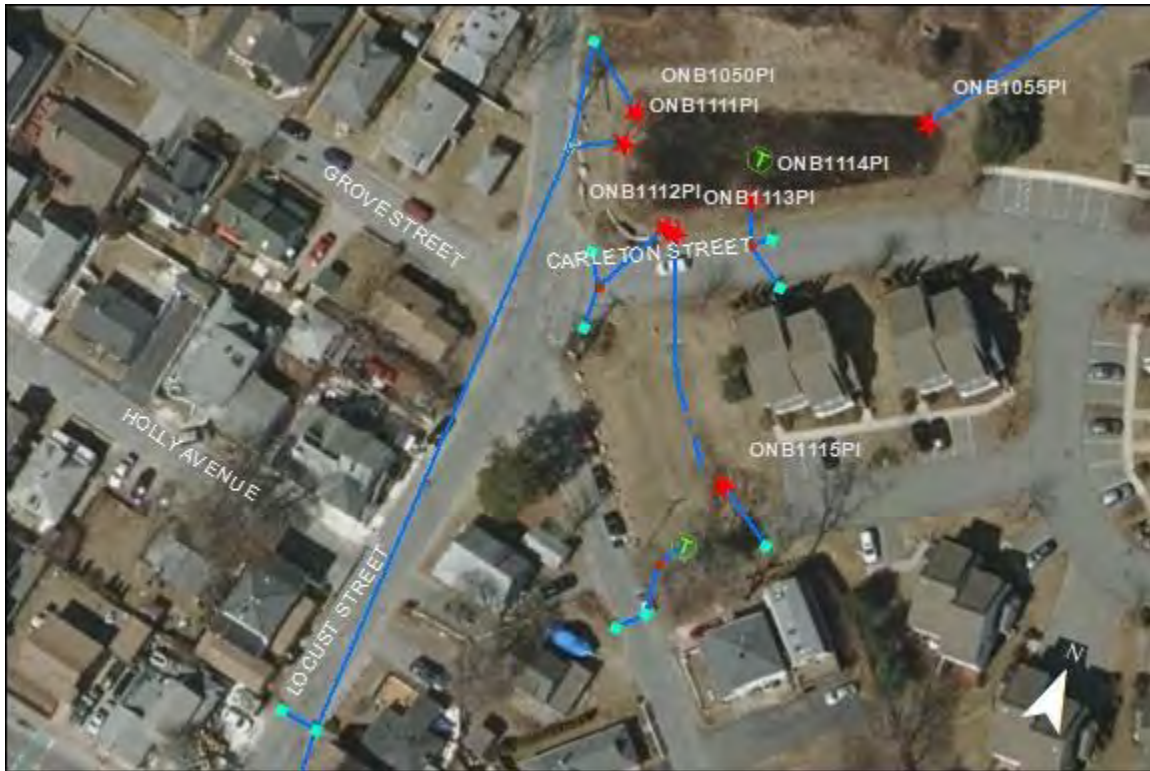
ONB1050PI, ONB1111PI, ONB1112PI, ONB1113PI, ONB1114PI, ONB1115PI- Locust Street and Carleton Street: No issues found.

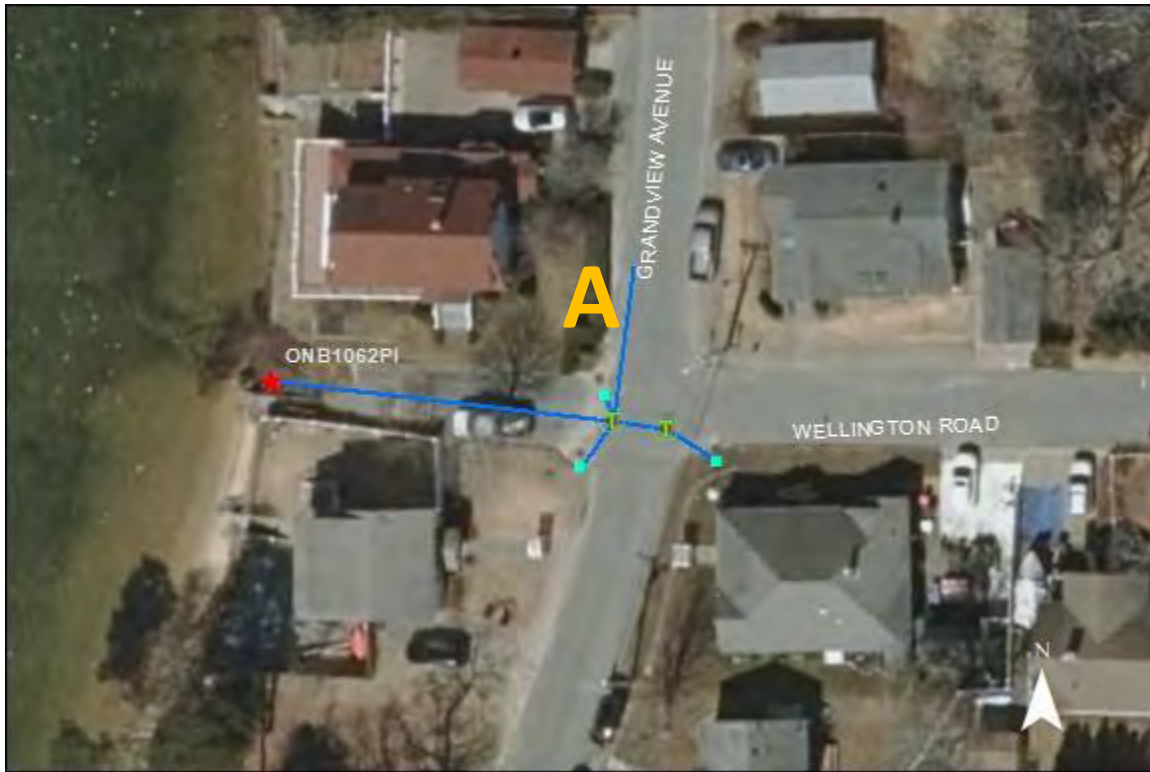
ONB1062PI- Grandview Avenue at Wellington Road: No issues found. At point A, a pipe enters the manhole; its origin is unknown. Further investigation is recommended.

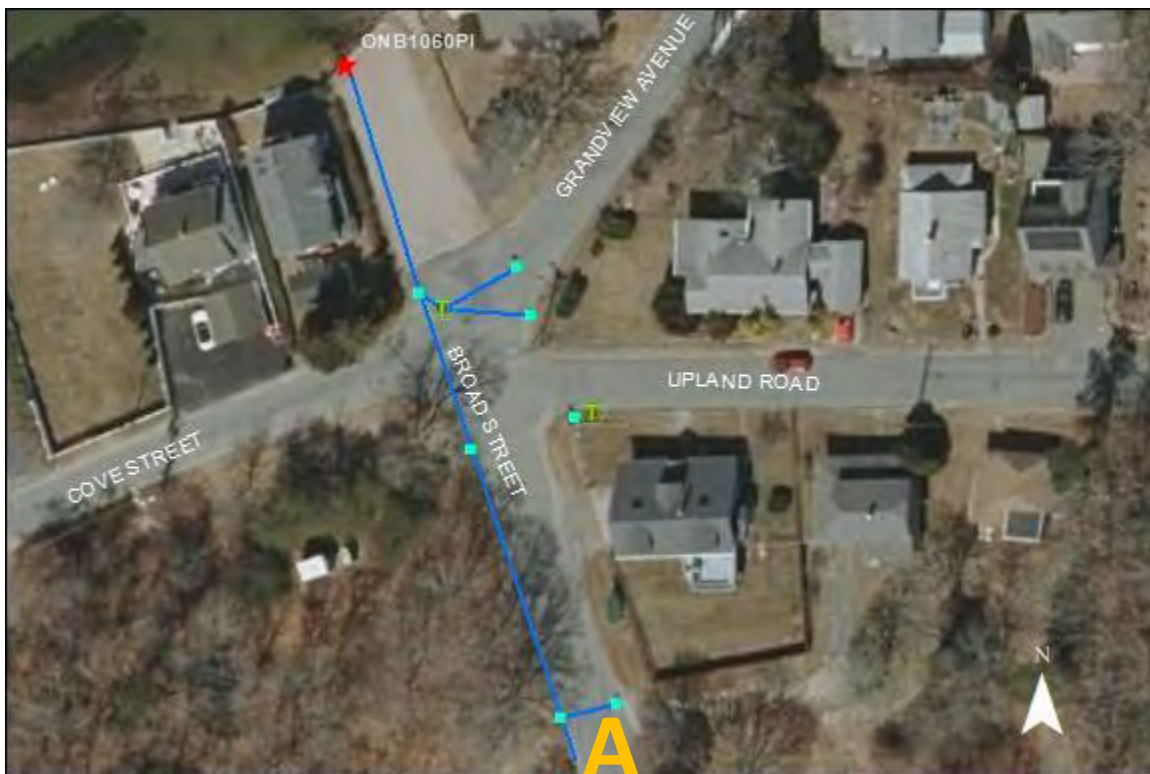
ONB1060PI- Grandview Avenue at Broad Street: No issues found. At point A, a pipe enters the catch basin. Its origin is unknown. Further investigation is recommended.

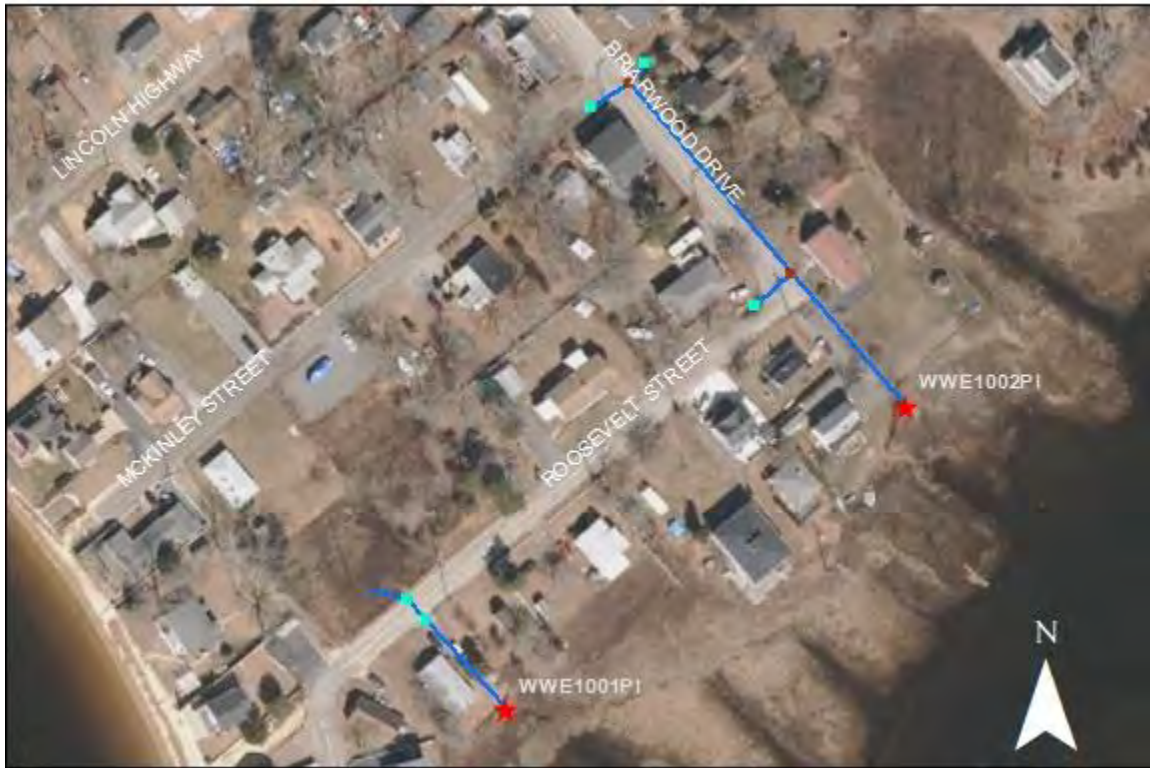
WWE1002PI and WWE1001PI- Briarwood Drive and Roosevelt Street: No issues found.

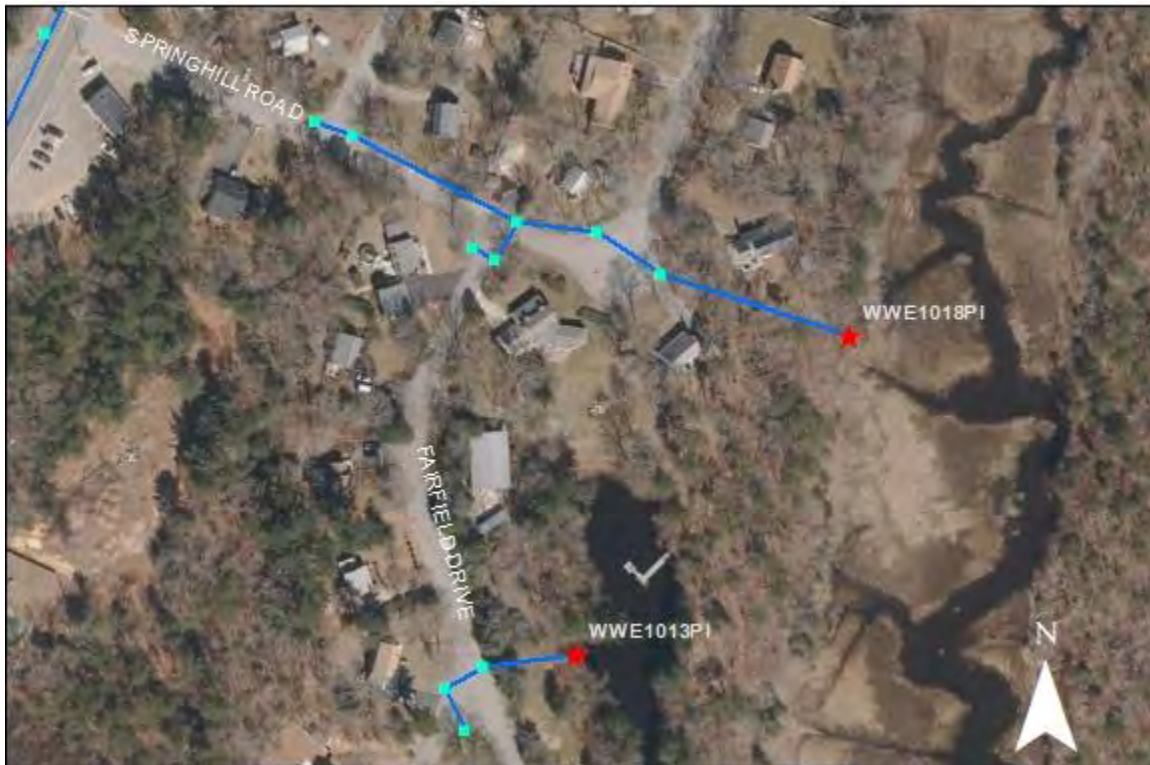
WWE1018PI and WWE1013PI- Springhill Road and Fairfield Drive: No issues found.

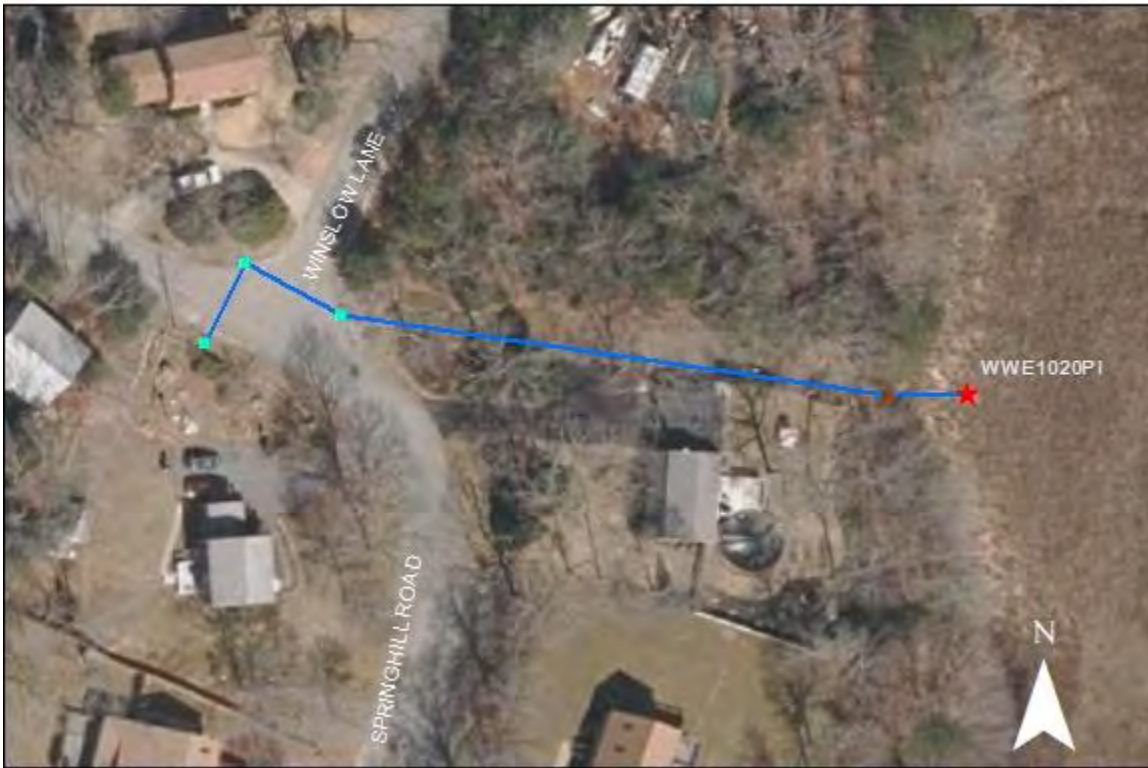
WWE1020PI- Winslow Lane: No issues found.

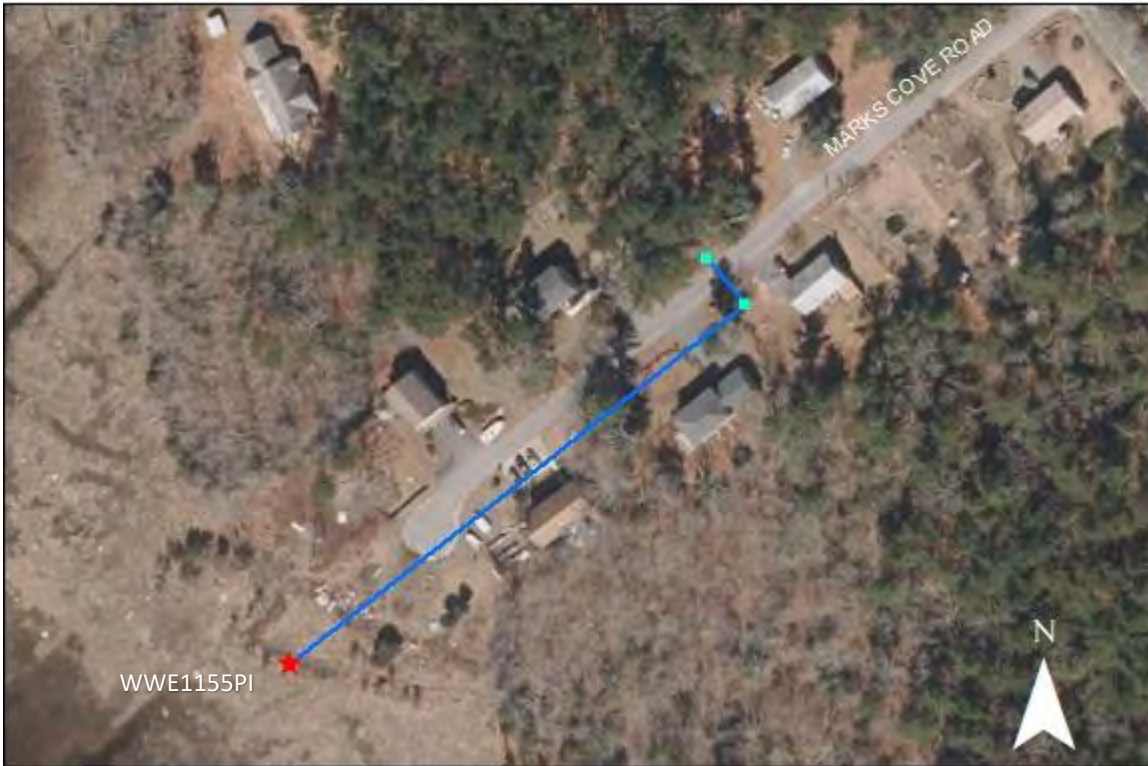
WWE1155PI- Marks Cove Road: No issues found. Newly discovered outfall.

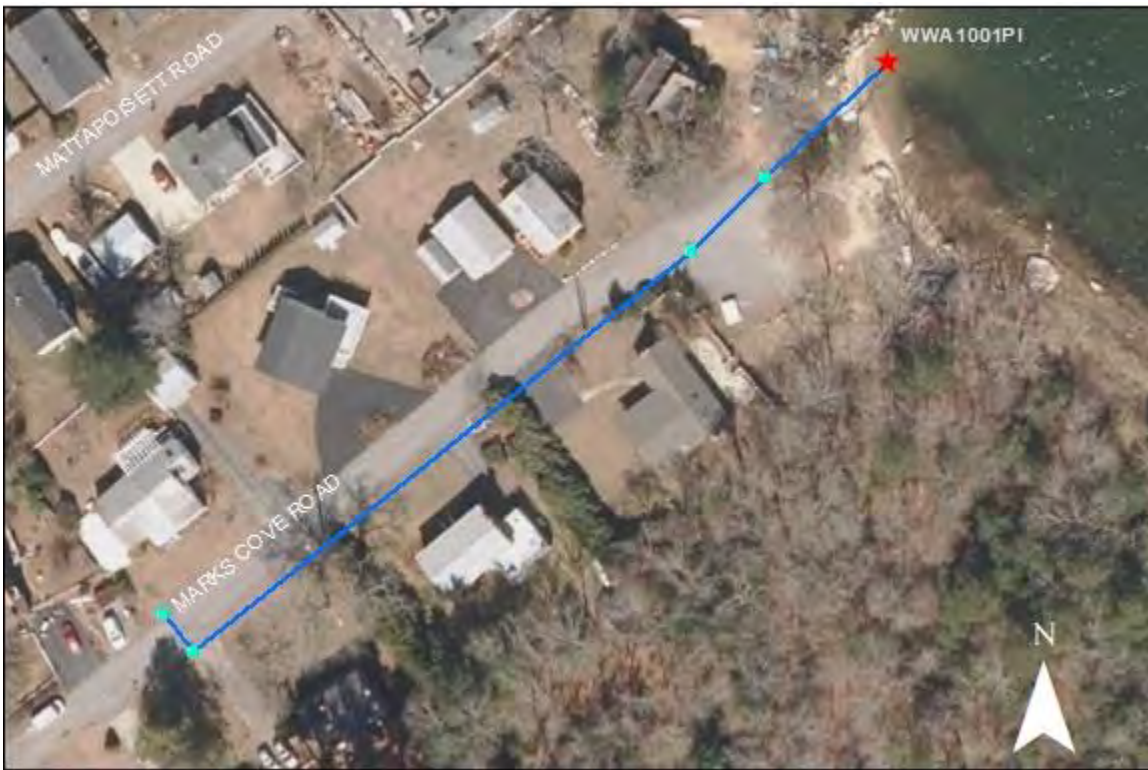
WWA1001PI- Marks Cove Road: No issues found.

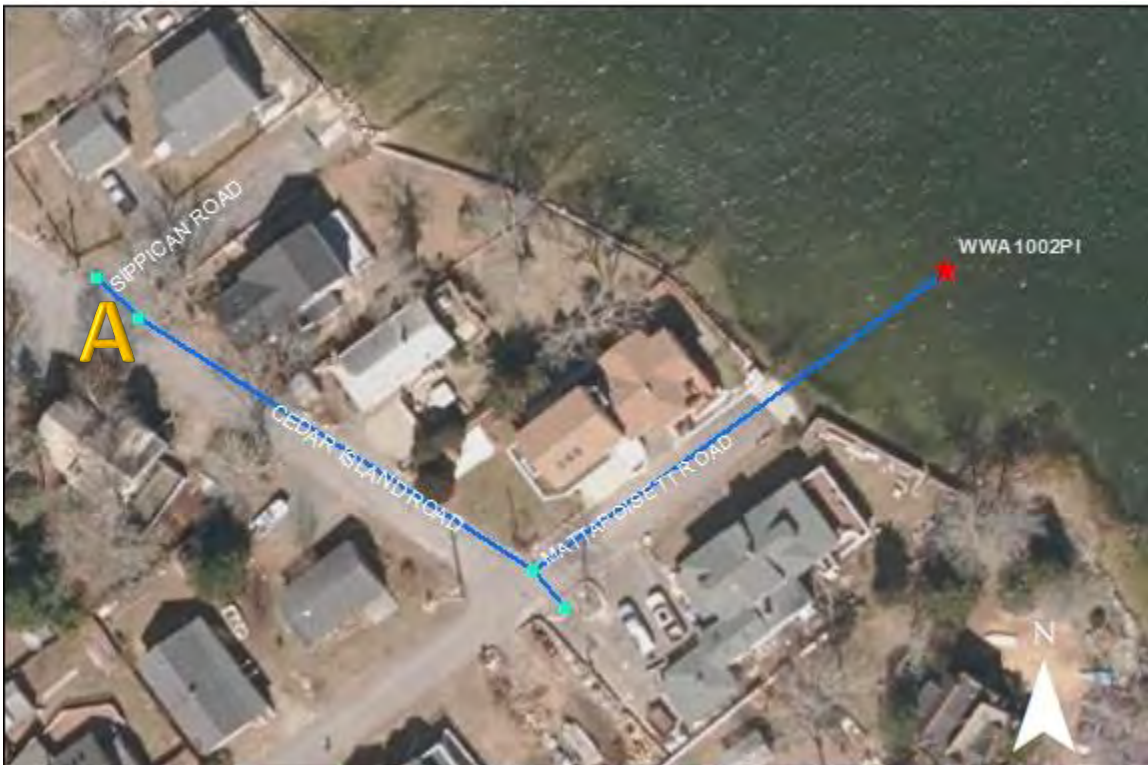
WWA1002PI- Sippican Road, Cedar Island Road, and Mattapoissett Road: At point A there is a very large sink hole. Further attention is necessary.

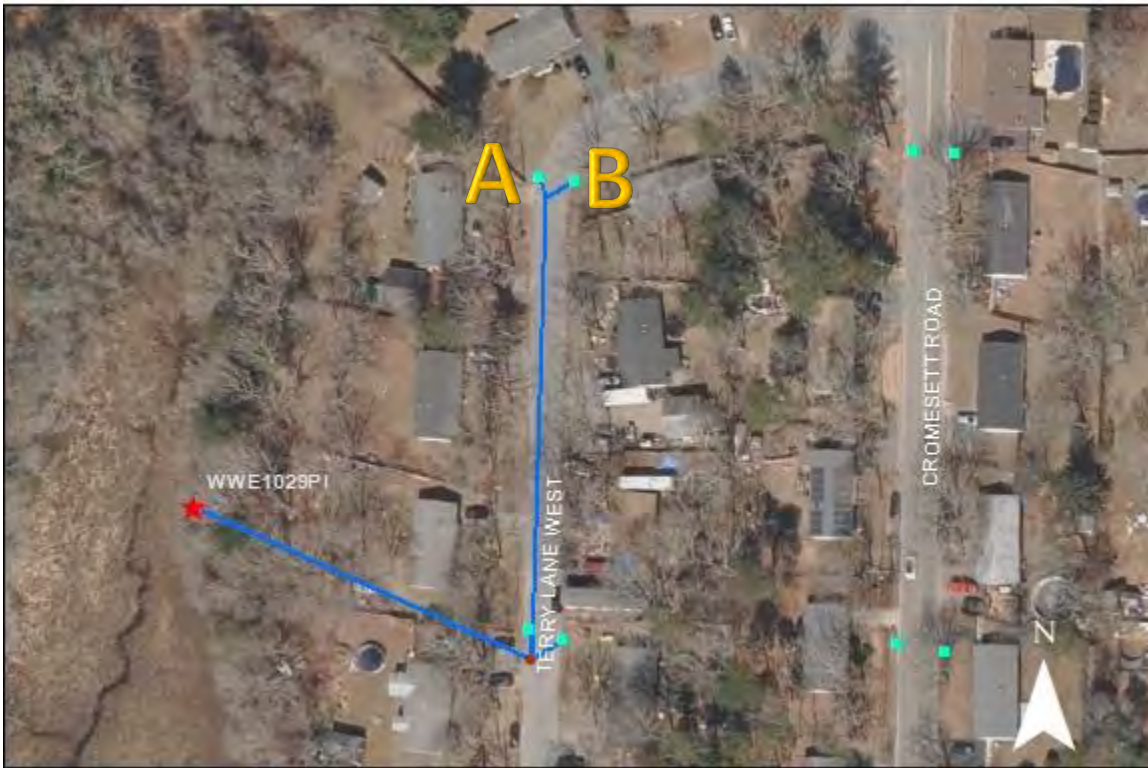
WWE1029PI- Terry Lane West: At point A and B catchbasins have begun to sink. Further preventative action is strongly recommended.

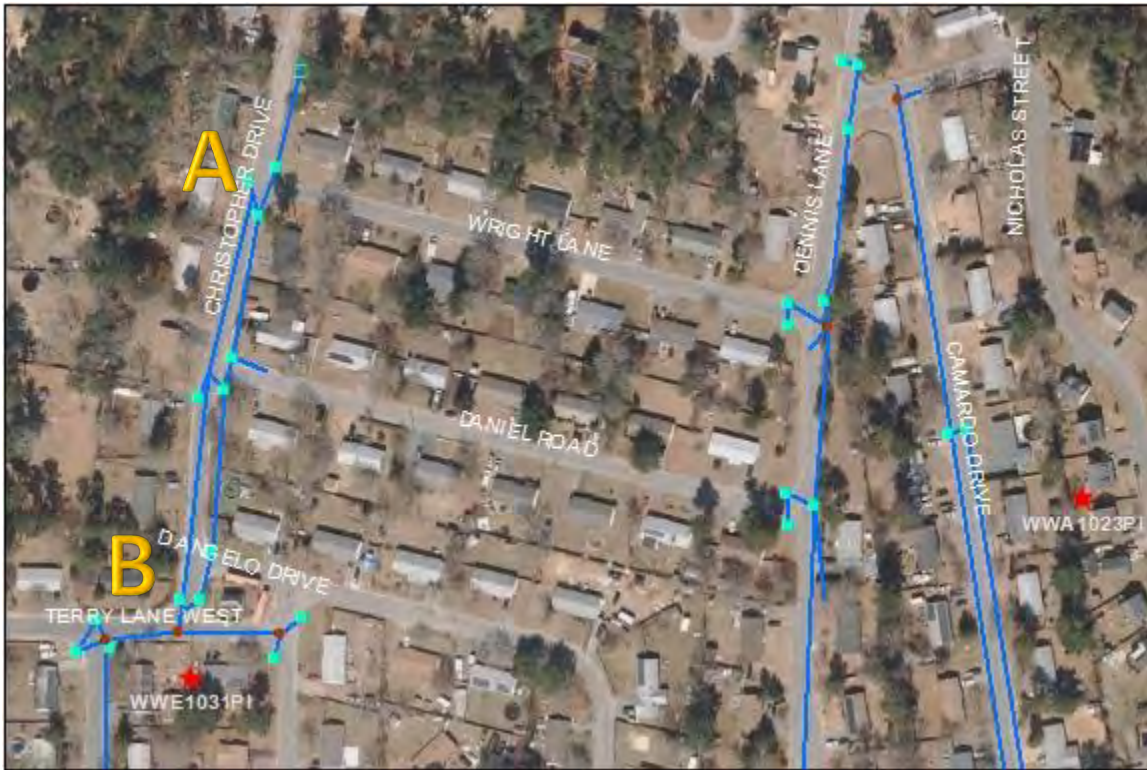
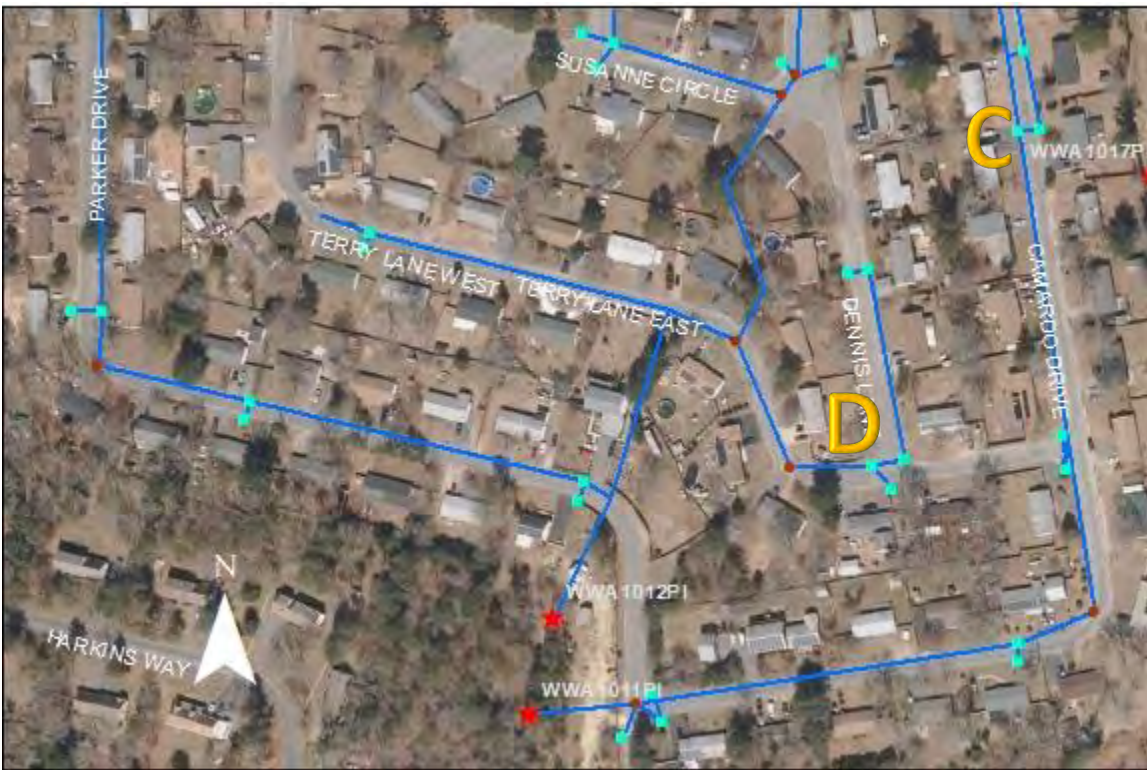
WWA1012PI and WWA1011PI- Parker Drive and Camardo Drive: At point A, B, C, and D the catchbasins are sinking. The inside of the basins are missing bricks. Preventative maintenance is recommended. Overall, this area is need of cleaning. Basins contain large amounts of debris, and many pipes are clogged especially on Camardo Drive. Further attention is strongly recommended.

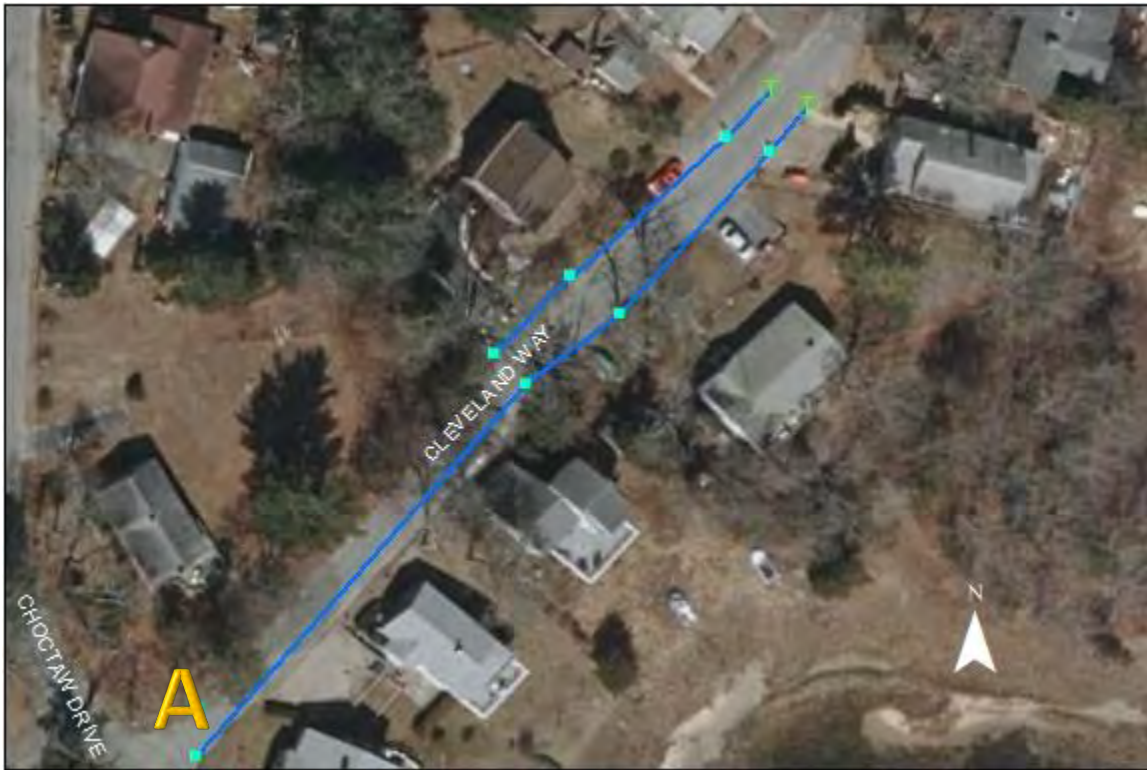
Cleveland Way: At point A the catchbasin is full of water. All other basins were dry. Highly likely the pipe exiting the basin is clogged. Neighbors reported major flooding during rain events. Maintenance is recommended.
