**The Buzzards Bay Stormwater Collaborative
Illicit Discharge Investigation Trailer**

Town of Wareham Report

November 2nd, 2022

Wareham IDDE Report

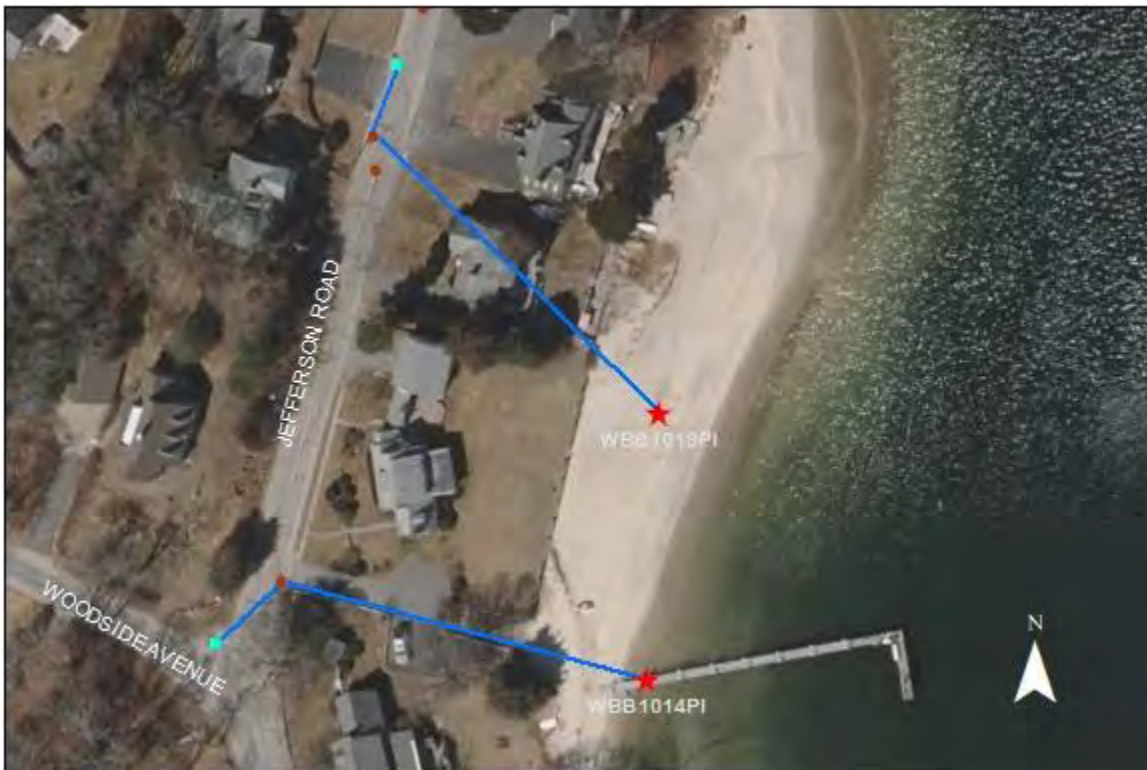
WBB1019PI and WBB1014PI- Jefferson Road: No issues found.

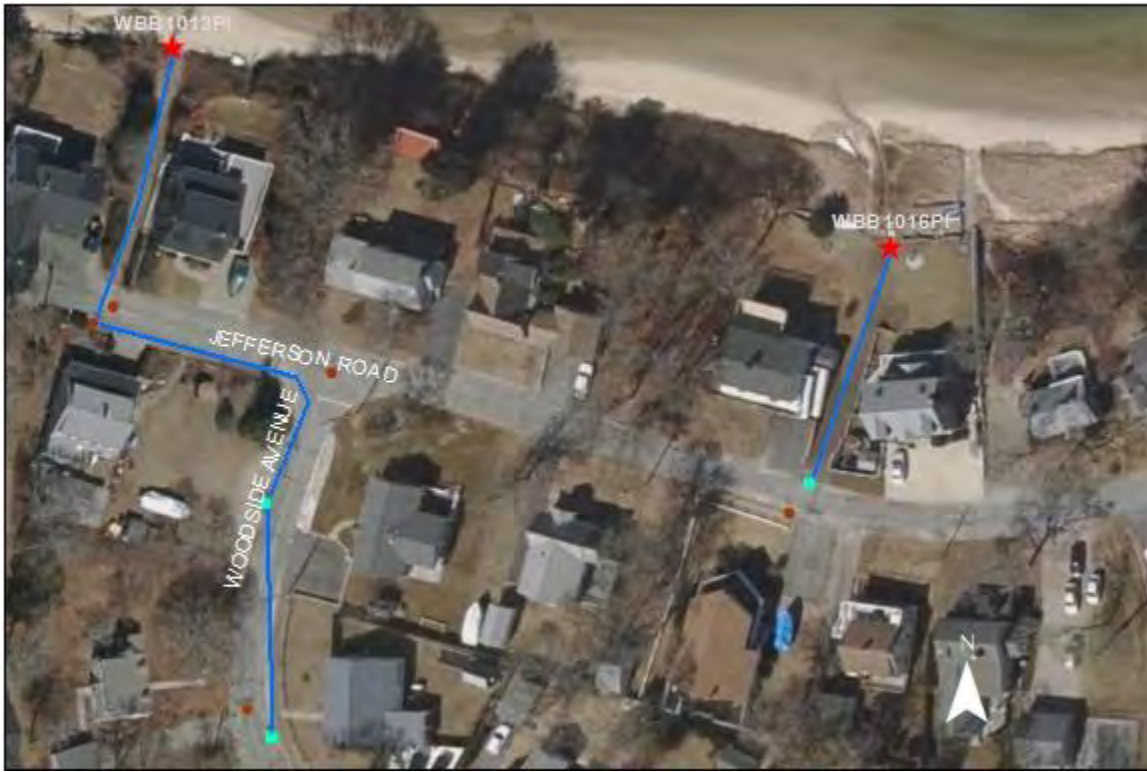
WBB1013PI and WBB1016PI- Jefferson Road and Woodside Avenue: No issues found.

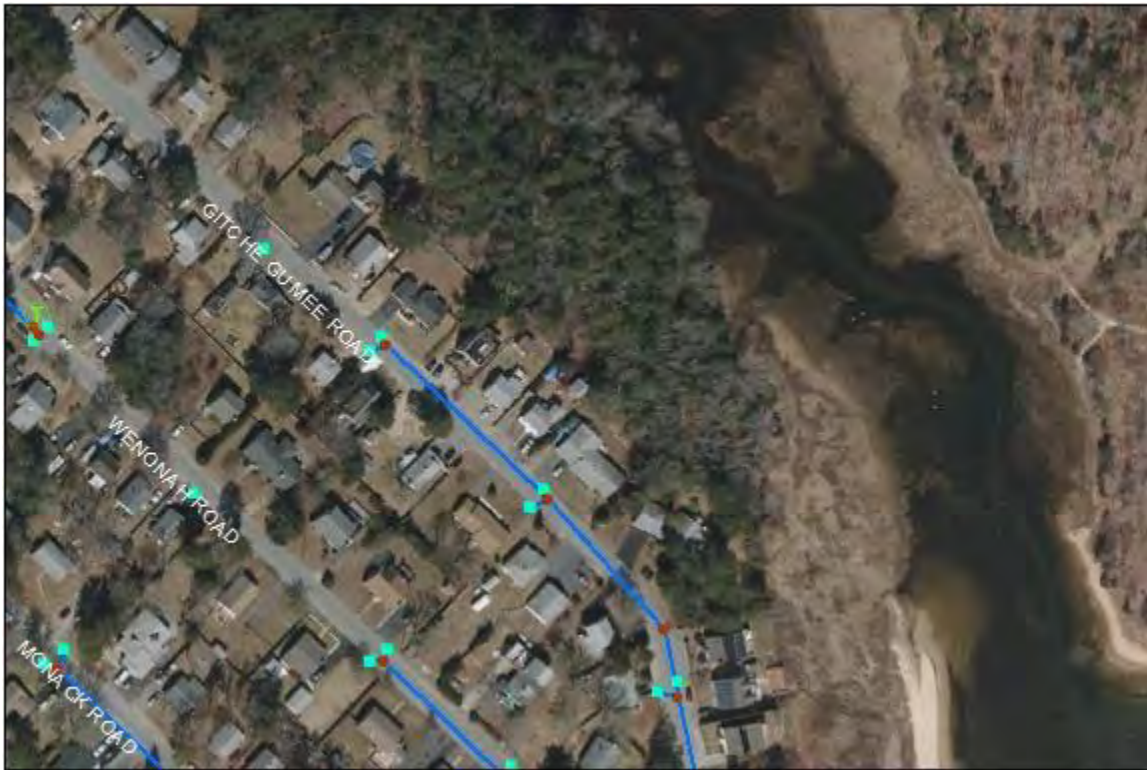
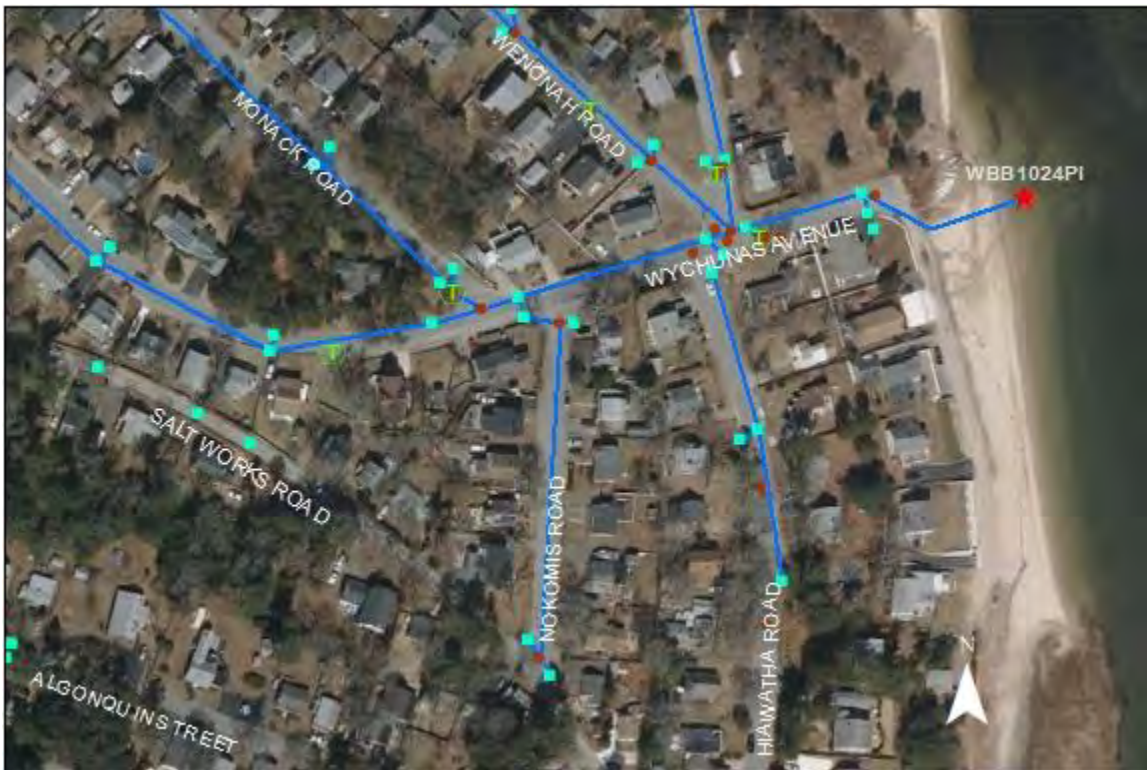
WBB1024PI- Wychunas Avenue, Gitche Gumee Road, Wenonah Road, Monack Road, Nokomis Road and Hawatha Road: No issues found.

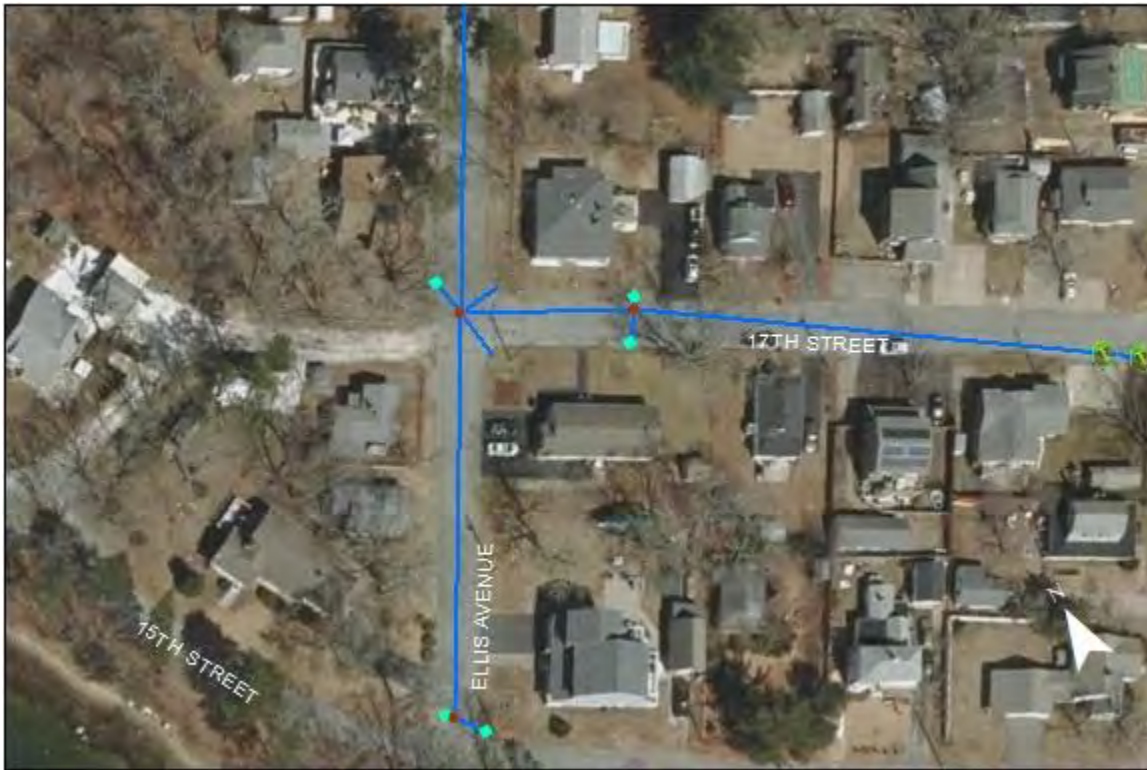
Ellis Avenue: No major issues found. The catchbasins and manholes in the Southern half of the catchment are full of sand. Maintenance is strongly suggested.

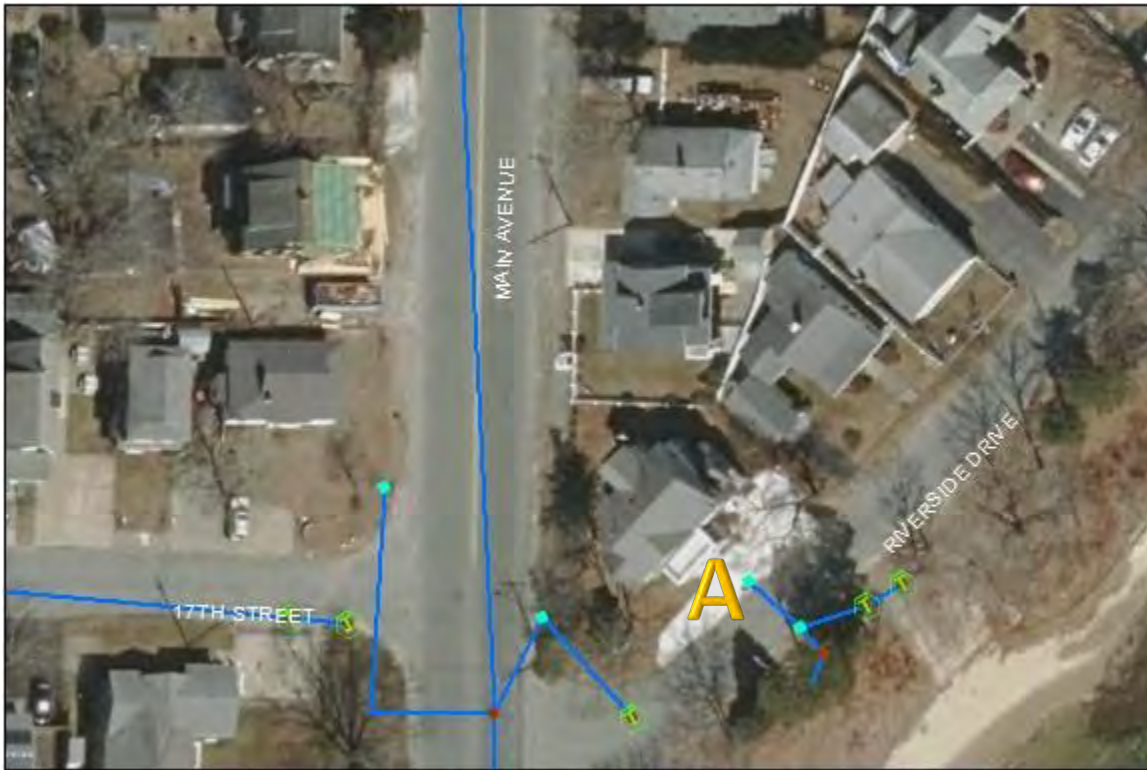
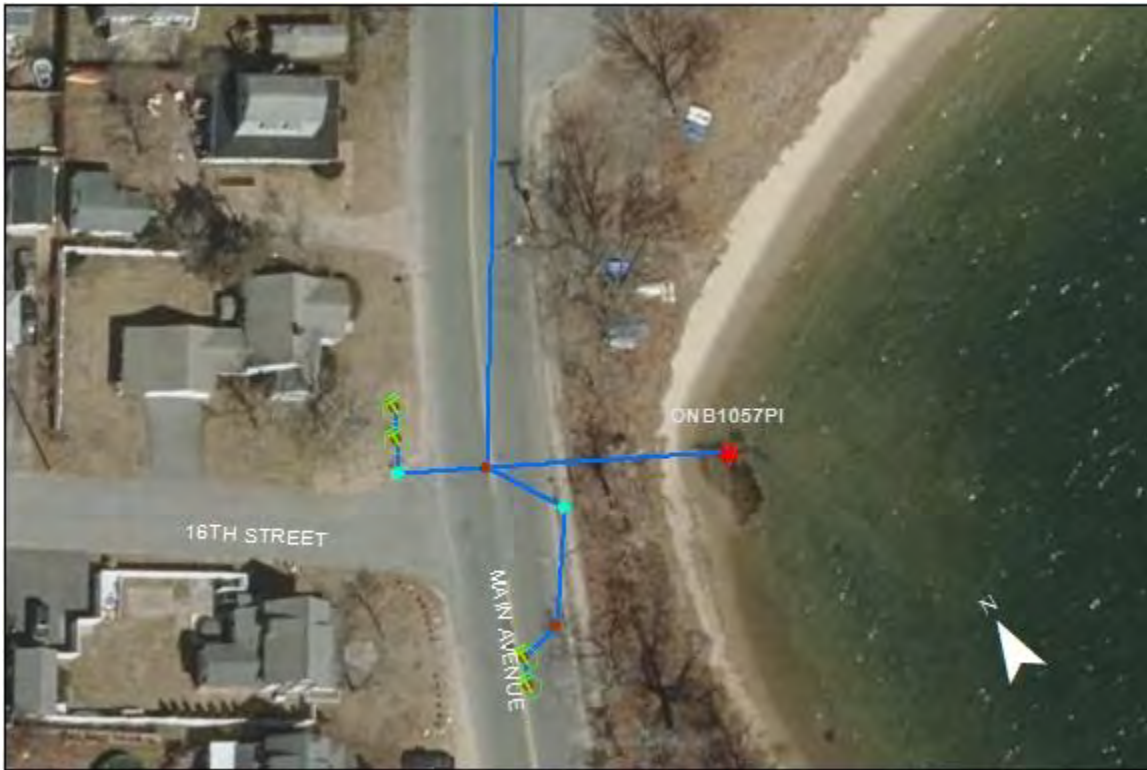
ONB1057PI- Main Avenue: Catchbasins and manholes at points A, B, C, D, E, and F are all sinking. Most of them are missing bricks inside. At point F there is a sinkhole between the catchbasin and the sidewalk and poses risk to pedestrians. Point F needs immediate attention. Additional maintenance to all other points is recommended.

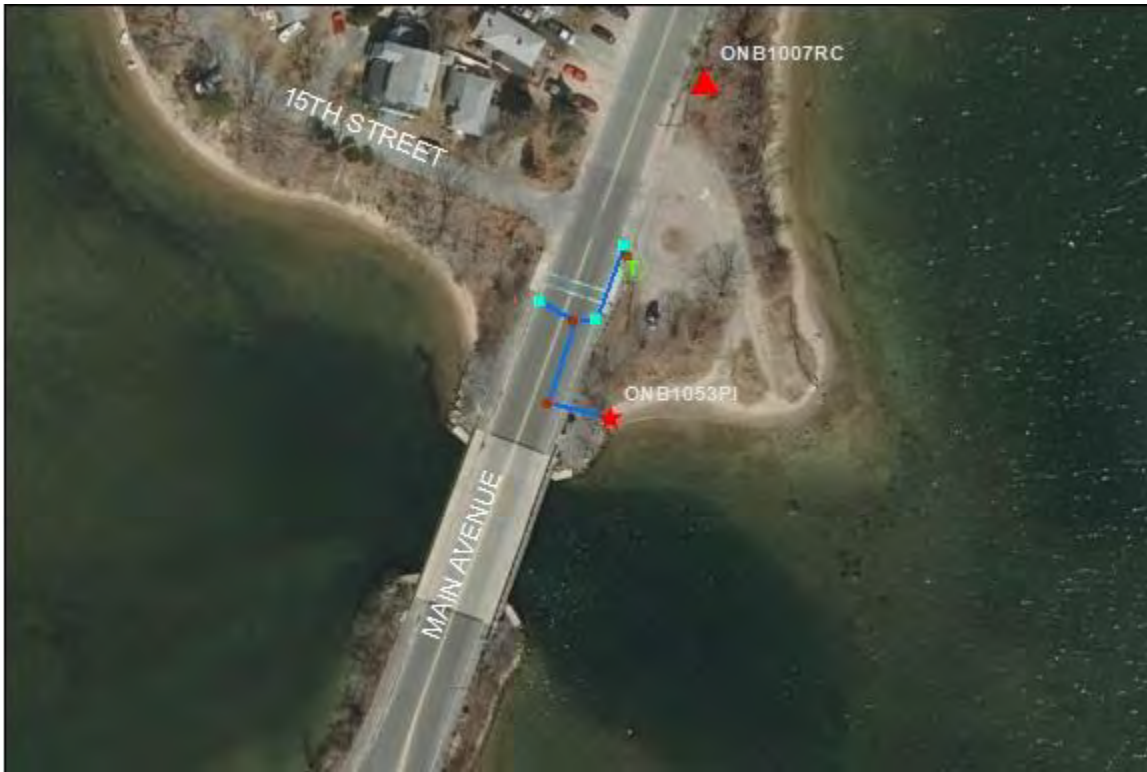
ONB1053PI- Maine Avenue: No issues found.

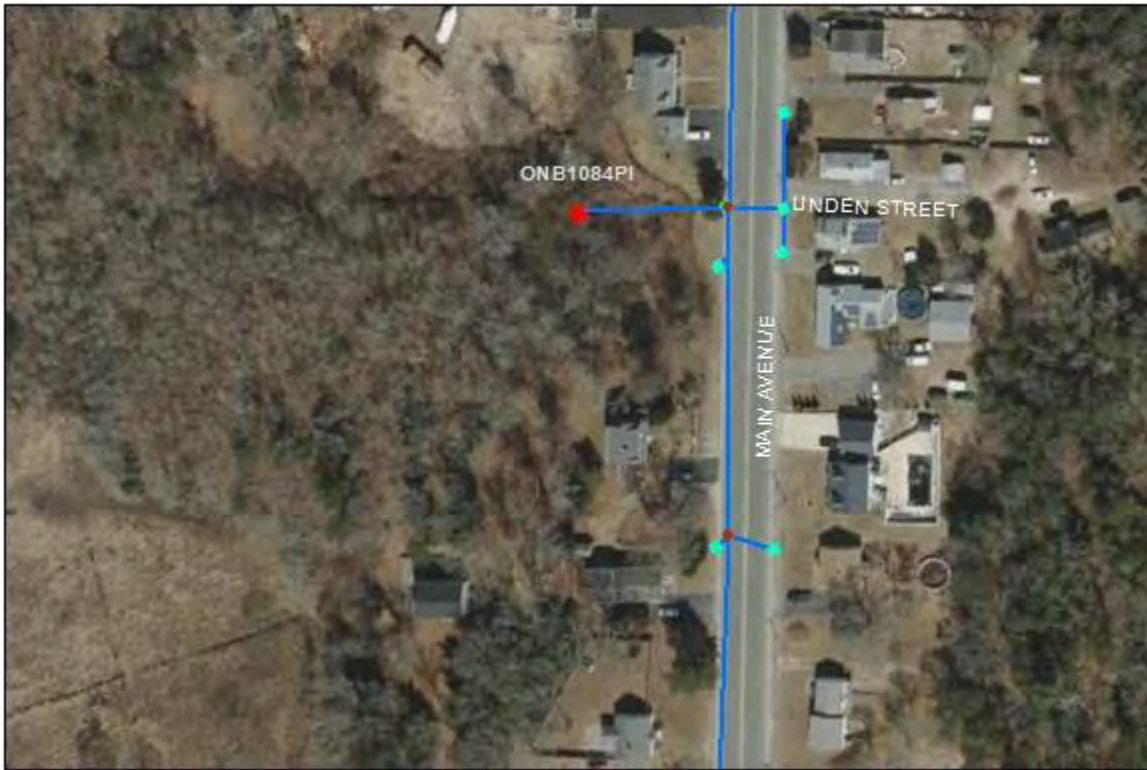
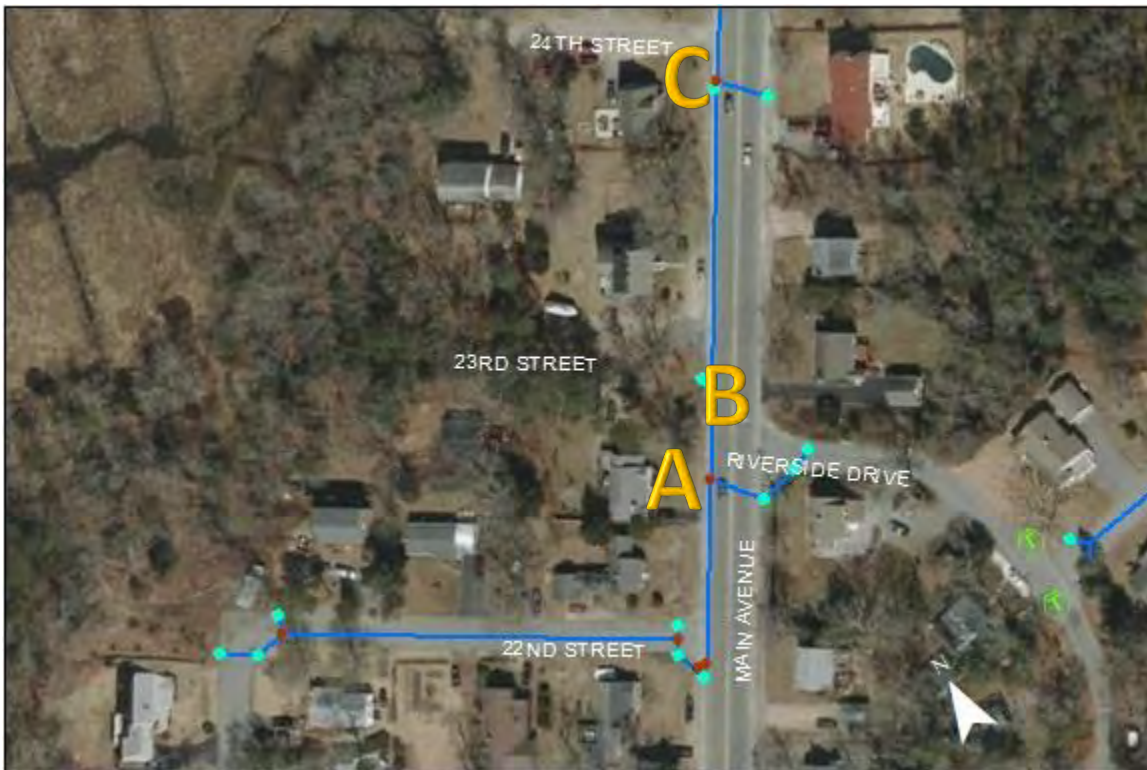
ONB1084PI- Main Avenue: Manhole covers at point A and C and the catchbasin cover at point D are all broken. The catchbasin at point B is sinking. Maintenance on all is suggested.

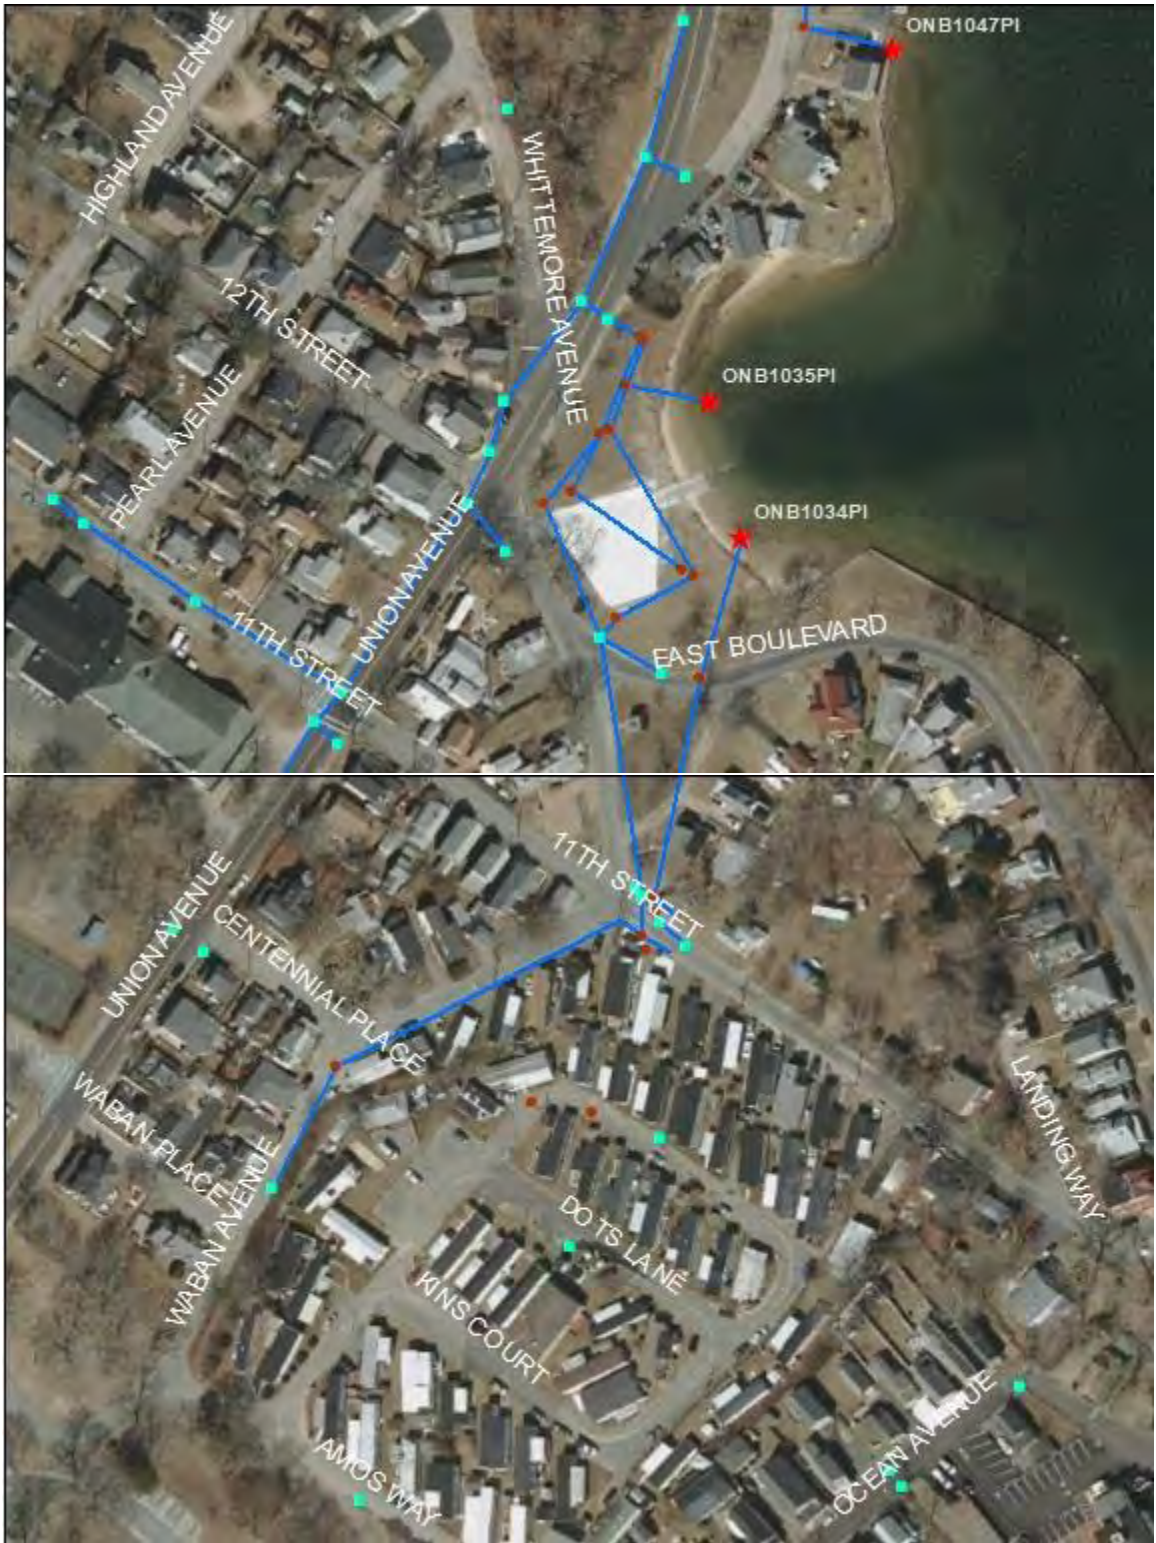
ONB1049PI- North boulevard and East Boulevard: No significant issues found.

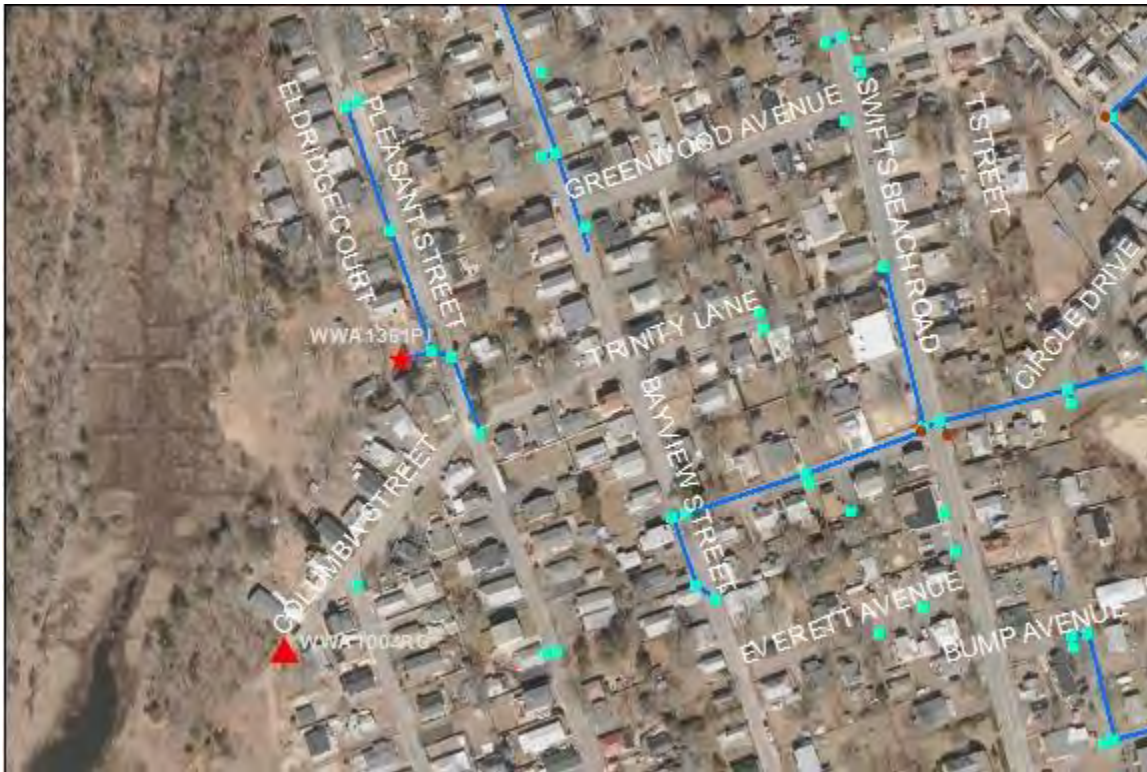
Swifts Beach Road (3/3): No issues found. There is still a lot more catchment investigation work to be completed on Swifts Beach Road and neighboring streets.
