**The Buzzards Bay Stormwater Collaborative
Illicit Discharge Investigation Trailer**

Town of Westport Report

August 2022

Westport IDDE Report

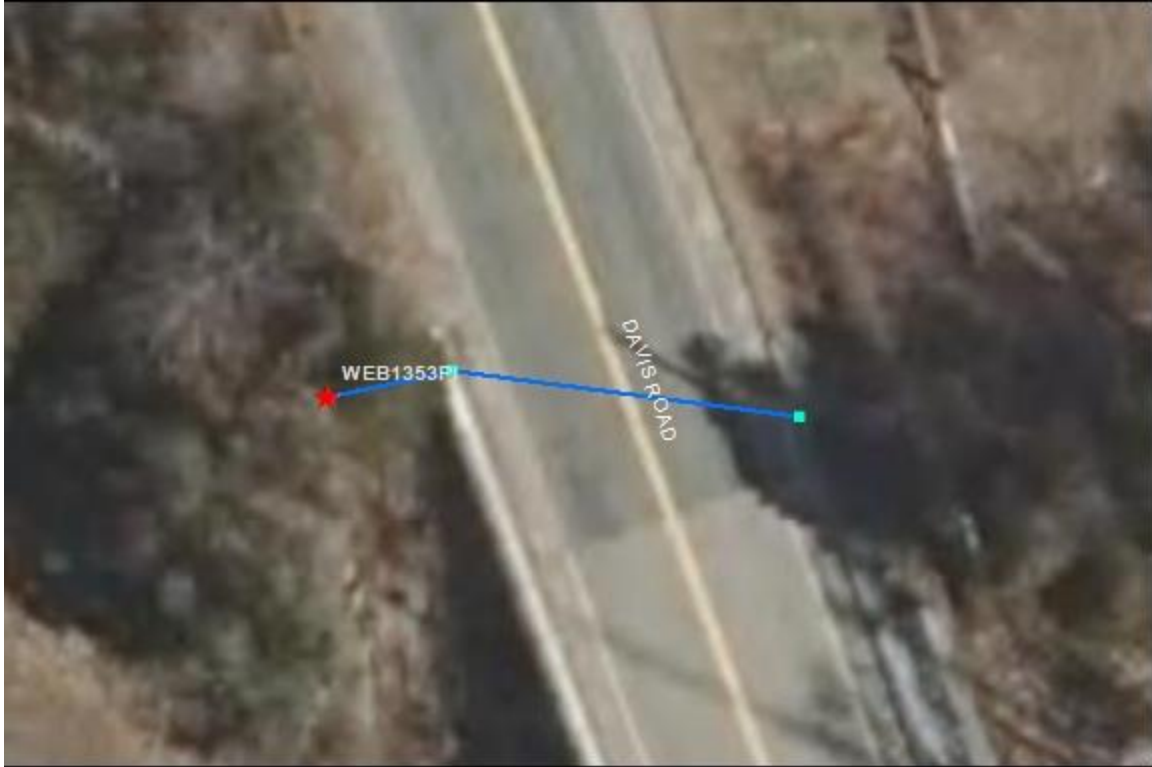
WEB1353PI- Davis Road: No issues found.

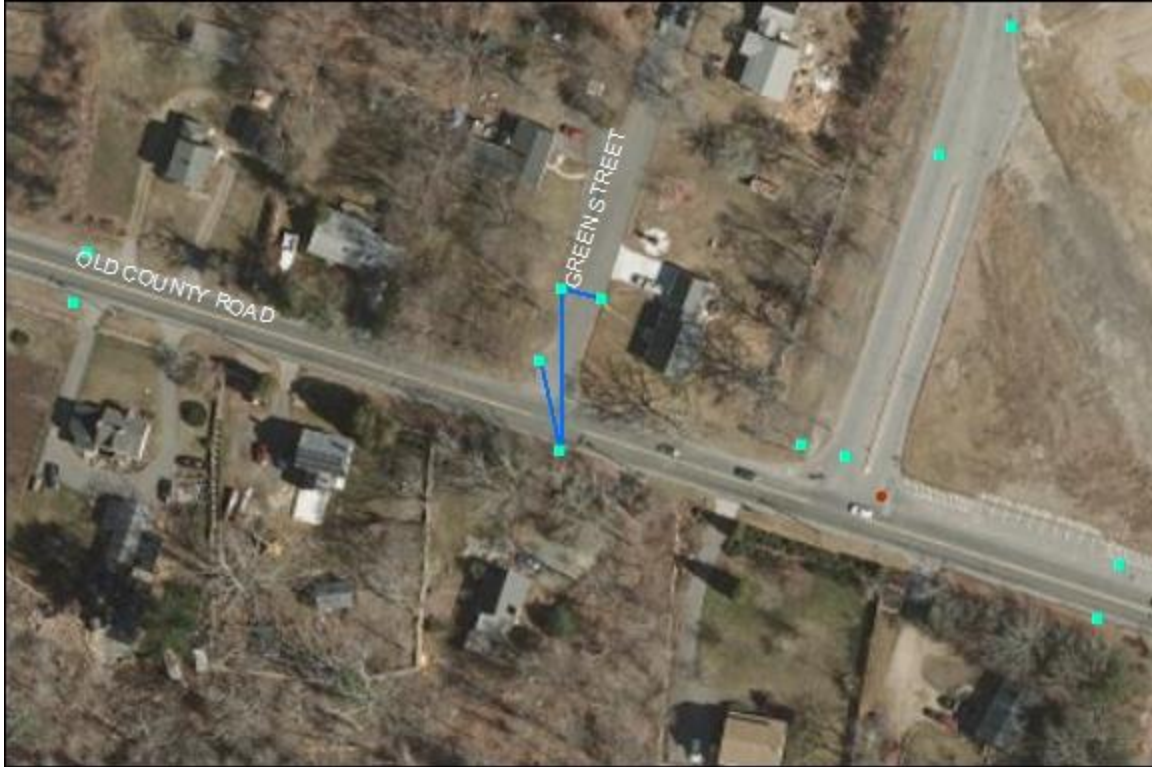
Green Street-No issues found.

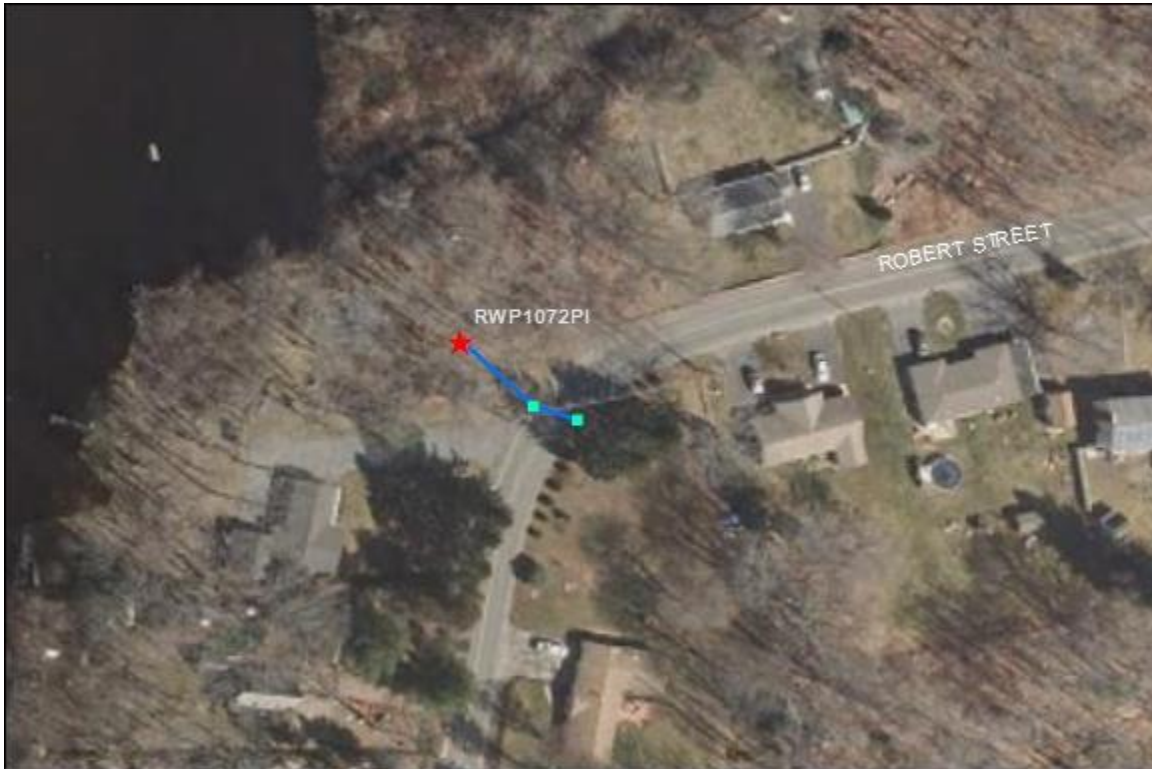
RWP1072PI: No issues found. Outfall was inventoried.

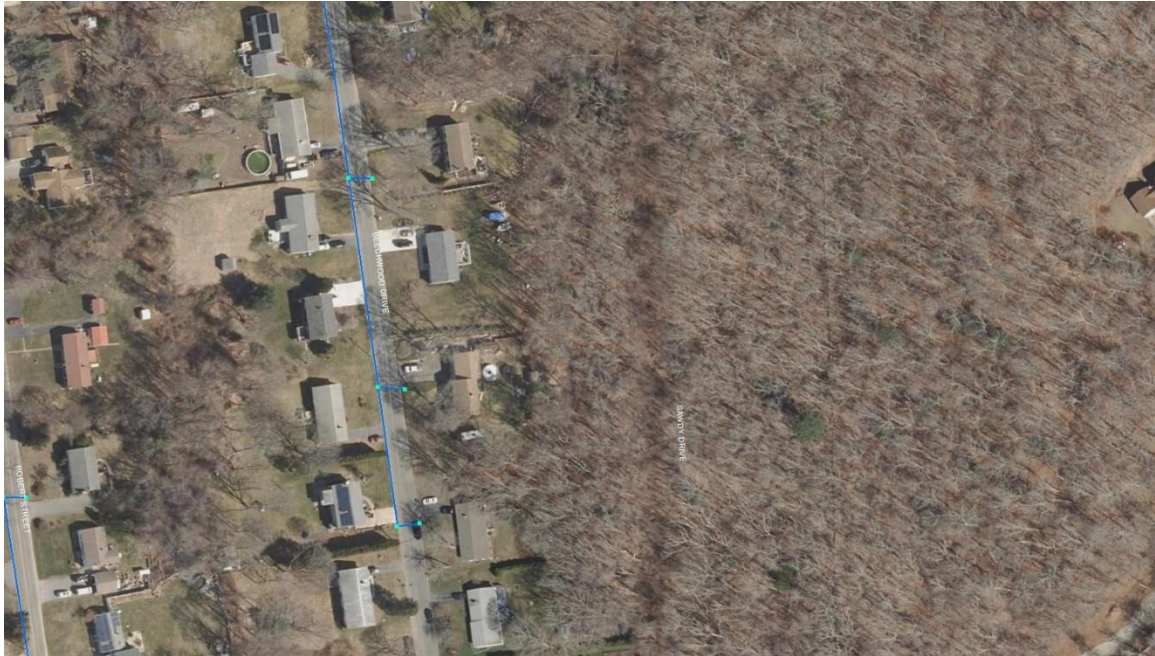
RWP1079PI- Beachwood Drive: No issues found.
