Stormwater Report for Catchment: FIH1007PI in the Town of Fairhaven

Reservation Road

Status and Recommendation based on the opinion of the BBNEP.

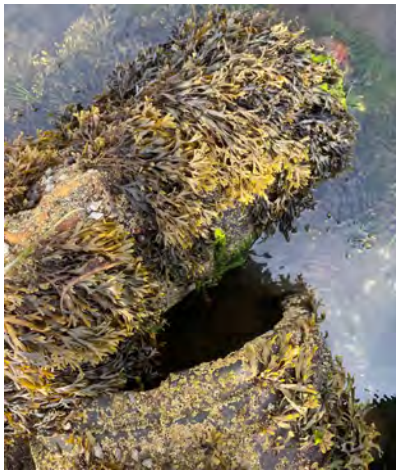
DW: No indication of Bact problem, but ammonia present in DW sump. Recommend: Recheck FIH1050MH in DW. If sample in sump, monitor when there is an indication of water flowing (not stagnant) and salinity is less than 5.5, otherwise collect sample in FIH1042MH. WW: No samples. Collect samples from FIH1050MH if salinity is less than 5.5 otherwise monitor FIH1042MH. ONBH Impair: Bact, N, DO

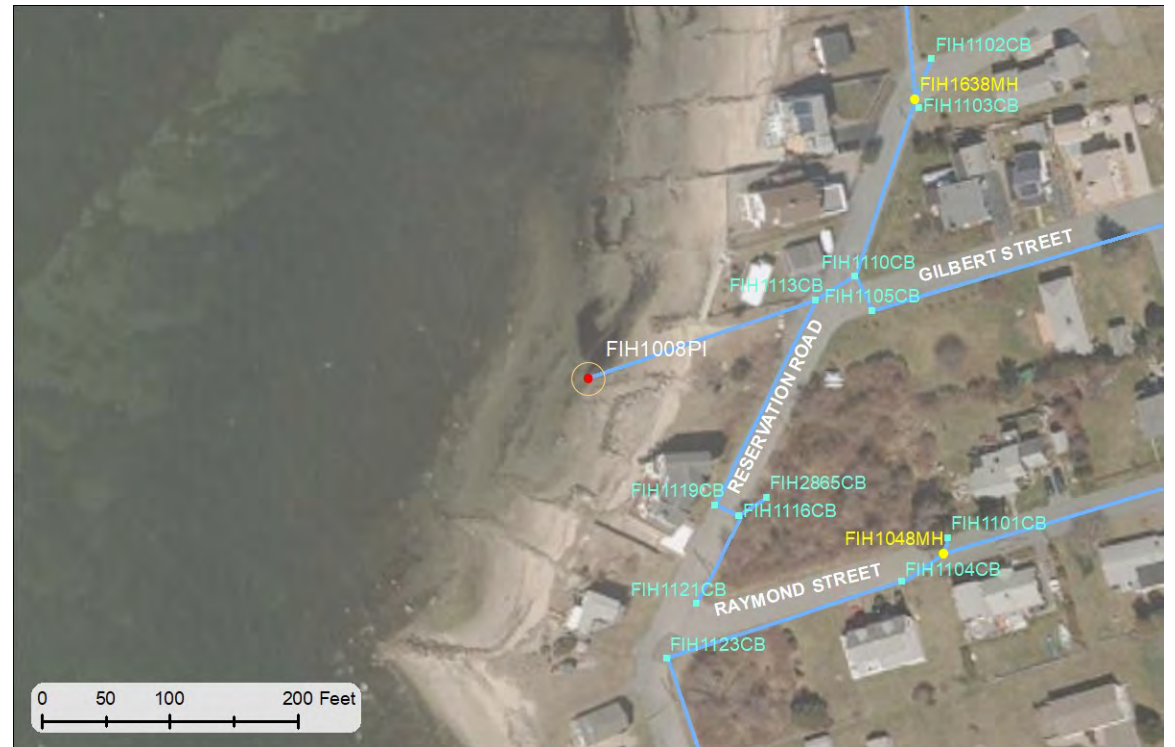
DW: FIH1113CB is backflushed w/tidal water Recommend: Monitor for DW and WW at next upstream in-line structure (FIH1110CB). If DW, collect sample if there is evidence of flow, If not flowing (stagnant), note no flow on data sheets. DW and WW collection: Check salinity, If salinity is less than 5.5, collect sample. If greater than 5.5, collect samples from both FIH110CB3 and FIH1090CB. ONBH Impair: Bact, N, DO

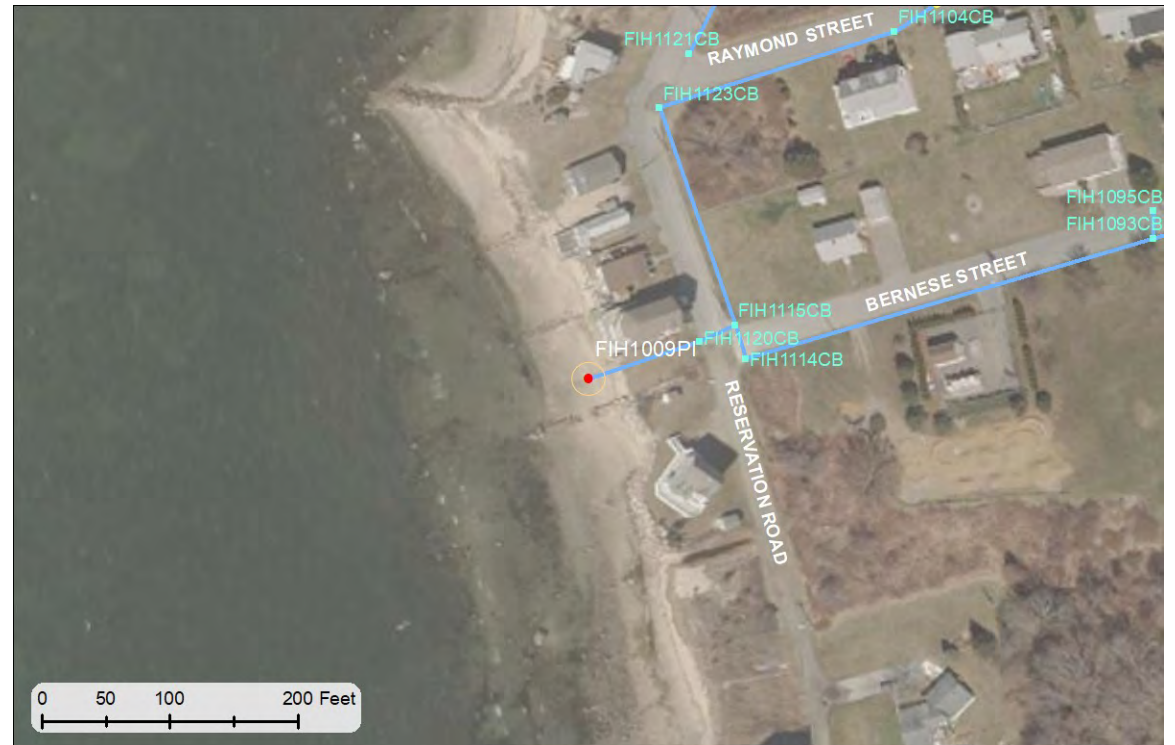
DW: FIH1120CB is backflushed w/tidal water. Recommend: Monitor for both DW and WW at next upstream in-line structure (FIH1115CB). If DW, collect sample if there is evidence of flow, If not flowing (stagnant), note no flow on data sheets. DW and WW collection: Check salinity in FIH1115CB, If salinity is less than 5.5, collect sample. If greater than 5.5, collect samples from FIH1123CB. ONBH Impair: Bact, N, DO

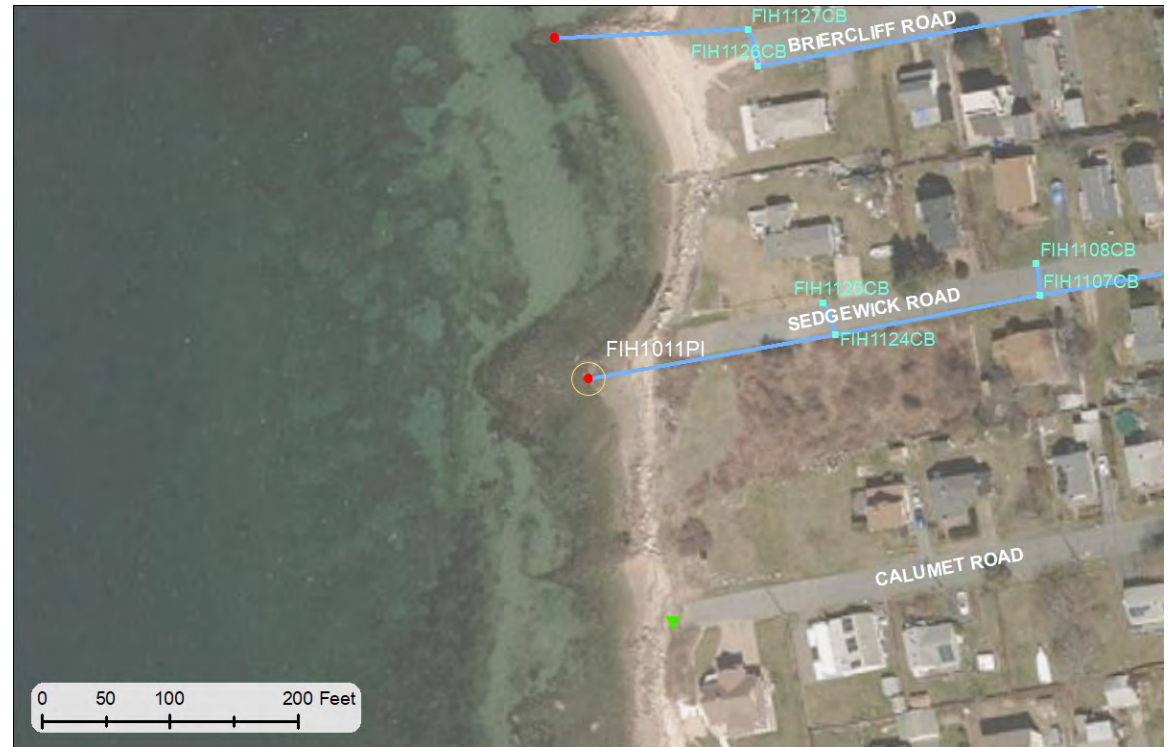
Based on existing data, FIH1124CB does not appear to be impacted by tidal backflushing. WW Rank (2 samples): Bact (1), Nitrates (1) Total 2. Recommend (for DW and WW): Check FIH1124CB. If sample is in sump, monitor when there is an indication of water flowing (not stagnant) and salinity is less than 5.5, otherwise collect sample in FIH1107CB.

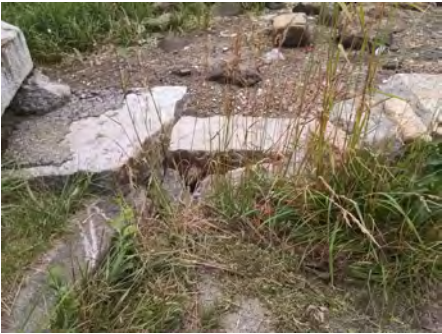
Recommendation:
 As this discharge is a RC, DW is not expected to be a problem. Based on 2 WW samples, WW Rank: Bact (2), Nitrates/Surf (1 ea), Total (4). Recommend: Continue WW monitoring, Investigation of possible ID and Investigate if uphill Leaching Catch Basins are functioning. INBH imp: Bact, N, HC, DO

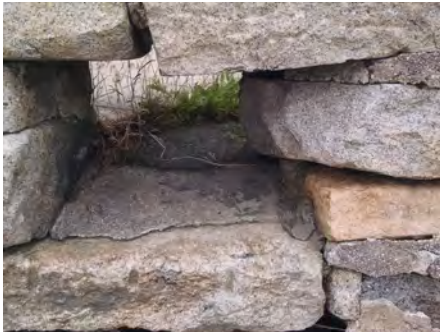
As this discharge is a RC, DW is not expected to be a problem. Based on 3 WW samples, WW rank: Bact (2), Nitrates/Surf/Amm (1 ea), Total (5). Investigation of possible ID and Investigate if uphill Leaching Catch Basins are functioning. INBH Impair: Bact, N, HC, DO

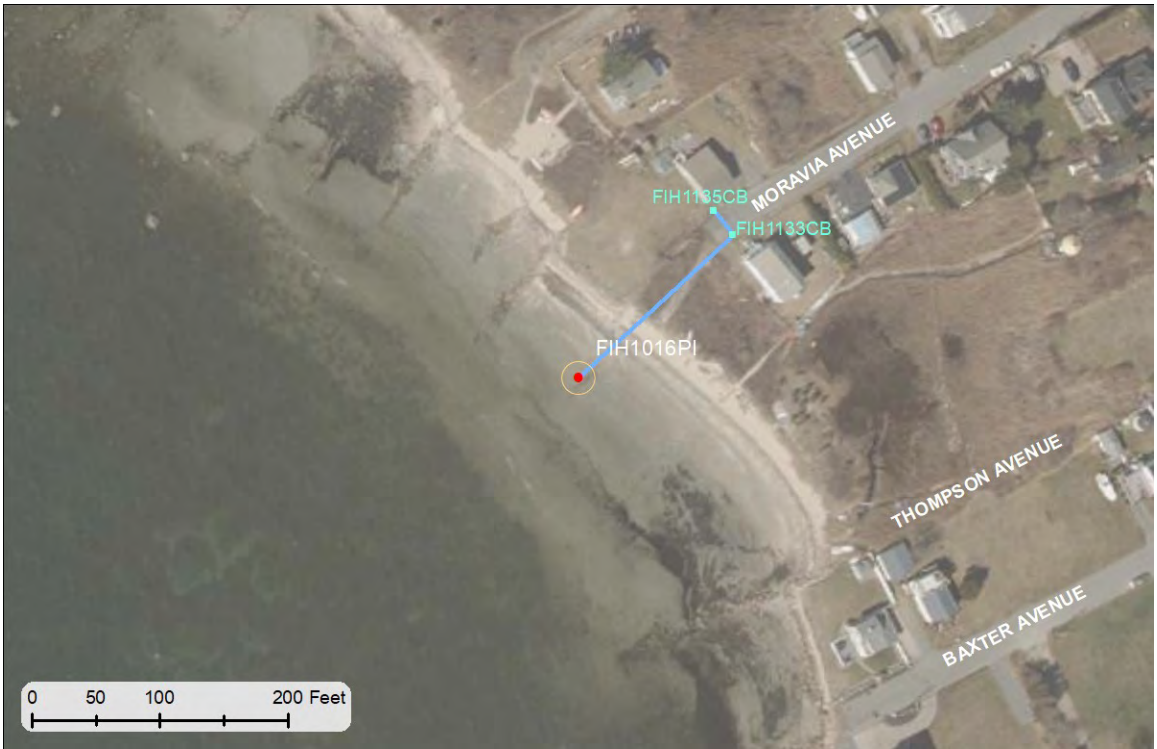
DW: As this drainage system consists of only 2 CB at the end of the road, it is unlikely that an ID exists during DW. WW: No samples collected. Recommend monitoring both CBs during WW, collect sample from road as it drops into CBs to avoid collecting sump water. ONBH Impair: Bact, N, DO

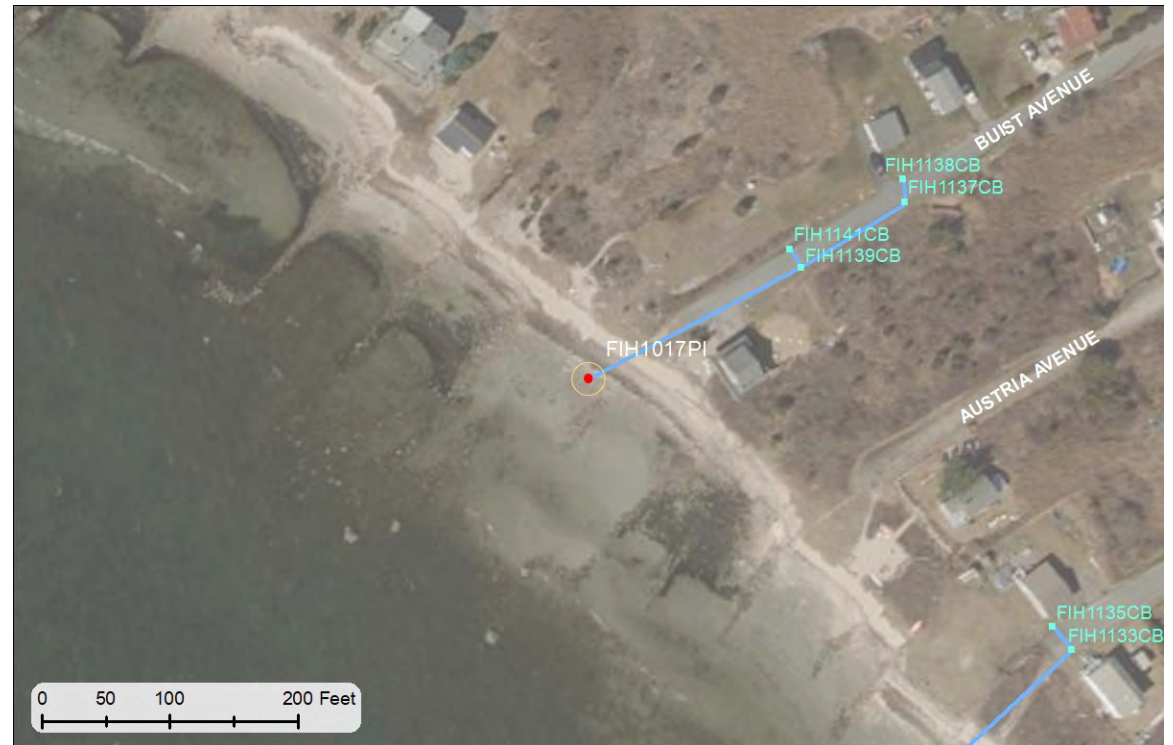
FIH1139CB is backflushed w/tidal water Recommend: Monitor for DW and WW. If DW, collect sample if there is evidence of flow, If not flowing (stagnant), note no flow on data sheets. DW and WW collection: Check salinity if less than 5.5, collect sample, otherwise collect sample from FIH1137CB. ONBH Impair: Bact, N, DO

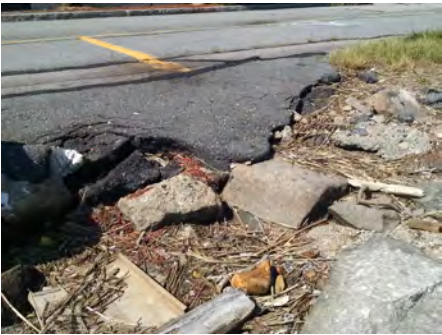
DW: No flow, no issues. WW: Only one sample taken. WW Rank: Bact (1), Nitrates (1), Tot. 2. Recommend: Continue monitoring for WW. INBH Impair: Bact, N, HC, DO

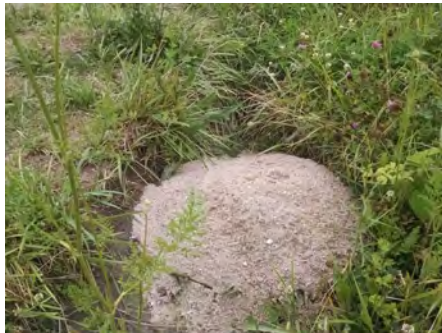
DW: no samples, no issues. WW Recommendation: Continue to monitor FIH1200CB. Consecutively monitor FIH1022RC. ONBH Impair: Bact, N, DO.

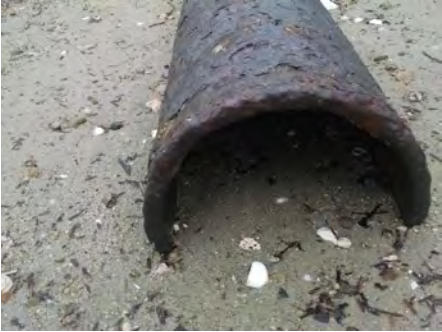
DW: No flow, no issues WW Rank (1 sample): Bact (1) and N (1), total 2, Recommend: Continue WW sampling. ONBH Impair: Bact, N, DO.

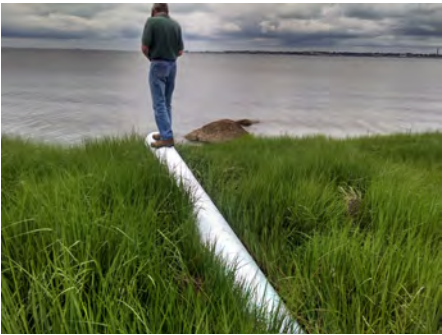
WW rank: Bact (2) and N (1), Tot 3. Recommend: Continue both DW and WW monitoring. During DW if sump appears stagnant, do not collect sample, but make a note on data sheet, drainage not flowing. Investigate for potential ID. ONBH Impair: Bact, N, DO.

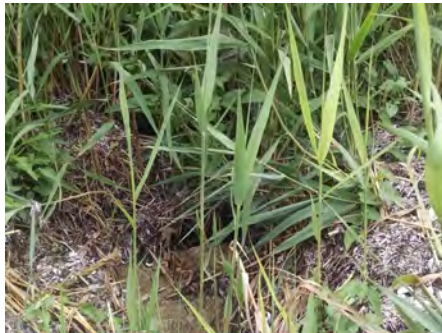
WW Rank (1 Sample) Bact (2), Nitrates (1), Total 3. Recommend: Continue to monitor both DW and WW. During DW if sump appears stagnant, do not collect sample, but make a note on data sheet, drainage not flowing. Investigate for potential ID. ONBH Impair: Bact, N, DO.

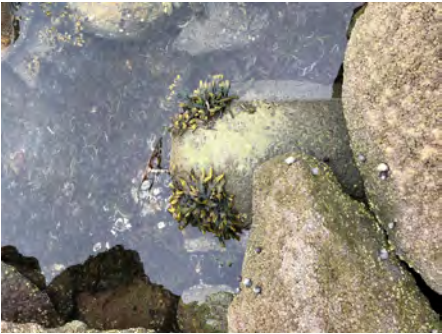
WW Rank (1 Sample); Bact (2), Nitrates/Ammonia (1 ea), Total 4.
 Recommend: Continue to monitor WW at FIH2672CB. Check salinity first. If greater than 5.5 monitor all three upstream facilities (FIH1081MH, FIH1264CB, FIH1262CB). During DW if sump appears stagnant, do not collect sample, but make a note on data sheet, drainage not flowing. Investigate for potential ID. ONBH Impair: Bact, N, DO.

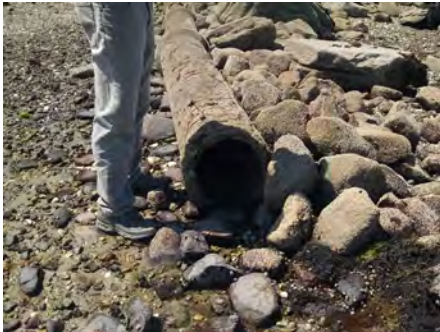
WW Rank (2 samples): Bact (2), Nitrates (1), Total 3. Recommend: Continue to monitor both DW and WW at FIH1358CB. During DW if sump appears stagnant, do not collect sample, but make a note on data sheet, drainage not flowing. Investigate for potential ID. ONBH Impair: Bact, N, DO.

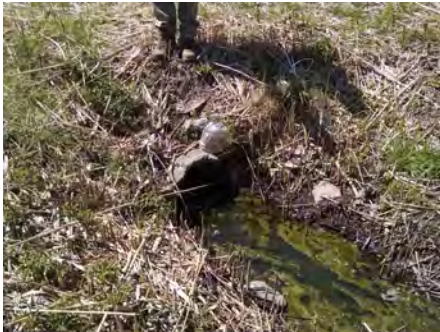
FIH1042PI

DW Rank: Bact (2), Amm (1), Total 3. Recommend: Continue to monitor for DW and WW. During DW if sump appears stagnant, do not collect sample, but make a note on data sheet, drainage not flowing. Investigate for potential ID. ONBH Impair: Bact, N, DO.

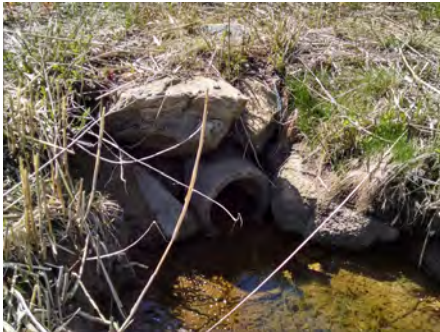
DW Rank (in sump): Bact (1), Nitrates (1): Total 2. Recommend: Continue to monitor DW and WW. If flow is stagnant in CB during DW, do not monitor and indicate on data sheet no drainage flowing. ONBH Impair: Bact, N, DO.

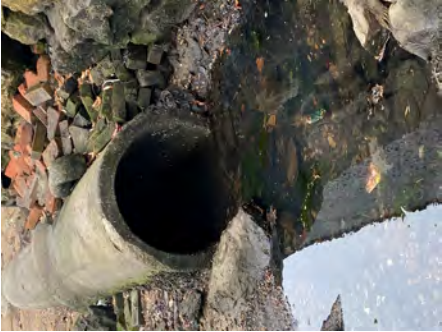
Not enough data to evaluate DW or WW. Recommend: Continue monitoring FIH1695CB (not FIH1221MH) for DW and WW. Based on 1 sample WW, Bact very high. INBH Impair: Bact, N, HC, DO.

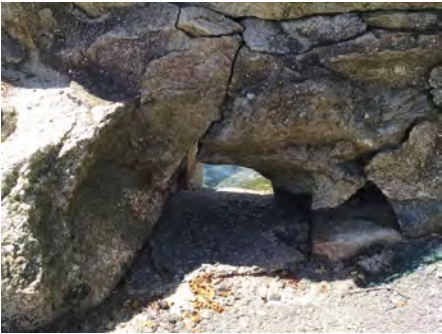
DW: No flow, no issues. WW: Even with little flow, all parameters are elevated. WW rank (2 samples), Bact (2), Amm/Nitrate/Surf (1 ea), Total 5. Recommend: Continue to monitor during WW, make notes on storwater flow, Is the drainage on Church St overtopping? Evidence of pets in the area, etc. Monitor FIH1256MH consecutively. INBH Impair: Bact, N, HC, DO.

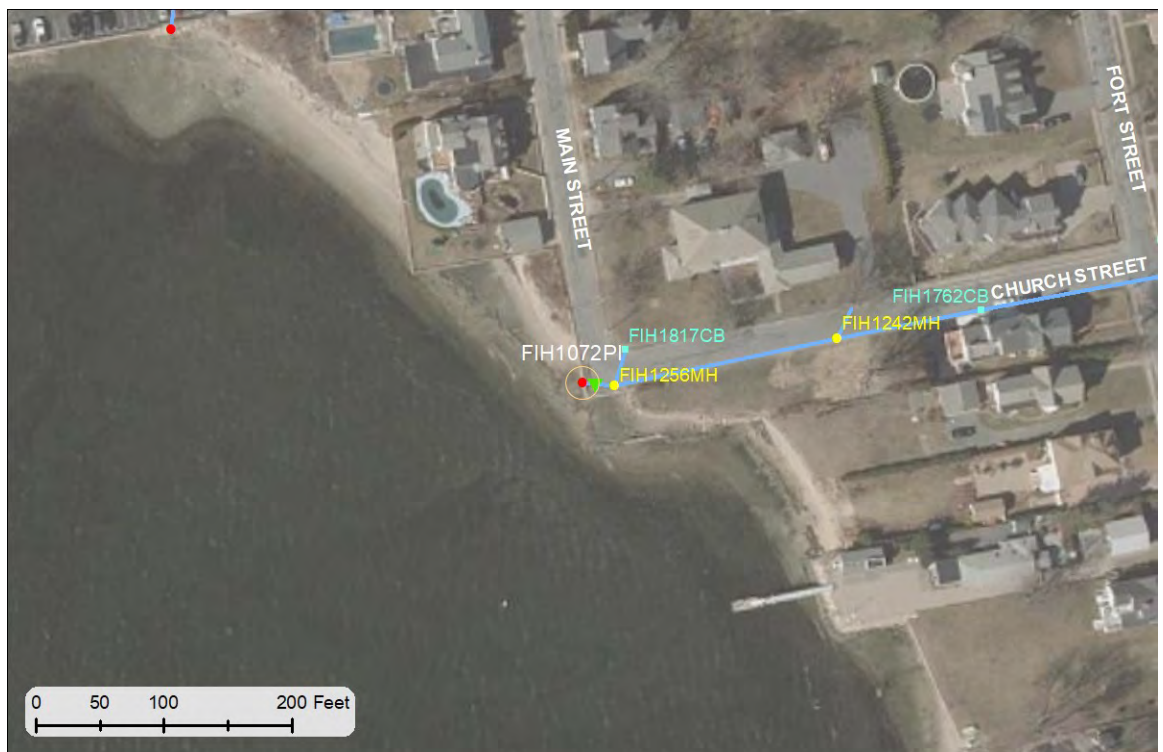
Recommendation:
 DW & WW Recommendation: Based on FH DPW's drainage maps, FIH1256MH, not FIH1817CB should be monitored. Also Suggest investigating FIH1817 PI for a potential ID (septic/sewer tie in or maybe pets in the area) as Bact counts high during 1 WW sample. INBH Impair: Bact, N, HC, DO.

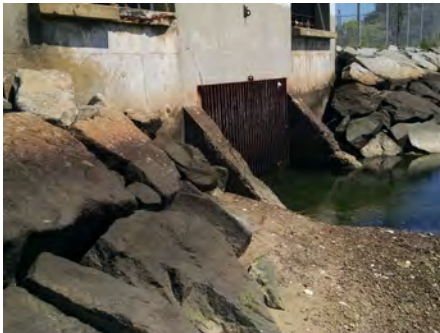
The bay water near the discharge was sampled as the drainage to this discharge point is significant. Recommend: Continue to monitor this discharge (DW and WW) and also begin to monitor some of the contributing stormdrain infrastructure: FIH1340MH on Middle, FIH1319MH and FIH1558MH on Main. INBH Impair: Bact, N, HC, DO

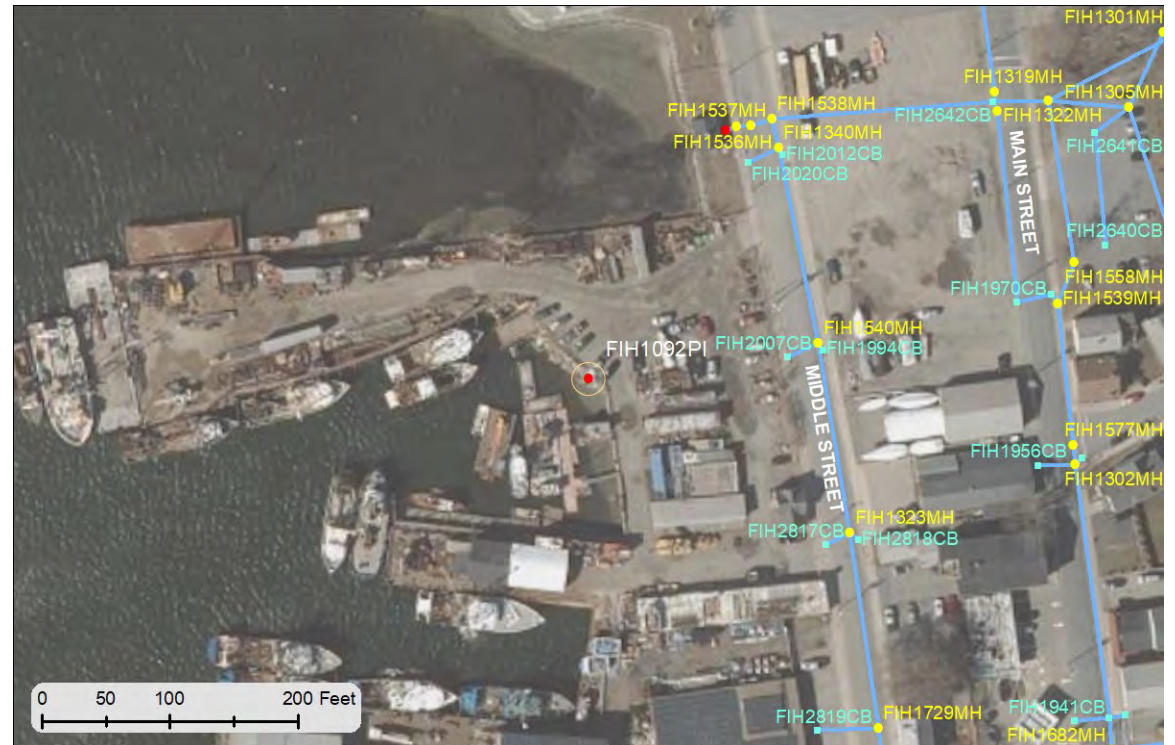
Town drainage no longer discharges to this pipe. The pipe was blocked off following Middle Street reconstruction. Drainage now flows to FIH1090PI. DW: No flow, no issues. WW Rank: Bact (1), Amm/Nitrates/Surf (1 ea), Total 4. Recommend: Even with the redirection of town stormwater, there is evidence of WW flow, probably from private property. Town will need to determine future investigation. Continue monitoring WW. If FIH1092PI salinity is greater than 5.5 monitor INBH Impair: Bact, N, HC, DO.

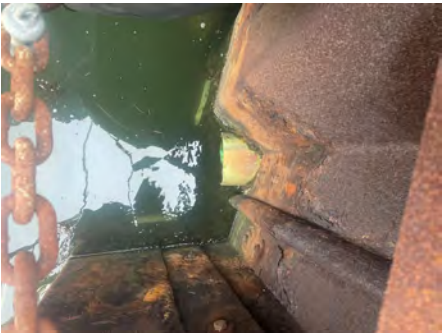
DW: No flow, No issues. WW: With minimal stormwater flow, all parameters are elevated WW rank: Bact (1), Amm/Nitrates/Surf (1 ea), Total 4. Investigate for ID. INBH Impair: Bact, N, HC, DO.

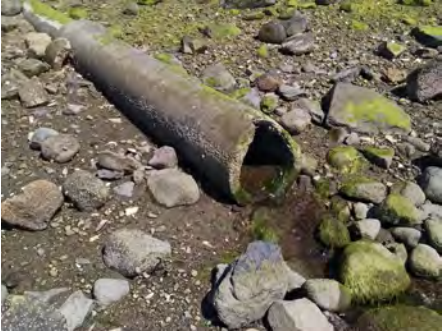
DW: No flow, No issues. WW: Almost all samples were affected by tidal backwash. WW rank (one sample): Bact (1), Nitrates/Surf (1 ea), Total 3. WW Recommend: Move monitoring site to FIH1347MH. INBH Impair: Bact, N, HC, DO.

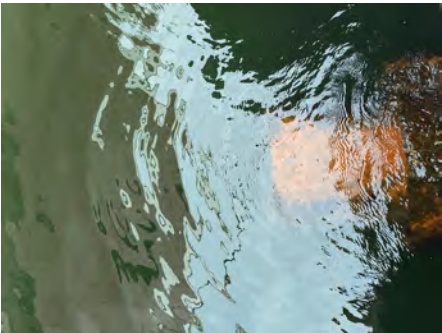
DW: No flow, No issues. WW: Almost all samples were affected by tidal backwash. WW rank (one sample): Bact (1), Nitrates (1), Total 2. Recommend: Move monitoring site to FIH1328MH and collect surface samples from Union Wharf at FIH2029CB andFIH2030CB. INBH Impair: Bact, N, HC, DO.

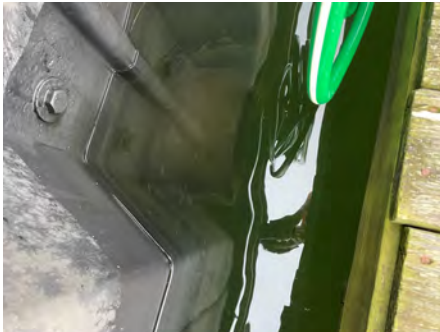
DW: No flow, No issues. WW: Almost all samples were affected by tidal backwash. WW rank (one sample): Bact (1), Nitrates/Surf (1 ea), Total 3. Recommend WW: Continue monitoring FIH1530MH at low tide. Check Salinity first, if less than 5.5 collect sample; if greater than 5.5 monitor both FIH2071CB and FIH1529MH. INBH Impair: Bact, N, HC, DO.

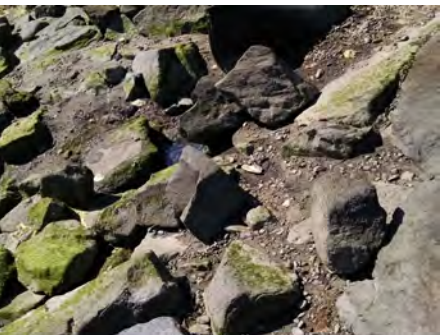
DW: No flow, No issues. WW: Almost all samples were affected by tidal backwash. WW rank (one sample): Bact (1), Amm/Nitrates/Surf (1 ea), Total 4. WW Recommend: Recommend WW: Continue monitoring FIH1527MH at low tide. Check salinity, if greater than 5.5 move monitoring to FIH1526MH. INBH Impair: Bact, N, HC, DO.

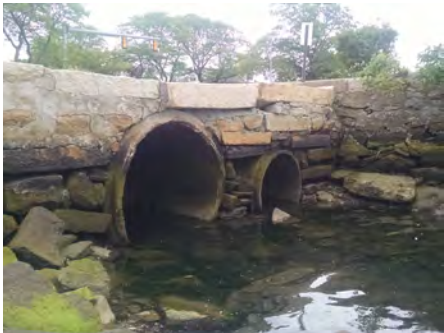
Due to the size of the watershed, it is expected at certain times of the year there will be some DW flow. Current status is unknown as monitoring stations are impacted by tidal backwash. Recommend: Begin evaluating the watershed starting at the Main St MH (FIH1373MH) for both WW and DW. INBH Impair: Bact, N, HC, DO.

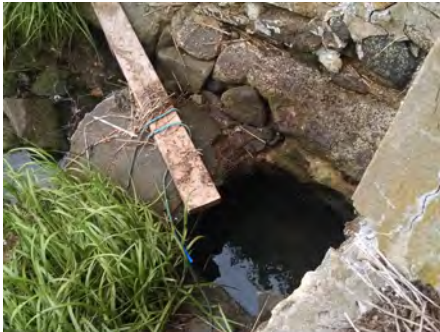
DW: No flow, No issues. WW: Almost all samples were affected by tidal backwash. WW rank (one sample): Bact (1), Amm/Nitrates/Surf (1 ea), Total 4. WW Recommend: Move monitoring site to FIH2200CB. INBH Impair: Bact, N, HC, DO.

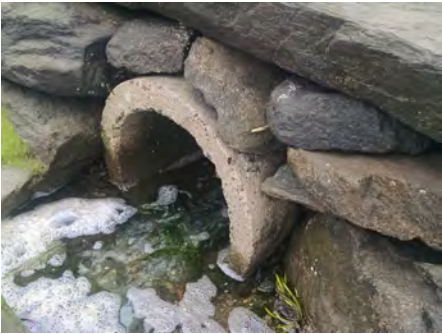
DW: No flow, No issues. WW: FIH2238CB is a "filtered" Catch basin, need to obtain info re function and maintnace. Only option is to monitor pipe as CB is inaccessible. Recommend: Continue monitoring for WW. WW rank (based on 1 sample) Bact (2), Nitrates/Surf (1 ea), Total 4. INBH Impair: Bact, N, HC, DO.

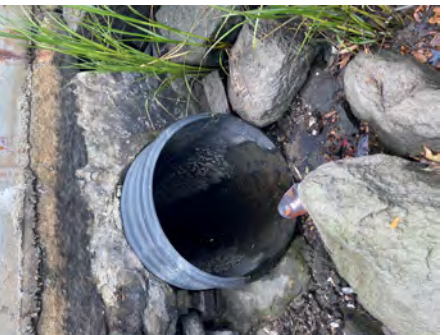
DW: No flow, No issues. WW Rank: (1 sample), Bact (1), Amm/Nitrates/Surf (1 ea). Total 4. WW Recommend: Check salinity of FIH2292CB. If less than 5.5 monitor, if greater than 5.5 then monitor both FIH2293CB and FIH1428CB. INBH Impair: Bact, N, HC, DO

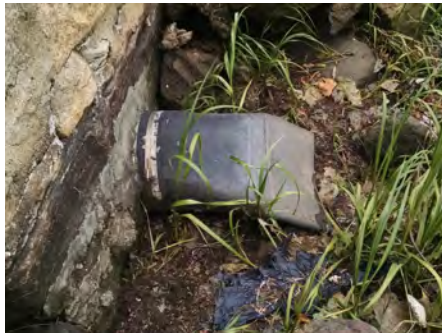
DW: No flow, No issues. WW: The stormwater is being filtered through a rain garden. Based on 1 fresh water sample, WW Rank: Bact (2), Nitrates/Surf (1 ea), Total 4. WW Recommend: Make notes of drainage characteristics during rainfall. Is stormwater discharging into the RG or bypassing and flowing directly into CB, Is it infiltrating down through the RG or bypassing and flowing directly from inflow to the FIH2316CB. Monitor FIH1129PI, FIH2316CB, outflow from RG to CB, and the inflow to the RG. Possible that the filter is creating a problem with bacterial growth. INBH Impair: Bact, N, HC, DO.

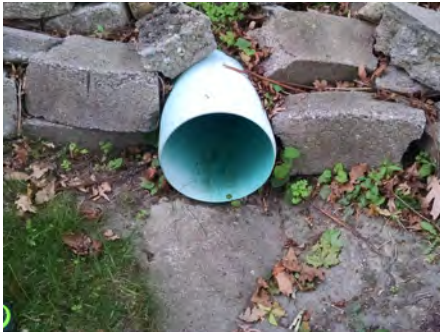
DW: No flow, No issues. WW rank: Based on 2 samples Bact(1),Nitrates/Surf (1 ea), Total 3. Due to the location of this discharge, would rate this as a low priority. INBH Impair: Bact, N, HC, DO

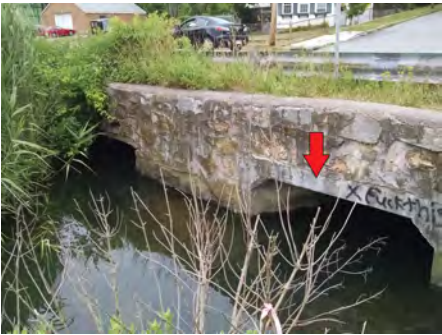
Based on drainage characteristics (stormwater plus stream flow), it is expected that during dry weather, this discharge point will almost always have flow. The monitored pipes were not under free-flowing conditions and were taken in the sumps. At this point, the drainage area is divided into 3 sections. The evaluations were based on either 1 or 2 samples on various dates. Sect 1 all the drainage including the stream flows, Sect 2 Magnolia, southeast Sycamore and Veron (including stream flow on Vernon (2A)) and Sect 3 southwest Sycamore. Sect 1 DW: 1 Sample, Ranking: Bact (1) Nitrates (1) Total 2. WW Rank: Bact (2), Nitrates/Surf (1 ea), Total 4. Sect 2 DW: Bact (1), Nitrates/Surf (1 ea), Total 3. WW:Bact (2), Nitrates/Surf/Amm (1

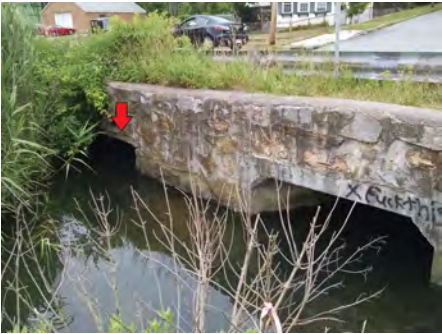
2 WW samples, one at pipe, one in sump in MH. WW Rank: Bact (1), Nitrates/Surf (1 ea). Total 3. Recommend: Continue monitoring at the same time at FIH1153PI. INBH Impair: Bact, N, HC, DO

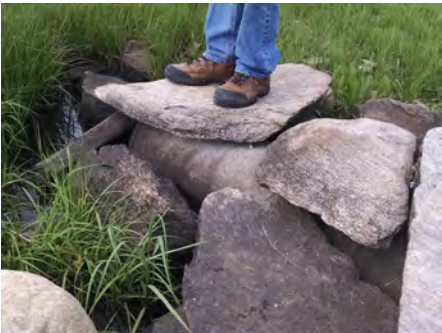
DW: No flow, no issues. WW: High levels of bact and elevated nitrates and surfactants indicate potential ID. WW ranking: Bact (2), Nitrates/Surf (1 ea). Total (4) . WW Recommend: Continue monitoring and investigate for potential ID. NB Impair: Bact.

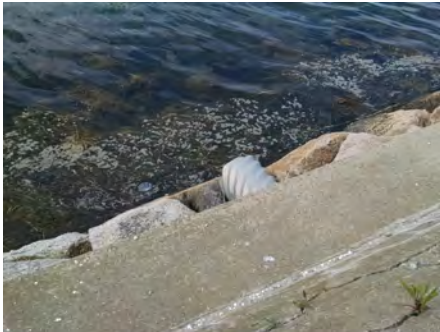
DW: No flow, no issues. WW Rank:(1 sample), Bact (1) Total 1. WW Recommend: Continue monitoring during WW. NB Impair: Bact.

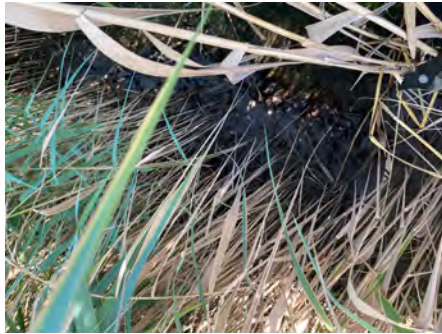
See FMR1015PI. FMR1017 is Drainage System #2 to FMR1015PI. Recommend (DW and WW): Monitor pipe, if not free flowing, monitor FMR1083CB, check salinity, if less than 5.5 monitor at that CB, if greater than 5.5, monitor next upstream structure...FMR1082CB, FMR1088CB. NB Impair: Bact

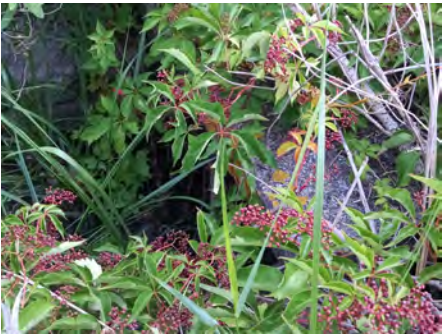
Stormwater runoff from Raymond St is treated in a series of Stormtreat systems. Recommend (DW and WW): Monitor inflow at FMR1023MH and outflow FMR1027PI consecutively. LB Impair: Bact
