**The Buzzards Bay Stormwater Collaborative
Illicit Discharge Investigation Trailer**

Town of Mattapoisett Report

June 2023

Mattapoisett IDDE Report

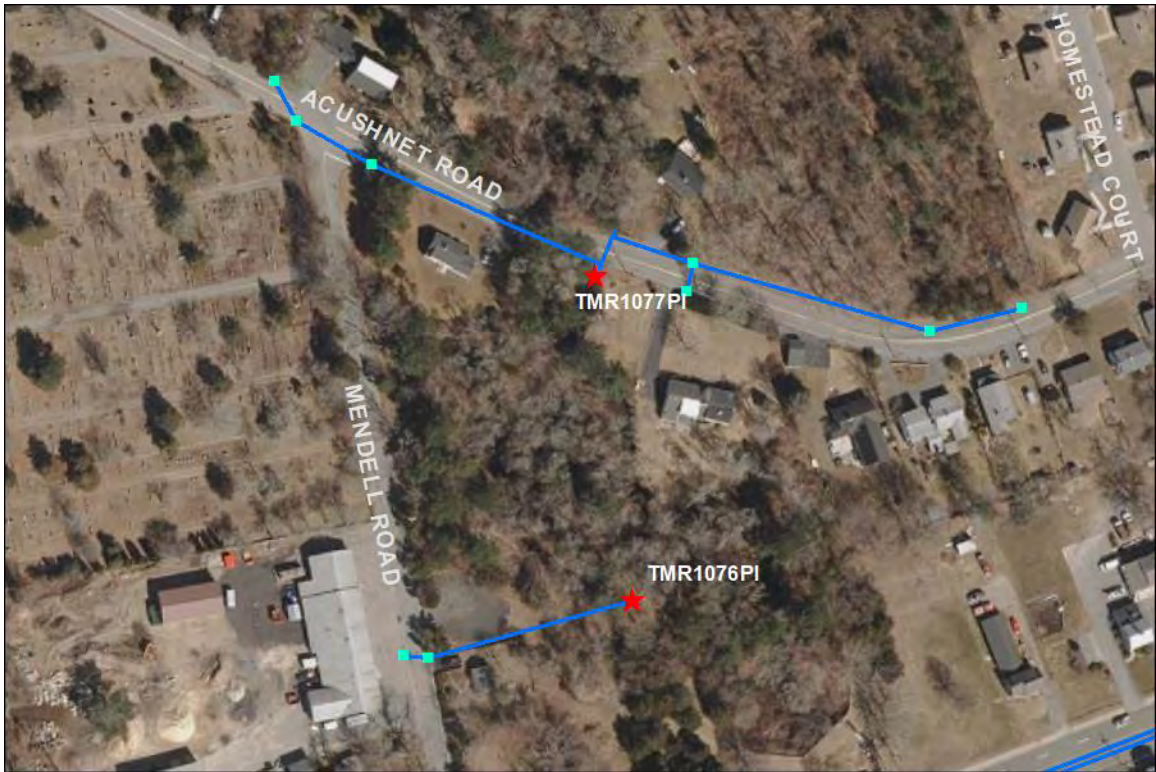
TMR1076PI – Mendell Road: No issues found; note that vehicle washing in front of the DPW garage will enter this system, recommend avoiding the use of detergents and address spill prevention. TMR1077PI – Acushnet Road: No issues found; the pipes from both directions enter into the culvert for Tub Mill Brook.

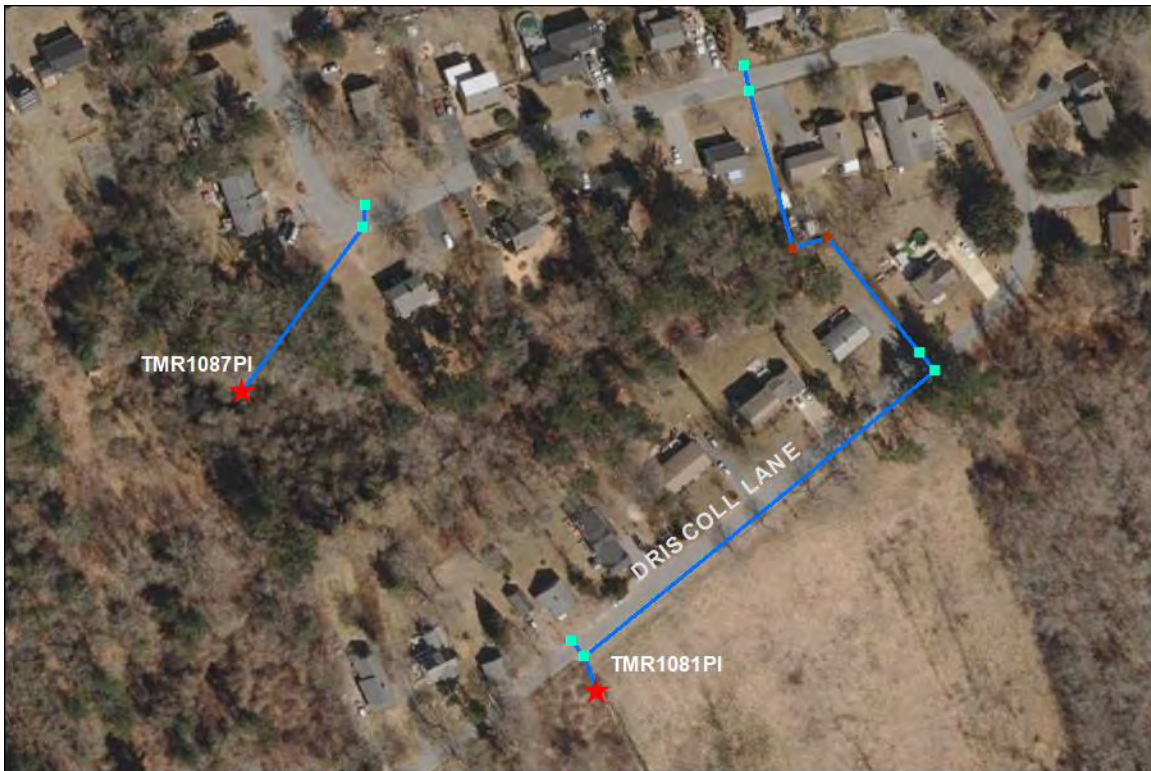
TMR1087PI and TMR1081PI – Driscoll Lane: No issues found; the two manhole junctions shown behind homes have concrete covers and could not be inspected; several sump pump drains were observed but none were flowing; the ground water flow at outfall TMR1081PI was tested for detergents but none were detected.

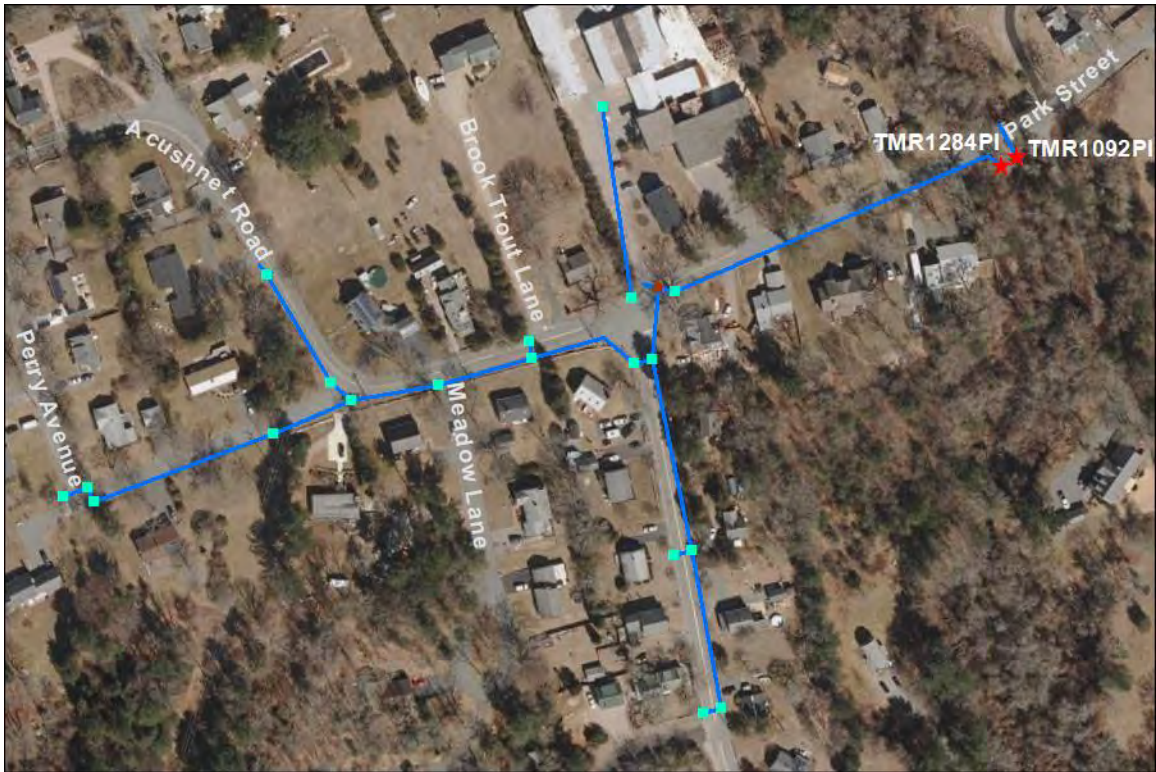
TMR1092PI (culvert) and TMR1284PI (outfall) – Park Street: No issues found; the boat yard appears to drain into this system; several dead-end pipes observed that are perhaps installed for future drain expansion.

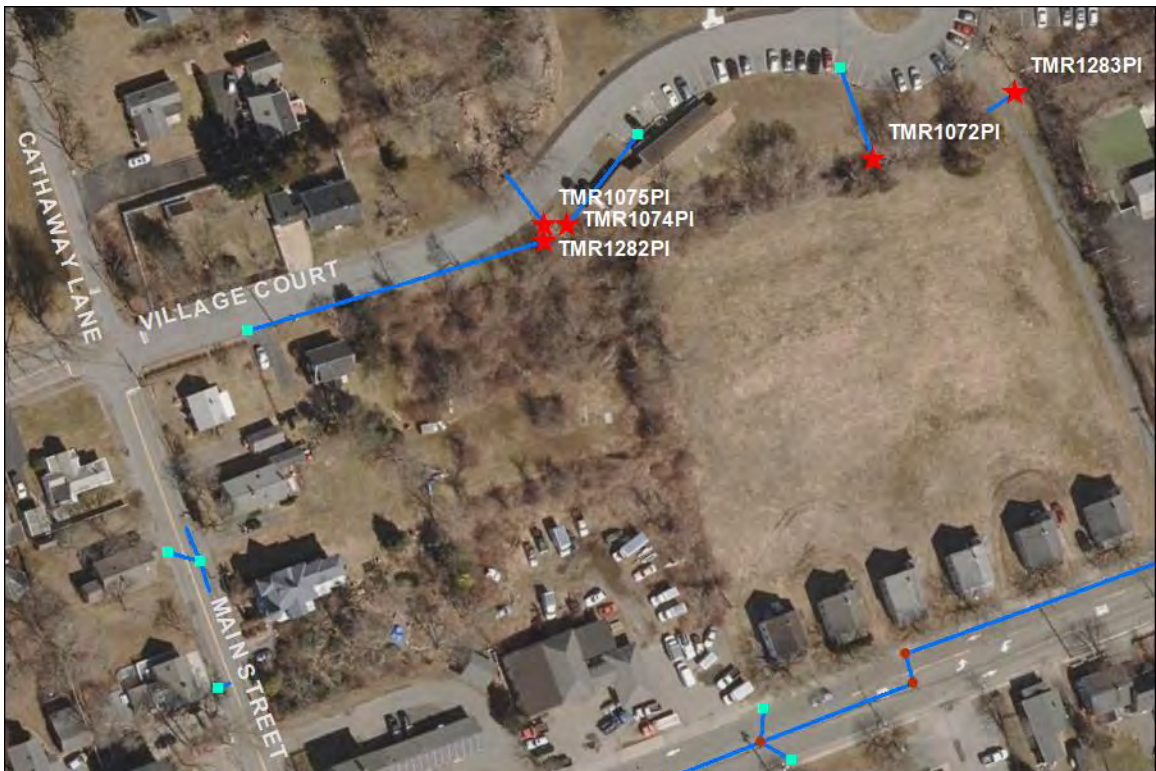
Housing Authority at Village Court: No issues found; TMR1075PI and TMR1283PI are simple culverts; TMR1074PI and TMR1072PI drain one catchbasin each; TMR1282PI could not be found; Main Street may connect to Route 6.

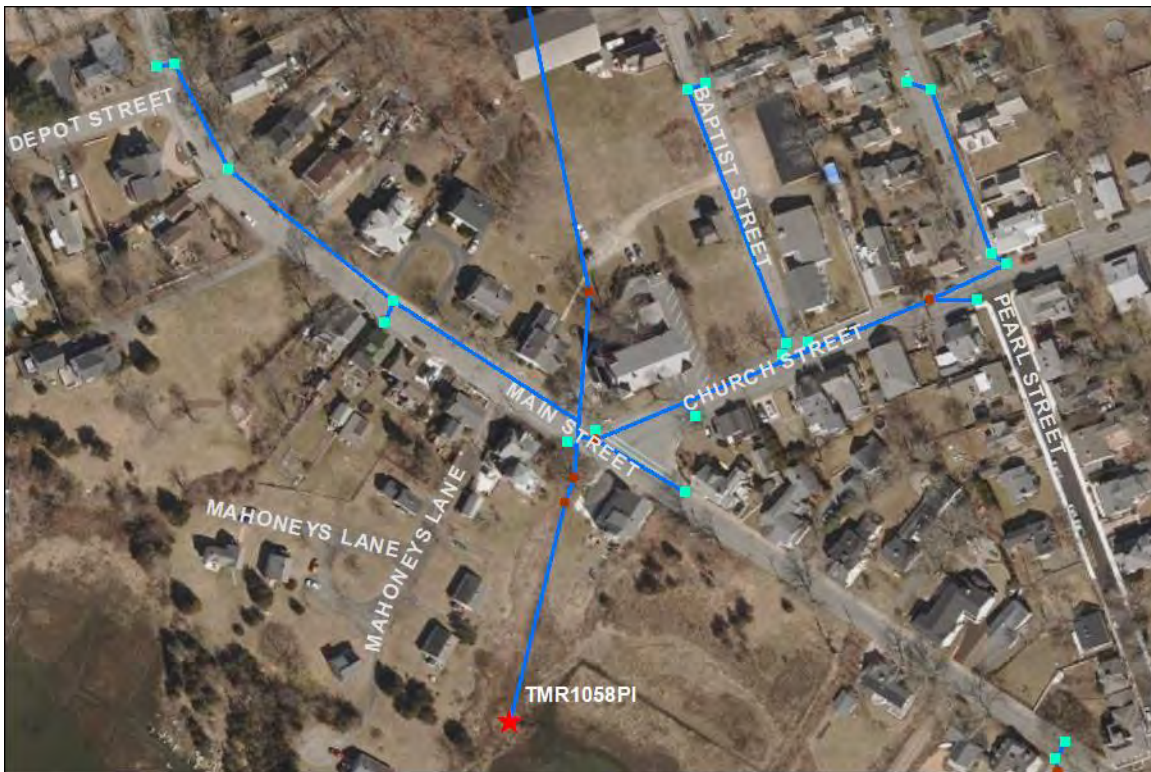
TMR1058PI – Main Street: No issues found; this is an extensive network and cumulates into a covered culvert with several pipes entering it across Main Street; catchbasins on Church Street and Baptist Street require cleaning.
