**The Buzzards Bay Stormwater Collaborative
Illicit Discharge Investigation Trailer**

Town of Westport Report

August 2022

Westport IDDE Report

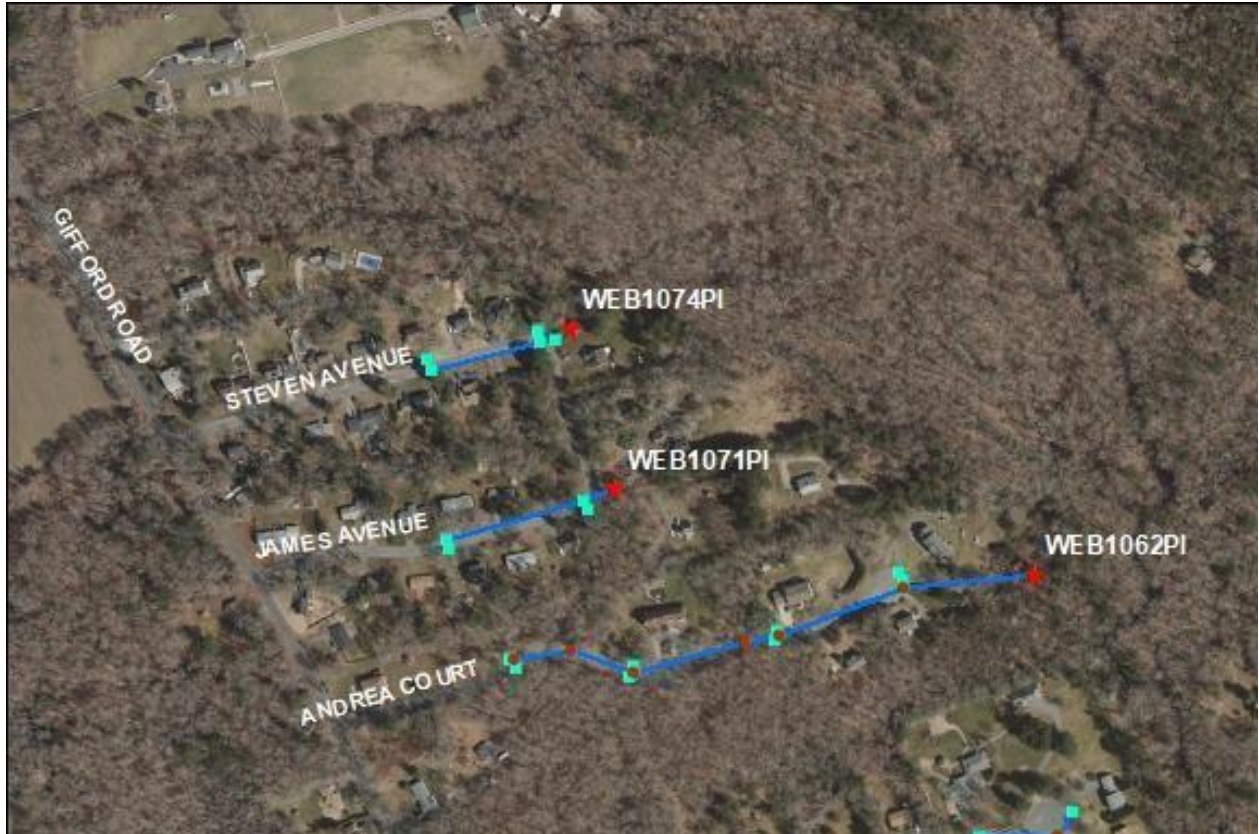
WEB1074PI - Steven Avenue, WEB1071PI - James Avenue, and WEB1062PI - Andrea Court: No issues found. The stormwater manholes on Andrea Court are labeled "SEWER".

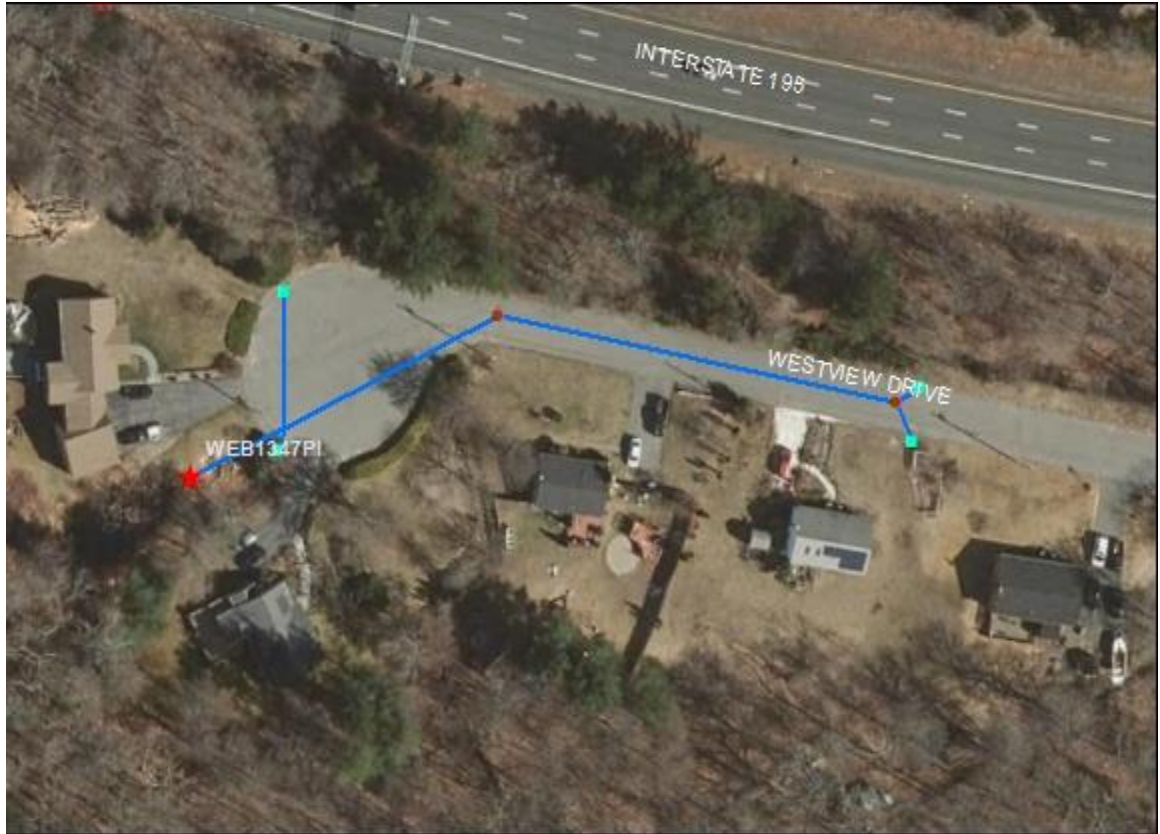
WEB1347PI- Westview Drive: No issues found.

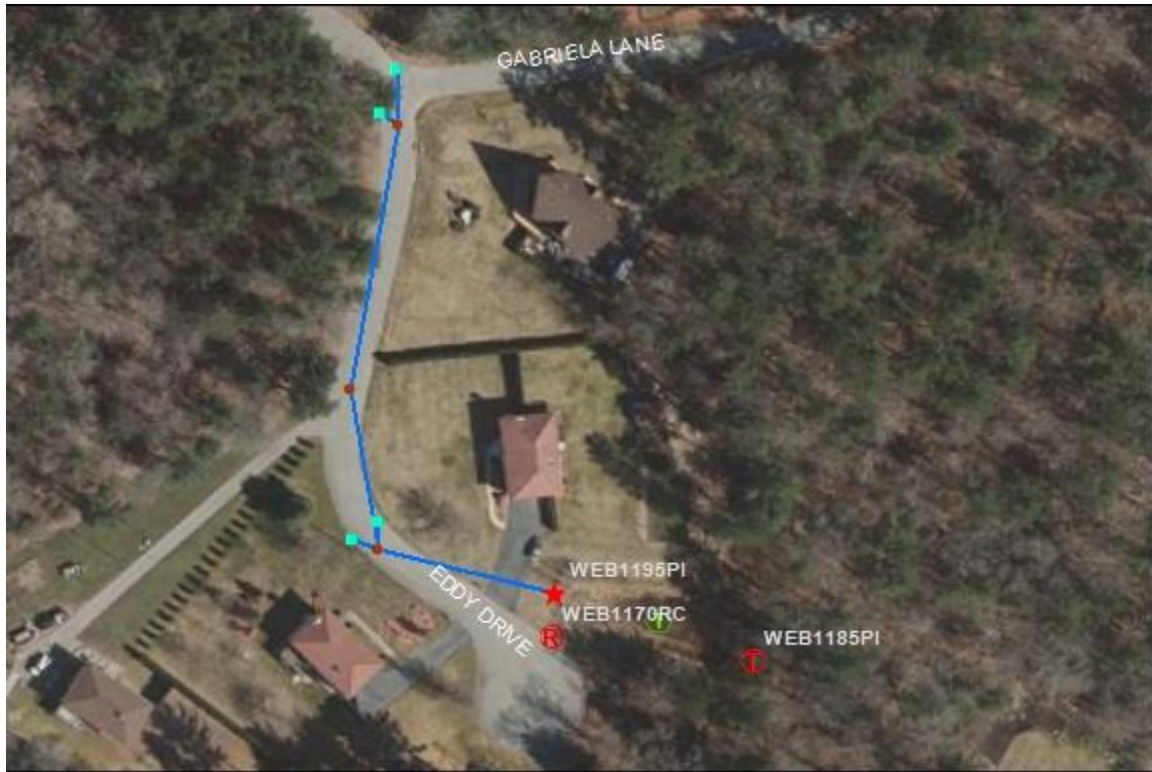
WEB1195PI and WEB1185PI- Eddy Drive: No issues found.

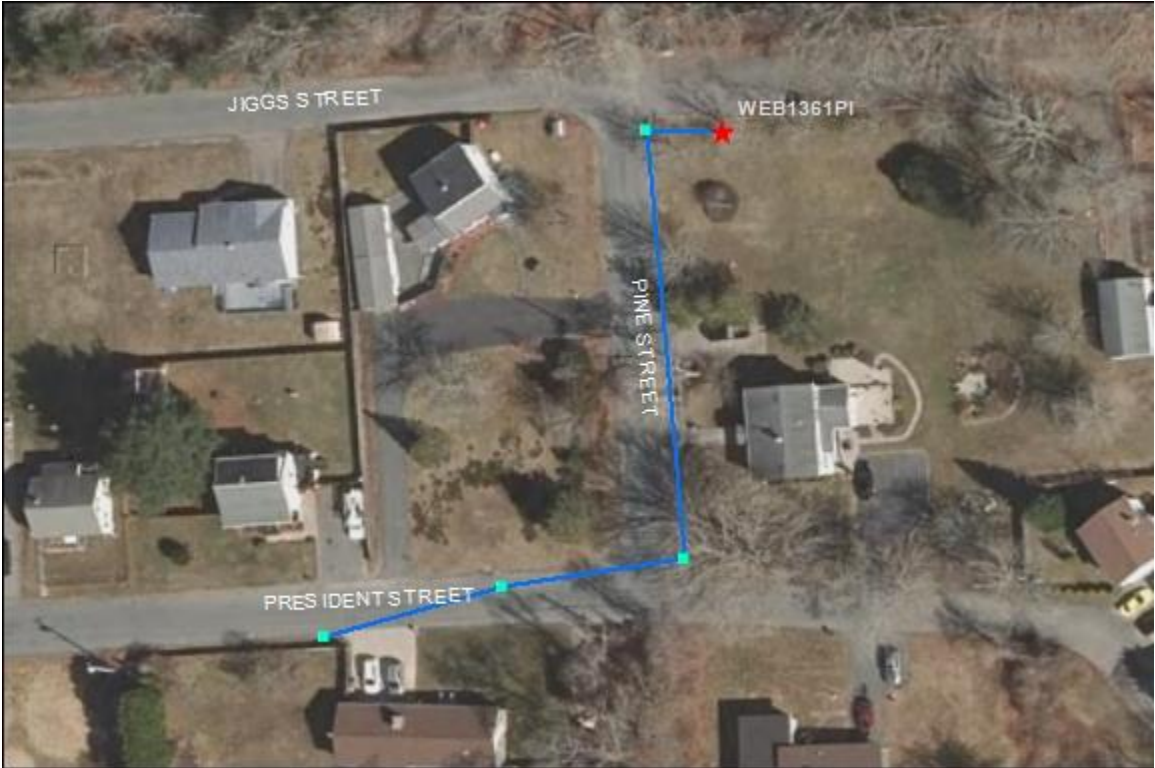
WEB1361PI- Pine Street and Presidents Street: No issues found. Pipes not shown have been blocked intentionally from catchment.
